Structural Report

Marine Buildings
Penarth Marina
Penarth

Structural Report On

Marine Buildings, Penarth Marina, Penarth

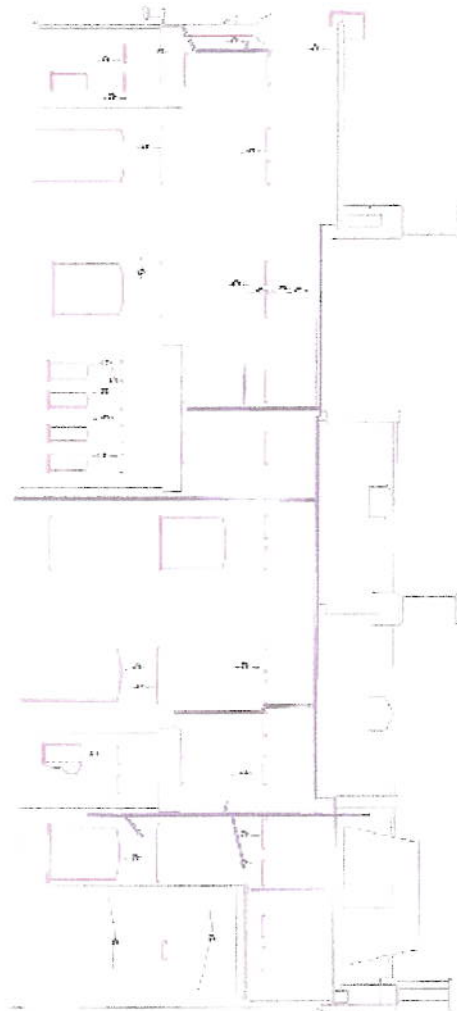
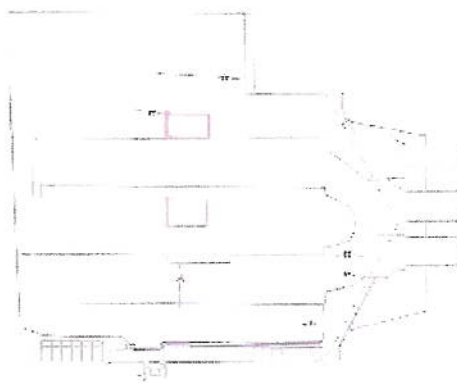
There is evidence of delamination to the face of the brickwork throughout, particularly around the down pipe areas (refer to sketch MH/SK100).

FACE OF BRICKWORK DELAMINATED
-

B PLANT GROWTH
-

S SPALLING
-

C CRACK

All external walls require a considerable amount of remedial work to restore their structural integrity including replacement of all timber lintel and any timber work embedded in the walls.

The possibility and practicality of restoring the facing brickwork should be discussed with a specialist on these matters.

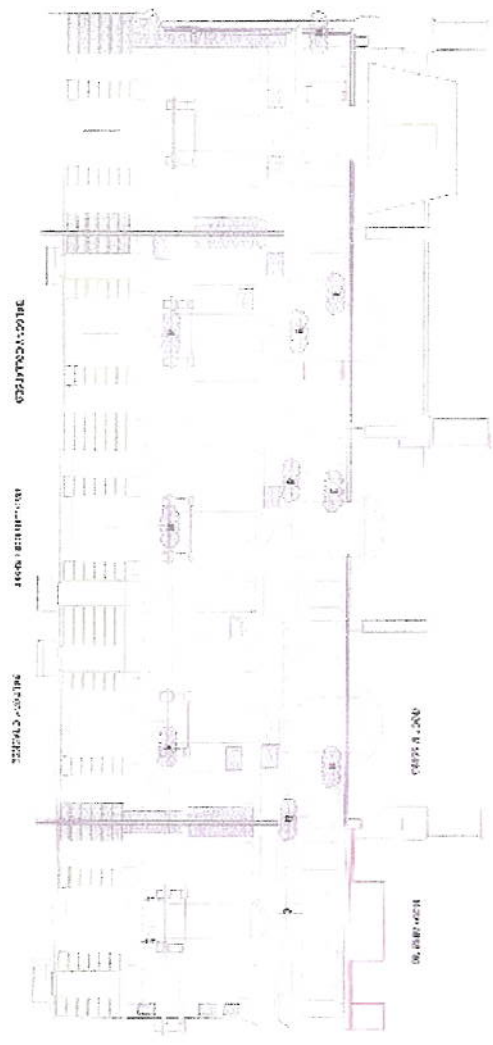
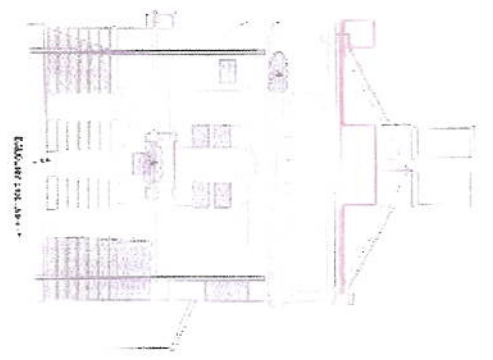
All of the windows have been boarded up. The complete elevation has been rendered over and there are numerous cracks and areas of spalling throughout (sketch SK/101). The general condition of the wall is very poor and there are cracks over the head of all windows/doors.

FACE OF BRICKWORK DELAMINATED
-

B PLANT GROWTH
-

S SPALLING
-

G CRACK
