# Tree Survey, Categorisation & Constraints Plan

in accordance with  
BS: 5837 2005 (Phase One)

The Former Barry Docklands

Dated June 2009

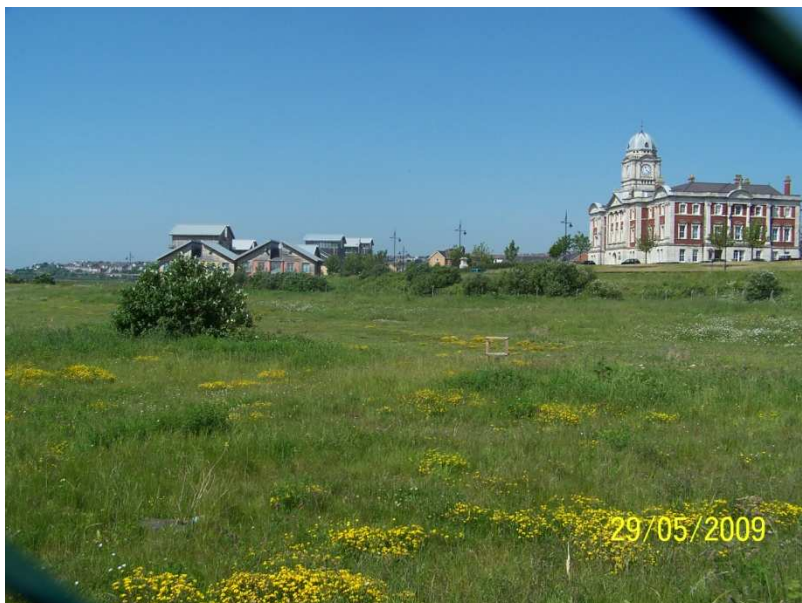
**Picture One**

Open grassland

Small amount of scrub (buddleia)  
in background

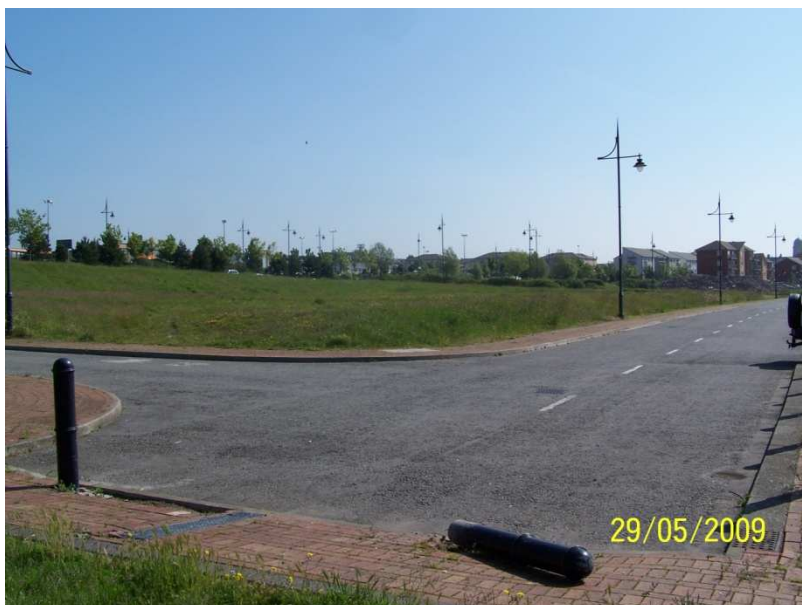
**Picture Two**

Group 2 on the skyline forming a  
roadside planting

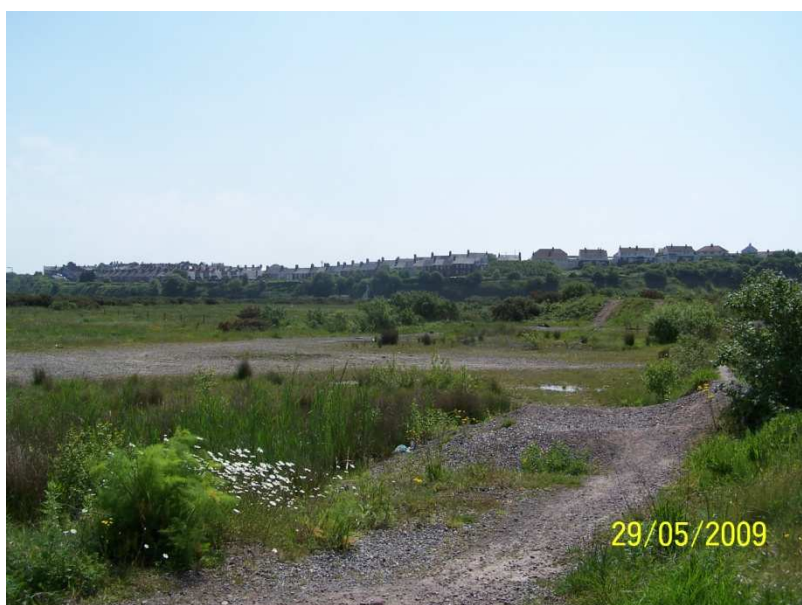
**Picture Three**

Open grassland with some scrub  
on concrete mounds

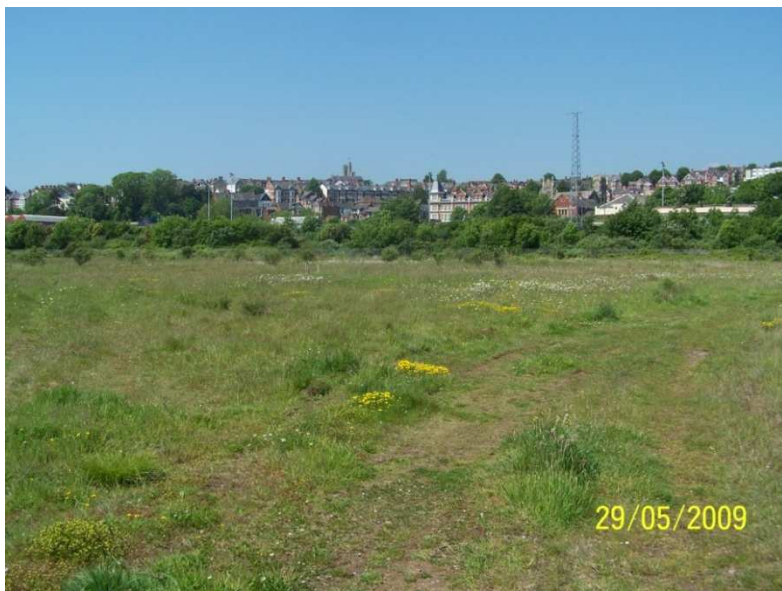
**Picture Five**

Group 3 developing in the background and screening into the site just beginning to form

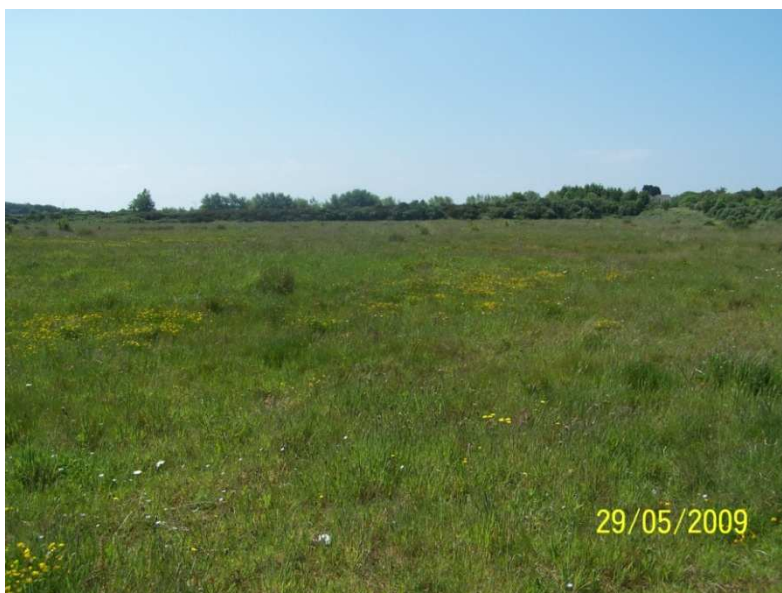
**Picture Six**

Group 4 left of centre in background and part of group 3 to the right of centre

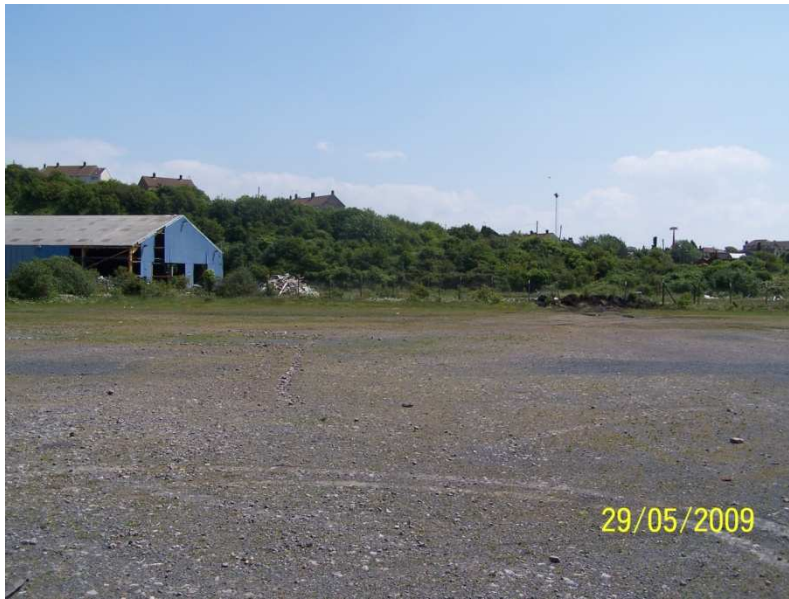
**Picture Seven**

Group 5 comprises of young material predominantly Hawthorn and buddleia

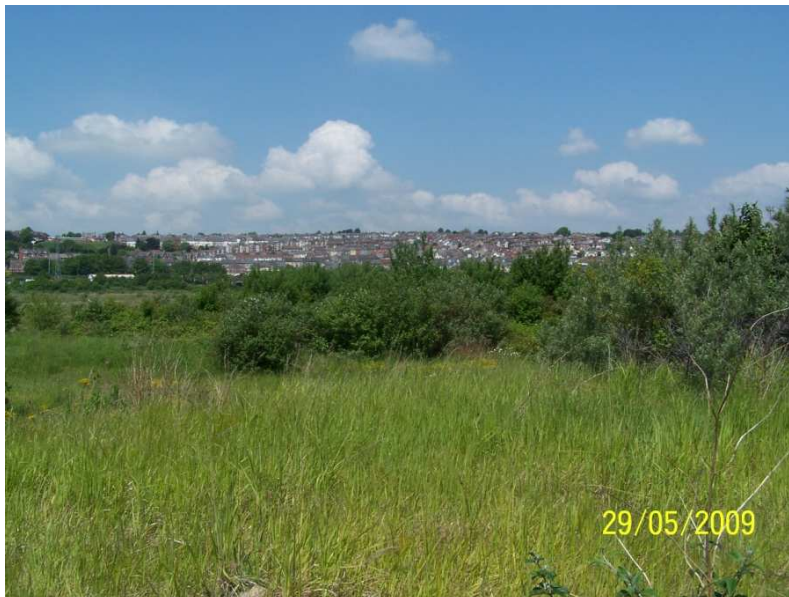
**Picture Eight**

Scrub Developing on mounds of industrial spoil

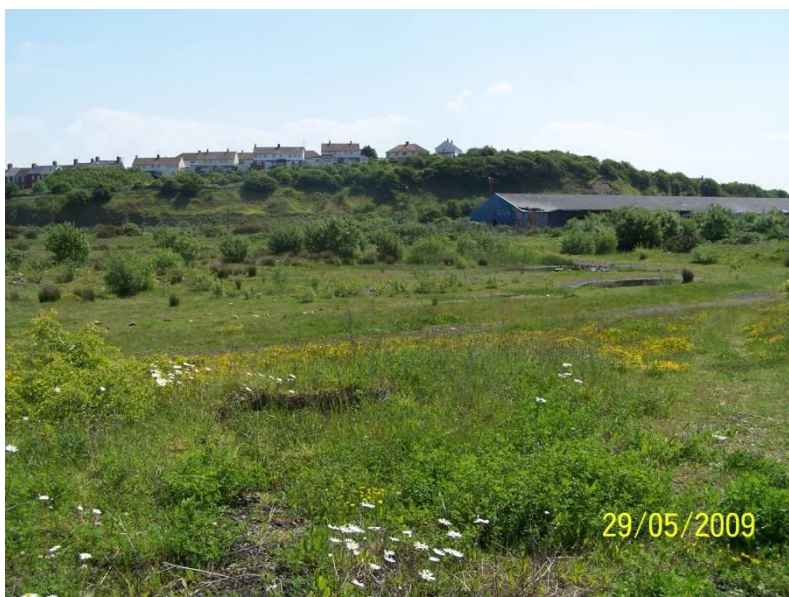
**Picture Nine**

Looking across Area C to the Tank Wash Building with Area D on the slopes to the rear. The houses along Clive Road are pictured on the skyline.

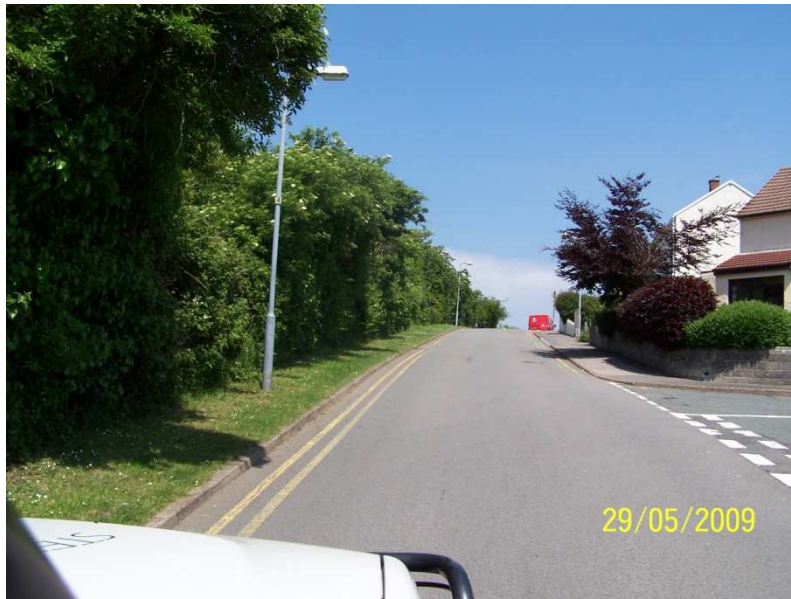
**Picture Ten**

Area D pictured to the left when  
viewed from Clive Road

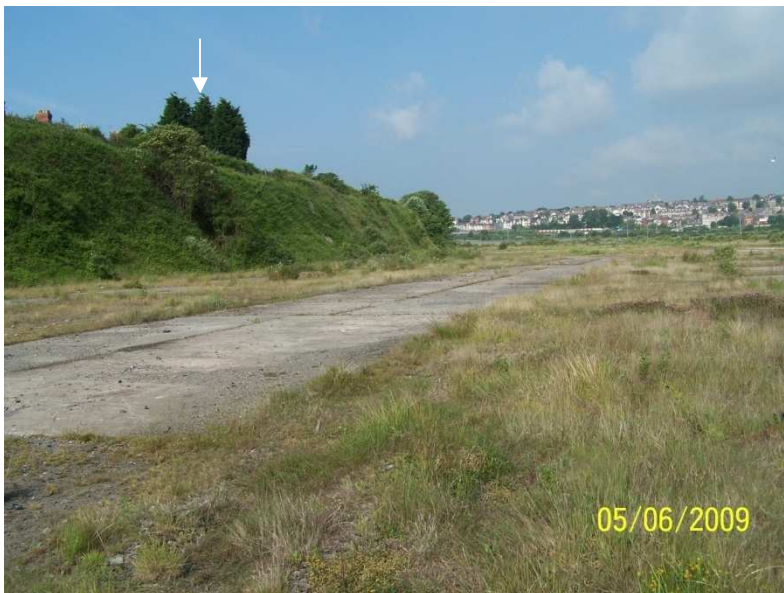
**Picture Eleven**

Looking West across Area E.  
(white arrow indicates Group  
Eight)

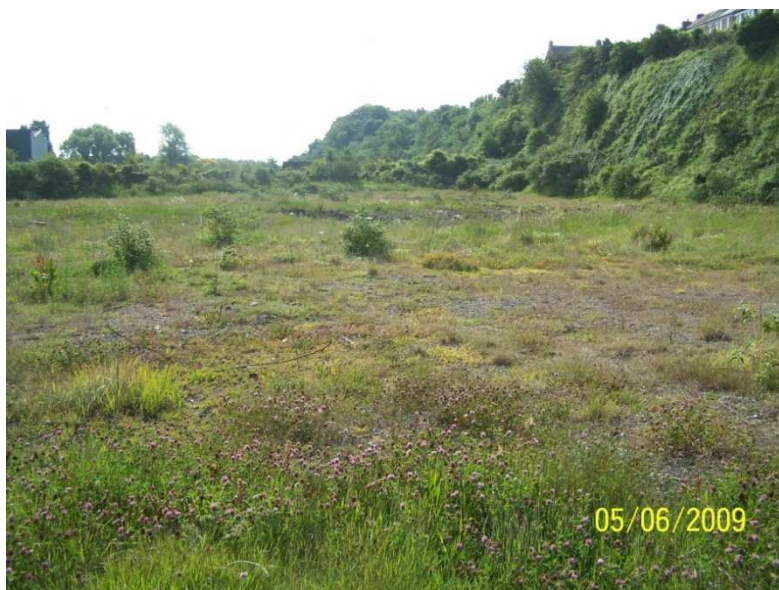
**Picture Twelve**

Looking East across open  
grassland to the scrub developing  
on the lower slopes of Area D

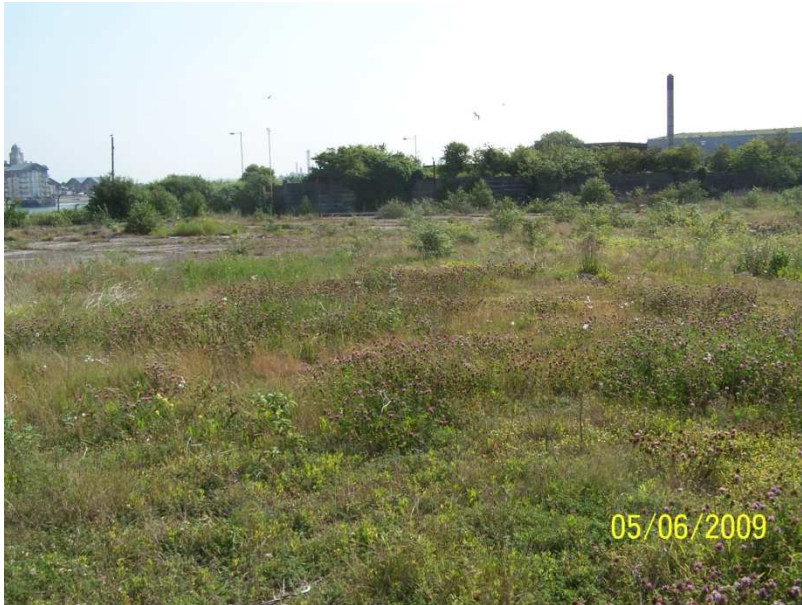
**Picture Thirteen**

Pictured at the rear of the site is a concrete fence and boundary to the now redundant dockland building. Scrub is developing against the fence on the outer side and on a mound of concrete spoil on the inner side.

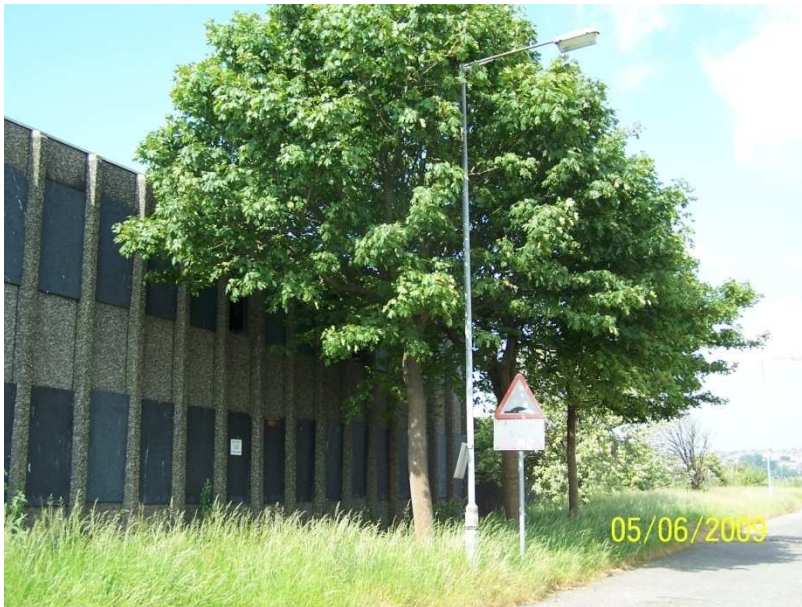
**Picture Fourteen**

Group Nine	Norway maple (Acer platanoides)	10	4	4	8	8	300	2.0	EM	F	F	A row of 3 maples to the frontage of the former industrial unit. They are in reasonable condition, perhaps a little low in vigour. <ul style="list-style-type: none"><li>No action necessary at this time</li></ul>	10-20	C1	3.6

3 Norway Maples to the frontage of the former industrial complex against the former access track of Charles Darwin Way

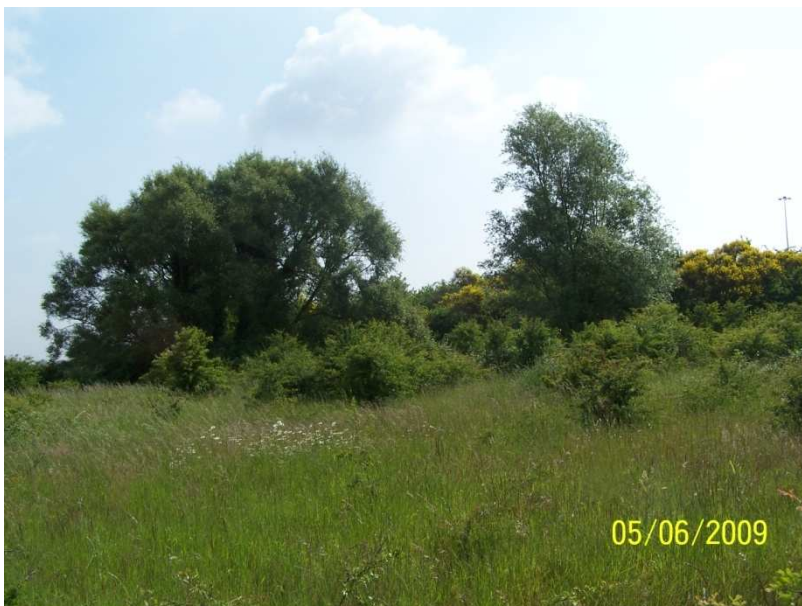
**Picture Fifteen**

Tree Number	Species	Height	Branch Spread				Effectual Diameter	Crown Clearance	Age class	Physiological Condition	Structural Condition	Notes	Remaining Contribution Years	Category	Protection Radius in M
			N	S	E	W									
Group Ten	2 White willow ( <i>Salix alba</i> )	16	8	8	10	10	500	1.0	M	F *	F *	2 or 3 mature willow trees. Unable to get access to assess base due to dense bramble and dog rose and therefore this assessment is provisional*  • <b>Clear bramble and dog rose and the Ivy from the main stem and re-inspect</b>	10-20	C2 *	6.0
Group Eleven	Wild cherry ( <i>Prunus avium</i> )	5	-	-	-	-	200	1.0	EM	G	F	A stand of early mature cherries planted in a tight group forming part of an early landscape scheme on the site.  • <b>No action necessary at this time</b>	20-40	C2	2.4
Group Twelve	Hawthorn ( <i>Crataegus monogyna</i> ), buddleia ( <i>Buddleia davidii</i> ), elderberry ( <i>Sambucus nigra</i> ), Ash ( <i>Fraxinus excelsior</i> ) goat willow ( <i>Salix caprea</i> ) dog rose ( <i>Rosa canina</i> ) & Gorse ( <i>Ulex europaeus</i> )	1-4	-	-	-	-	< 100	0.0	Y	G	G	Predominantly hawthorn although containing a mix of species. Situated on the lower eastern levels and some on the slopes facing north. The larger tree sizes are contained on the slopes and the younger material below 75-mm diameter is found on the level area.  With any developing woodland such as this, a longer term management plan should be formed and intervention management necessary. This however is not necessary at this time.  • <b>No action necessary at this time</b>	20-40	C2	1.2

White willows fairly mature

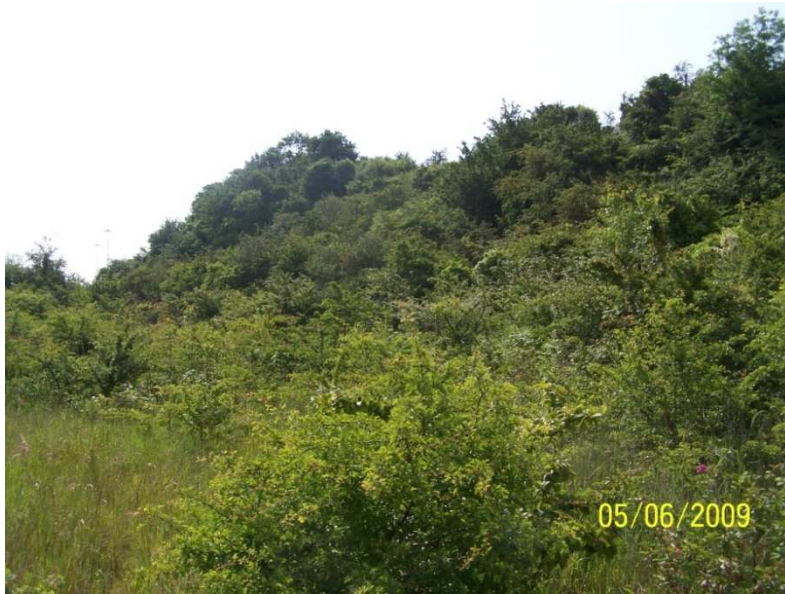
**Picture Sixteen**

An expanse of young hawthorn and other trees and shrubs developing on the level area to the east. Further up the slopes, the mix becomes more diverse and larger in size.

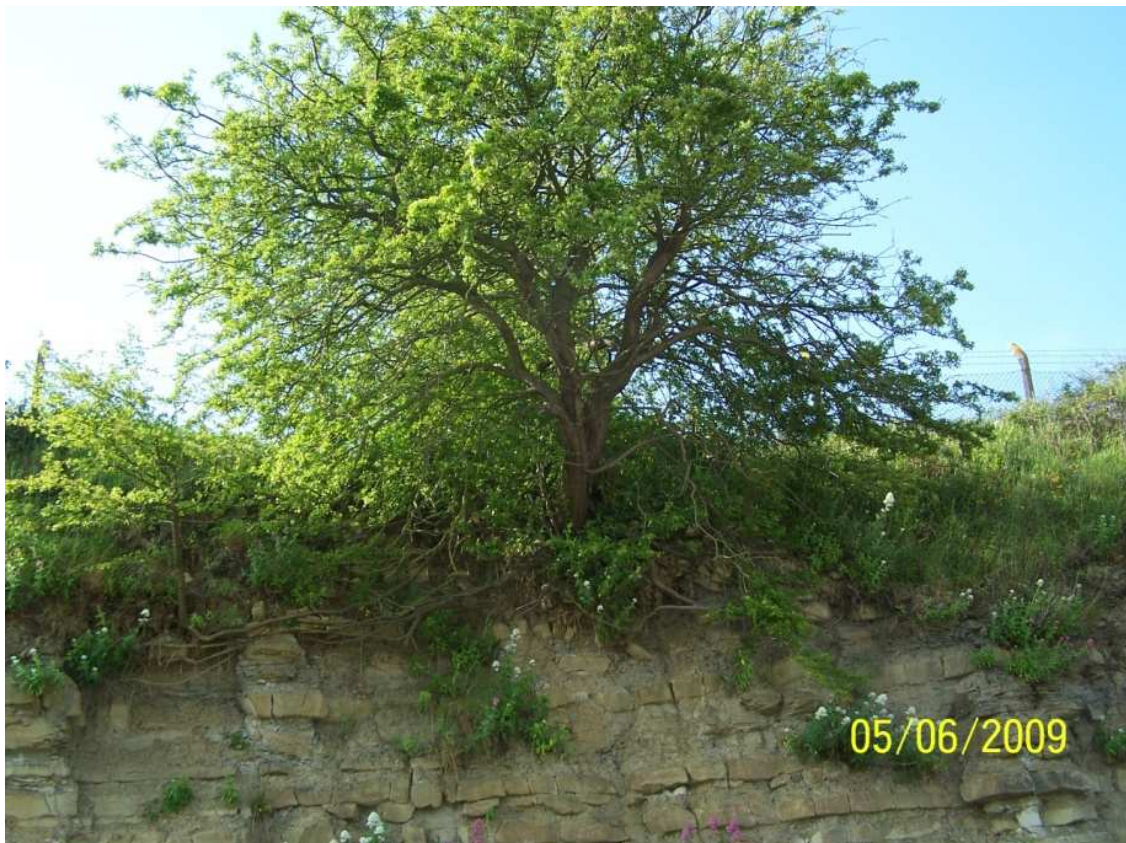
**Picture Seventeen (above)**

A single hawthorn growing from the exposed rock face of Area D. Its exposed tree roots are visible. An unsuitable topography for supporting tree development in the long-term and management will be required to discourage trees establishing in such locations.
