**Waterfront Barry,
Vale of Glamorgan**

Stage 1 Road Safety
Audit

March 2010

Job number 122374-00

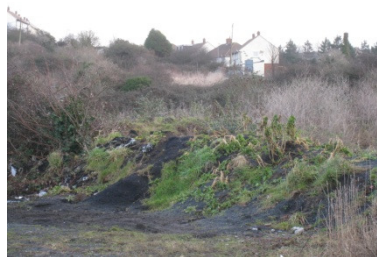
IMG_0528jpg

Description The Paget Road / Plymouth Road junction is significantly elevated above the existing dock area.

Steep grades can limit large vehicle's speed leading to frustration and overtaking conflicts.

Recommendation Ensure the grade does not exceed 6% (Waterfront Barry Link will be a bus route), and that vertical curves do not restrict the forward visibility of junctions.

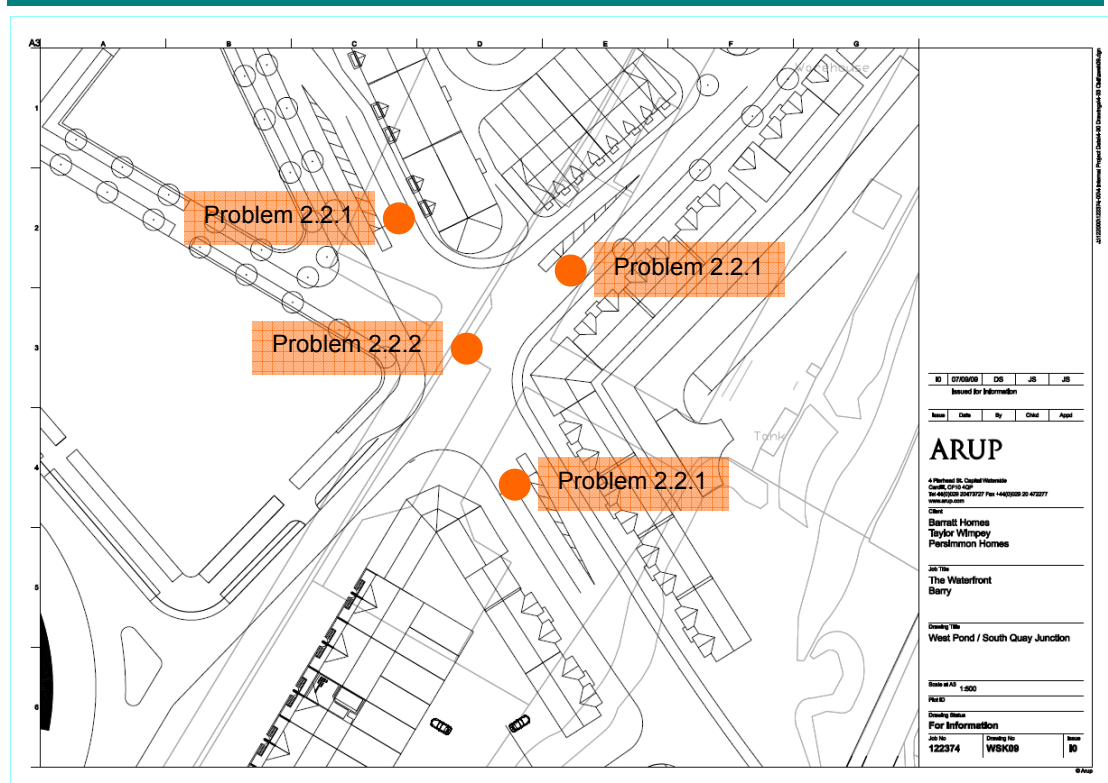
**2.2 Waterfront Barry Link / West Pond / South Quay Junction
(TA Figure 7.7 Drawing WSK09)**

Description The stop lines at the proposed junction are set back a significant distance from the junction centre.

As a result there is a significant distance (approximately 60m) between opposing stop lines resulting in a large expanse of unmarked road surface. This is likely to result in large unused areas promoting the build up of detritus on the carriageway. In addition, some drivers may find the lack of direction here confusing leading to hesitancy.

Description The junction layout is such that it promotes an offside right-turning arrangement.

An off-side right-turning (hooking) arrangement can result in blocking during peak periods which can lead to driver frustration and side swipe accidents if vehicles are poorly positioned.

Recommendation Reduce the size of the junction.

Recommendation Provide additional road markings in the junction as appropriate to assist right turning drivers.

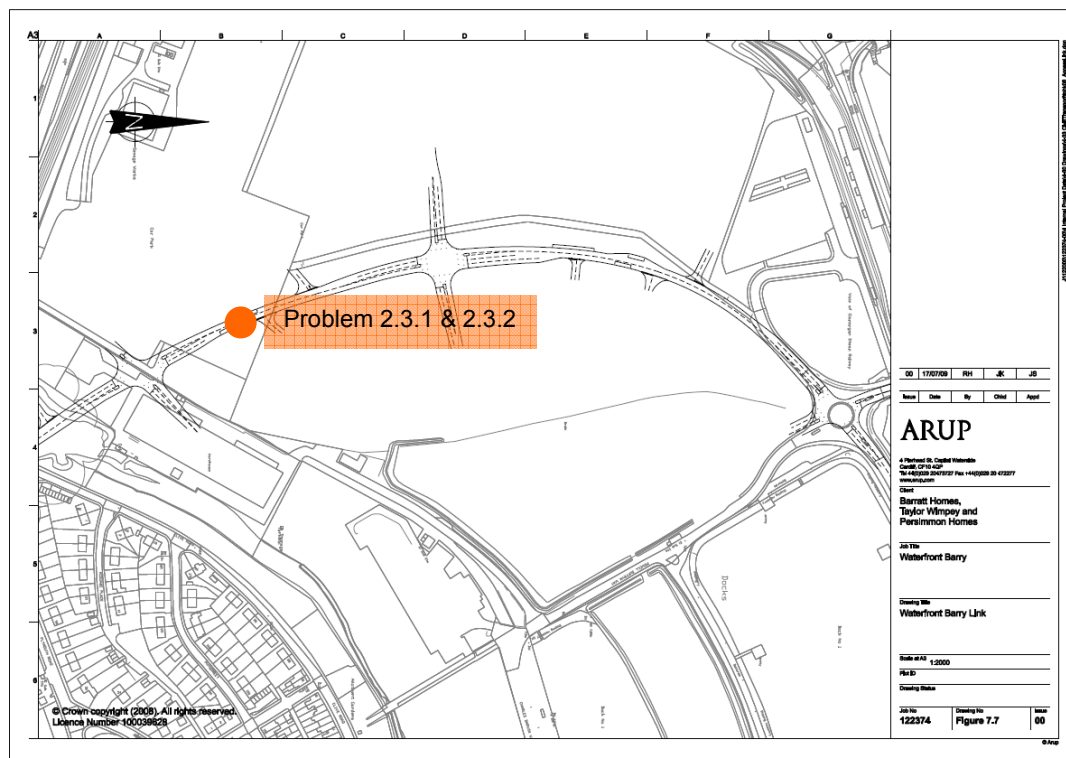
2.3 Waterfront Barry Link between West Pond / South Quay and West Pond / Supermarket junctions (TA Figure 7.7)

Description The eastbound and westbound bus stops on the southern section of the Waterfront Barry Link are located in close proximity to priority accesses serving residential properties.

Recommendation Relocate the bus stops away from the junction.

Recommendation Provide a minimum tail to tail offset of 40 metres to allow traffic to safely pass a stationary vehicle.

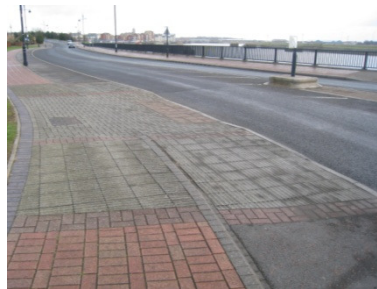
IMG_0554.jpg

Description It is not clear from the proposed arrangement how National Cycle Route 88, currently running alongside the existing junction is to be accommodated.

Cyclists are particularly vulnerable to side swipes at junctions and could be struck while crossing at splitter islands not specifically designed to accommodate them.

Recommendation Include measures to assist cycles at the junction.

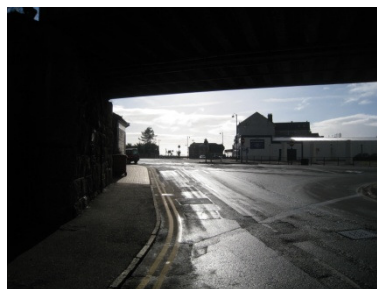
IMG_0495.jpg

Description The Paget Road arm of the junction runs under a railway bridge in the immediate vicinity of the junction. As a result drivers will emerge from the shadow of the bridge as they meet the traffic signals.

As a result the signals may be difficult to see, especially in bright or low winter sun conditions, leading to overrunning of the stop line.

Recommendation Provide backing boards on the traffic signal heads in order to maximise visibility.

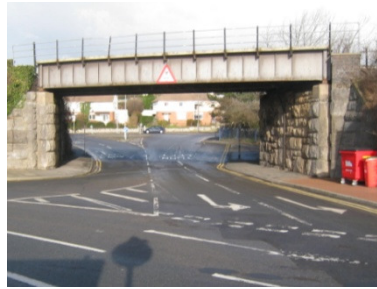
IMG_0486.jpg

Description Paget Road is a bus route and buses currently struggle to turn from Harbour Road without encroaching on the southbound lane. The proposed kerb line will narrow the exit arm.

This could result in sideswipe or even head on collisions on this arm of the junction.

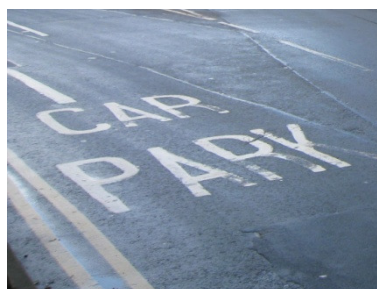
IMG_0521.jpg

Road markings presently directing visitors to the car park are not shown on the proposed road layout.

A lack of adequate direction signing could result in drivers entering the residential streets of Barry Island leading to unnecessary congestion and conflict.

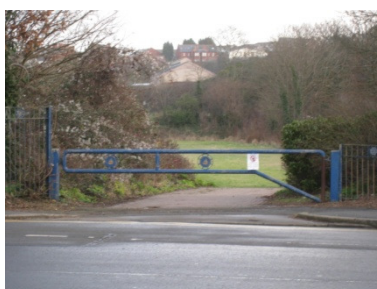
IMG_0518.jpg

The maintenance access to Maslin Park from Paget Road is not maintained in the proposed road layout.

A failure to provide for existing accesses can result in damage to footways and unexpected pedestrian vehicle conflicts.

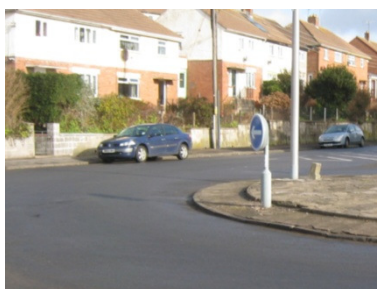
IMG_0506.jpg

There are several properties set around the junction area where, despite parking restrictions, kerbside parking occurs. It is proposed to enlarge the footway in this area which may be attractive for parking.

Parking on footways causes damage leading to trips and falls. Furthermore vehicles joining the carriageway within the controlled junction are unexpected and can present a danger to other drivers.

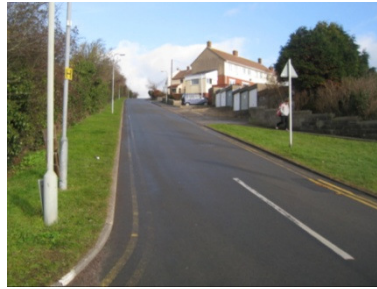
IMG_0510.jpg

Clive Road has a steep grade, and the proposals introduce a priority junction at the foot of the grade.

Steep approaches lead to difficulty braking leading to over-running.

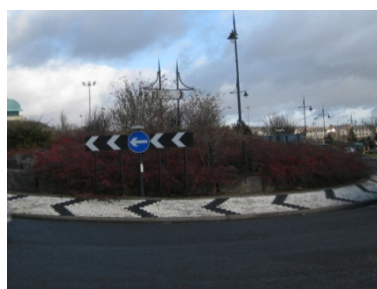
IMG_0567.jpg

There is an excessive amount of vegetation and hard landscaping on the circulatory island of the roundabout

Excessive landscaping blocks visibility for all road users, especially pedestrians who cannot see approaching vehicles, whilst hard landscaping can present a hazard for errant vehicles.

Recommendation Remove the vegetation and hard landscaping.

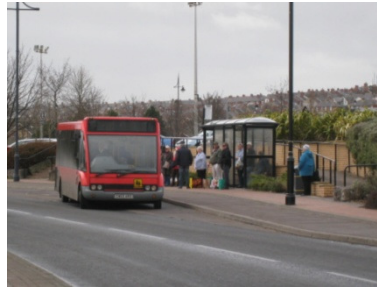
IMG_0604.jpg

Description The proposals appear to show the removal of the existing bus stop lay-by on the north side of Ffordd y Mileniwm, adjacent to Morrison's supermarket.

This bus stop appears well used and removal of the bay would result in an obstruction to traffic, leading to overtaking conflicts on this busy stretch of road.

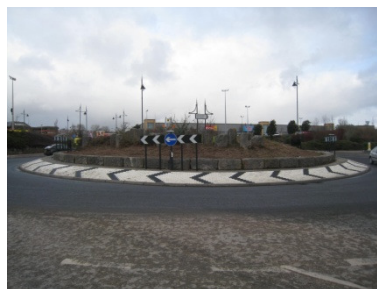
IMG_0599.jpg

There is an excessive amount of vegetation and hard landscaping on the circulatory island of the roundabout

Excessive landscaping blocks visibility for all road users, especially pedestrians who cannot see approaching vehicles, whilst hard landscaping can present a hazard for errant vehicles.

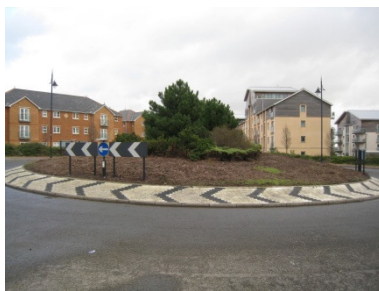
IMG_0646jpg

Description There is an excessive amount of vegetation and hard landscaping on the circulatory island of the roundabout.

Excessive landscaping blocks visibility for all road users, especially pedestrians who cannot see approaching vehicles, whilst hard landscaping can present a hazard for errant vehicles.

Recommendation Remove the vegetation and hard landscaping from the roundabout

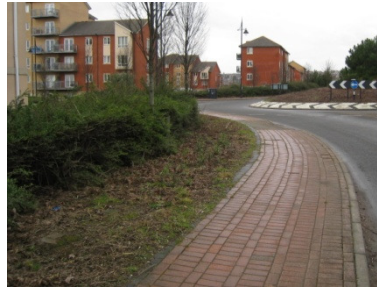
IMG_0666.jpg

Description The widening of the road to the south on the approach to the junction will increase forward visibility.

An increase in forward visibility is likely to result in higher vehicle entry speeds leading to conflicts within the circulatory carriageway, and loss of control accidents, especially on the exit arms.

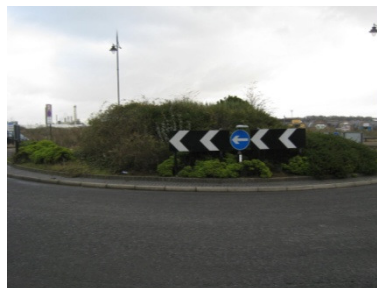
IMG_0670.jpg

There is an excessive amount of vegetation on the circulatory island of the roundabout

Excessive landscaping blocks visibility for all road users, especially pedestrians who cannot see approaching vehicles.

Recommendation Remove the vegetation.

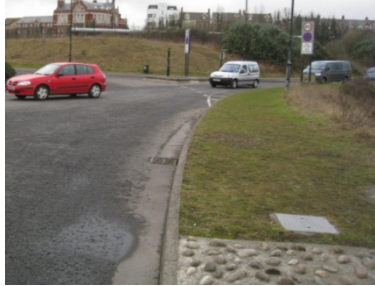
IMG_0690.jpg

Description There is no footway around the eastern side of the junction, between the north side of Ffordd y Mileniwm to the east side of Cory Way.

Cory Way will provide the principal access to the East Quay development area, a predominantly residential development. This is likely to significantly increase pedestrian movements at the junction. Insufficient pedestrian facilities are likely to lead to inappropriate crossing movements resulting in pedestrian vehicle conflicts.

Recommendation Extend the footway on the eastern side of Cory Way to Ffordd y Mileniwm and provide an appropriate pedestrian crossing point on Ffordd y Mileniwm.

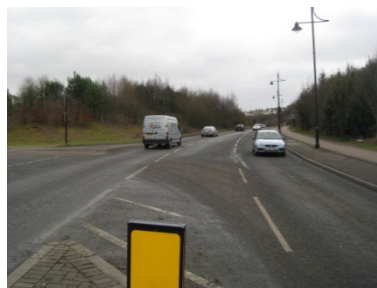
IMG_0717.jpg

The Ffordd y Mileniwm / Wimbourne Road junction is located on a grade 150m inside a 40 mph speed limit.

The junction location is likely to result in high approach speeds on Ffordd y Mileniwm, especially northeast bound traffic. This could lead to over-running the give-way line.

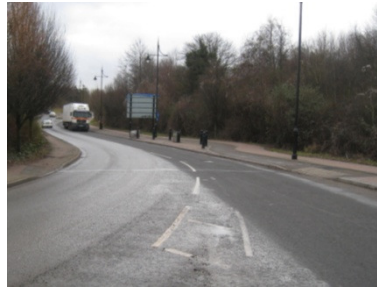
IMG_0745.jpg

Description The proposed slip lane merge would occur coincident with an existing pedestrian crossing point to the southwest of the junction.

Pedestrians crossing in the merge area will be at significant risk from collision with vehicles, as well as facing two streams of traffic, pedestrians will also face drivers who will be concentrating on their merge manoeuvre, rather than the presence of pedestrians.

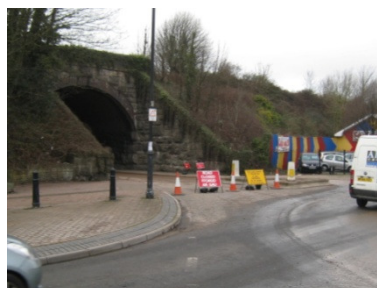
IMG_0748.jpg

The exit lane from the roundabout to Cardiff Road is situated immediately after the Ffordd y Mileniwm entry arm. The location of the splitter island results in a narrow exit lane.

Narrow exit lanes can result in overrunning by larger vehicles placing pedestrians on the footway at risk of collision, particularly for left turning vehicles from Ffordd y Mileniwm.

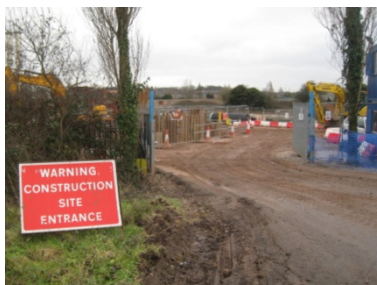
IMG_0735.jpg

Description Welsh Water has a permanent access to the land to the southwest of the junction.

Maintaining the access from the slip lane is likely to result in turning conflicts and shunt type accidents, as traffic on the slip lane will not expect to have to slow until the merge. In addition access traffic would be limited to left in left out, leading to inappropriate u-turns in the vicinity of the junction.

Recommendation Provide an alternative access for utilities.

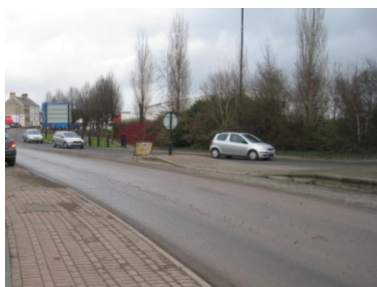
IMG_0757.jpg

Description The proposed slip lane crosses an existing pedestrian crossing point immediately west of the southwestbound diverge point.

The crossing point is situated immediately after the diverge of the slip lane and as a result pedestrians will have to cross two distinct traffic streams placing themselves at greater risk.

Recommendation Ensure there is an appropriately sized refuge between the traffic streams at the crossing, and that pedestrians are aware of the road layout.

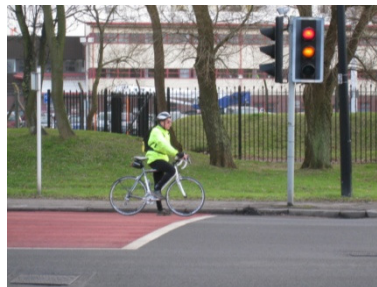
IMG_0762.jpg

Description The proposed junction omits the existing advanced cycle stop lines provided on Cardiff Road at the junction, which is located on National Cycle Route 88.

Cyclists are particularly vulnerable to side swipes at junctions and could be struck while crossing at splitter islands not specifically designed to accommodate them.

Recommendation Replace the cycle stop lines.

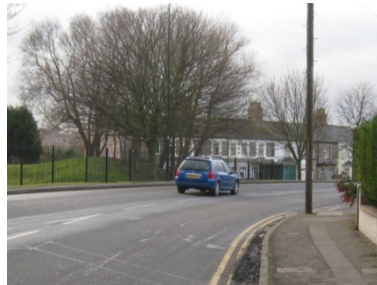
IMG_0789.jpg

Edmund Place on the north side of the Cardiff Road is located such that vehicles waiting to turn right into the road would have to wait within the westbound exit merge.

Vehicles waiting in the merge area are at risk of rear end shunt from drivers concentrating on the merge manoeuvre.

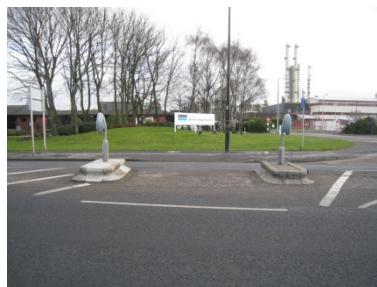
IMG_0769.jpg

The proposed junction affects the removal of the existing refuge on Cardiff Road to the east of the junction. No pedestrian facilities are proposed at the revised junction.

The removal of the pedestrian refuge will be a disbenefit for pedestrians crossing Cardiff Road, increasing the risk of pedestrian conflicts.

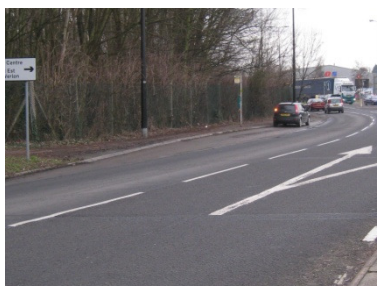
IMG_0862.jpg

Location	Cardiff Road (west)
Summary	Relocation of bus stop
Description	The proposed Left Turn Slip Lane (LTSL) from Sully Moors Road to Cardiff Road would require the relocation of the existing bus stop on Cardiff Road.

Repositioning the bus stop in the vicinity of the merge could result in rear end shunts by drivers concentrating on the merge manoeuvre.

Recommendation	Ensure the bus stop is relocated so as to avoid undue influence on the LTSL merge.
-----------------------	--

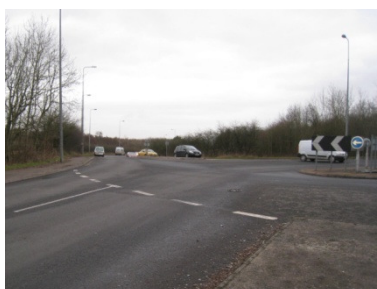
IMG_0908.jpg

Location	Junction
Summary	Poor forward visibility of junction
Description	Moving the junction to the west will reduce forward visibility of junction over the crest from A4231 Barry Docks Link Road.

Poor forward visibility of the roundabout is likely to lead to overshoot accidents at the circulatory carriageway, or rear end shunts on the approach due to late braking.

Recommendation	Ensure adequate forward visibility can be maintained throughout the junction.
-----------------------	---
