**Waterfront Barry, Vale
of Glamorgan**

Stage 1 Road Safety
Audit - Designer's
Response

April 2010

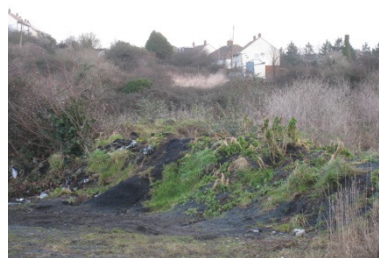
IMG_0528.jpg

Description The Paget Road / Plymouth Road junction is significantly elevated above the existing dock area.

Steep grades can limit large vehicle's speed leading to frustration and overtaking conflicts.

Recommendation Ensure the grade does not exceed 6% (Waterfront Barry Link will be a bus route), and that vertical curves do not restrict the forward visibility of junctions.

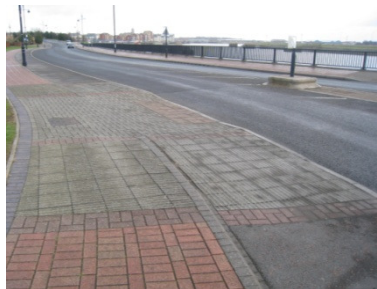
IMG_0554.jpg

Description It is not clear from the proposed arrangement how National Cycle Route 88, currently running alongside the existing junction is to be accommodated.

Cyclists are particularly vulnerable to side swipes at junctions and could be struck while crossing at splitter islands not specifically designed to accommodate them.

Recommendation Include measures to assist cycles at the junction.

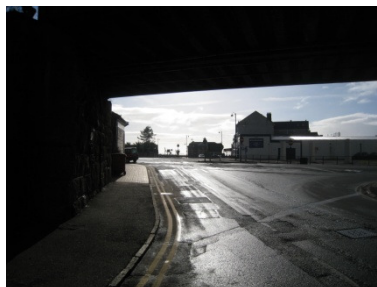
IMG_0495.jpg

Description The Paget Road arm of the junction runs under a railway bridge in the immediate vicinity of the junction. As a result drivers will emerge from the shadow of the bridge as they meet the traffic signals.

As a result the signals may be difficult to see, especially in bright or low winter sun conditions, leading to overrunning of the stop line.

- Recommendation** Provide backing boards on the traffic signal heads in order to maximise visibility.
- Designer's response** Agreed.

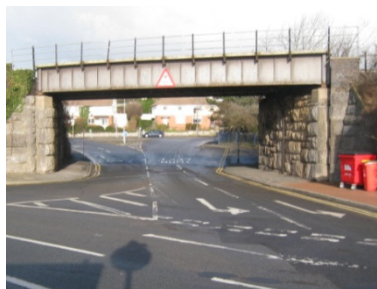
IMG_0486.jpg

Description Paget Road is a bus route and buses currently struggle to turn from Harbour Road without encroaching on the southbound lane. The proposed kerb line will narrow the exit arm.

This could result in sideswipe or even head on collisions on this arm of the junction.

- Recommendation** Ensure the lane markings provided on Paget Road can accommodate buses turning from Harbour Road.
- Designer's response** Agreed.

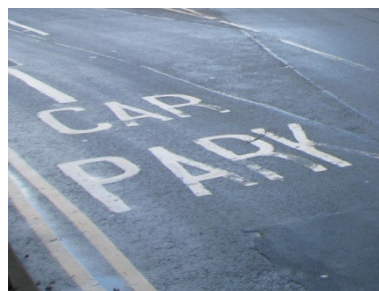
IMG_0521.jpg

Description Road markings presently directing visitors to the car park are not shown on the proposed road layout.

A lack of adequate direction signing could result in drivers entering the residential streets of Barry Island leading to unnecessary congestion and conflict.

Recommendation Provide appropriate traffic signing and/or road markings to guide visitors to the car park.

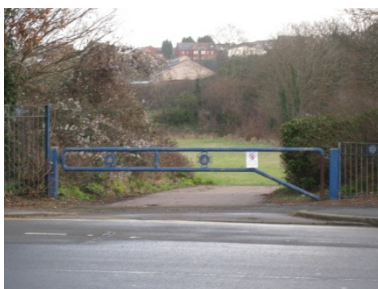
IMG_0518.jpg

Description The maintenance access to Maslin Park from Paget Road is not maintained in the proposed road layout.

A failure to provide for existing accesses can result in damage to footways and unexpected pedestrian vehicle conflicts.

Recommendation Ensure adequate access is maintained for the park.

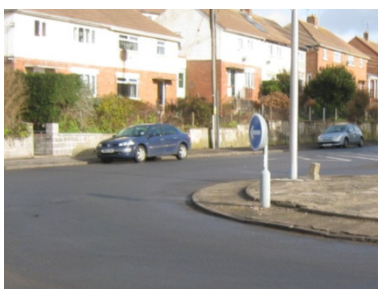
IMG_0506.jpg

Description There are several properties set around the junction area where, despite parking restrictions, kerbside parking occurs. It is proposed to enlarge the footway in this area which may be attractive for parking.

Parking on footways causes damage leading to trips and falls. Furthermore vehicles joining the carriageway within the controlled junction are unexpected and can present a danger to other drivers.

Recommendation Introduce deterrent measures to prevent footway parking around the junction.

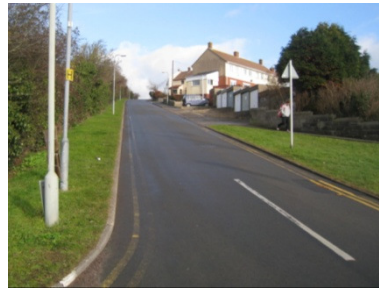
IMG_0510.jpg

Description Clive Road has a steep grade, and the proposals introduce a priority junction at the foot of the grade.

Steep approaches lead to difficulty braking leading to over-running.

Recommendation Provide speed reduction measures and high friction surfacing on the Clive Road approach to the Waterfront Barry Link

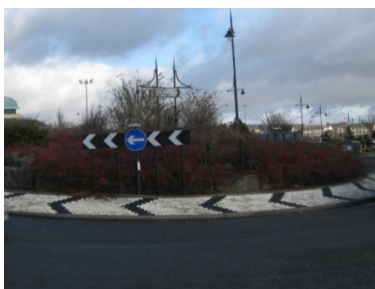
IMG_0567.jpg

Description There is an excessive amount of vegetation and hard landscaping on the circulatory island of the roundabout

Excessive landscaping blocks visibility for all road users, especially pedestrians who cannot see approaching vehicles, whilst hard landscaping can present a hazard for errant vehicles.

Recommendation Remove the vegetation and hard landscaping.

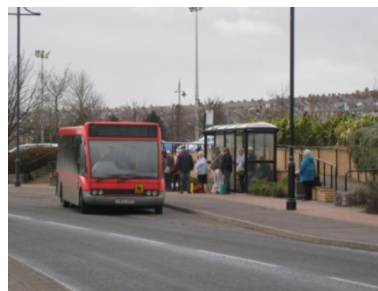
IMG_0604.jpg

Description The proposals appear to show the removal of the existing bus stop lay-by on the north side of Ffordd y Mileniwm, adjacent to Morrison's supermarket.

This bus stop appears well used and removal of the bay would result in an obstruction to traffic, leading to overtaking conflicts on this busy stretch of road.

Recommendation Retain the bus stop bay on Ffordd y Mileniwm.

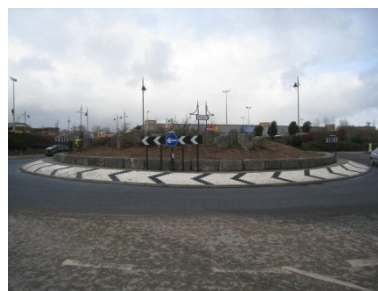
IMG_0599.jpg

Location	Junction
Summary	Heavily landscaped circulatory island
Description	There is an excessive amount of vegetation and hard landscaping on the circulatory island of the roundabout

Description	Excessive landscaping blocks visibility for all road users, especially pedestrians who cannot see approaching vehicles, whilst hard landscaping can present a hazard for errant vehicles.
Recommendation	Remove the vegetation and hard landscaping from the roundabout
Designer's response	There are no works now proposed to this junction.

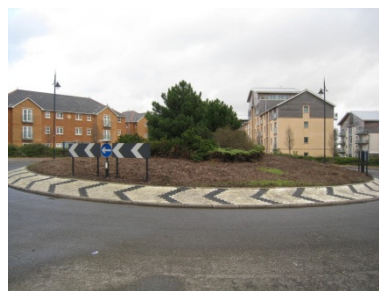
IMG_0646.jpg

Description There is an excessive amount of vegetation and hard landscaping on the circulatory island of the roundabout.

Excessive landscaping blocks visibility for all road users, especially pedestrians who cannot see approaching vehicles, whilst hard landscaping can present a hazard for errant vehicles.

Recommendation Remove the vegetation and hard landscaping from the roundabout

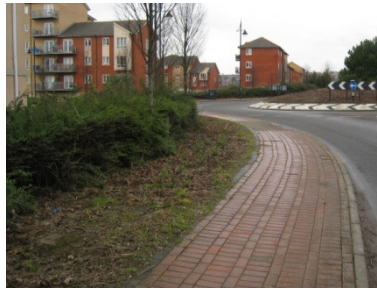
IMG_0666.jpg

Description The widening of the road to the south on the approach to the junction will increase forward visibility.

An increase in forward visibility is likely to result in higher vehicle entry speeds leading to conflicts within the circulatory carriageway, and loss of control accidents, especially on the exit arms.

Recommendation Review the junction layout to ensure sufficient entry deflection is provided to minimise entry speeds.

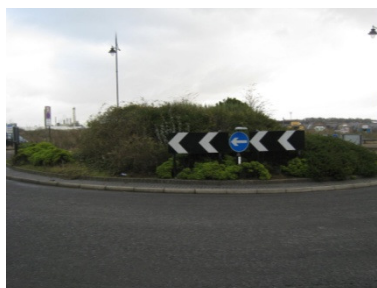
IMG_0670.jpg

Description There is an excessive amount of vegetation on the circulatory island of the roundabout

Excessive landscaping blocks visibility for all road users, especially pedestrians who cannot see approaching vehicles.

Recommendation Remove the vegetation.

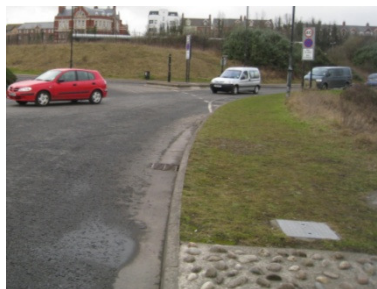
IMG_0690.jpg

Description There is no footway around the eastern side of the junction, between the north side of Ffordd y Mileniwm to the east side of Cory Way.

Cory Way will provide the principal access to the East Quay development area, a predominantly residential development. This is likely to significantly increase pedestrian movements at the junction. Insufficient pedestrian facilities are likely to lead to inappropriate crossing movements resulting in pedestrian vehicle conflicts.

Recommendation Extend the footway on the eastern side of Cory Way to Ffordd y Mileniwm and provide an appropriate pedestrian crossing point on Ffordd y Mileniwm.

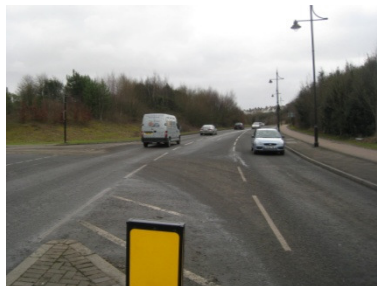
IMG_0717.jpg

Description The Ffordd y Mileniwm / Wimbourne Road junction is located on a grade 150m inside a 40 mph speed limit.

The junction location is likely to result in high approach speeds on Ffordd y Mileniwm, especially northeast bound traffic. This could lead to over-running the give-way line.

Recommendation Extend the 30 mph speed limit to the west of the junction and introduce speed reducing measures on Ffordd y Mileniwm on the approaches to the junction.

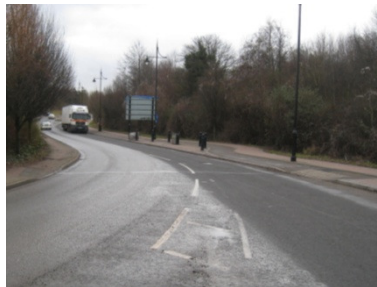
IMG_0745.jpg

Description The proposed slip lane merge would occur coincident with an existing pedestrian crossing point to the southwest of the junction.

Pedestrians crossing in the merge area will be at significant risk from collision with vehicles, as well as facing two streams of traffic, pedestrians will also face drivers who will be concentrating on their merge manoeuvre, rather than the presence of pedestrians.

Recommendation Relocate the pedestrian route away from the merge.

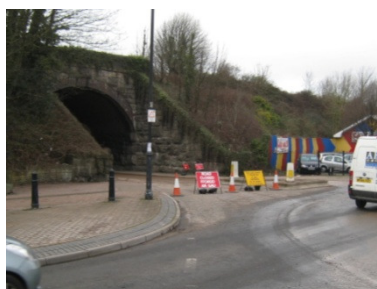
IMG_0748.jpg

Description The exit lane from the roundabout to Cardiff Road is situated immediately after the Ffordd y Mileniwm entry arm. The location of the splitter island results in a narrow exit lane.

Narrow exit lanes can result in overrunning by larger vehicles placing pedestrians on the footway at risk of collision, particularly for left turning vehicles from Ffordd y Mileniwm.

- Recommendation** Ensure the exit lane can accommodate all types of traffic.
- Designer's response** There are no works now proposed to this junction.

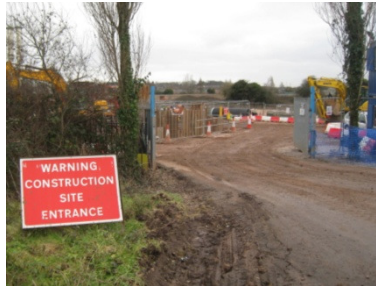
IMG_0735.jpg

- Location** Junction
- Summary** Site access from junction
- Description** Welsh Water has a permanent access to the land to the southwest of the junction.

Maintaining the access from the slip lane is likely to result in turning conflicts and shunt type accidents, as traffic on the slip lane will not expect to have to slow until the merge. In addition access traffic would be limited to left in left out, leading to inappropriate u-turns in the vicinity of the junction.

- Recommendation** Provide an alternative access for utilities.
- Designer's response** There are no works now proposed to this junction.

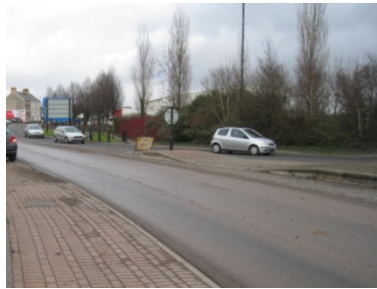
IMG_0757.jpg

- Location** Ffordd y Mileniwm (northeast)
- Summary** Crossing on slip lane
- Description** The proposed slip lane crosses an existing pedestrian crossing point immediately west of the southwestbound diverge point.

The crossing point is situated immediately after the diverge of the slip lane and as a result pedestrians will have to cross two distinct traffic streams placing themselves at greater risk.

Recommendation Ensure there is an appropriately sized refuge between the traffic streams at the crossing, and that pedestrians are aware of the road layout.

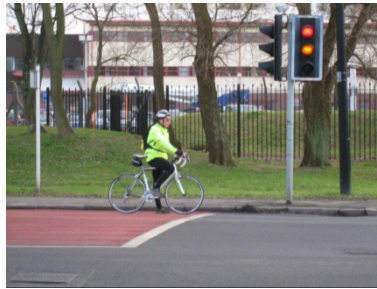
IMG_0762.jpg

Description The proposed junction omits the existing advanced cycle stop lines provided on Cardiff Road at the junction, which is located on National Cycle Route 88.

Cyclists are particularly vulnerable to side swipes at junctions and could be struck while crossing at splitter islands not specifically designed to accommodate them.

Recommendation Replace the cycle stop lines.

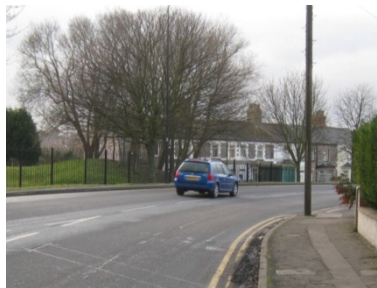
IMG_0789.jpg

Description Edmund Place on the north side of the Cardiff Road is located such that vehicles waiting to turn right into the road would have to wait within the westbound exit merge.

Vehicles waiting in the merge area are at risk of rear end shunt from drivers concentrating on the merge manoeuvre.

Recommendation Alter the proposed road layout in order to provide a right turning pocket for Edmund Place.

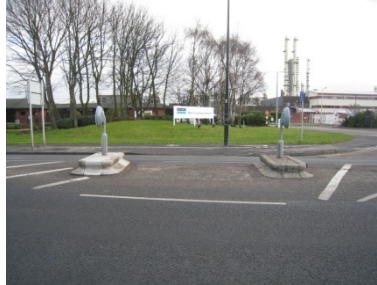
IMG_0769.jpg

Description The proposed junction affects the removal of the existing refuge on Cardiff Road to the east of the junction. No pedestrian facilities are proposed at the revised junction.

The removal of the pedestrian refuge will be a disbenefit for pedestrians crossing Cardiff Road, increasing the risk of pedestrian conflicts.

Recommendation Provide pedestrian facilities at the junction.

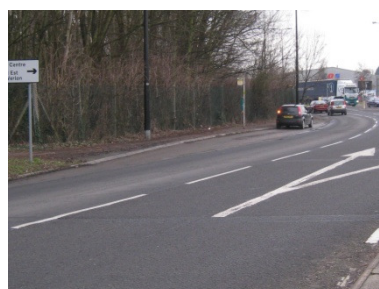
IMG_0862.jpg

Location	Cardiff Road (west)
Summary	Relocation of bus stop
Description	The proposed Left Turn Slip Lane (LTSL) from Sully Moors Road to Cardiff Road would require the relocation of the existing bus stop on Cardiff Road.

Recommendation	Repositioning the bus stop in the vicinity of the merge could result in rear end shunts by drivers concentrating on the merge manoeuvre.
Designer's response	Ensure the bus stop is relocated so as to avoid undue influence on the LTSL merge.
Designer's response	There are now no works proposed at this junction.

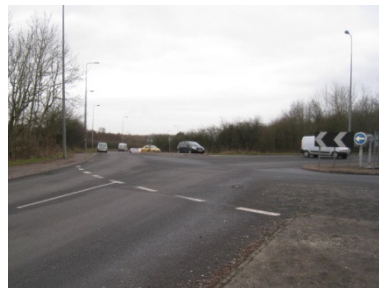
IMG_0908.jpg

Location	Junction
Summary	Poor forward visibility of junction
Description	Moving the junction to the west will reduce forward visibility of junction over the crest from A4231 Barry Docks Link Road.

Description	<p>Poor forward visibility of the roundabout is likely to lead to overshoot accidents at the circulatory carriageway, or rear end shunts on the approach due to late braking.</p>
Recommendation	Ensure adequate forward visibility can be maintained throughout the junction.
Designer's response	Agreed.
