# Structural Report

Marine Buildings  
Penarth Marina  
Penarth

# Structural Report On

**Marine Buildings, Penarth Marina, Penarth**

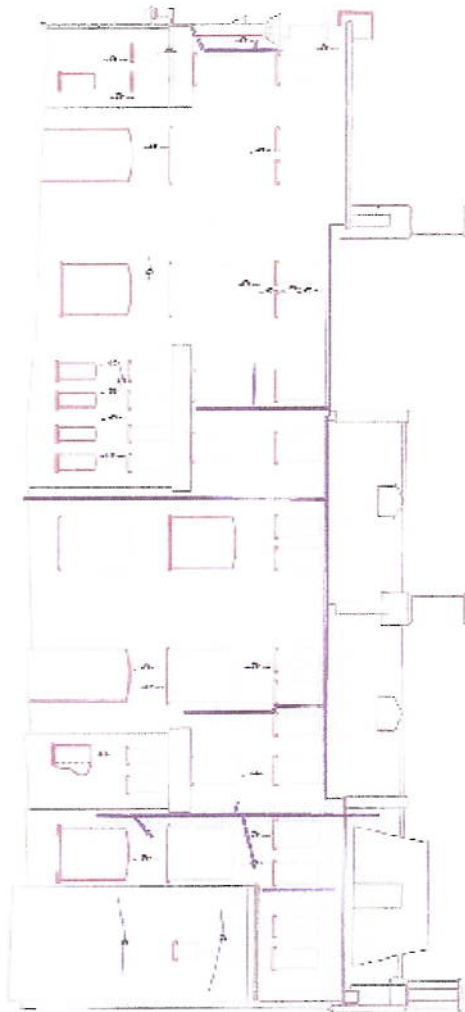
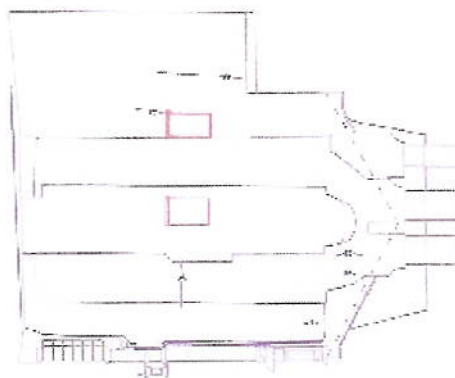
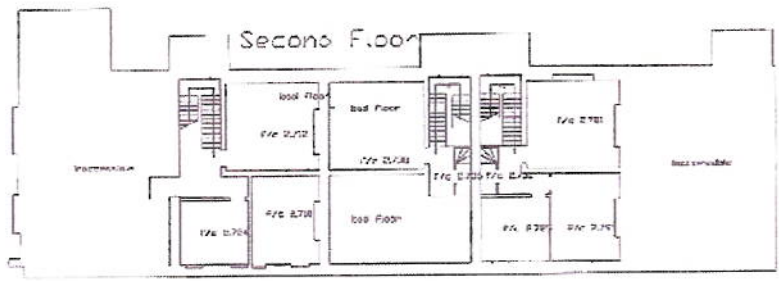
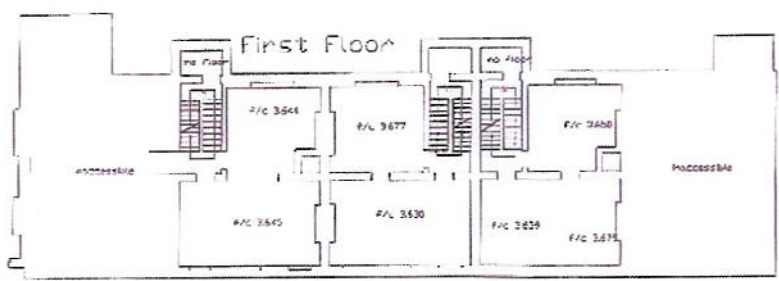
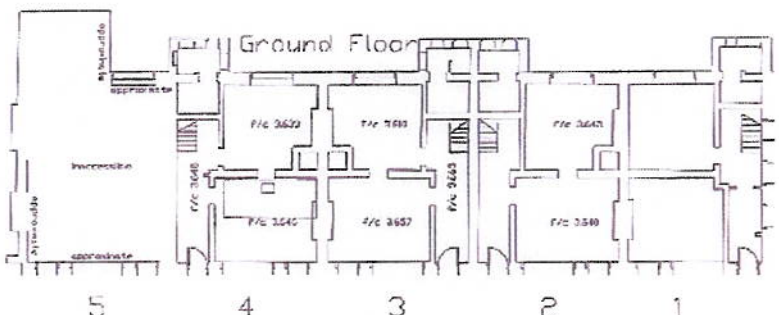
There is evidence of delamination to the face of the brickwork throughout, particularly around the down pipe areas (refer to sketch MH/SK100).

- The high level entablature stonework has spalled in areas and there are several cracks in evidence.
- Sections of the stonework balcony have collapsed
- Support corbels to the balcony have cracked.

There are areas of plant growth at high level, adjacent to downpipes and along brickwork/stonework banding levels.

**FACE OF BRICKWORK DELAMINATED**
-

**B PLANT GROWTH**
-

**S SPALLING**
-

**C CRACK**

All external walls require a considerable amount of remedial work to restore their structural integrity including replacement of all timber lintel and any timber work embedded in the walls.

The possibility and practicality of restoring the facing brickwork should be discussed with a specialist on these matters.

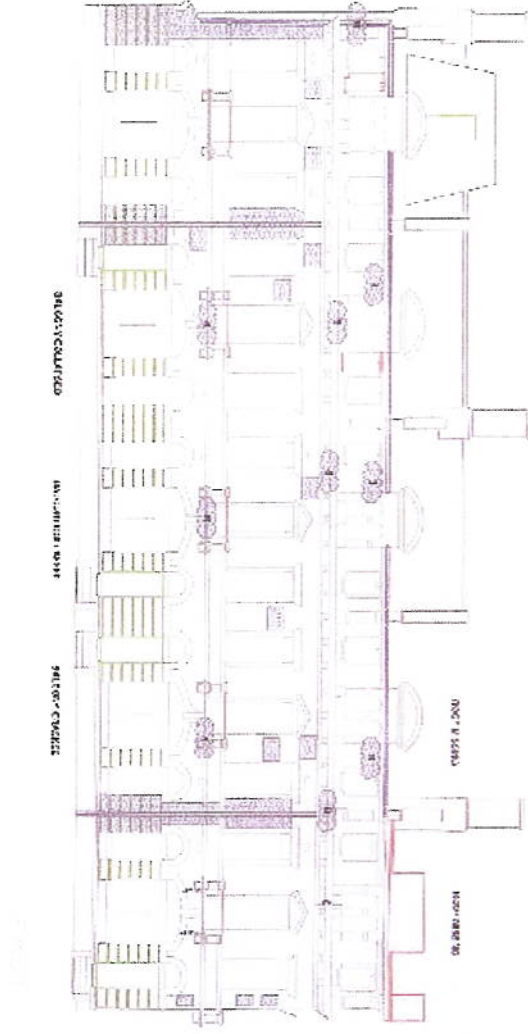
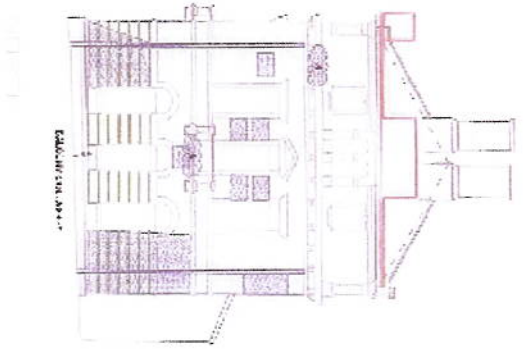
All of the windows have been boarded up. The complete elevation has been rendered over and there are numerous cracks and areas of spalling throughout (sketch SK/101). The general condition of the wall is very poor and there are cracks over the head of all windows/doors.

FACE OF BRICKWORK
-

DELAMINATED
-

PLANT GROWTH
-

SPALLING
-

CRACK
