11 April 2014

**Hayes Point, Sully:  
Preliminary assessment of trees near the former mortuary building.**

SITE **Hayes Point, Sully:  
 Former mortuary building**

DRAWING TITLE  
**Tree Location Pla  
 (preliminary tree assessment)**

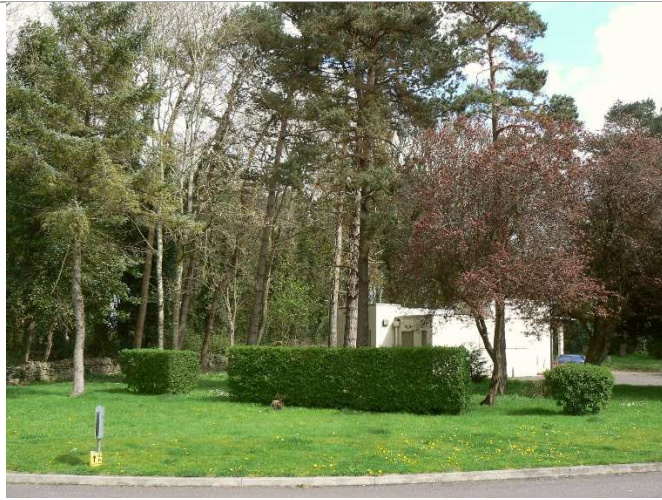
3- Above: view from the SW

To the west there are several trees that are also drawn-up and of poor form, notably trees 30, 31 and 33 but also trees 28 and 29. The suitability of tree 28 a Corsican pine significantly larger than the other (Scots) pines is questionable in view of its close proximity to what is proposed as a residential building.

The *individual* quality of some of trees 20 to 24 is not great, some of the purple-leaved plums (*Prunus cerasifera* 'Pissardii') being distinctly one-sided. *Collectively*, however, they form an attractive grouping which could be regarded as setting-off and softening the effect of the building rather than being in any way over-dominant.

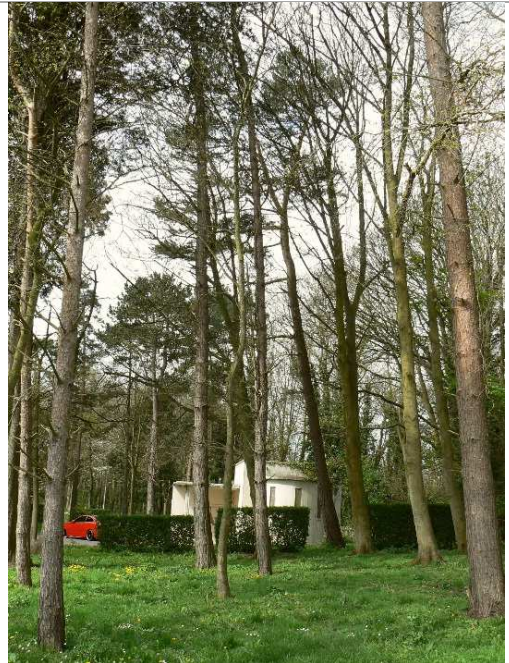
4- Left: As seen from the east.

The trees to the east (photo 4) are mostly conifers with some evergreen holm oaks. A few deciduous trees are also present including some sycamores are present towards the rear (north) and there are also a few, evidently self-sown young wych elms. The trees here are at rather close spacing and in their competition to seek light most have developed forms typical of such 'group trees'. They have become tall with slender stems and those within the groups have rather small, high crowns while those around the edges are more or less one-sided or leaning. While collectively the group is generally acceptable, it should be noted that removing trees, especially around the edges, may leave individuals with forms that may be unsatisfactory, both visually and in terms of their stability in the more exposed conditions.

With respect to the potential instability of slender trees, it has been postulated that when the ratio of the height of a tree to its diameter is equal to or greater than fifty ( $H/D \geq 50$ ) there is a significantly increased risk of failure as a result of exposure to high winds.<sup>1</sup> While some trees here are in excess of this limit and could prove to be hazardous if left fully exposed: this does not preclude all possibility of opening up the group, but careful consideration must be given to the form and condition of retained trees.

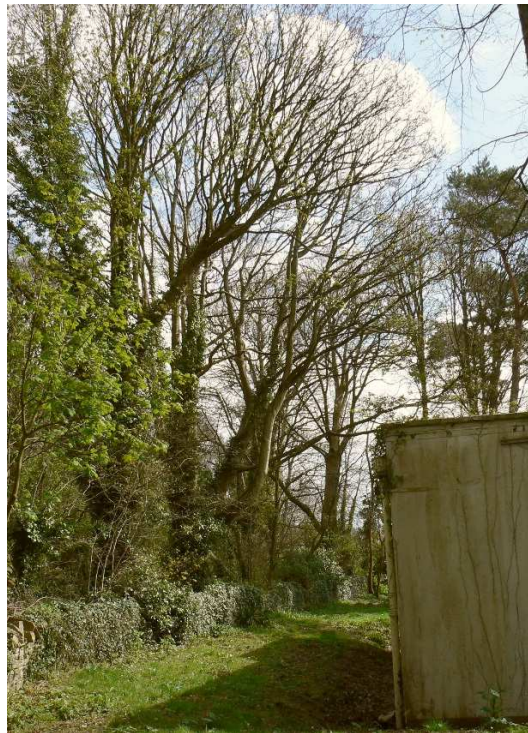
5- Woodland trees at rear of building

To the rear is a low stone retaining wall, about .0.5m high, beyond which is an area of mature, semi-natural woodland:

Turning to the woodland area to the north, several of the older trees have become very tall, with high crowns and rather few branches low down; several have height to diameter ratios close to or in excess of 50 (see above). They could therefore be regarded as being *potentially* at risk of storm damage. Where they are standing amongst other trees they afford one another a good degree of shelter, but any loss of trees could have a 'knock-on' effect on their neighbours.

In one location some shelter has already been lost: as within the wood, some way north of the boundary wall, a particularly large tree has uprooted and fallen. This has been largely cleared but some of the remaining debris shows evidence of Honey Fungus (*Amillaria sp.*) suggesting that it was decayed and weakened prior to its collapse. No signs were observed to suggest that other trees near to the site in question were similarly infected, but the loss of this tree has opened up part of the wood thereby increasing to some extent the degree to which other nearby trees may be exposed to winds.

Some selective removal of woodland trees in the vicinity of the building may therefore be called for. It would be prudent to remove both of trees 40 and 41, especially if the rather unsatisfactory poor pines in the western sector (trees 30, 31 and 33) are to go. It would also be expedient to remove other, poor quality trees such as numbers 42 and 44, as well as other smaller (unrecorded and generally insignificant) specimens. It is also likely that some pruning of trees 46 and 47 would be advisable to remove (or at least significantly reduce) the heavy boughs that lean out over the site (see photo 5.)

While natural regeneration would no doubt make good any losses in this area, consideration might be given to reinforcing the woodland edge through new planting of native woodland shrubs and small trees such as would typically be found in such a location.
