**STRUCTURAL SURVEY
AT
18 CLIVE PLACE, PENARTH**

PETER CHAPMAN ASSOCIATES
Consulting Engineers
2 Royal Buildings
Stanwell Road
Penarth
Vale of Glamorgan

October 2013

Structural Survey at 18 Clive Place, Penarth

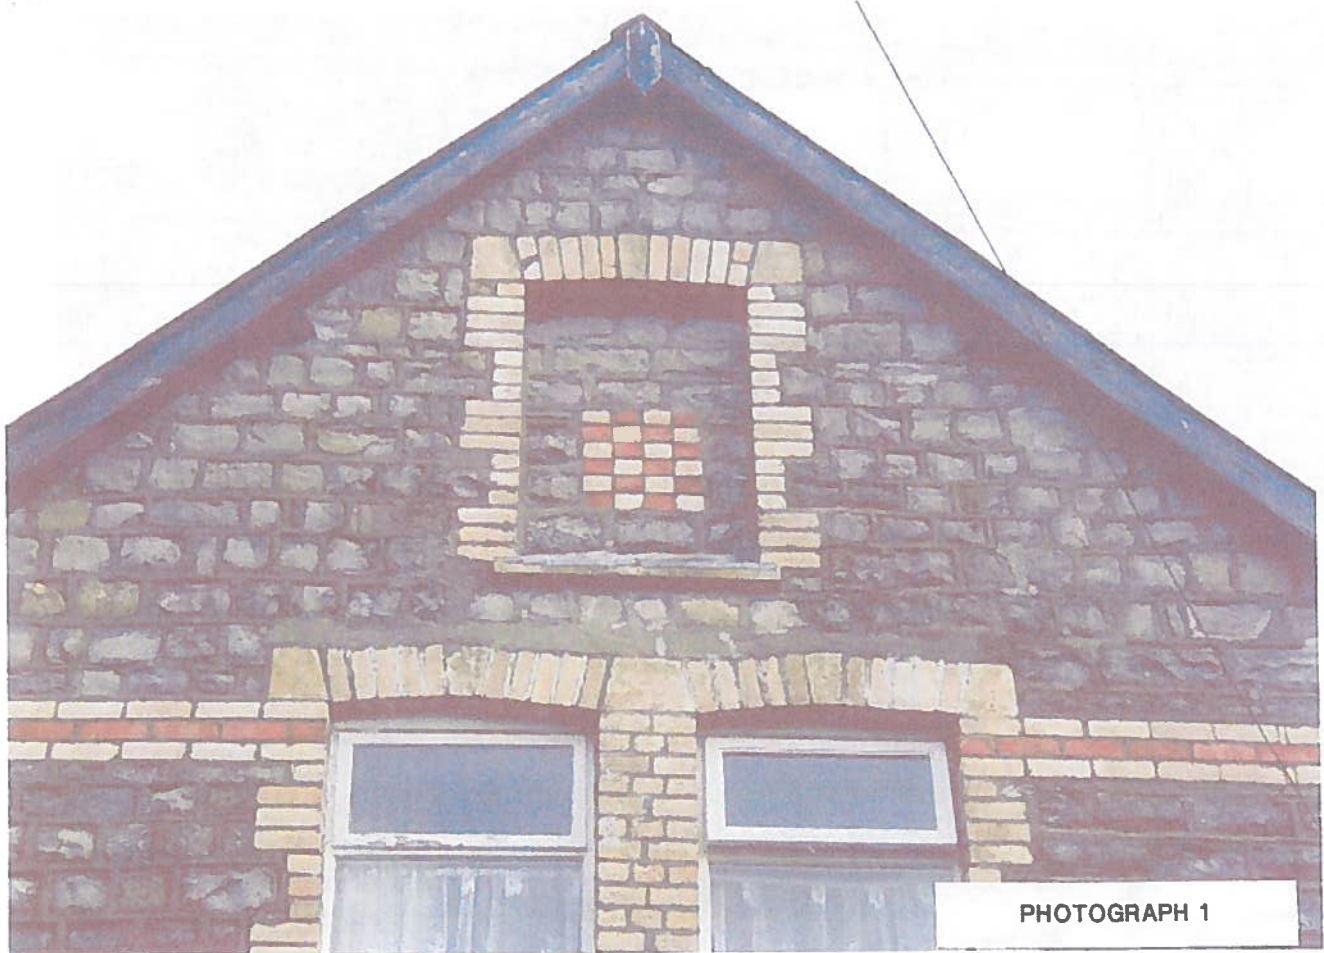
PHOTOGRAPH 1

The replaced pointing is most intensive around a blocked up window above the first floor bedroom windows, (ref. Photograph 1) which presumably gave light into the roof space .

Immediately below this area there two bedroom windows separated by a brickwork pier forming a shared mullion (ref. Photograph 1). It can be clearly seen that the two brick arches above these windows have suffered a degree of failure, the arch springings on the central brickwork pier being noticeably lower than those on the outer brickwork reveals. Much re-pointing has been carried out on the arches themselves, and it is clear that at some time in the past there was extensive disruption of the arch brickwork, with several bricks in each of the arches having been replaced to restore their integrity and their ability .to support the stonework panel above

The loading from this stonework will be considerable, with the major proportion being carried on the brickwork pier between the windows which has moved downwards by an estimated 20-25mm. This has resulted in the movement in the brick arch springings referred to above, and the arch failures. are a direct consequence. If Photograph 2 is referred to it will be seen that the two external window sills slope noticeably downwards towards the pier, confirming its downward movement.

The loading from the pier will be carried on a bressummer, most probably a double timber beams, spanning across the bay window opening in the front wall, and the downward movement of the pier is an indication that it has become overloaded, either because it was sized inadequately when the house was built, or because there has been a deterioration in the timber.

This could happen if the end bearings of the beams developed wet rot as a result of becoming exposed to moisture for a significant length of time due to rain penetrating into the wall through cracks in the mortar joints. Alternatively the timber could have been weakened by insect infestation or possibly dry rot. At all events, whatever the cause it is highly likely that it will continue to develop, increasingly weakening the bressummer, with continuing downward movement. In a 'worst case scenario' the bressummer could fail completely at some future time, leading to a partial collapse of the front wall

A priority item will be to investigate the cause of the bressummer deflecting. To achieve this it will be necessary to expose the bressummer from within the front room inside the bay window. As a first stage the timber bearings at each end on the front wall should be exposed so that their condition can be ascertained. If they are found to be sound, more exposure along the length of the beams will be required to check for infestation by boring insects or dry rot. If serious defects are found in the timber beams there is a likelihood that the movement, the results of which are seen externally, will redevelop, with the extensive repaired cracks re-opening, and the timber beams should be replaced by steel.

When all the work found to be required in these walls has been carried out the cracks in the masonry should be repaired by breaking out cracked or broken stone, and raking out cracked mortar joints to a minimum depth of 75mm, to be refilled with a well-rammed semi-dry 1:1:6 mix cement:lime:sand mortar, to be neatly pointed. on completion.

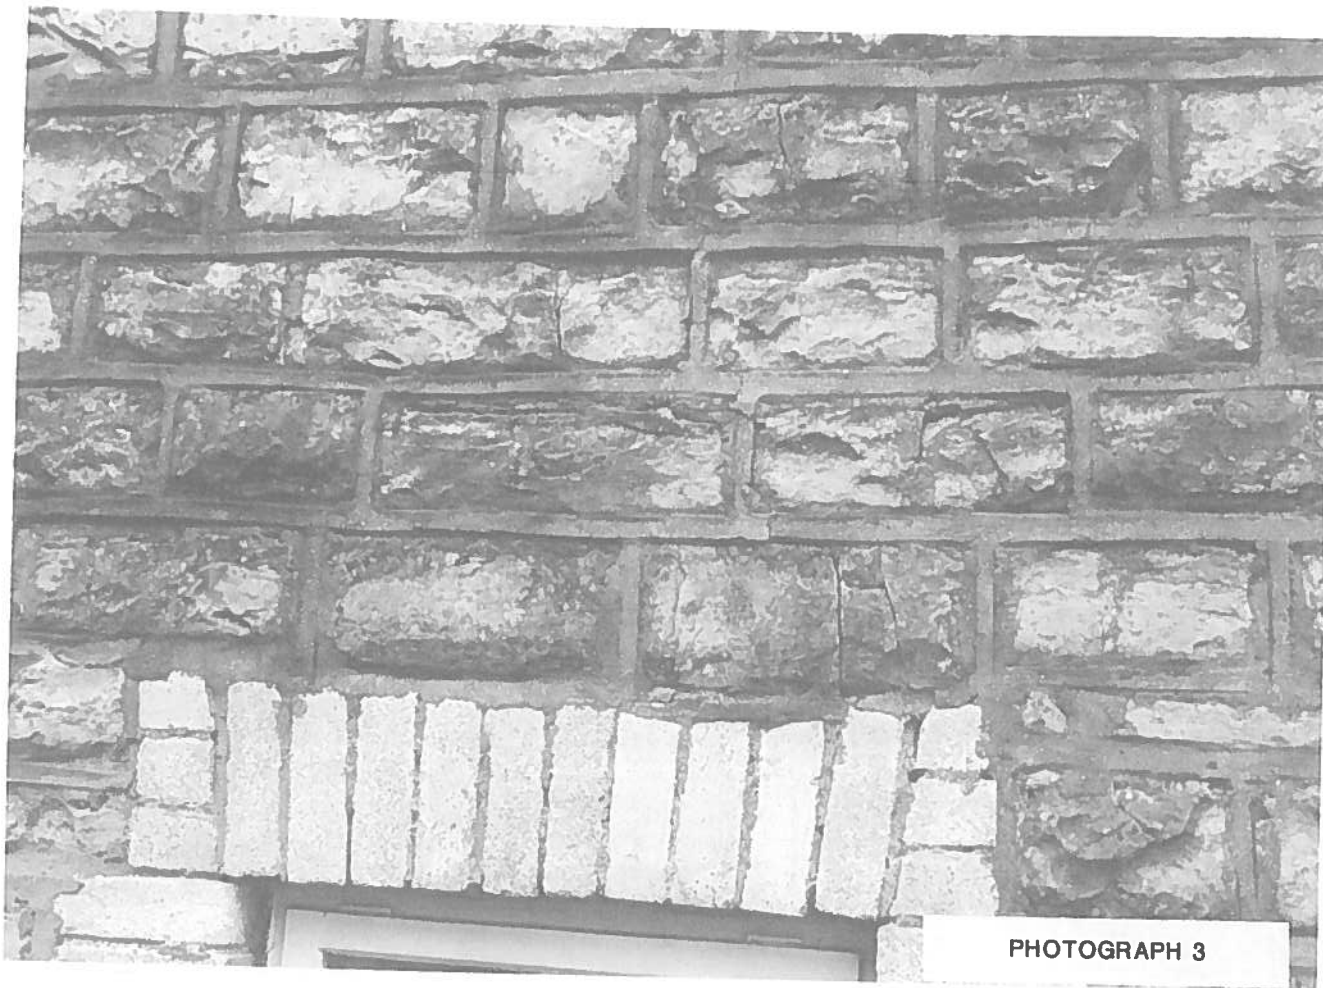
PHOTOGRAPH 3

The side wall of the rear annexe shows signs of subsidence at and near the rear corner. Vertical movement of the wall is indicated by a very noticeable failure of a brick arch over a window approximately 1.2m from the corner (ref Photograph 3), where a block of three bricks has become displaced downwards, requiring re-pointing at some time in the past. There is a raking crack sunning upwards towards the right from the arch and meeting another crack near the corner where the brick quoin has separated from the main stonework. (ref. Photograph 4.

Before considering measures, if any, to eliminate the subsidence at the right hand rear corner of the building, it will be necessary to establish why this has developed. One possible cause could be a weakening of the subsoil beneath the foundations due to leakage from a fractured drain or water supply pipe in that locality, so it will be necessary to excavate around that corner to investigate the foundations and their bearings and the drain runs and their proximity to the walls. Before commencing this work it would be wise to monitor the crack by installing tell-tales, to be read every two months for at least six months, to confirm or otherwise that the subsidence movement is continuing.

This exercise will determine whether underpinning of the foundations is required or merely repairing any defects found in underground pipes

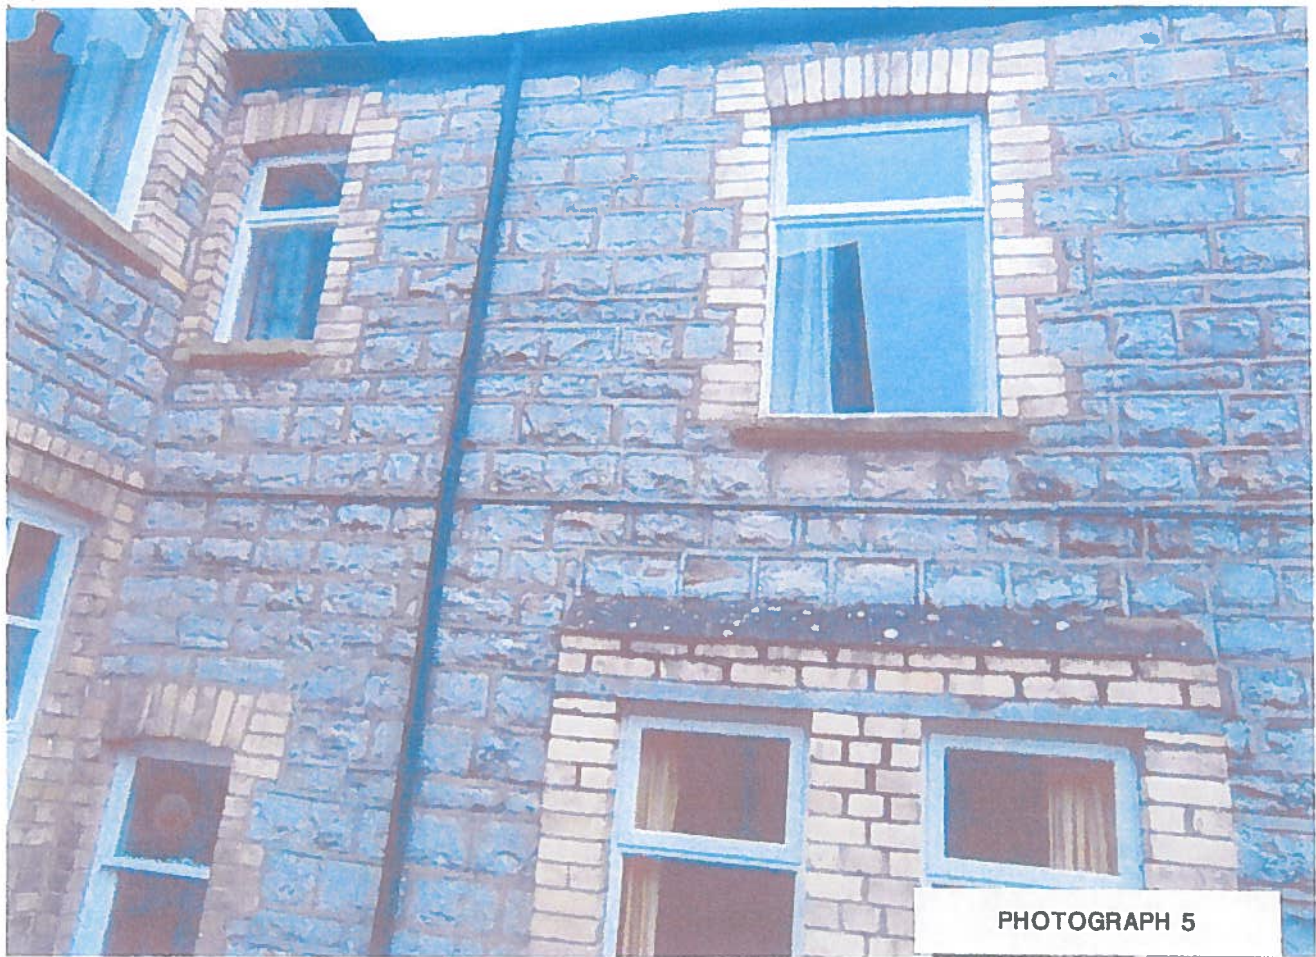
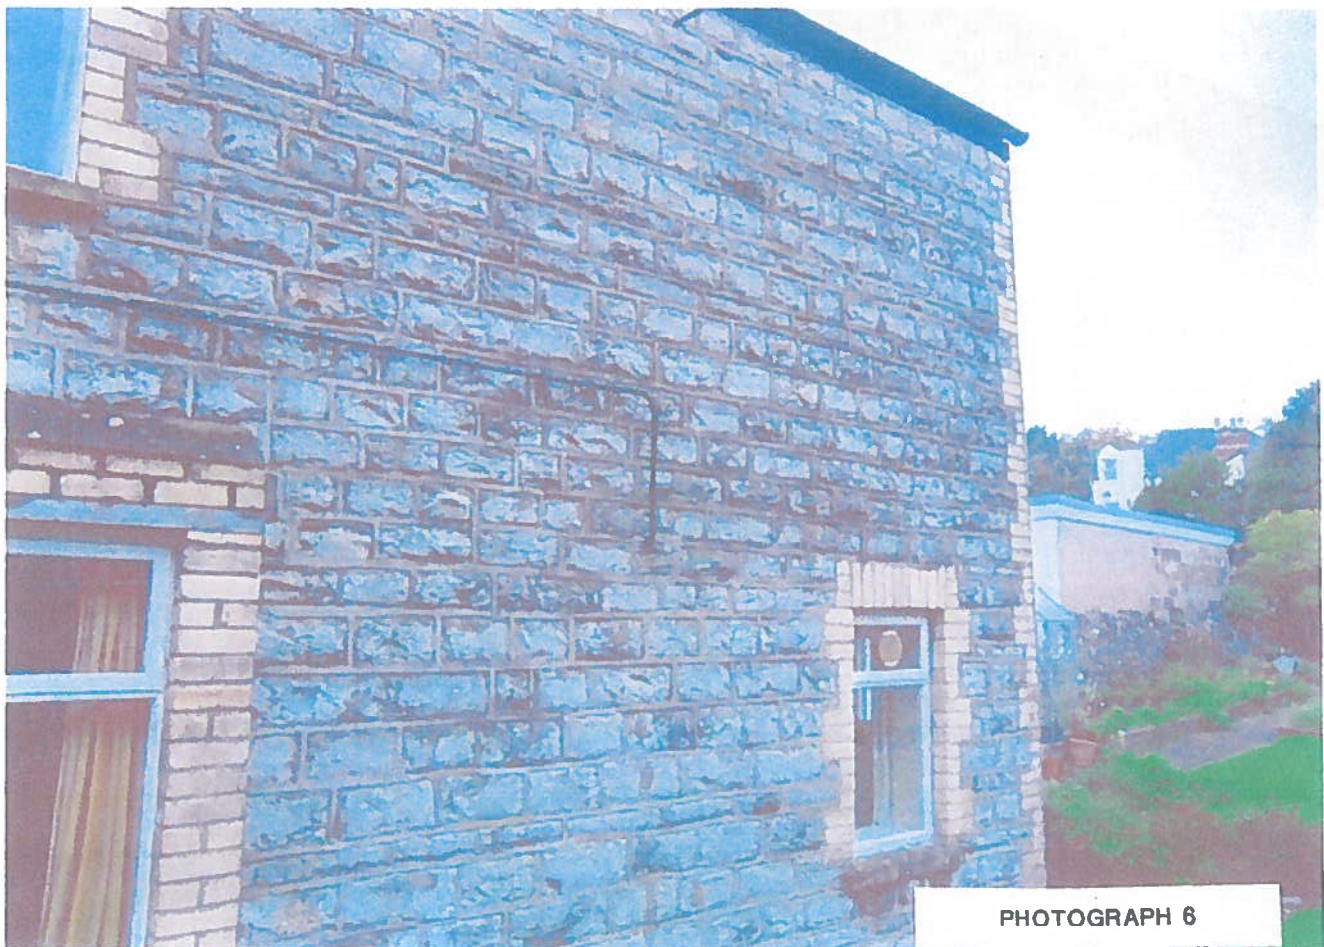
The remainder of this wall is in a reasonable sound condition, (ref Photographs 5 & 6) but the rear wall, which is rendered, has minor cracks which run with a mainly vertical orientation upwards to the gable roof verge near the outer corner. (ref Photographs 7 & 8) The disposition and orientation ,of this cracking is indicative of a minor subsidence at the rear corner of the building

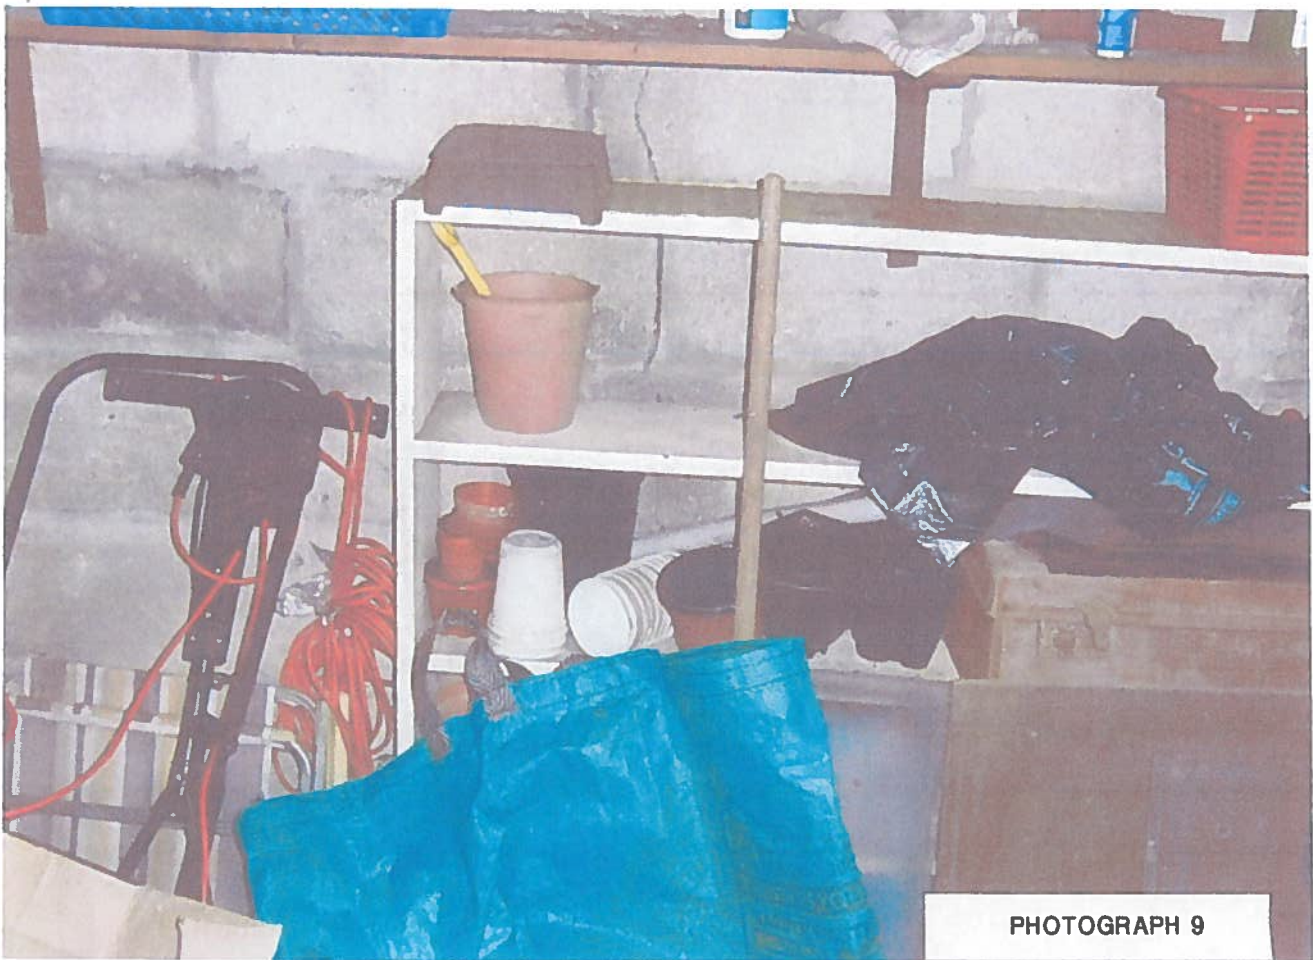
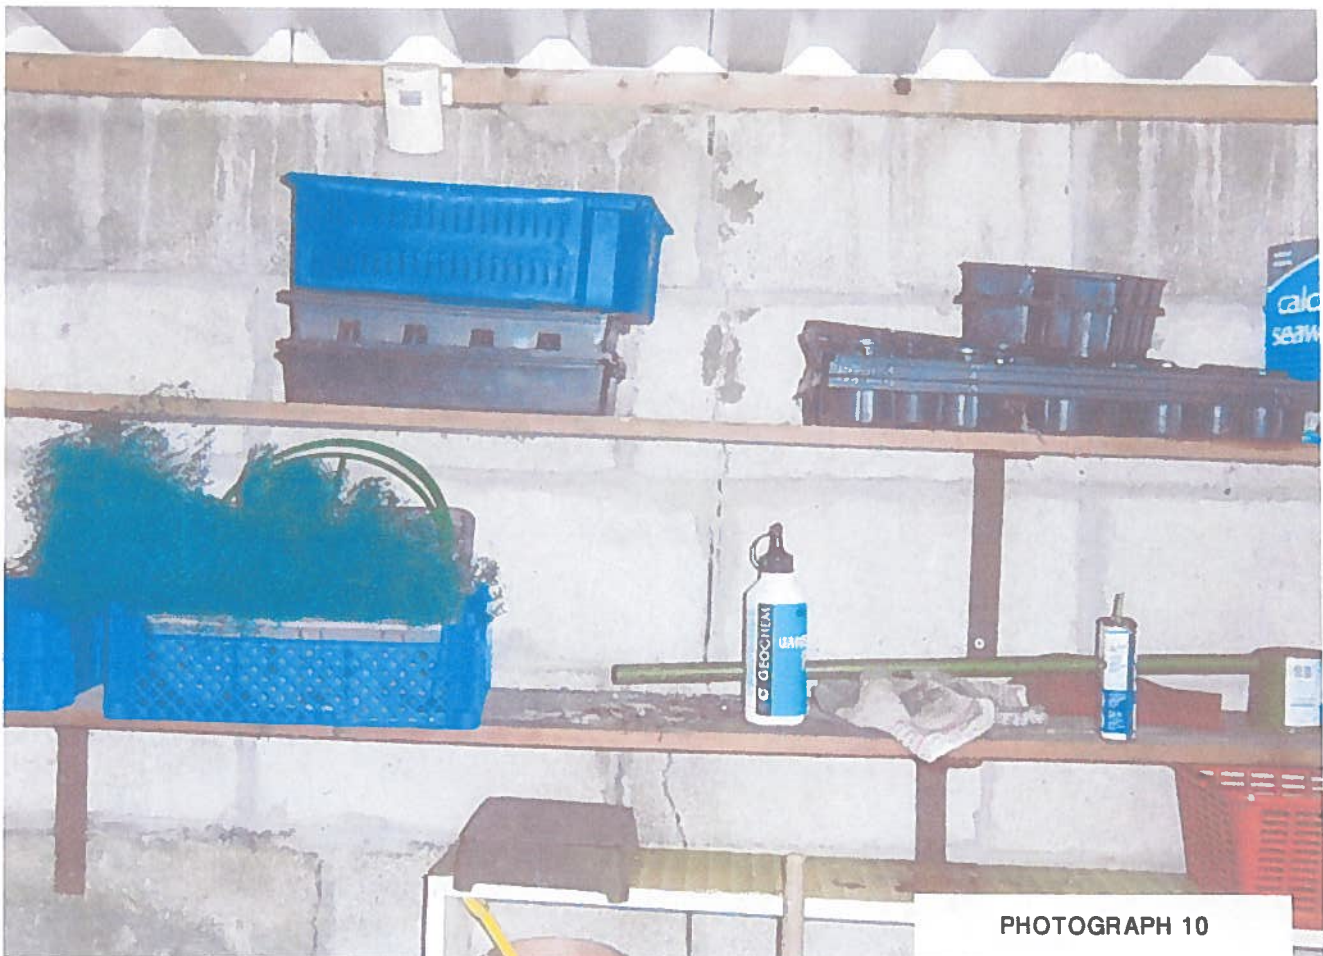
The garage is in an overall poor condition, bordering on dilapidation. There is a pronounced vertical crack, varying between 4mm - 8mm, in the front wall, running for the full height from ground level to roof' ref Photographs 9 & 10 (crack behind shelving). The cause of this is not clear, but it is likely to be either a degree of subsidence at one of the front corners or a result of the wall contracting with seasonal thermal changes. The vertical orientation suggests that the latter is the most likely. The remaining walls are in sound condition.

The crack in the garage wall should be repaired by carefully breaking out cracked or broken blocks which straddle the crack, and replacing them with new blocks as necessary, set in neatly pointed mortar as above, followed by replacing the external cement mortar rendering, and decoration.
