MR LUKE ENGLAND

BRYNHEULOG, WELSH ST DONATS

DAY-TIME INSPECTION SURVEY REPORT

04 December 2014

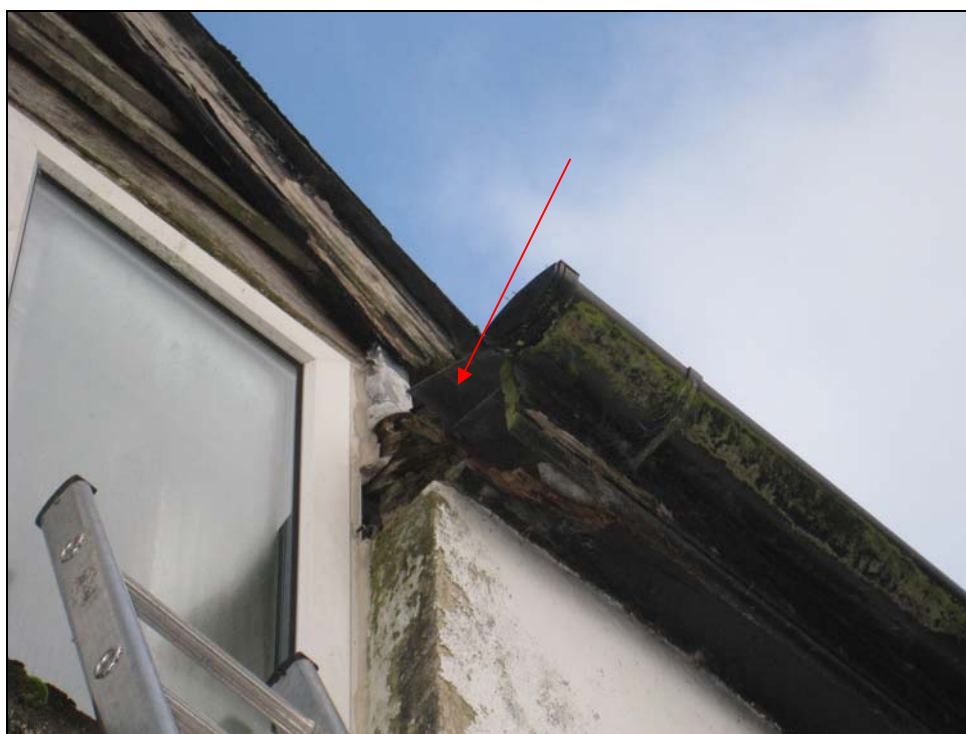
- 3.3 The residential building is a two storey, rendered, brick and stone built building with a pitched slate roof and timber fascias/soffits (see front cover). As described above and in the target notes, timber fascias and soffits as well as wooden framed windows to the southern elevation were generally in poor condition with a number of gaps noted (e.g. Plate 1). For example, the southern elevation supported two dormers with timber cladding and shallow gaps beneath these boards were visible from the ground (Plate 2). Checks from the ladder confirmed the gaps are shallow (1 – 2 inches) and do not lead into a void with cobwebs noted in places partially covering the gap. No bat droppings or staining were noted on the boards or on the timber-framed windows below. A section of the soffit is missing to the right hand side of each of these 2 dormers, and old bird nesting material was present in each location (Plate 1); but no evidence of bats was seen. .

Plate 1. Gaps in southern elevation soffit with bird nesting material found within space

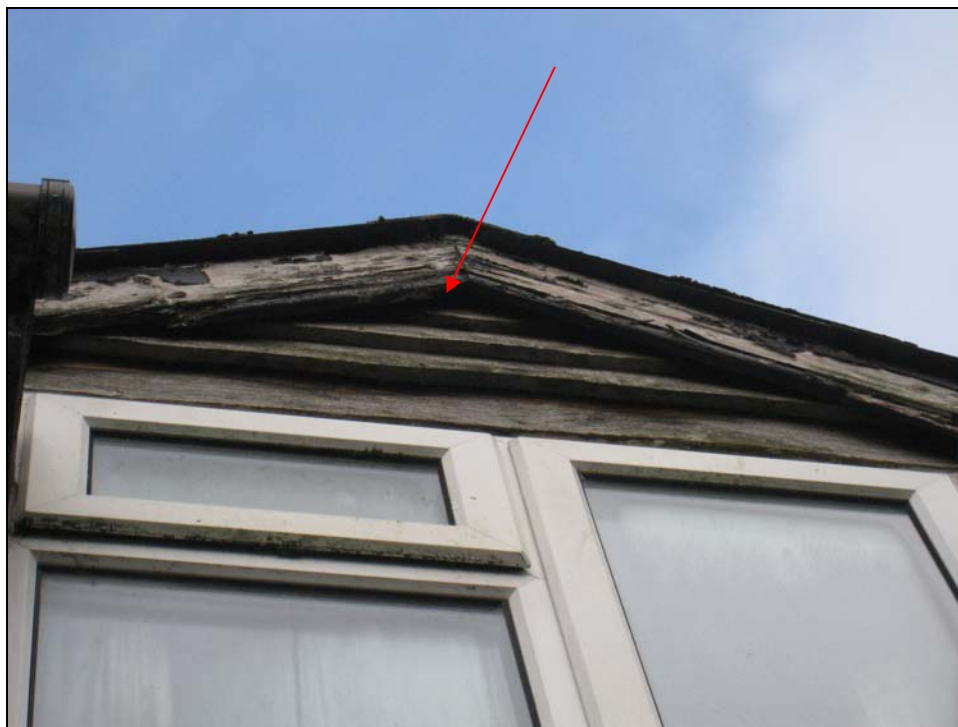
Plate 2. Shallow gaps beneath timber cladding at southern elevation

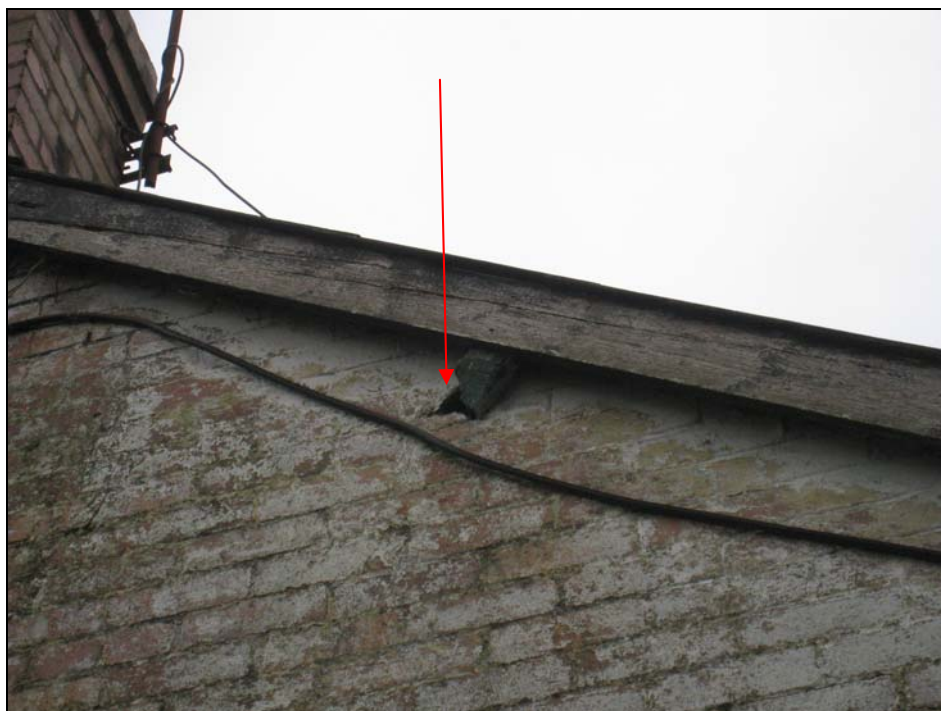
- 3.5 The western gable end comprised of painted brick with old ivy growth to the north western corner; the ivy has been cut at the base so only dead stems remain. The fascia and soffit were missing at the apex of the gable, with the exposed brickwork providing possible access to the cavity wall although this feature was too high to access directly. No bat droppings were visible of the painted brick below the apex although the remains of an old bird best were present lodged between the fascia and the wall to the south. Missing brickwork/render were also noted at 2-3 locations where the structural timbers protrude from the gable end (e.g. Plate 3). , these were checked via a ladder and no bat droppings or other evidence of use was noted.

Plate 3. Missing brickwork/render where the structural timbers protrude from the gable end

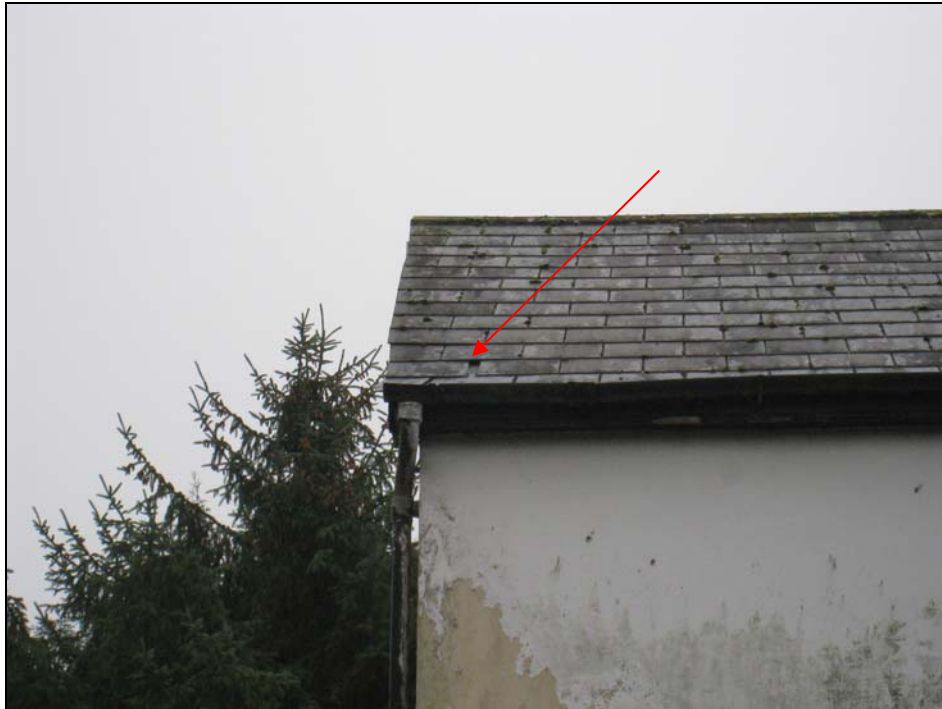
- 3.6 The north western corner of the building at ground level was overgrown with Bramble and Ivy providing some potential for scrub nesting birds. The roof and ridge tiles were generally in good condition, with no obvious loose or missing slates apart from a small gap at north east corner (Plate 4). Raised tiles & flashing were also noted to the small dormer (west side), with a gap in the fascia on the north west corner. No evidence of birds or bats was noted from the ground-based check or from inside the property as viewed through the open first floor window.

Plate 4. Gap in roof tile on northern elevation

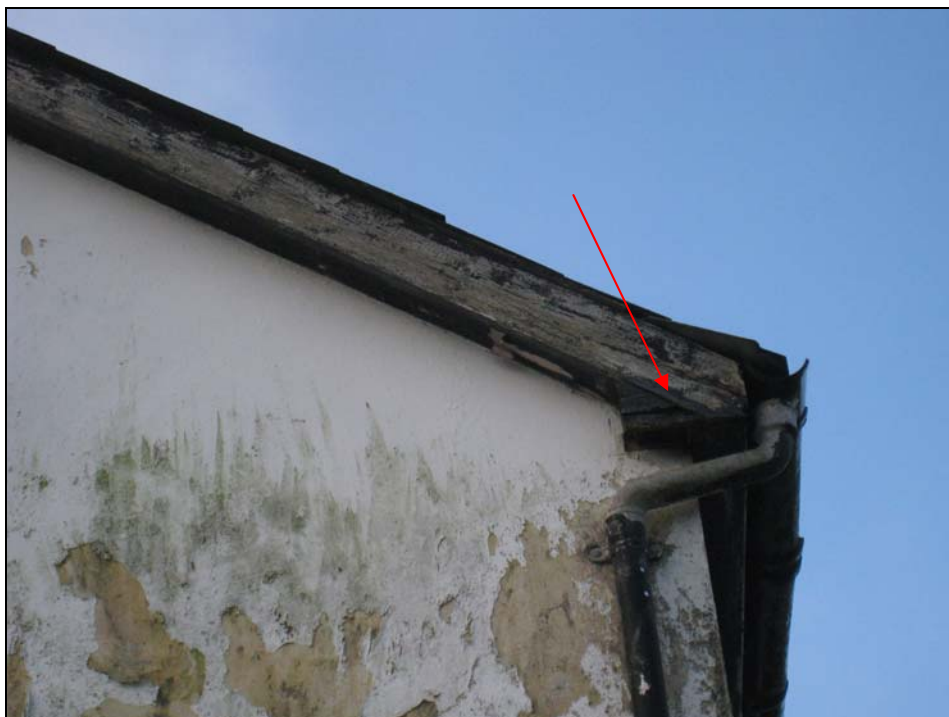
- 3.7 The eastern gable end consisted of white render, with fascias/soffits generally sound; with the exception of a gap at the north east corner (Plate 5). No external evidence of birds or bats were noted at this location or on the walls below.

Plate 5. Gap in the fascia on the north east corner of building

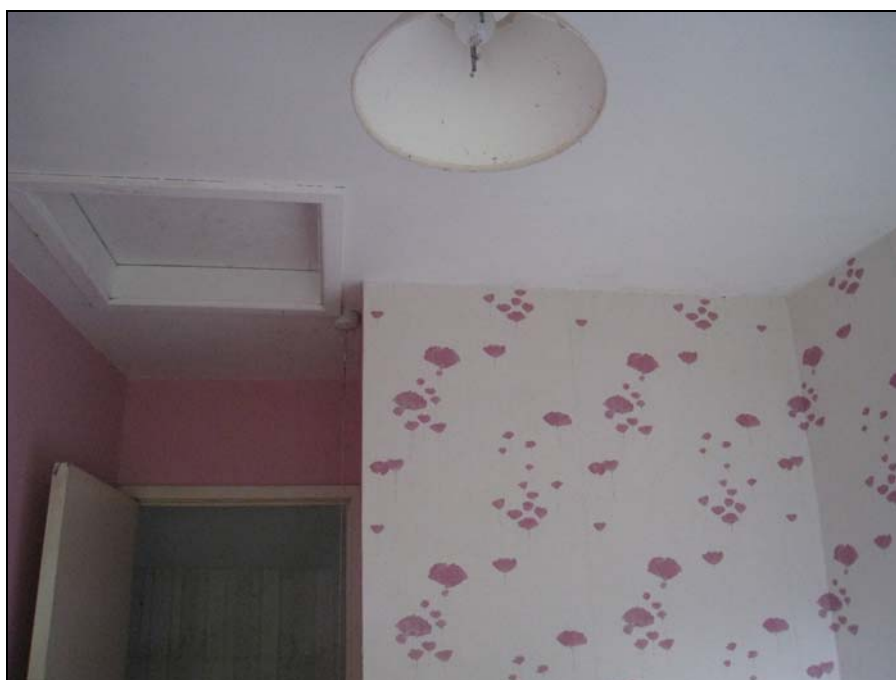
- 3.8 The interior rooms were all light, open and generally sound with painted or papered walls and no obvious means of entry (i.e. ceilings all sound) or features of potential value to crevice dwelling or free hanging bats noted (e.g. Plate 6). Open windows were noted on the first floor which could provide possible access for birds or bats, but no evidence of this was recorded inside the building. The airing cupboard to the side of the bathroom on the first floor was dark and dry but there was no obvious means of access for birds or bats when the door is shut (as it is presently). This is also applicable to the coat cupboard on the ground floor at the foot of the stairs. The fireplaces on first floor and ground floor were checked, but no evidence to indicate use by birds or bats was identified.

Plate 6. First floor bathroom to show loft hatch and condition of ceiling/walls

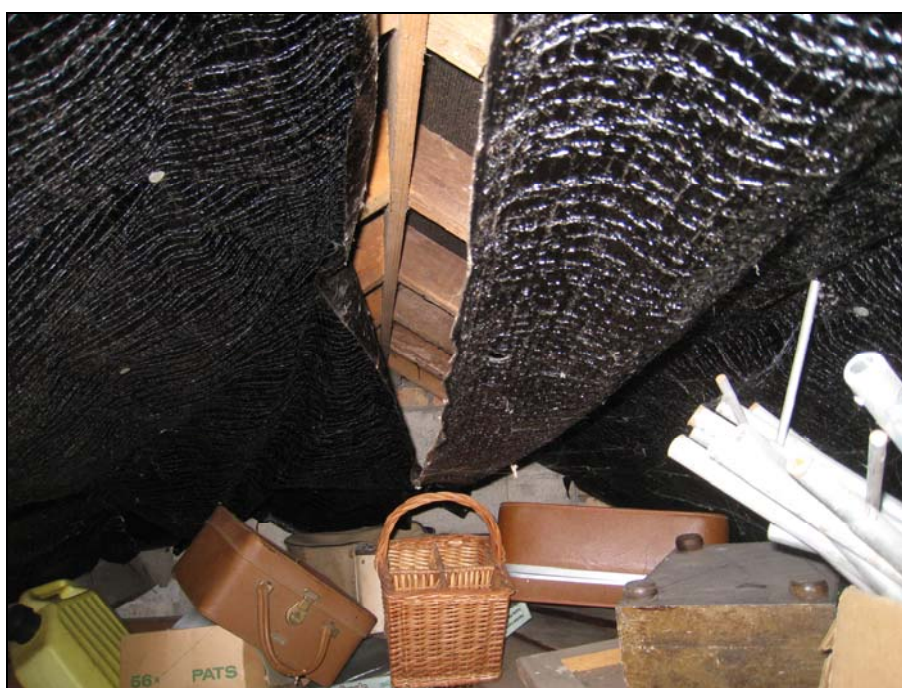
- 3.10 Bitumen underfelt was present to the underside of the slates with a second layer of felt affixed to the roof timbers – this was ripped/hanging in a number of locations (e.g. Plate 7). No evidence of use by bats was recorded within the roof space and the small/cluttered nature is likely to limit its potential value – for example it would be less suitable for free-hanging species such as Brown Long-eared *Plecotus auritus*. Two dead mice and two bird skeletons (possibly Starling *Sturnus vulgaris*) were noted close to the loft hatch and rodent droppings were scattered throughout the roof space. An accumulation of bird droppings was also identified on the southern side towards the centre of the roof space, but no nesting material or other evidence of recent use was noted.

Plate 7. Loft space – View from loft hatch towards eastern gable end

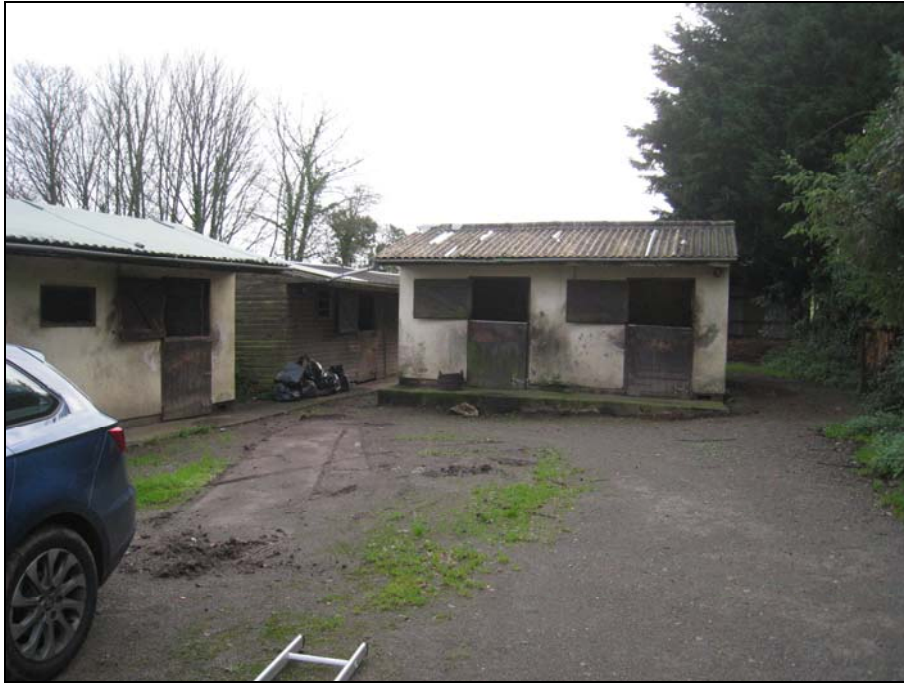
- 3.11 The garage and outbuildings comprised of timber or block wall construction (Target Notes 2 – 5, Appendix II & Plate 8) with corrugated sheet roofing (asbestos cement type or similar) and all were considered of Negligible potential for use as day roosts by bats although could be used on irregular basis as a night roost or feeding perch. All of the outbuildings have window or door openings which could easily be accessed by birds or bats but no evidence of bats was noted in any location. Evidence of use by birds including scattered droppings on stable doors and several dis-used mud nests were identified (e.g. Target notes 3, Appendix II). The outbuilding in the south of the site was constructed from corrugated metal sheeting over a timber frame and was open to the north side (Target Note 6). This structure was considered of Negligible potential to

Plate 8. Outbuildings (Target Notes 2-4)

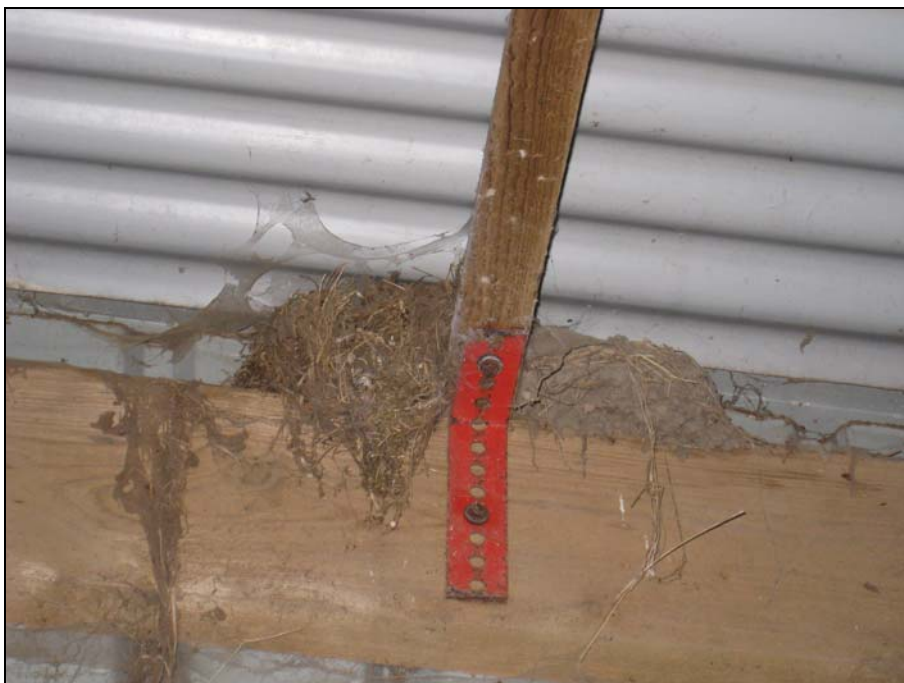
roosting bats although 2 old mud nests were identified on the eastern side of the building lodged against the timber frame (Plate 9).

Plate 9. Two disused mud and hay bird nests in Outbuilding 6
