## **Appendix 9.2 Asbestos Material Investigation, ASM January 2012**

**Asbestos Material Investigation  
Barry Waterfront  
Report Number: A0712/030  
Visual**

**Premises  
Barry waterfront  
Barry**

**Commissioned By  
Cuddy Group**

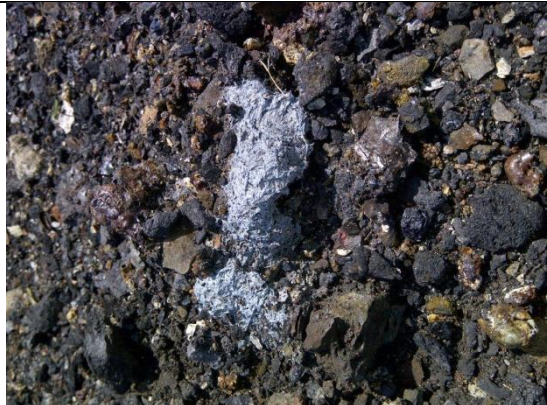
Loose spray coating on surface of surcharge	Spray coating on ground between trial pit and surcharge

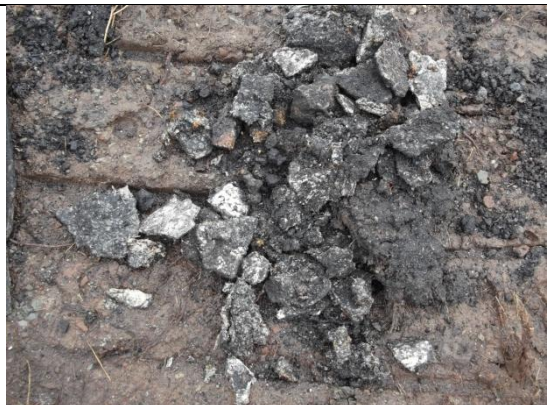
Loose asbestos insulation out of pit 12	Bag containing spray material and loose material on plant road to site
<b>Comments</b>	<b>Examples of fibrous materials at Barry Waterfront. Pockets of severe contamination were found in a number of areas of the site</b>
<b>Recommendations</b>	
Under the 2012 Control of Asbestos Regulations most work on this material would usually require a licensed contractor, however any works would have to be risked assessed and the potential fibre release considered before making a final decision

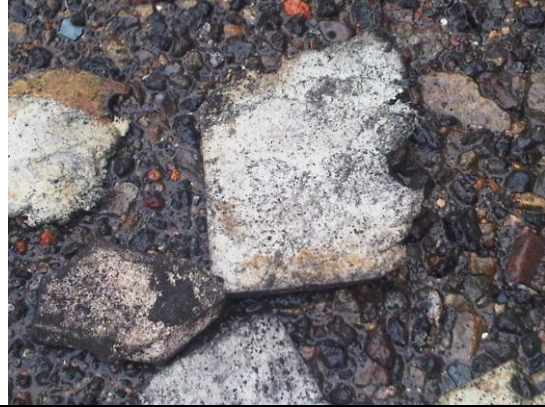
Gasket material from pit 3

SCOPE SAMPLE	CLIENT SAMPLE No.	Sample Location	Fibre Type Detected
1	A0712/030/001	PIT 3- CEMENT	CHRYBOTILE
2	A0712/030/002	PIT 3- ROPE	CHRYBOTILE
3	A0712/030/003	PIT 3- GASKET	CHRYBOTILE
4	A0712/030/004	PIT 4- CEMENT	CHRYBOTILE
5	A0712/030/005	PIT 4- CEMENT	CHRYBOTILE
6	A0712/030/006	PIT 4- TEXTILE	CHRYBOTILE

Under the 2012 Control of Asbestos Regulations most work on this material would not usually require a licensed contractor, however any works would have to be risked assessed and the potential fibre release considered before making a final decision

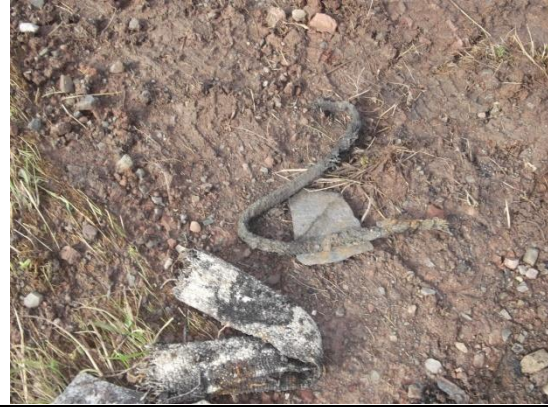
Rope & textile material pit 3

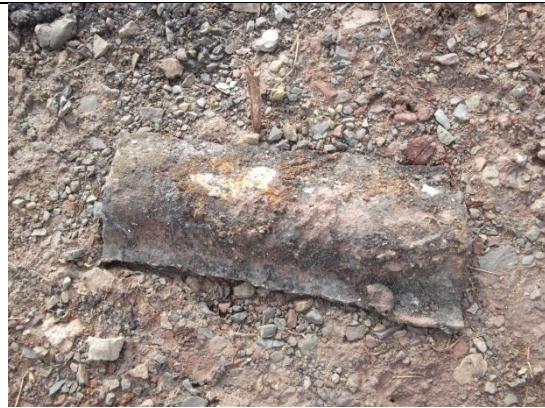
Cement material pit 3

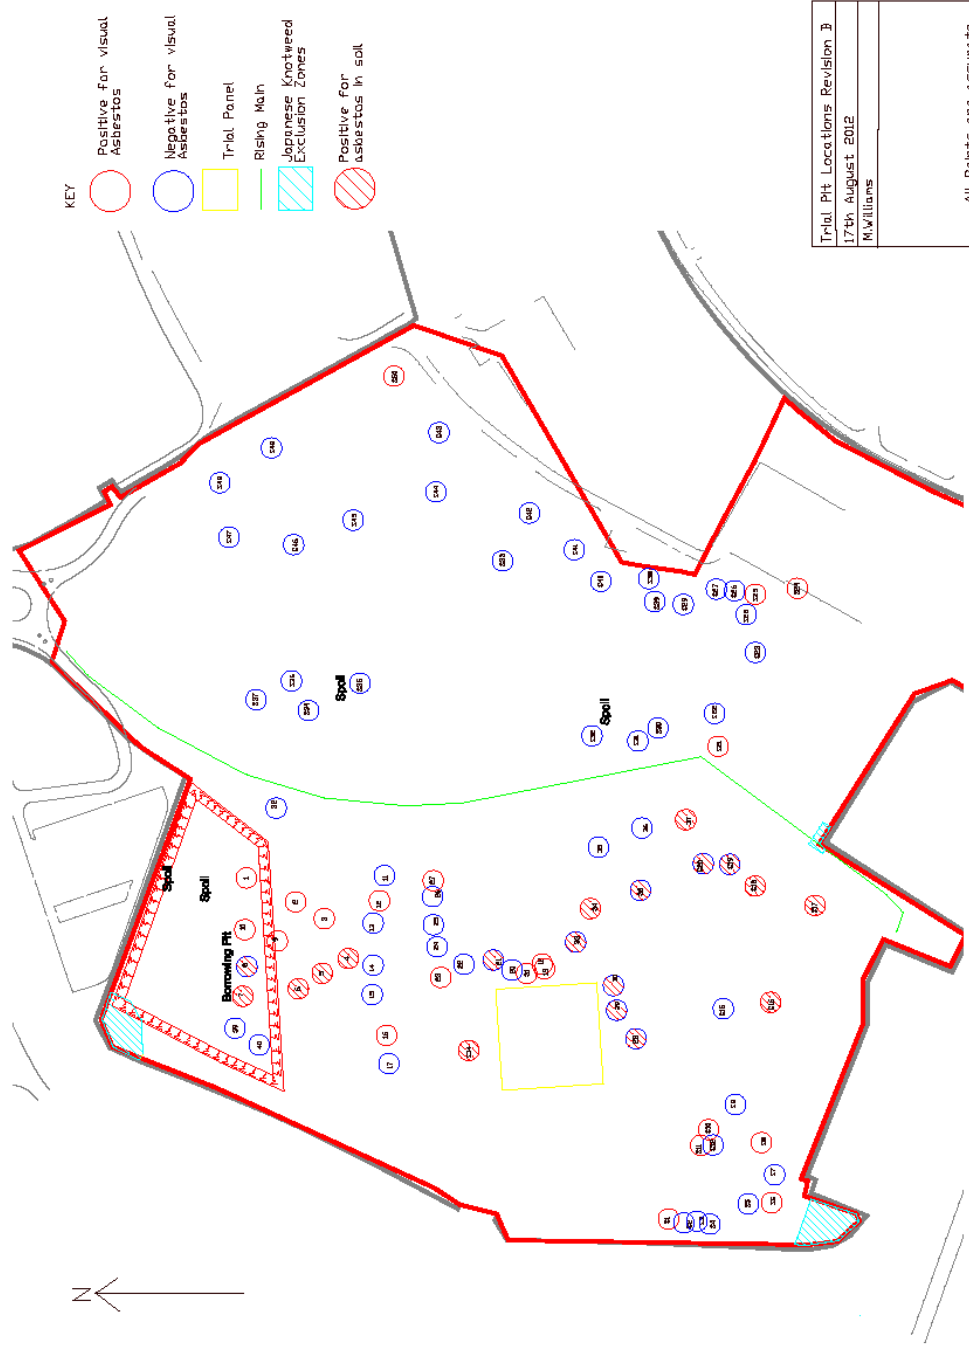
# Appendix II Site Schematics

From the results an L shaped area of land highly contaminated with asbestos is seen to be present to the west and south of the rising main. To the west of the Rising main (West Pond area) in the trial pits dug only one piece of asbestos cement was found to be present, no soil samples were taken in the area. Due to the incompleteness of previous information and the limited current investigation in the area it is advised that a more comprehensive systematic program of inspection is introduced of the area to confirm if the area is free from contamination.
