Project Title:  
**Barry Pump House, Barry**

Client:  
**DS Properties**

Date:  
**January 2015**

## **STRUCTURAL SURVEY AND REPORT**

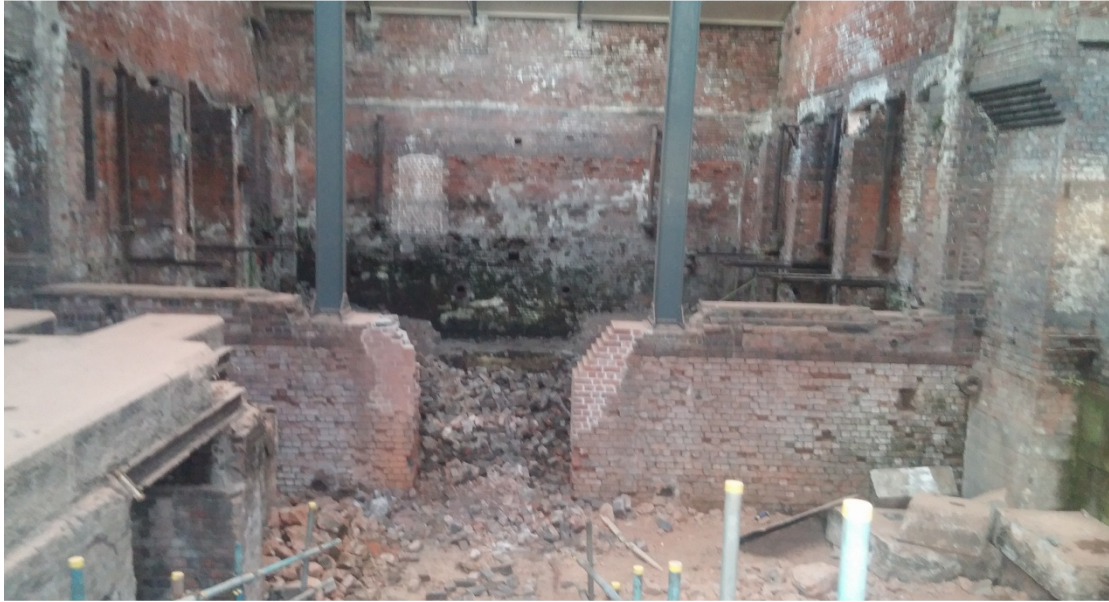
Photograph 1

At the time of our visit, machine base two, three and four had been removed down to slab level (*figure 1*). The removal of machine base one (Photograph 3) had commenced. The granite blocks which sat on the brickwork plinth of machine base two were still within the South Range building and some can be seen in the right hand corner of photograph 1.

There appeared to be recent masonry repairs (Photograph 1) to the internal spine wall supporting the pair of existing steel columns which in turn support the steel roof trusses. Both sections of the internal spine wall were in poor structural condition, but appeared to be satisfactorily supporting the existing roof structure.

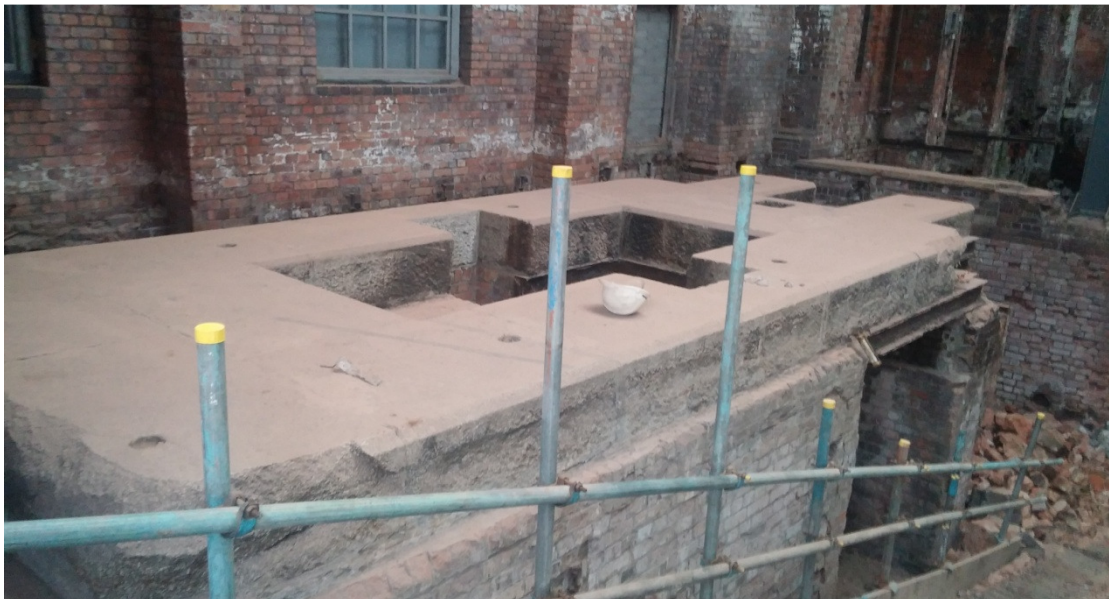
Photograph 2

Machine base one (Photographs 1 & 2) comprises of predominately a solid mass of English bonded brickwork (Photograph 3), supporting approximately 0.5m thick individual sections of granite block. The machine base is approximately 2.6m high from the existing finished floor level and has a plan area of approximately 10.4m x 3.6m

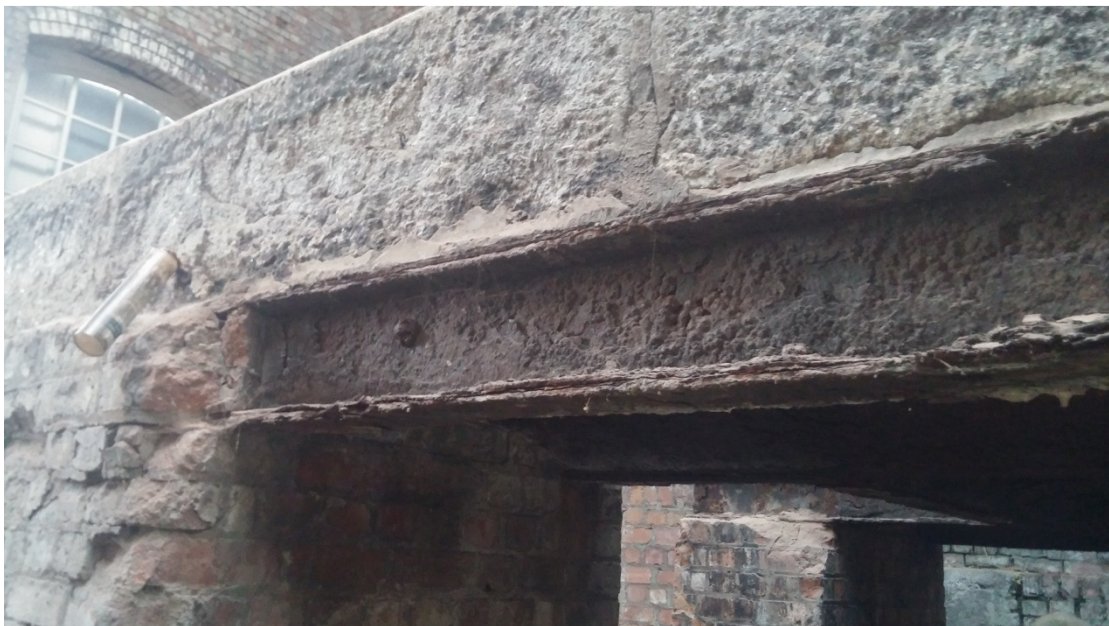
*Photograph 4*

There was a passageway through machine base one, with the granite blocks above supported by Cast Iron 'I' sections on the perimeter (Photographs 4, 5 & 6) and curved iron plates, internally (Photograph 7). All of the structural sections have suffered significant amount corrosion, probably due to atmospheric conditions. Whilst the sections on the perimeter did not have any obvious signs of section loss they were extremely friable. Given the weight of the granite blocks above there is a potential risk of these sections failing at any time, which could result in death or serious injury to persons in the vicinity.

The granite blocks on machine base one local to the passageway, grids 1-3 (C-D) should be either immediately lifted off the supporting structure, or temporarily propped to prevent death or serious injury. If temporary propping is to be installed, it is likely the granite blocks will still need to be removed to enable the corroded sections to be cut out new supporting members to be fitted.

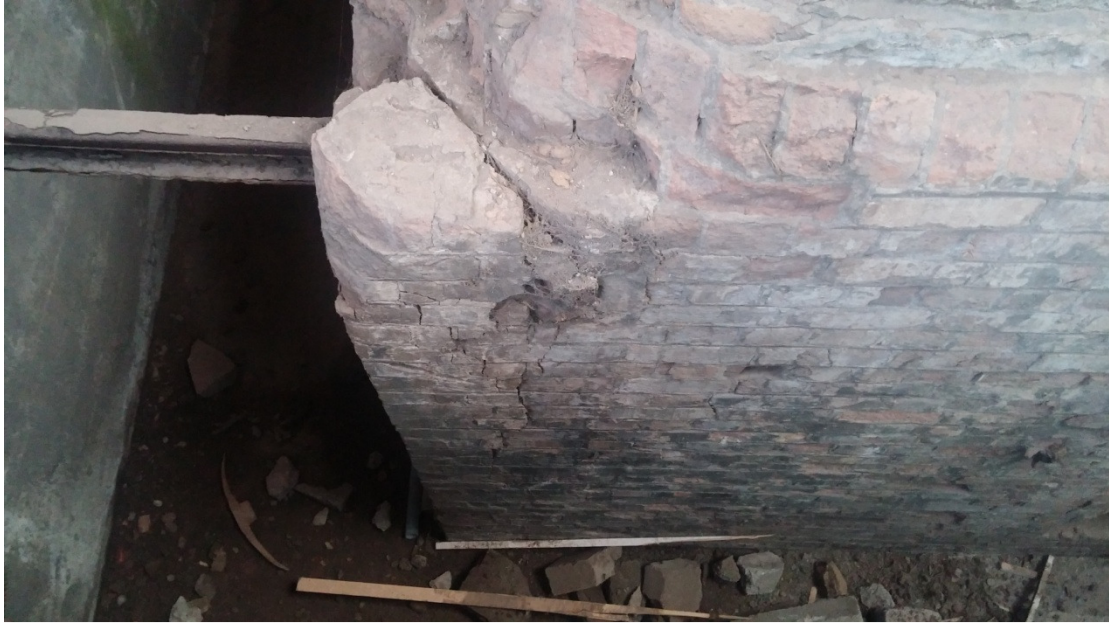
Photograph 9

The corner of machine base one (Photograph 9) had a full-height vertical crack on the one corner. It is not known whether this was a recent crack or historic. There are number of other similar vertical horizontal and vertical cracks in the masonry, which may result in the brickwork locally spalling. It should be recognised that if spalling does occur, due to the solid mass of the machine base, it should not have an adverse effect on the structure.

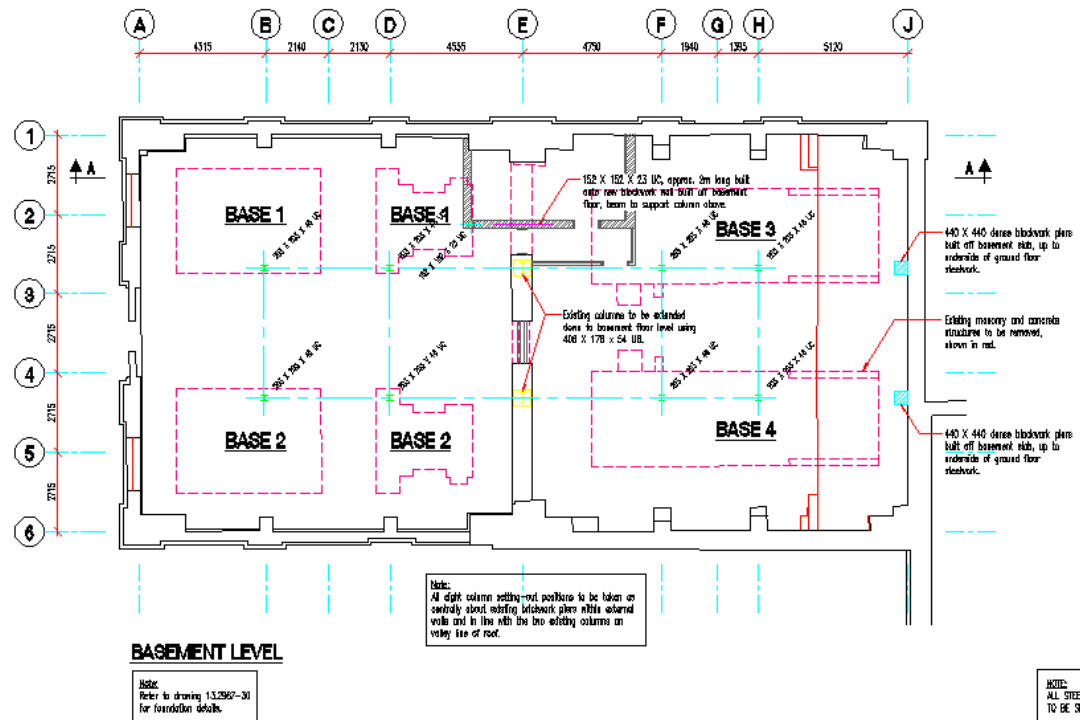
Figure 1

The machine bases have been removed to enable four new 203x203 UC structural steel columns to be installed to support the new upper floors (Figure 1).

It should be noted the new 203x203 UC structural columns (Figure 1) will be supported off new 1.6x1.6m reinforced concrete pad foundations at basement level i.e. below the level of the existing machine.

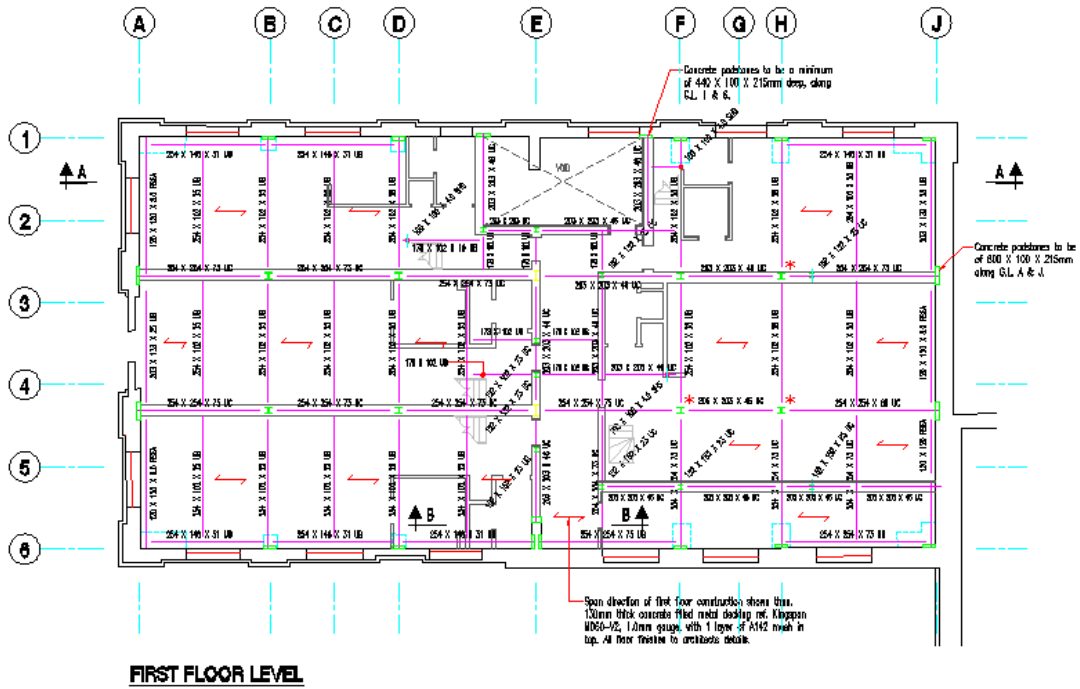
Figure 2

The columns have been positioned such that they support the primary steel beams that support the structural walls and floors above. These primary structural lines are between grids 2-3 (A-J) and 4-5 (A-J) (Figures 2 & 3).

Our intention is also to utilise the existing steel columns on grid line E (2-3) & (4-5). We have calculated the axial load through these columns from the new structure above will be in the order of 450kN (ULS). Having reviewed the condition the internal masonry spine wall on grid line E, we recommend the steel columns are extended down to floor level and new foundations are constructed beneath. A further section of this wall will need to be removed on grid line E (1-2/3) to enable the new fire escape staircase to be constructed (Figure 2)

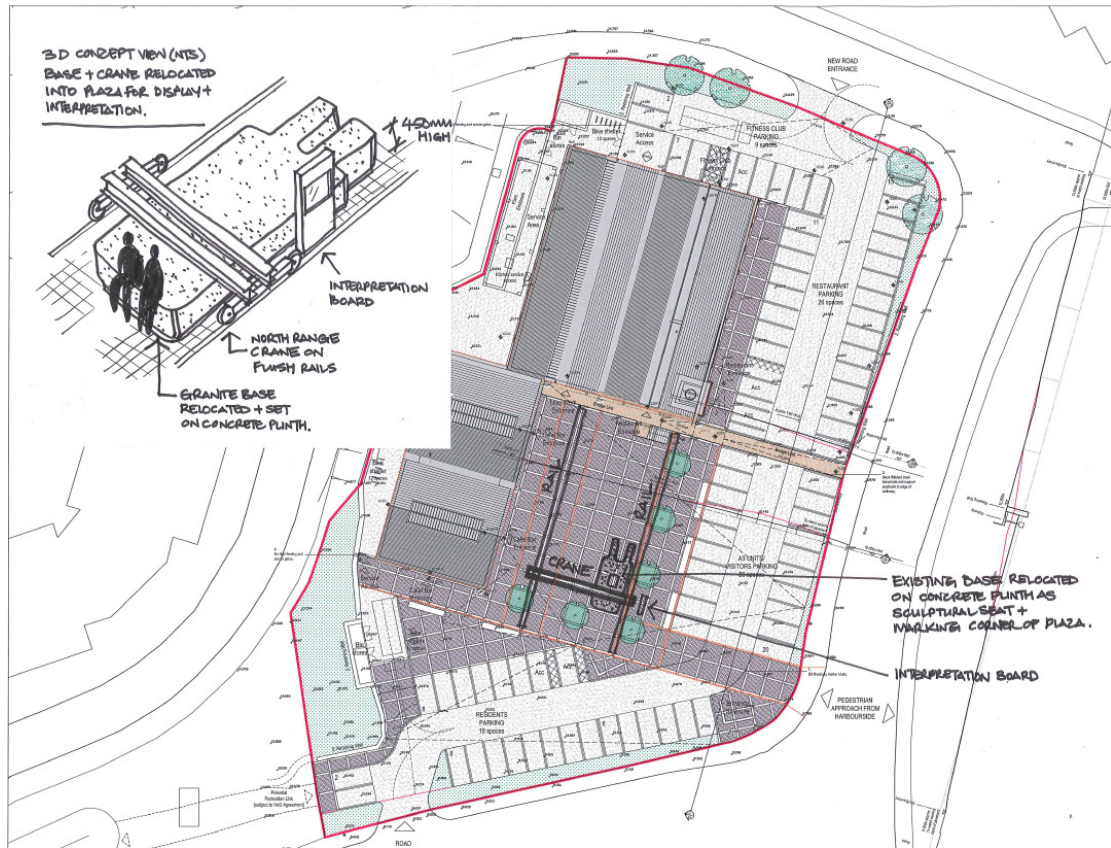
*Figure 4*

As we understand, DS properties have consulted with their Architect EWA, and they are proposing to reconstruct the machine bases one and two in the external Piazza area (Figure 4 - illustrating a typical relocation proposal). As can be seen from the Architect's illustration, the intention would be for both of the machine bases, the anvil and one of the existing cranes in the North Range building all to be sited in the Piazza area to preserve the historic history of the pump house.
