TARGET NOTES FOR DAY-TIME INSPECTION, 03 JULY 2015

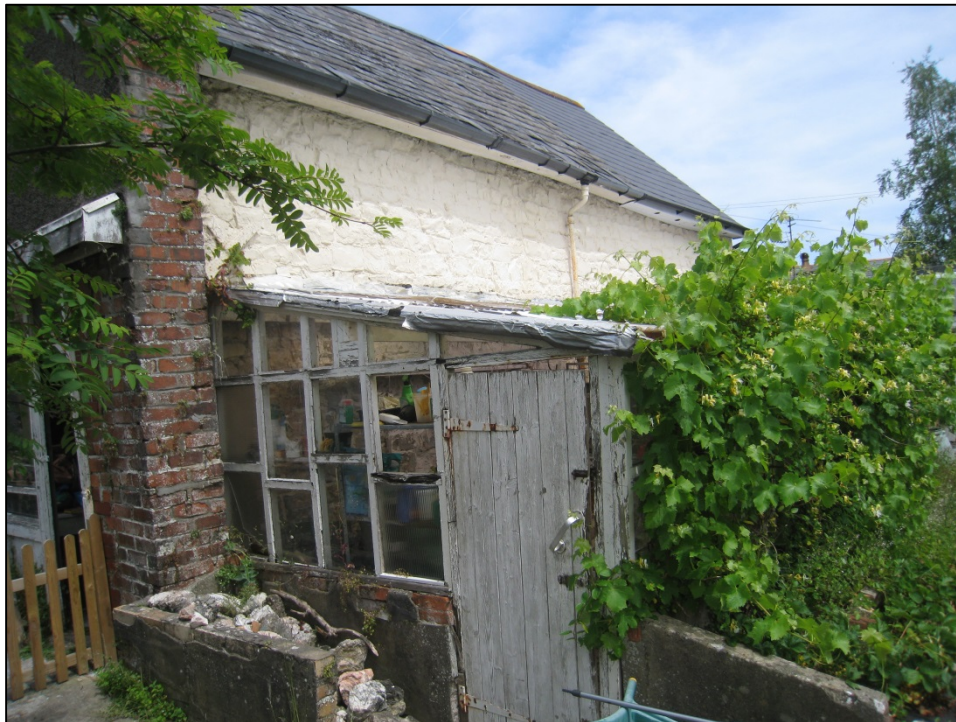
Plate 1 Green House to southern side of Coach House

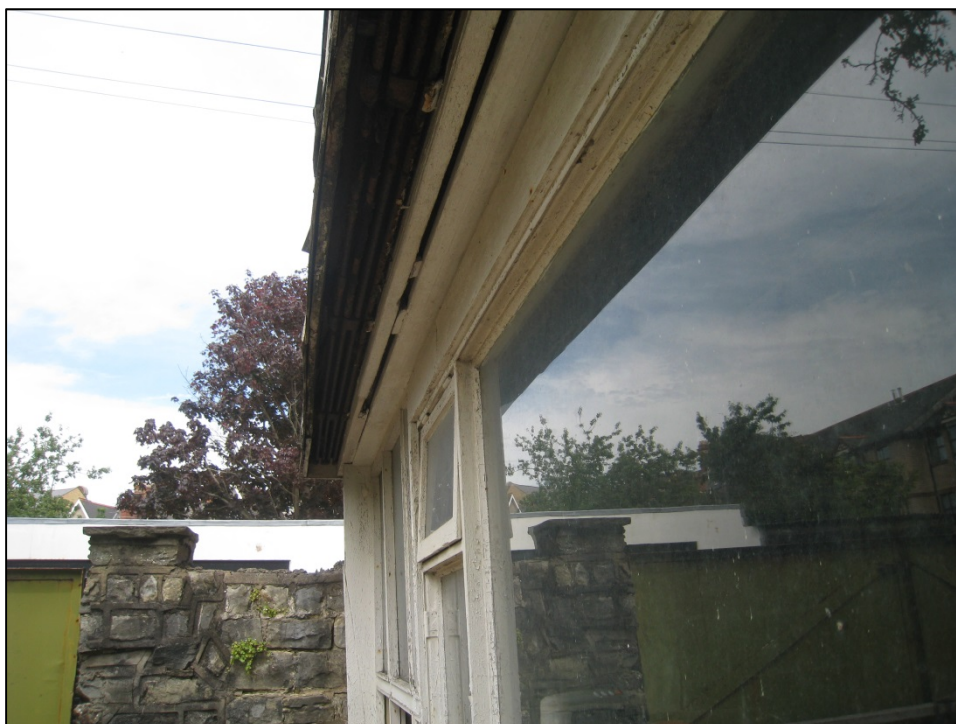
Plate 2 Timber cover for metal bracket of former roller door or awning

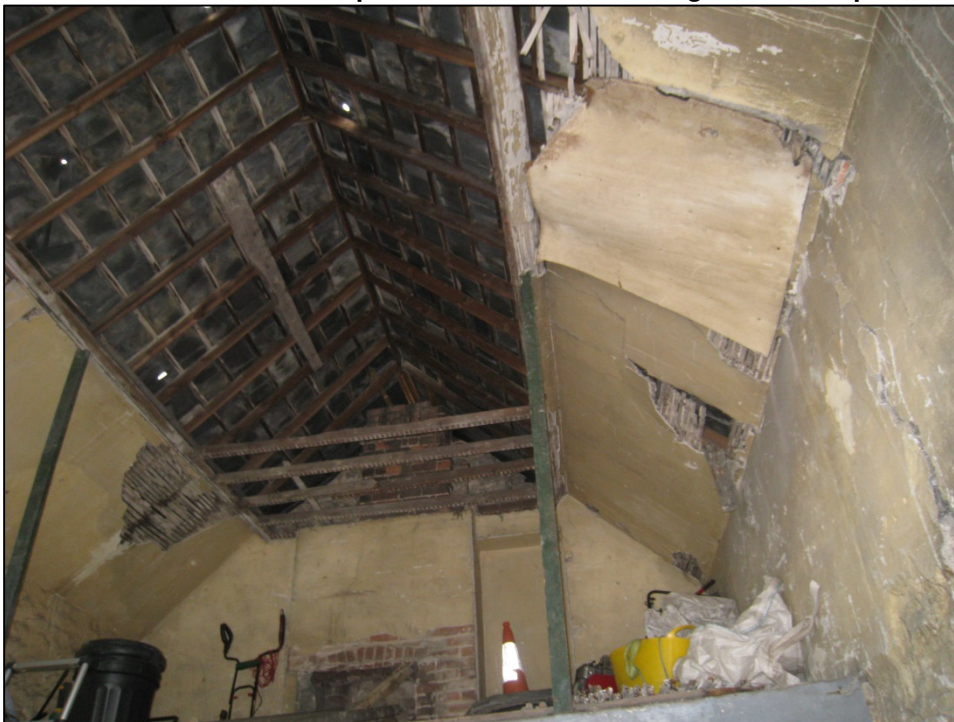
Plate 4 Interior of Coach House – Exposed roof slates and damage to lathe & plaster ceiling
