TARGET NOTES FOR DAY-TIME INSPECTION, 03 JULY 2015

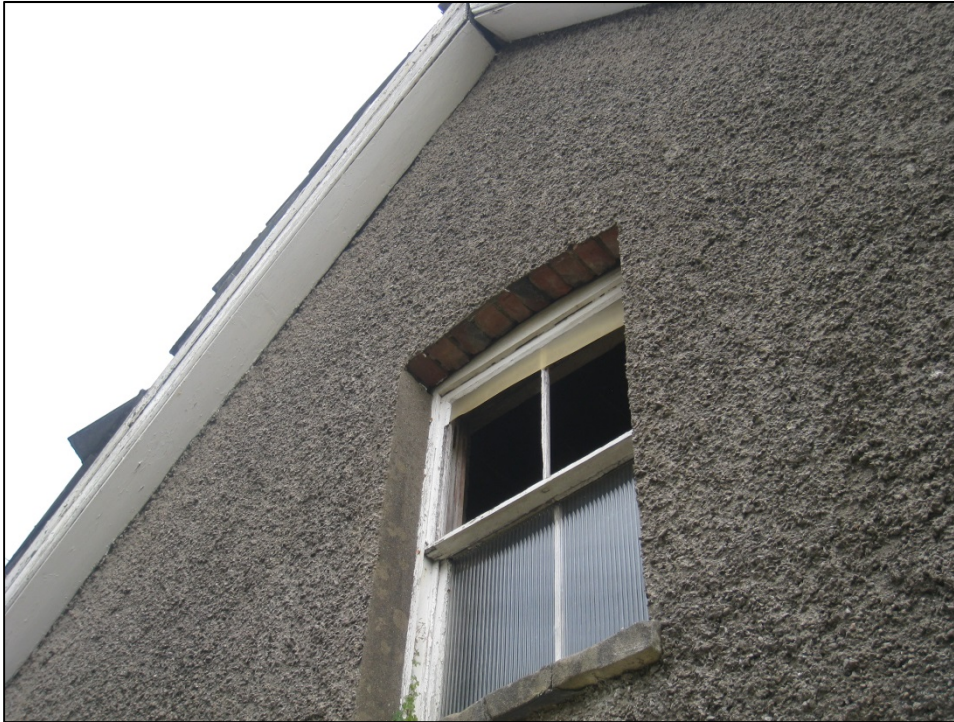
Plate 3 Window in western gable and gap in fascia at apex of gable end

Note 4	Open window in western gable end provide access to interior and obvious gap around the top of the frame (Plate 3). Timber soffit & fascia generally sound apart from obvious gap at apex of gable (Plate 3). No droppings etc. noted on the top of the awning cover below the window, or on window reveals, window sills or glass and none on brickwork below the shallow cavity (4-5 inches deep) at the top of the window. No bats or evidence of bats seen in this gap.
<i>Interior of Coach House</i>	<p>Single open space used for storage of garden tools/equipment. No separate enclosed roof space and much of underside of roof is exposed – i.e. slates visible affixed to timbers. Remains of lath and plaster ceiling in places but in poor condition with 'hanging' sections in places. Generally light and open interior (Plate 4) with little or no potential for day roosting – possible use as night roost or feeding perch but no evidence of this noted.</p> <p>Old cup and moss nest on roof timber above the window in north western corner – no evidence to suggest current use (no droppings seen on walls or stored material, no young in nest).</p> <p>Some gaps in stonework to north west corner but these cobwebbed and no droppings etc. on walls or stored material below.</p> <p>No droppings etc. on ground floor stored material or on window frames/interior sills to ground floor on northern elevation or western gable end.</p> <p>First floor mezzanine – used for storage and no droppings etc. on stored equipment. Ridge line is relatively free of cobwebs and several gaps in roof slates provide potential access. No evidence on floor or stored materials or on roof timbers.</p> <p>Chimney breast and fireplace on eastern partition wall – no evidence on stored timber or in fireplace opening.</p>

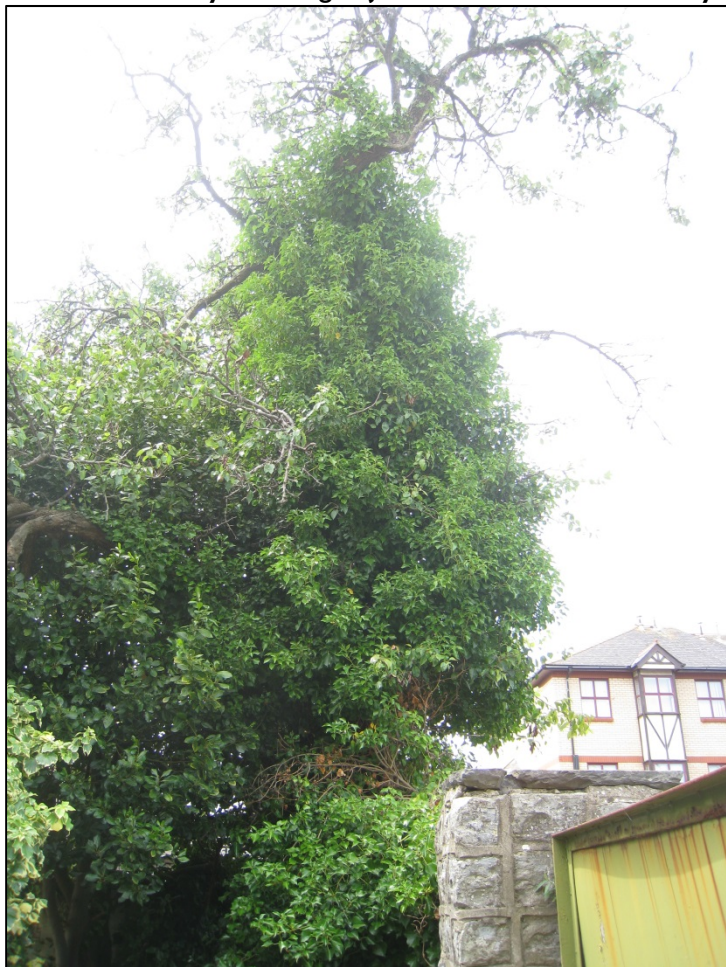
Plate 5 Fruit tree with Ivy covering adjacent to northern boundary wall

Note 5	Fruit tree (Apple or Pear) with heavy ivy leaf cover (Plate 5) but stem cover is relatively light. Bay tree to west close to boundary wall. No obvious features associated with the apple tree apart from the Ivy and considered of Category 2 potential (BCT 2012 Guidelines). Bay tree of Negligible potential (Category 3).
Note 6	Gap at north west corner of fascia/soffit allowing possible access to soffit box. Checked from lane via ladder – no evidence of bats found on walls below or visible within the cavity.
Note 7	Gap to south west corner allowing possible access to soffit – no evidence on

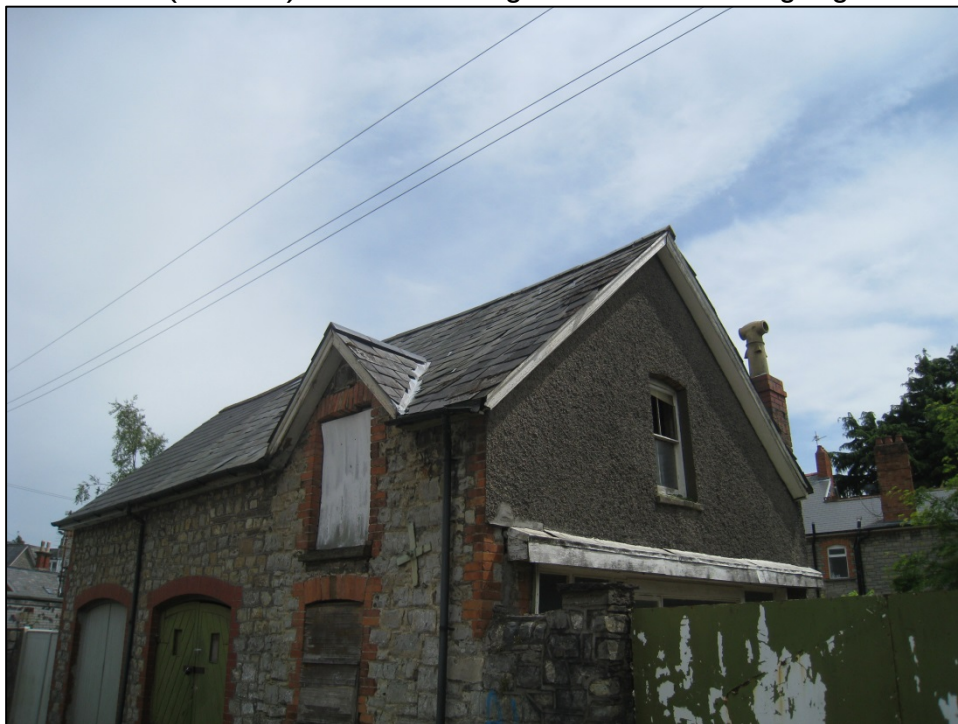
Plate 6 Lane (northern) elevation showing boarded windows & garage door

Target Note	Description/Comment
	timber or wall below.
Note 8	<p>Lane elevation (north). Numerous gaps at eaves and top of 1st floor window (Plate 6) – both windows boarded. No evidence on boarding or walls below the gaps around the windows or eaves. Old nest material noted in the hole to the top right corner of the first floor window.</p> <p>Gap at top of garage door provides possible access to interior but no droppings on the door and none noted inside the building (see above).</p>
	Overall no evidence of use by bats and building considered of Negligible/Low potential.
