Preliminary Slope Stability Analysis
Proposed Residential Development
Northcliff Lodge
Penarth

Prepared for:
Celtic Developments Penarth Limited

November 2016

Job No: 13124/1

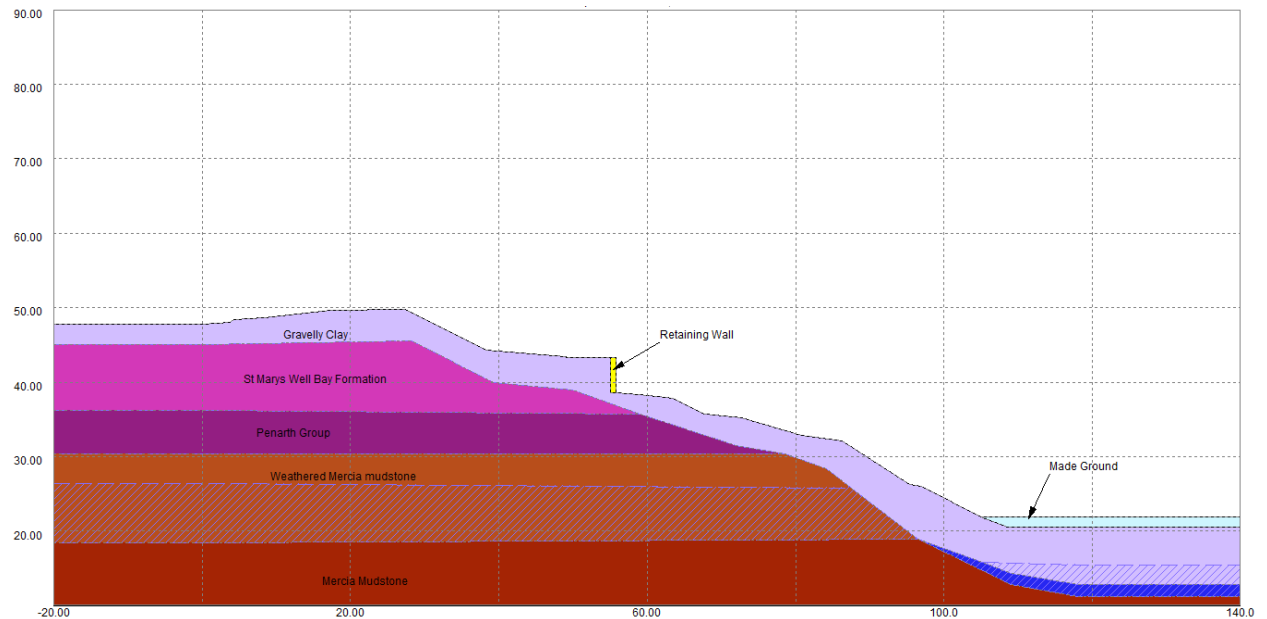
Figure 2.1 - Profile for Slope 1

Slope stability analyses for a single section through the centre of the site was undertaken. The boundary between each strata has been determined from depths confirmed during drilling and estimated where required through extrapolation taking into account ground conditions in general across the site.

This section was chosen as it contained the most precipitous slopes is are presented below.

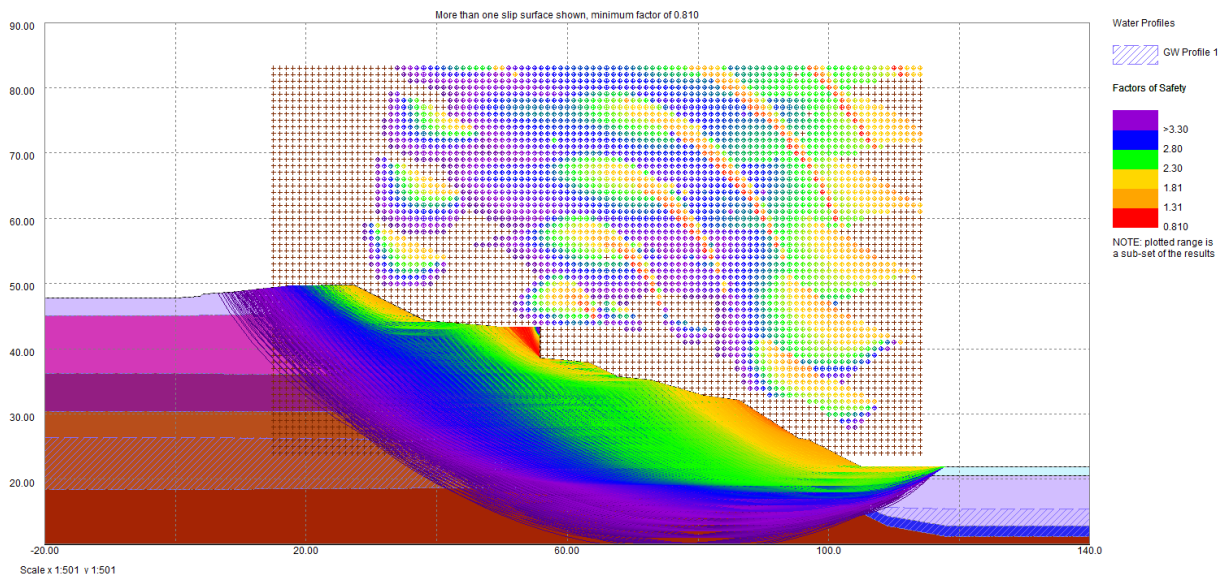
Figure 3.1: Failure Surfaces - Bishop Method Slip Surface

Table 3.1. Factors of Safety for Least Stable Failure Circles		
Slope Section	Analysis Method	Factor of Safety
1	Bishop	0.810

The predicted slip surface identified is seen to pass through the existing retaining wall. Figure 3.1 shows the analysed failure planes. All failure planes with a factor of safety of less than 1.3 are located directly behind the existing retaining wall a on the surface of the escarpment face as it drops towards Marine Buildings/ Custom House.

The slope stability analysis has revealed that based upon the soil profile and generic soil shear stress parameters all significant failure plains are within the stiff and very stiff gravelly clays generally located behind the existing retaining wall with very shallow failure planes at the top of the escarpment slope. The presence of cracking in the wall would confirm this.

The slope stability modelling has not identified an unacceptable risk of deep seated failure beneath the site. The shallow slip circles with unacceptable factors of safety identified can be engineered using common design techniques.

The recommended foundation solution of steel piles installed into the underlying competent bedrock will not add any weight to the ground surface and will maintain the stability of the development.

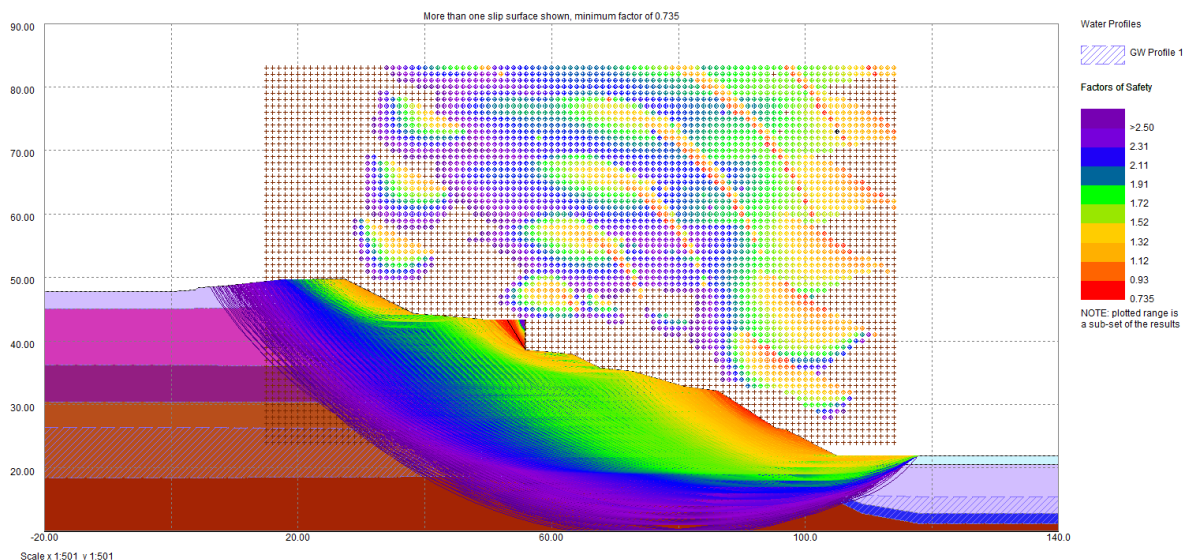
Figure 4.1: Failure Surfaces – 25% reduction in shear strength

The shear strength parameters were reduced by 25%. The resultant Factors of Safety of presented in **Table 4.1**. The graphical output of the analysis is shown in **Figure 4.1**.

Table 4.1 Factor of Safety for Least Stable Failure Circles - 25% Reduction in Shear Strength Parameters	
Stability Run	Factor of Safety
Original	0.810
-25%	0.735

Again the predicted failure planes pass through or behind the retaining wall with a lowered factor of safety. The analysis has also shown an increased area of shallow failure on the escarpment slope.

A 25% reduction in shear strength showed a reduced factor of safety, though the significant failure planes generally remained behind the retaining wall with slightly deeper failure planes at the top of the escarpment slope. The occurrence of the past slope instability to the east of the site confirms this.
