**Cosmeston
Lakes Wake
Park, Penarth**

**Arboricultural
Condition
Inspection and
Impact
Assessment**

Prepared by:
**The
Environmental
Dimension
Partnership Ltd
(EDP)**

March 2017
Report Reference
EDP3861_02

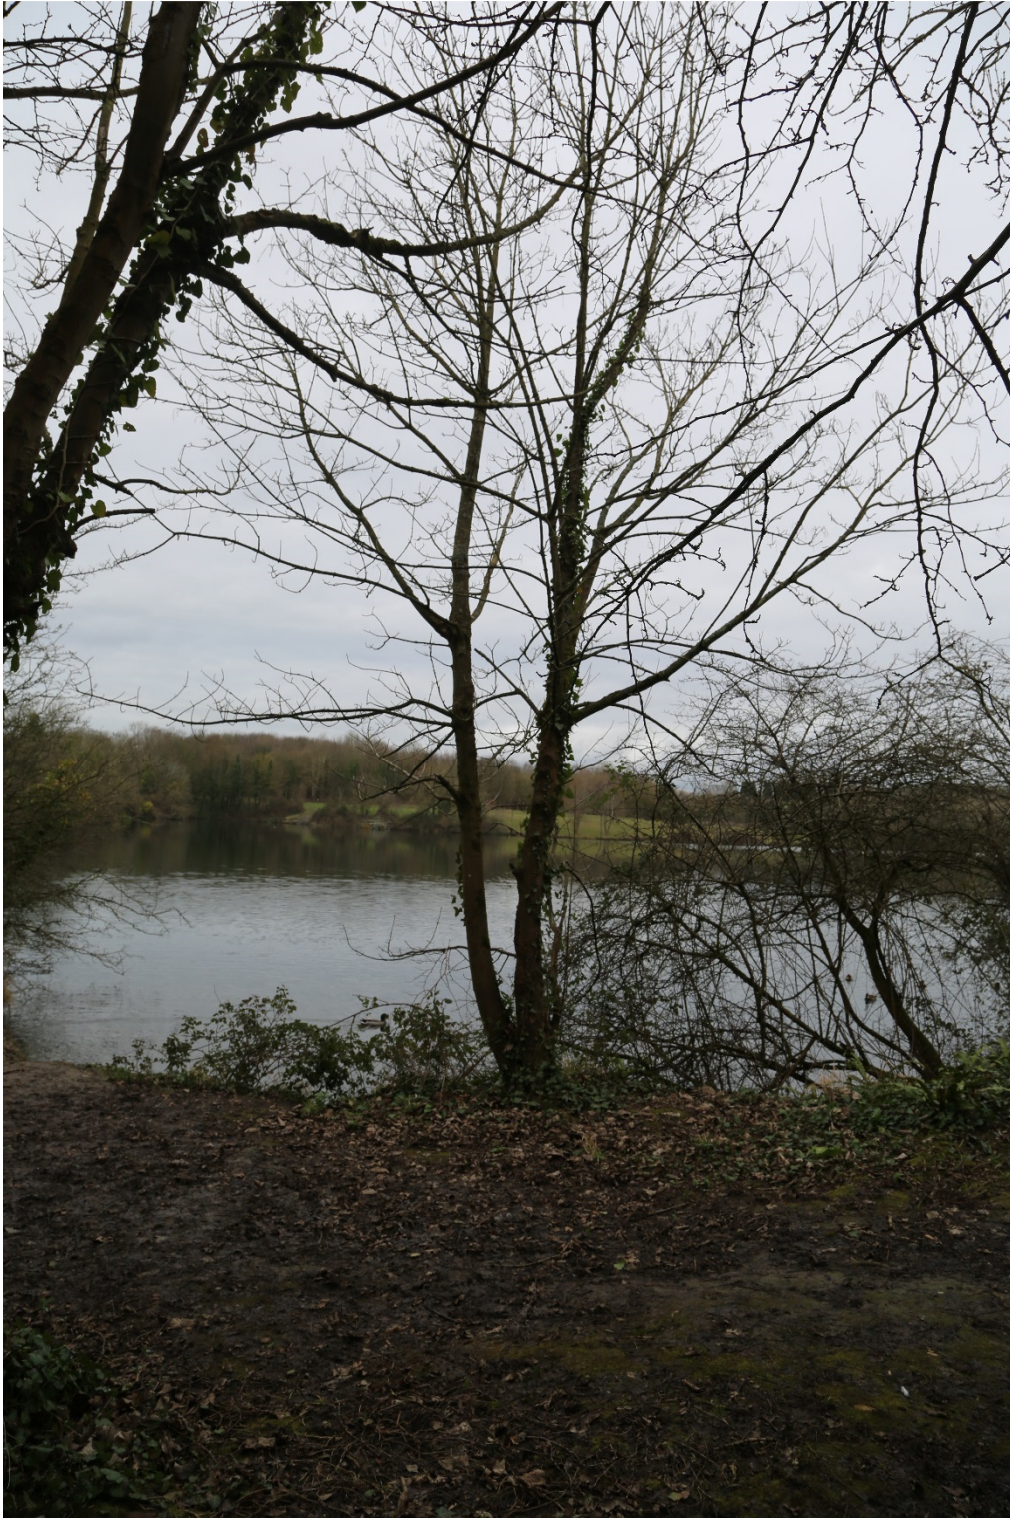
Image EDP 1
Item T1

- 2.6 **Image EDP 1** shows T1, an early mature sycamore of 8m tall in fair condition situated on the water's edge. It bifurcates from the base and shows some minor signs of historic damage.

Ref. Number	Species	Reasoning for Removal
T1	Sycamore	Proximity to overhead cable, retention possible but would require annual crown reductions.
G3	Hawthorn	To facilitate the viewing area.

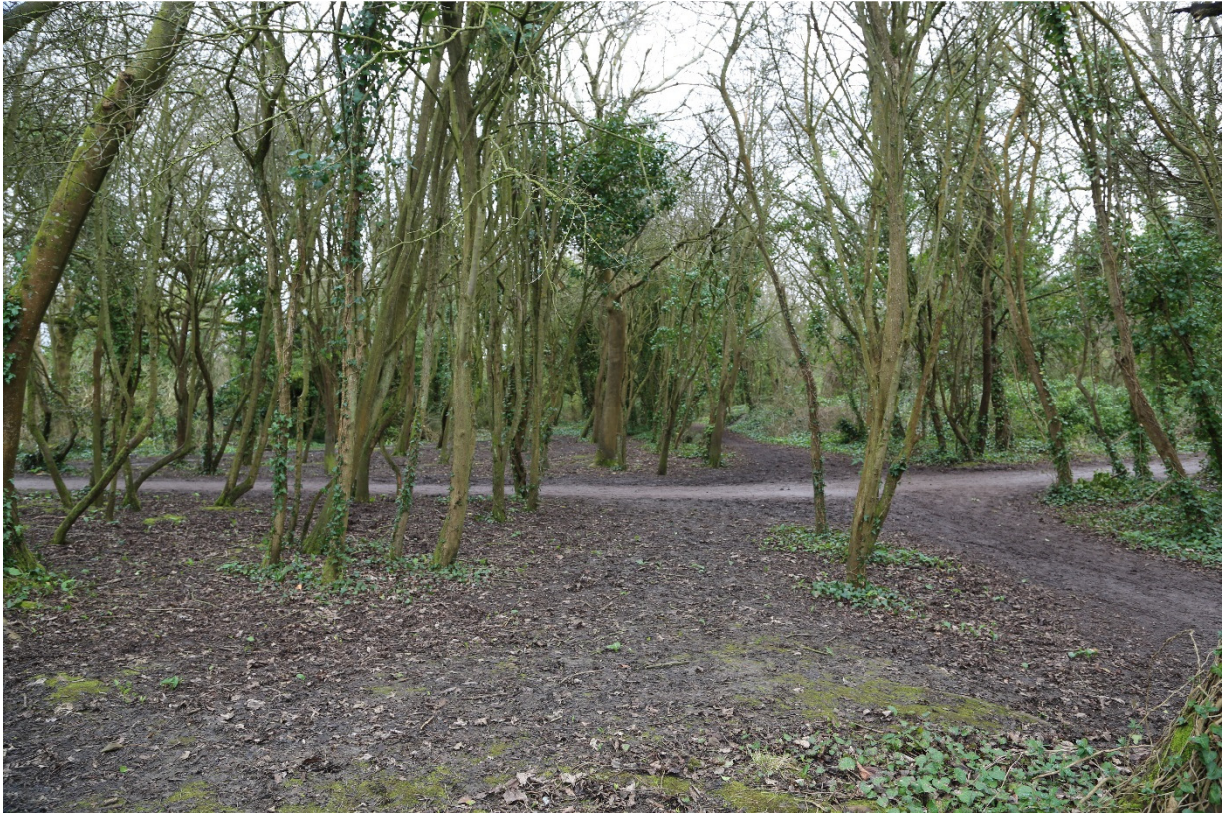
Image EDP 2
Item G2

- 2.7 **Image EDP 2** shows G2, a collection of small hawthorn trees, situated at the southern end of the site surrounding the proposed location for the anchor points.

Ref. Number	Species	Reasoning
G2	Hawthorn	To allow clearance for anchor line.
G5	Alder	Clearance for pylon and anchor line.
G6	Alder	Clearance for pylon and anchor line.

- 3.9 Assessment of the development proposals determines that the southern anchor point is cited in close proximity to retained items, G2. The construction of this anchor point will be mitigated by the use of hand dig construction methodologies to reduce the potential impact on the rooting environment. During excavation, any roots over 25mm diameter will be retained, protected and reburied post construction. Roots of smaller diameter will be cleanly trimmed only so far as is necessary to facilitate construction.
- 3.10 It is recommended that construction of the development is undertaken using small machinery with low ground pressures or the use of larger machinery with suitable ground protection systems to prevent compaction of the area.

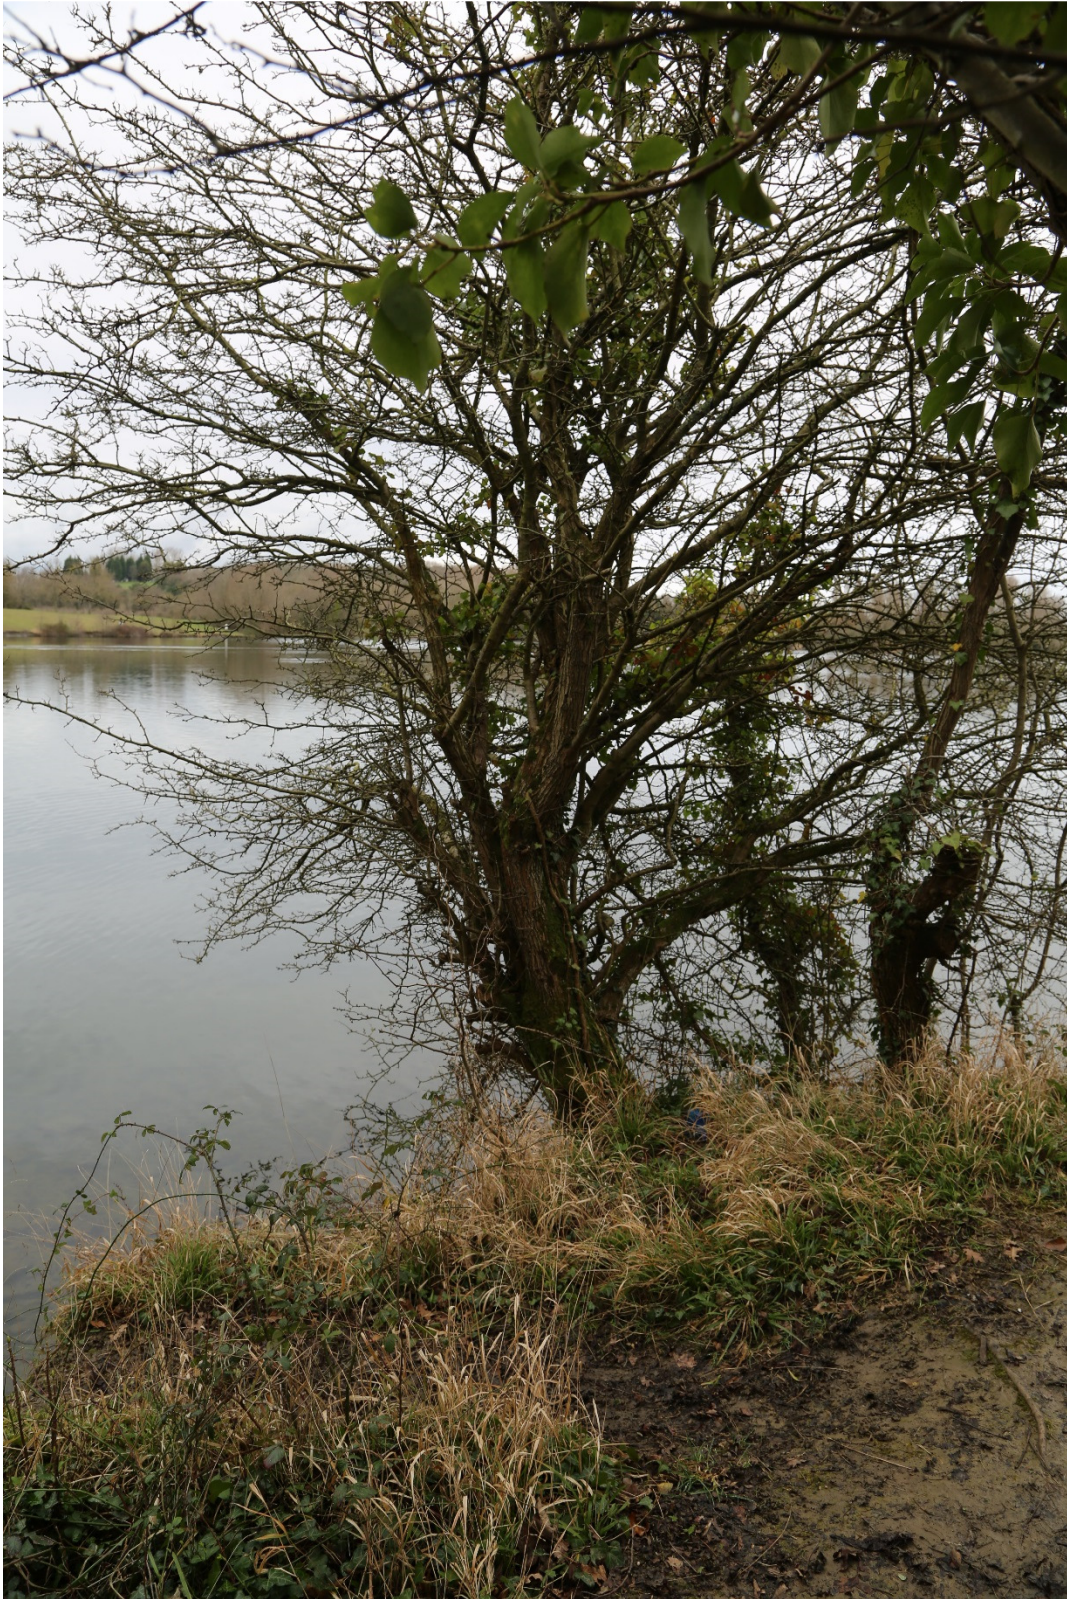
**Image EDP 3
Item G3**

- 2.8 **Image EDP 3** shows item G3, comprising a small group of Hawthorn overhanging the water's edge, encompassing one larger item surrounded by several younger items, likely to have self-set into the area.

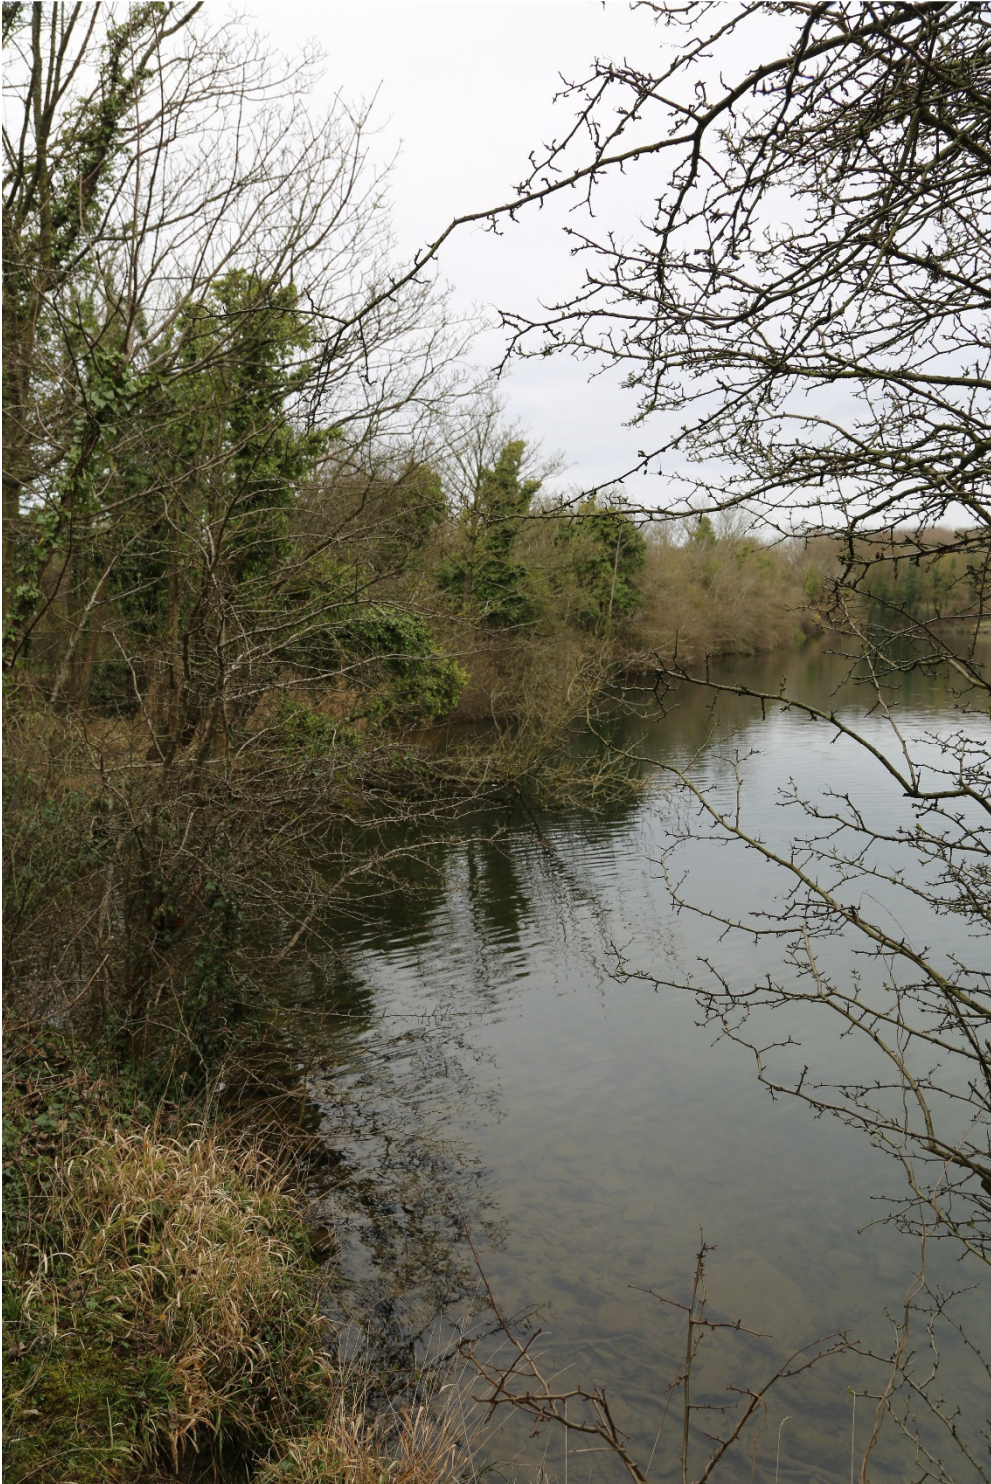
**Image EDP 4
Item G4**

- 2.9 **Image EDP 4** shows a view northwards up the lake and shows the collection of Hawthorn overhanging the water.
- 2.10 **Image EDP 5** and **Image EDP 6** are situated at the northern extent of the development looking south.

- 3.11 It is recommended that the overhang of G4 is reduced back from over the water to allow for safe usage of the proposed development.

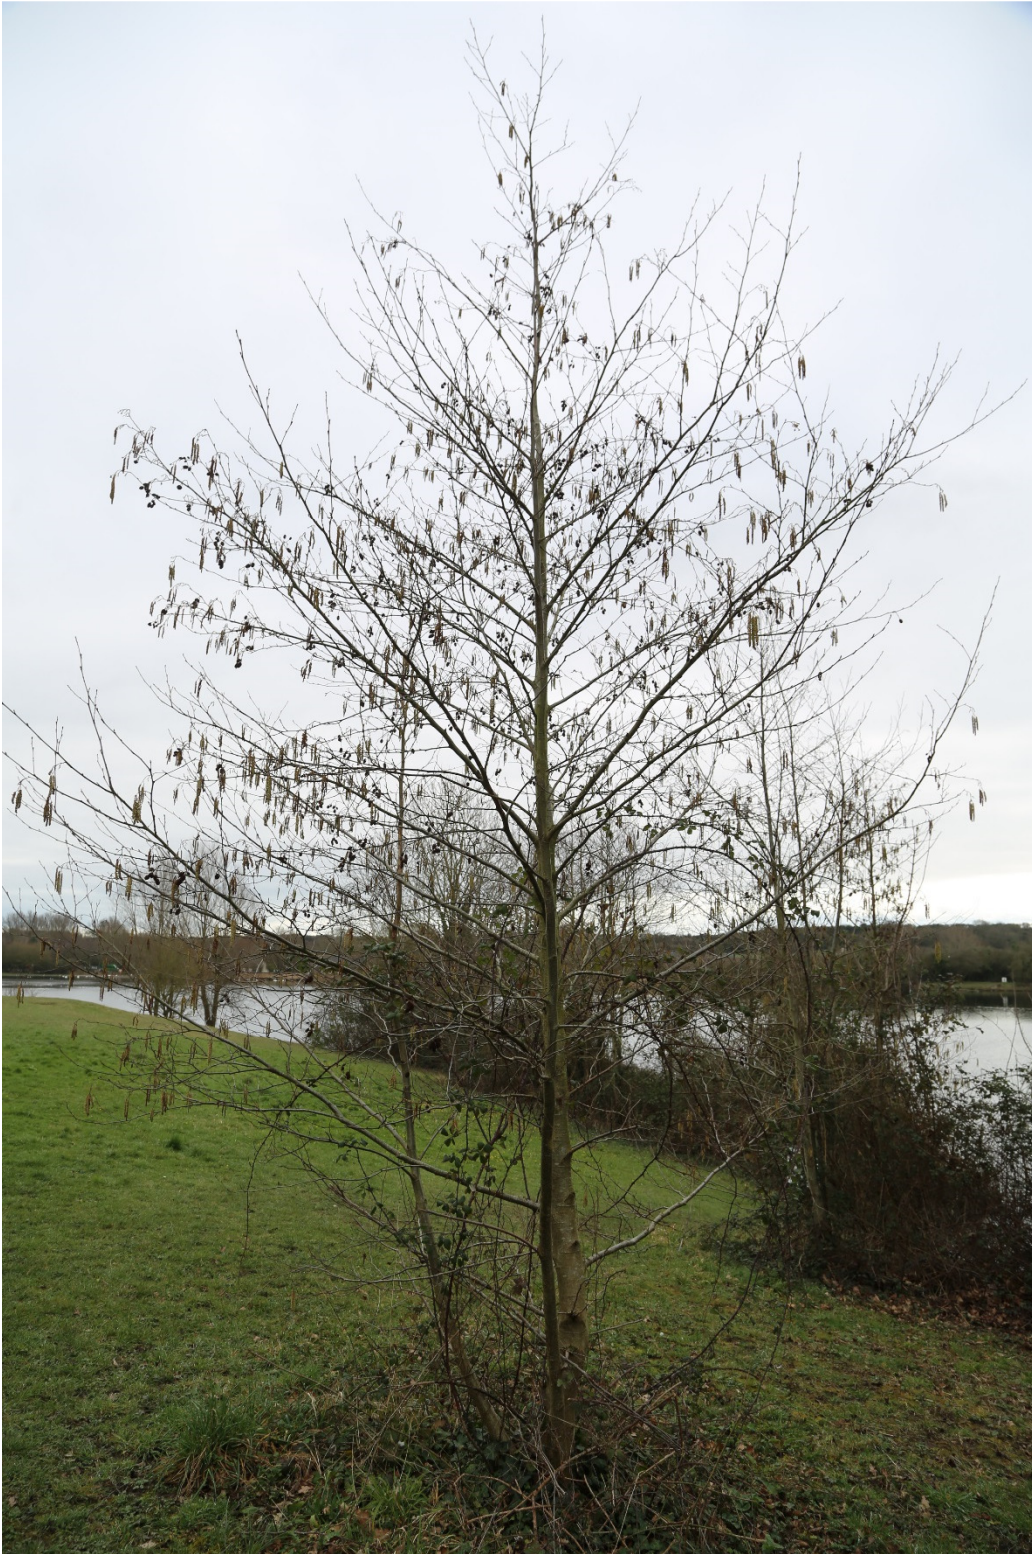
**Image EDP 5
Item G5**

- 2.11 **Image EDP 5** depicts G5, a young collection of Alder trees.
- 2.12 **Image EDP 6** shows G6 a more mature group of Alder trees with young trees at the fringes. This image also shows the view south, down the proposed development to the southern point.
