Document type  
**Structural Engineering Report**

Date  
**February 2017**

Document Number  
**1620001247-RP-001**

# GREENYARD FARM, ST ANDREWS MAJOR INITIAL STRUCTURAL INSPECTION REPORT

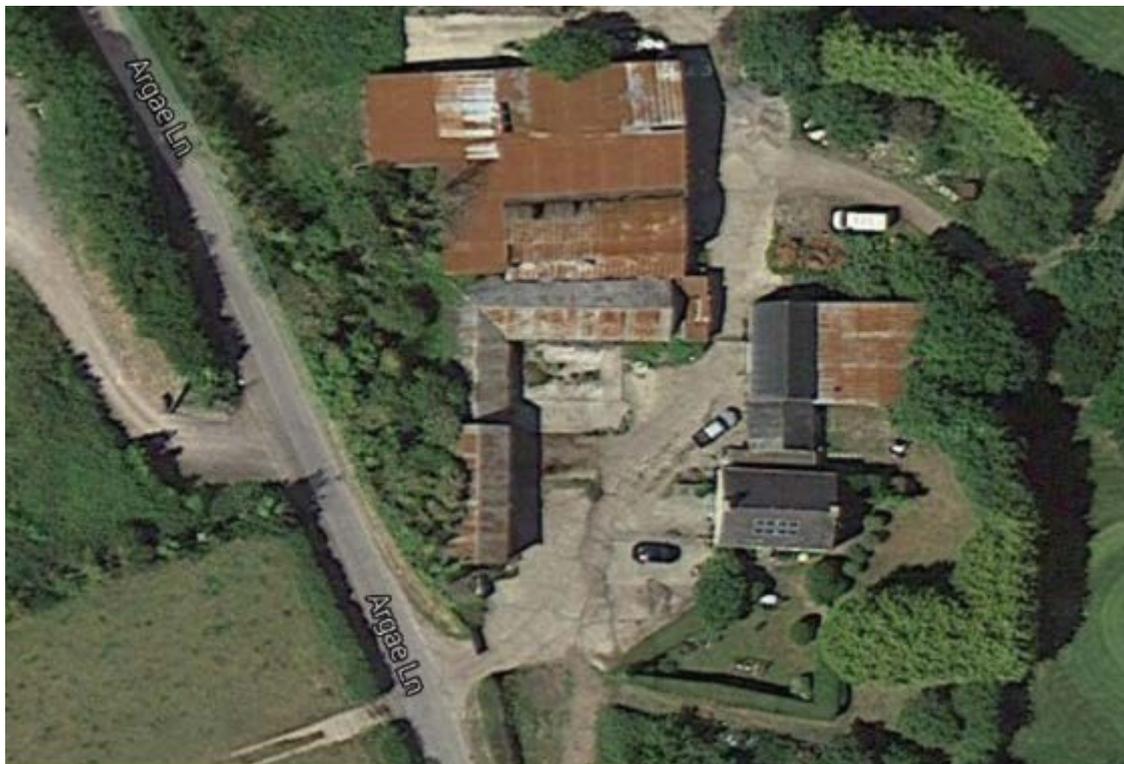
Figure 1 – View of Existing Site

The site is presently occupied by 4 buildings including a timber barn, a stone barn, a masonry milking parlour and another stone dwelling.

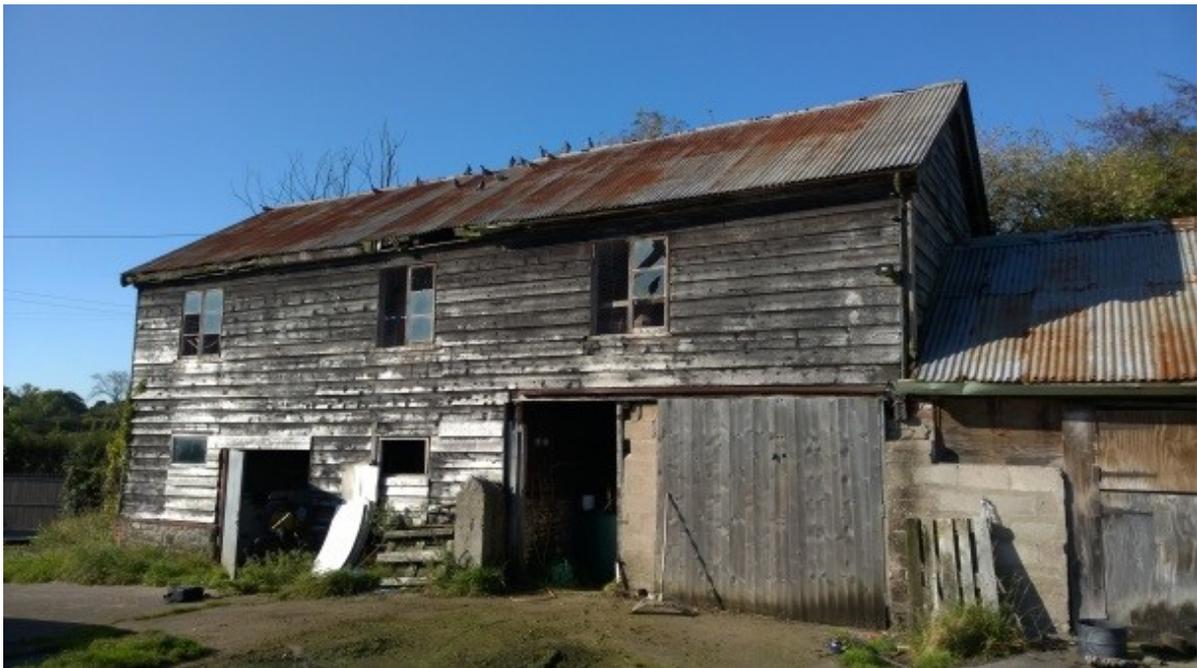
Figure 2 – External View of Barn

The building is formed from a timber framed structure with a duo pitched roof. The roof slopes at approximately 32°, and is formed from profiled metal sheeting. The external walls are covered with timber cladding.

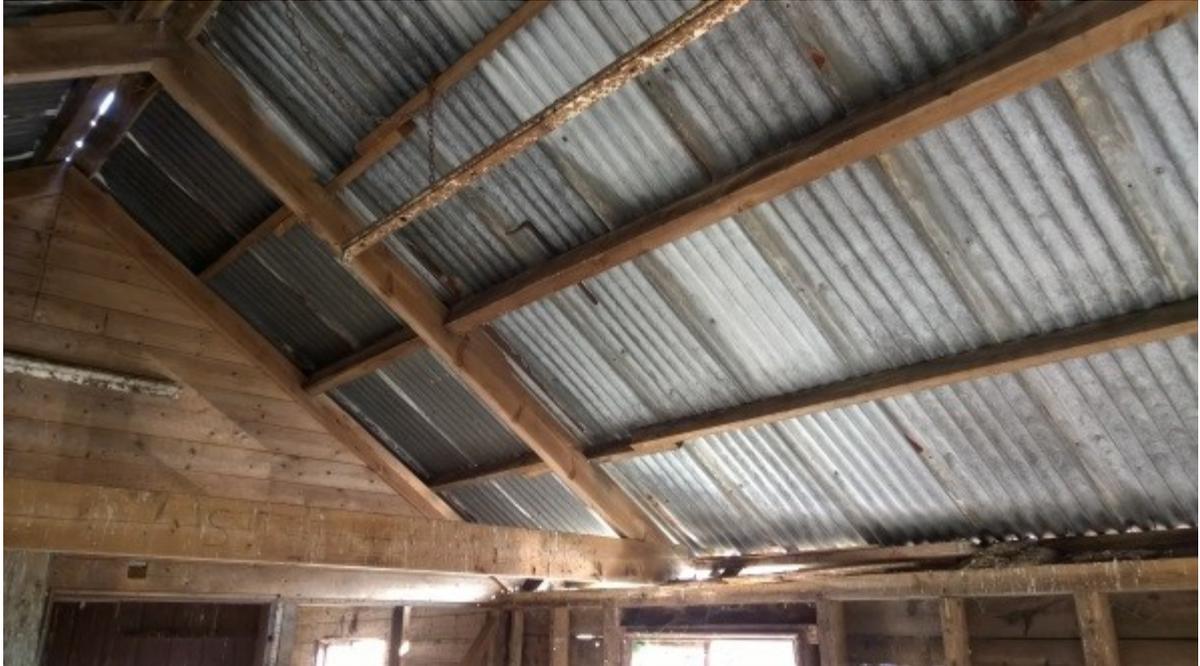
Figure 4 – Internal View of Roof

The metal roof sheeting is supported on 6 timber purlins of varying size, 3 on each side, spaced equally along the roof and perpendicular to the direction of fall.

These timber purlins are supported at the gable ends of the building, on 3 tied rafters and one internal wall.

The tied rafters are then supported on the perimeter timber stud wall comprising a 3.5" x 4.5" top timber with 3"x4.5" verticals at approximately 1'10" c/c with additional framing around door and window apertures.

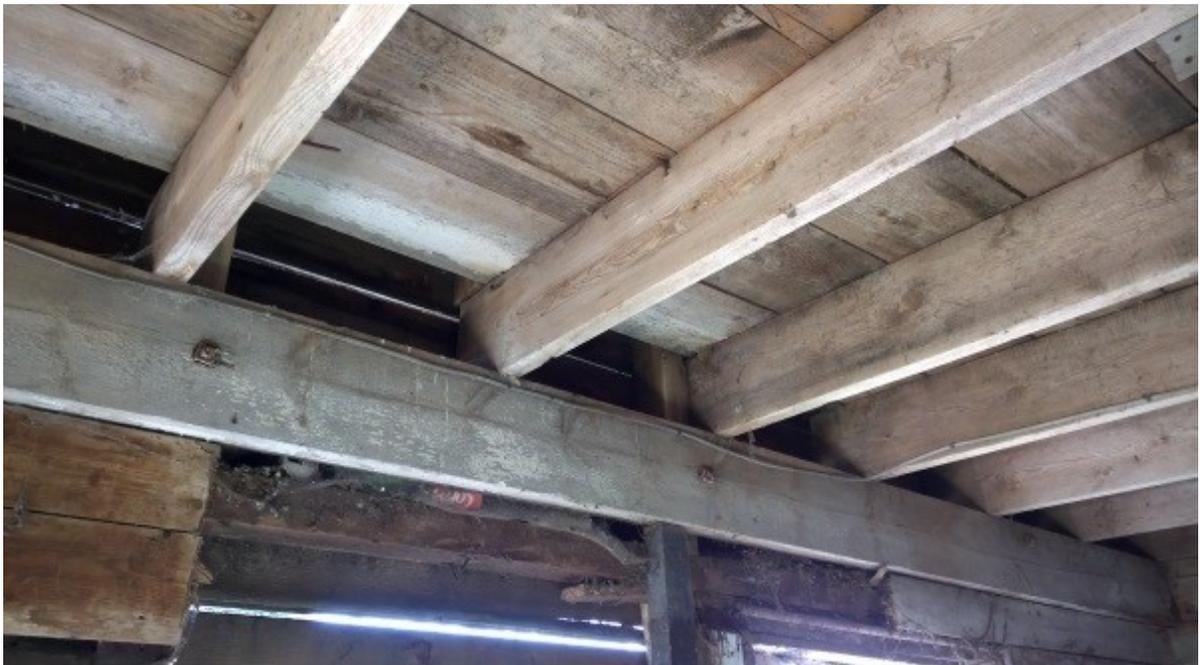
Figure 5 – Floor Joist Junction at External Wall

The first floor is formed from timber boards supported on 2.25" wide x 9" deep timber joists, at 2' centres, supported on the front and rear walls and a central timber beam.

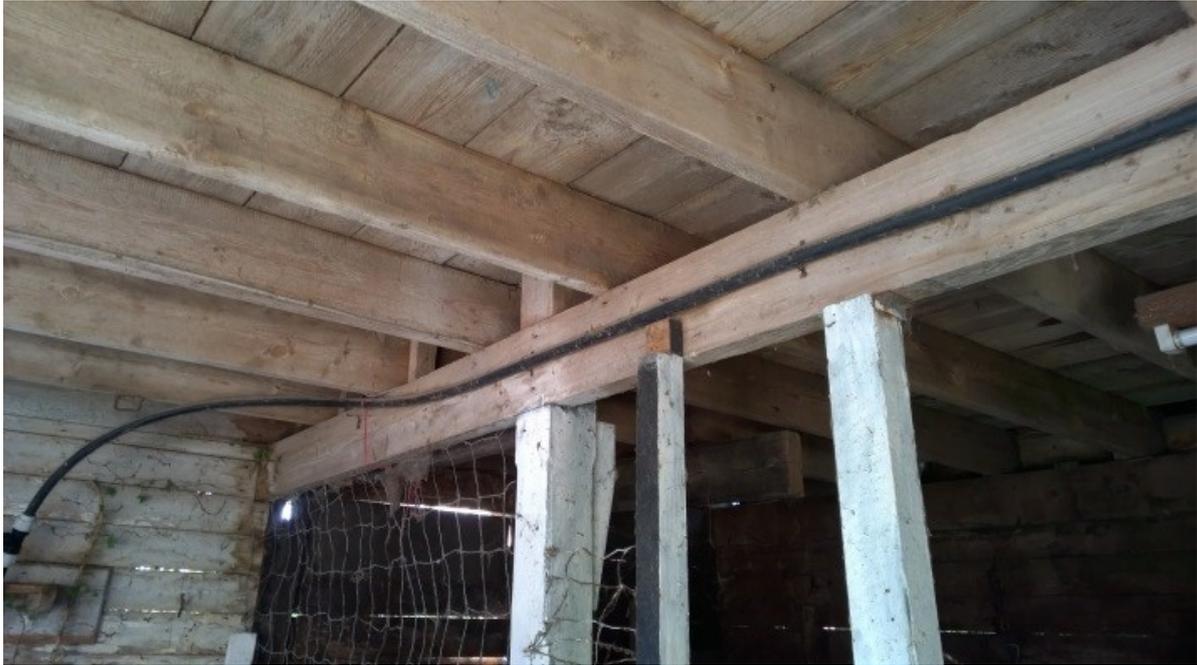
**Figure 6 – Floor Joist Beam Junction**

The central beam is supported on the gable walls, 3 columns 6" square in the left hand side of the building, an internal wall and external wall at the right hand side of the building.

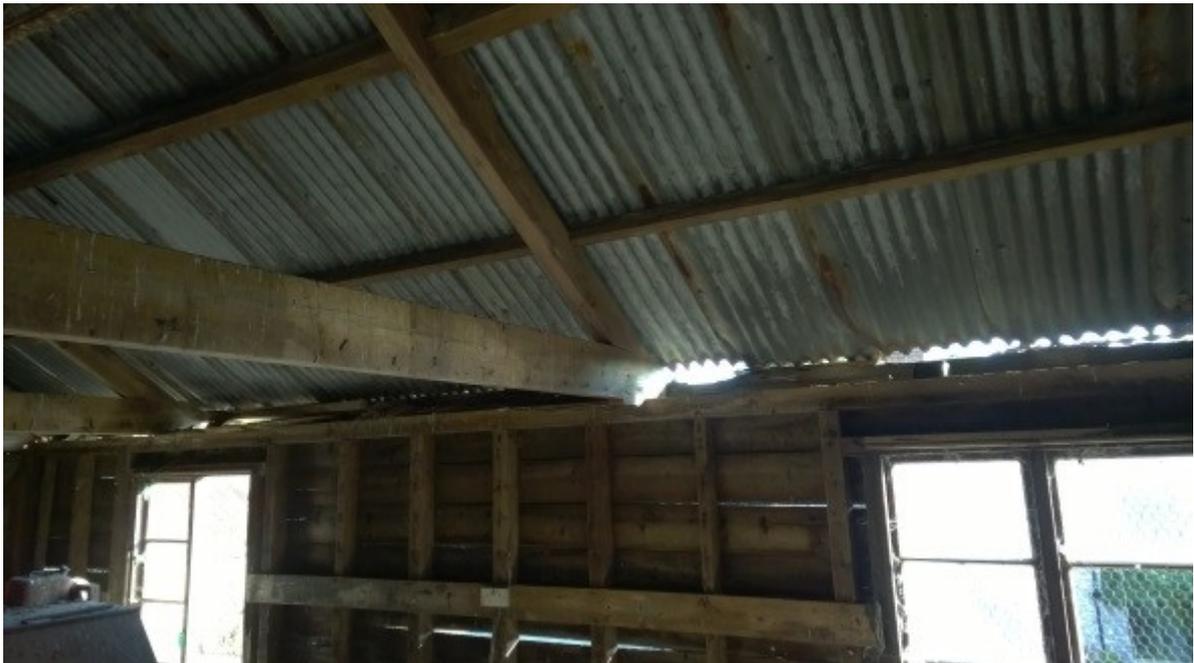
**Figure 7 – Openings in External Fabric**

The building is not at present weather or water tight; however the structural elements at present appear to show little sign of persistent water ingress or damage. There are unglazed window openings at first floor and some openings at both levels within the external cladding.

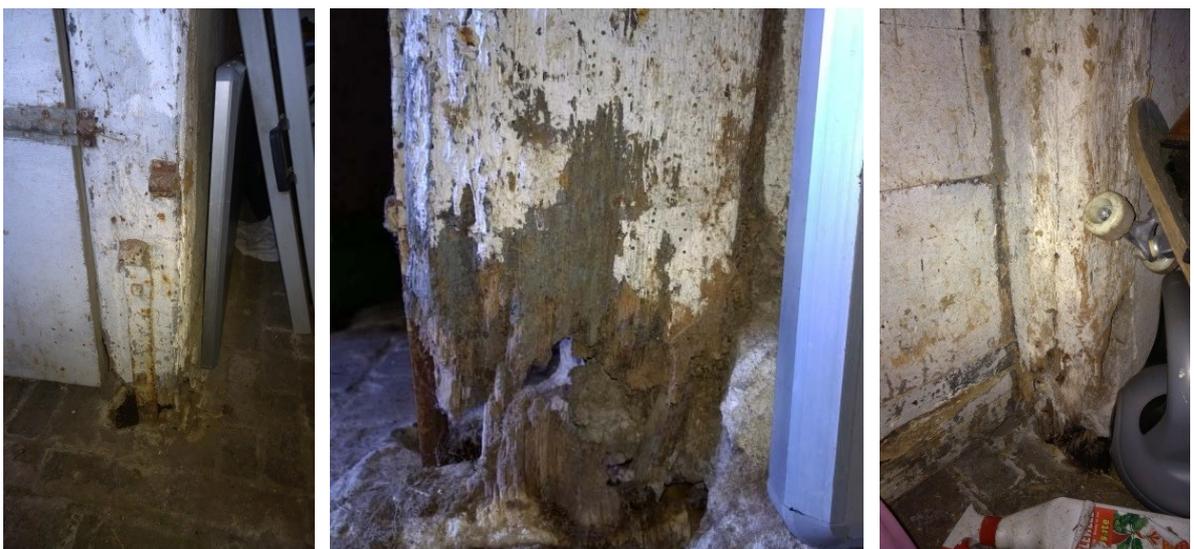
**Figure 8 – Decay to base of existing posts**

The bases to all of the central timber columns showed significant amounts of decay, and it is likely that at present these columns are being supported by the concrete walls forming the animal enclosures. The base of these columns would need removing, to leave only competent material, and the base would then need replacing to maintain the integrity of the building, careful consideration would need to be taken in developing the sequence of propping, removal and

replacement to ensure the temporary stability of the overall structure. It is presently unclear as to the size or nature of the foundations supporting these columns and it would therefore be prudent to locate, verify and strengthen if required these foundations as part of these works.

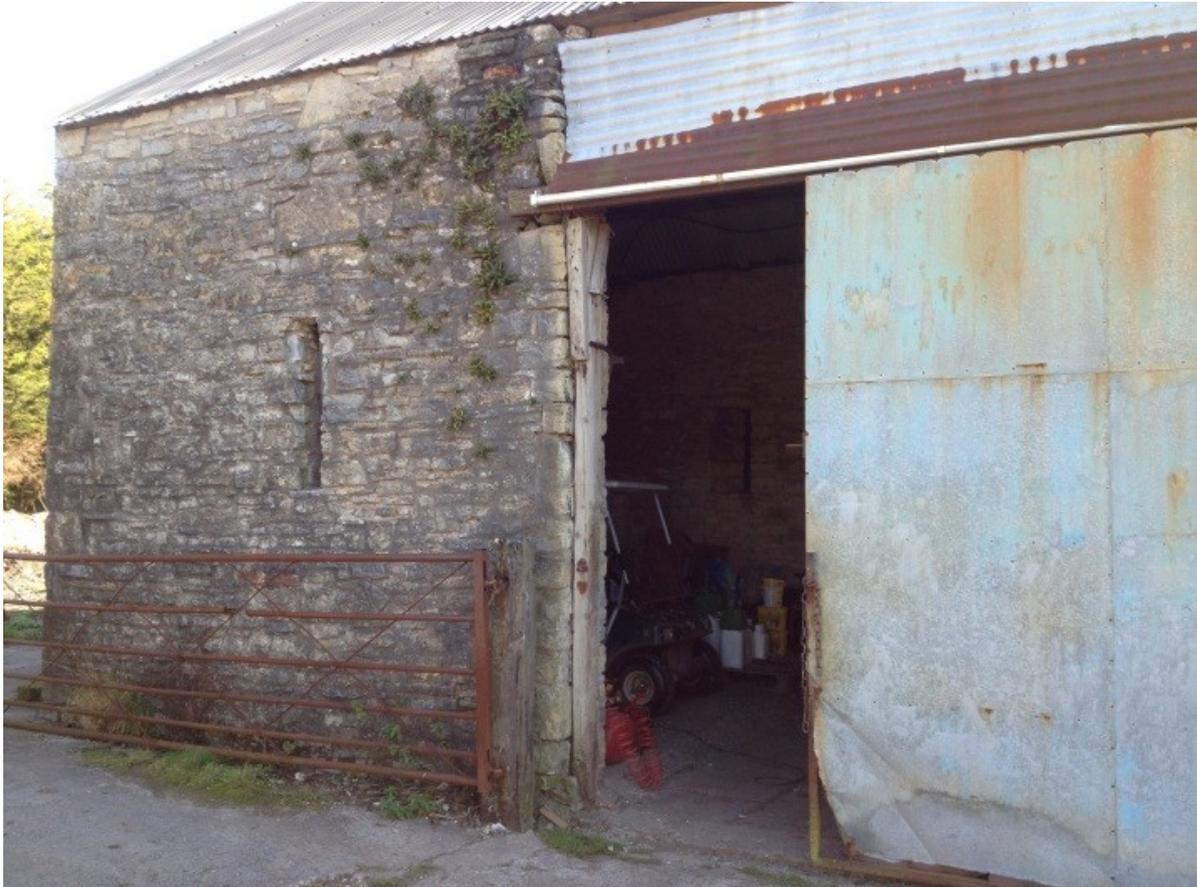
Figure 9 – External View of Barn

The building is comprised of three connected spaces, the main barn area, an adjacent room presently used for storage and a rear extension which will be demolished as part of the proposed works. The building is comprised of a sheet metal roof supported on stone walls.

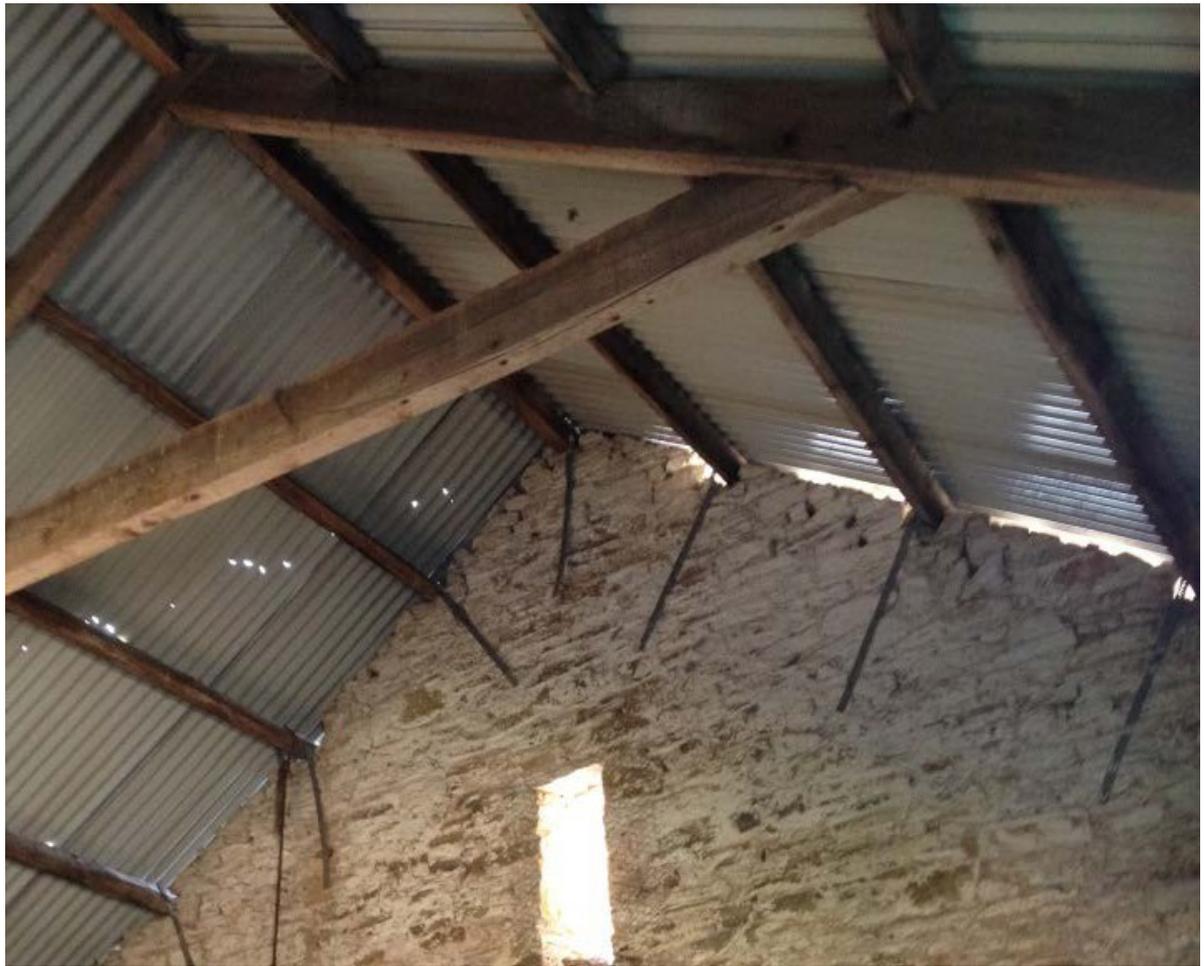
Figure 10 – Roof of Stone Barn

The duo pitch metal sheeting roof of the main barn area is supported on 4 timber purlins spanning between the gable end walls, and two internal raised tied rafters on each pitch and a single ridge beam. These timber beams are also strapped down to the stone gable end walls to resist uplift on the roof. The roofs to the two smaller areas to be retained appear to be of similar construction.

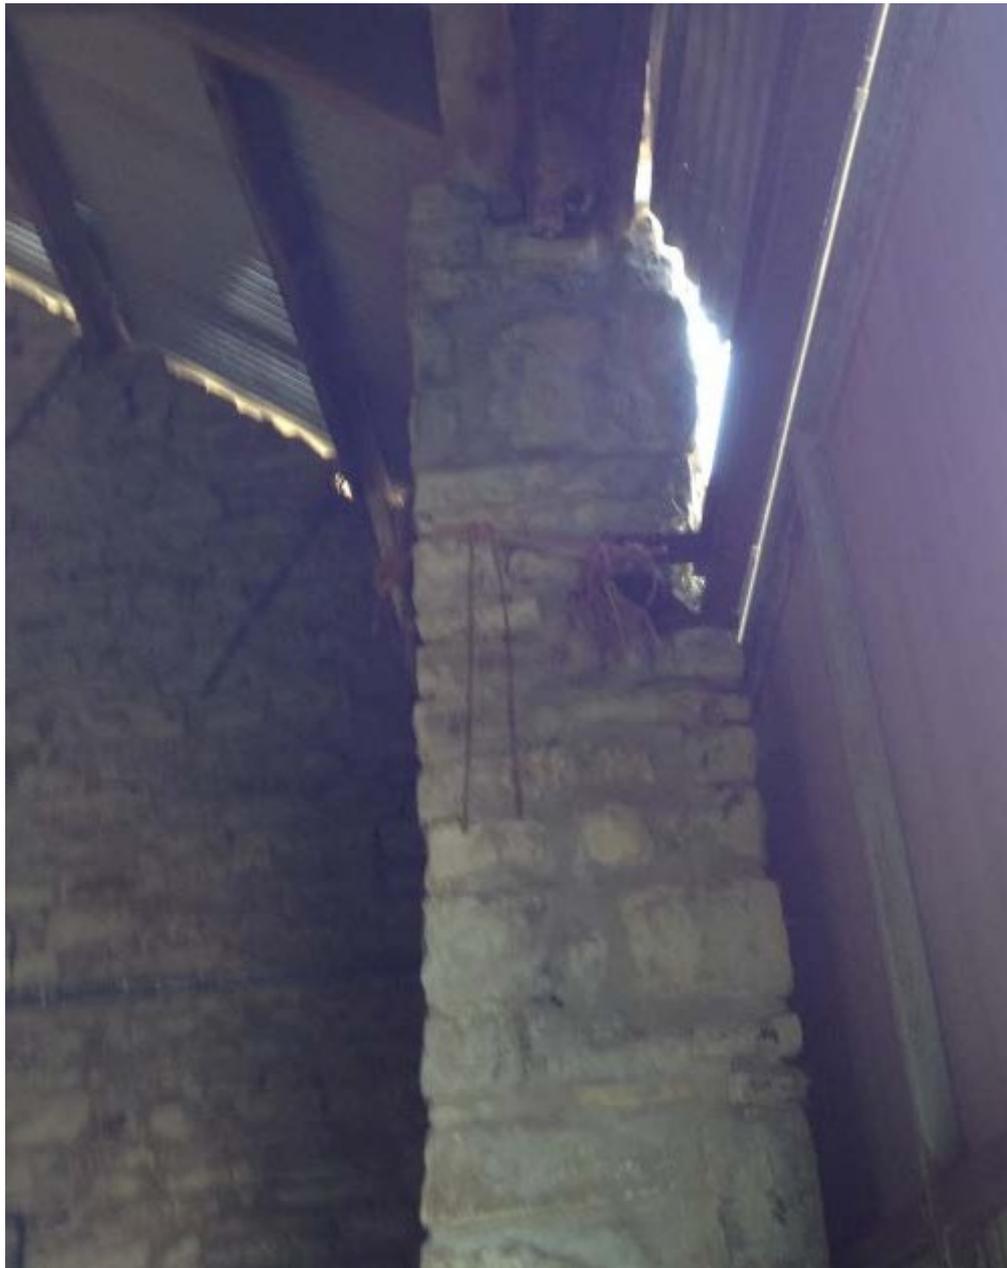
Figure 11 – Stone Barn External Wall

The walls appear to be constructed from random rubble limestone with cut stone around openings and are approximately 20" thick. It is not clear from the visual inspection if these walls are constructed from solid stone or are comprised of external stone faces with a rubble core. The visible stone and mortar appear to be in good condition with no visible sign of significant deterioration.
