FORMER BOYS VILLAGE SAINT ATHAN

UPDATE BAT SURVEY

June 2015

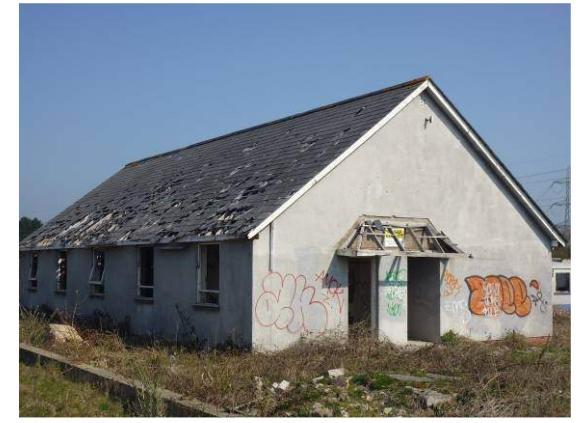
- Multiple slipped or missing slates (See Plate 1);
- Broken timber soffits along the western elevation (See Plate 2);
- A moderate sized gap at the apex of the northern gable end wall where the soffit box has worn away (See Plate 3); and
- Between the slate roof and exposed bitumen lining which is torn in many places.

Plate 1: Building 1 – South-east elevation

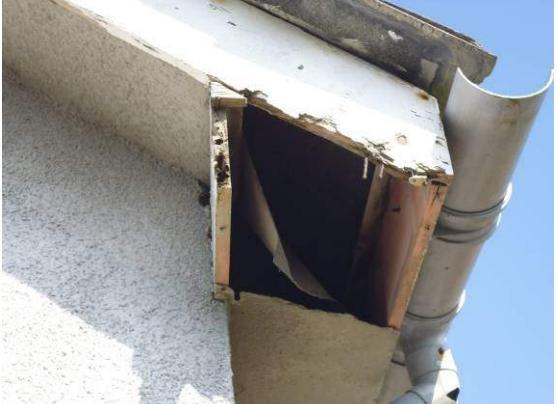
- Underneath multiple slipped or missing slates;
- Between the roof slates and the torn bitumen lining (See Plate 5);
- Beneath the slates along the ridge of the building, which remain relatively intact but easily accessible;
- Within the soffits at the western elevation;
- Between the rafters and overlying slates that have been exposed by the eroded soffits (See Plate 2); and
- Within the moderate sized gap at the apex of the northern gable end wall where the soffit box has worn away (See Plate 3).

Plate 3: Access into soffit box of building 1

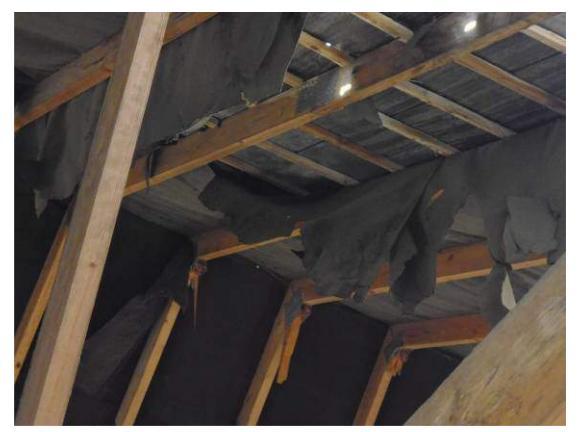
Plate 5: Loose lining within building 1

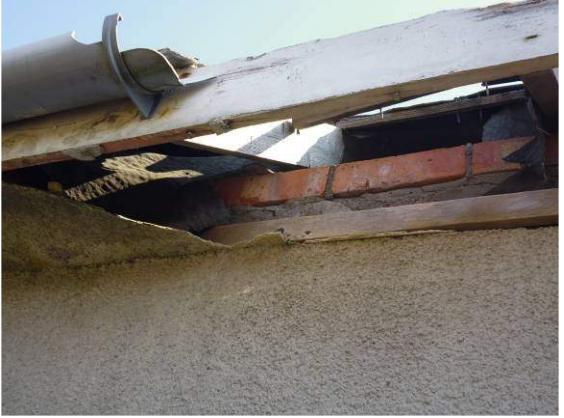
Plate 2: Eroded soffit of building 1

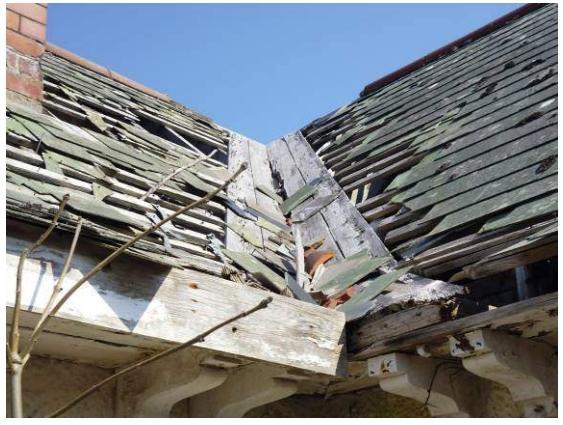
- In between multiple slipped or missing slates (See Plate 7);
- Gaps in the soffit boxes on all elevations of the building;
- Into the main roof structure between the exposed rafters (See Plate 8); and
- Within the uncapped chimney flue.

Plate 7: Numerous missing tiles and exposed cavities behind fascias of building 2

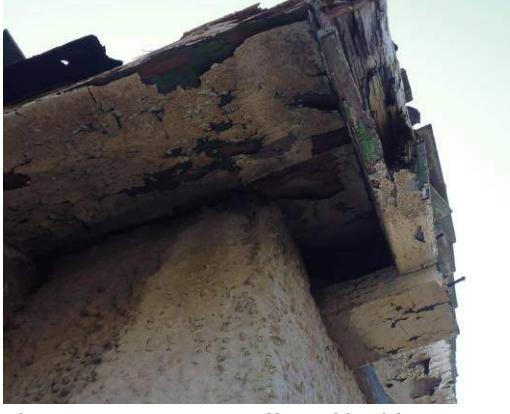
- Between multiple slipped or missing slates (See Plate 10);
- Within areas where roof lining has come loose beneath the sarking and slates;
- Within the soffit box at the north-western elevation of the buildings western pitch (See Plate 11); and
- Within the uncapped chimney.

Plate 11: Gaps into soffits of building 3

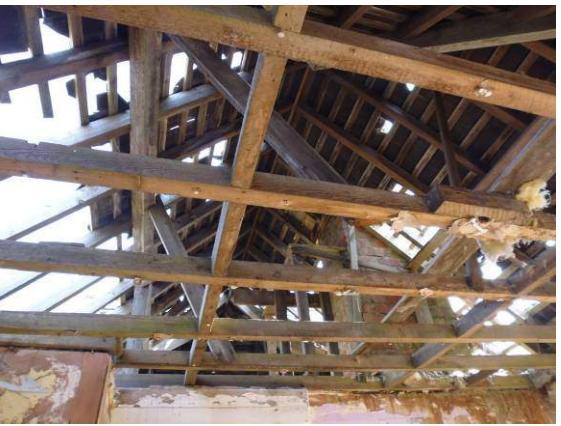
Plate 8: Internal roof structure of building 2

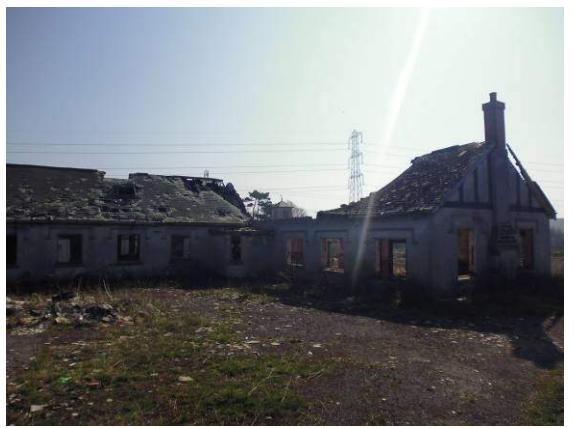
Plate 10: Building 3 - North-west elevation

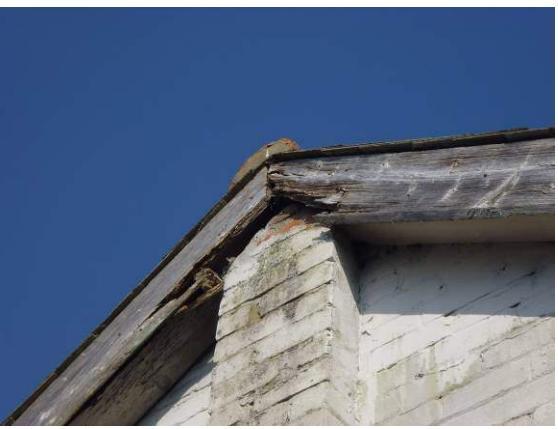
- Underneath multiple slipped or missing slates;
- Within the soffit box on the southern elevation;
- Within the two gaps at the apex of the southern elevation wall (See Plate 14); and
- Between the eroded ceiling plaster and the exposed slates of the roof structure (See Plate 17).

Plate 14: Eroded bargeboards at southern elevation

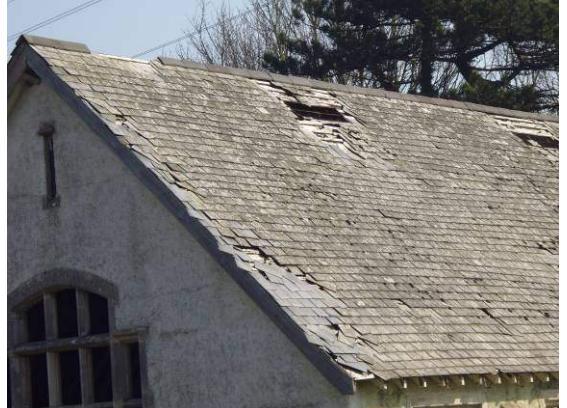
- Beneath slipped tiles (See Plate 23);
- Beneath missing ridge tiles;
- Within gaps created where the bargeboards have partially fallen away on the western elevation, near the bell tower (See Plate 24);
- Within gaps in the soffit boxes;
- Between the slit window grills of the bell tower (See Plate 22); and
- Through the large hole that has developed in the plaster board ceiling at the eastern end of the building, which allows access into the void above (See Plate 28).

Plate 23: Building 6: Slipped tiles and gaps in roof

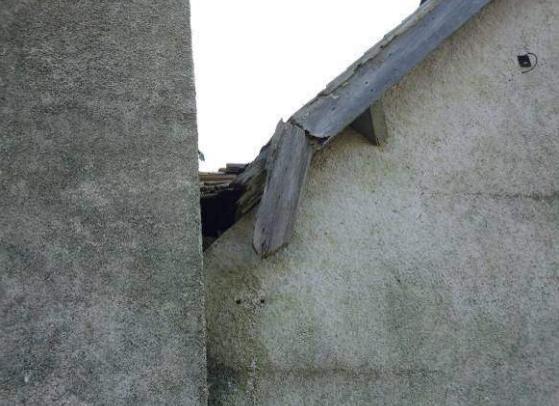
Plate 24: Hole in the bargeboard of the western elevation of building 6, near the bell tower

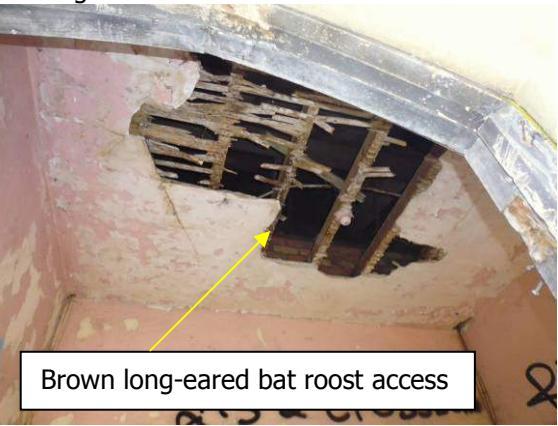
- Underneath multiple slipped or missing slates;
- Beneath ridge tiles;
- Within the cavity that is exposed at the western elevation (near the bell tower), where a section of the bargeboard has fallen away, thus exposing direct access up in between the sarking and slates of the main roof structure (See Plate 24);
- Within the soffit box;
- Behind gaps in the internal ceiling where sections of the plaster board ceiling have weathered or fallen away, thus exposing the slates and timber sarking above (See Plate 27);
- Within the void in the eastern end of the building (See Plate 28, 29); and
- Potentially within the bell tower.

Plate 28: Access to roof void at east of building 6 (2012)

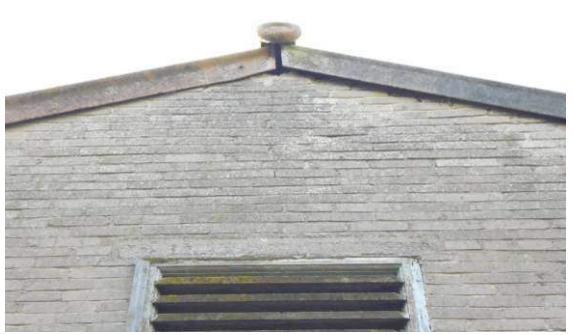
Plate 37: Gaps beneath asbestos bargeboards at Plate 38: Moderate sized gap at apex of northern elevation wall
