DEVELOPMENT CONTROL ISSUE	REVISIONS	A	B

ARCHITECT: DAVID A COURNEY PLASSER STREET, PENARTH, CF64 1EL. TEL. 021 221 1000		All dimensions indicated in millimetres PROJECT: COACH HOUSE, 1 RECTORY ROAD, PENARTH, VALE OF GLAMORGAN.	
DRAWING DESCRIPTION: EXISTING PLANS ELEVATIONS & SECTION		CLIENT: Mr & Mrs Stradling/Ms Alexander 1 Rectory Road, Penarth, Vale of Glamorgan, CF64 3AN.	
SCALE 1:50 1:100	DATE 27.03.15	DRAWN DAC	DRAWING NO. 540/DC/01B
		REV

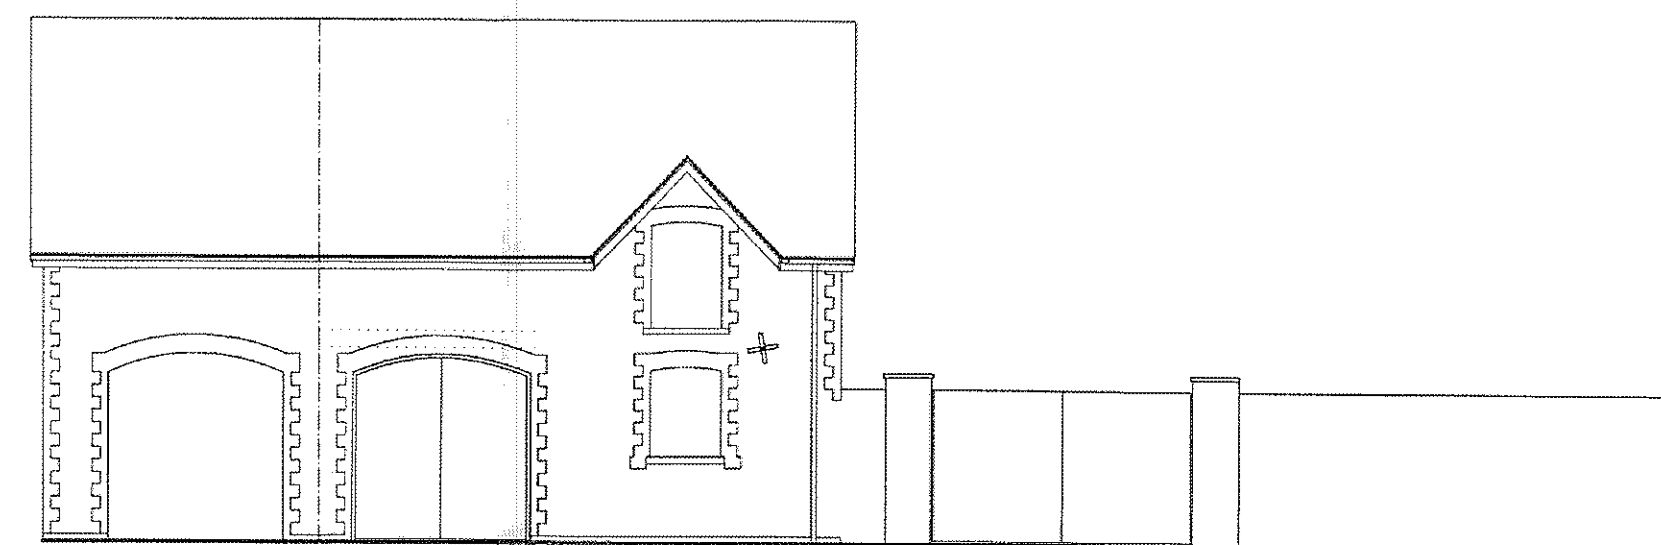
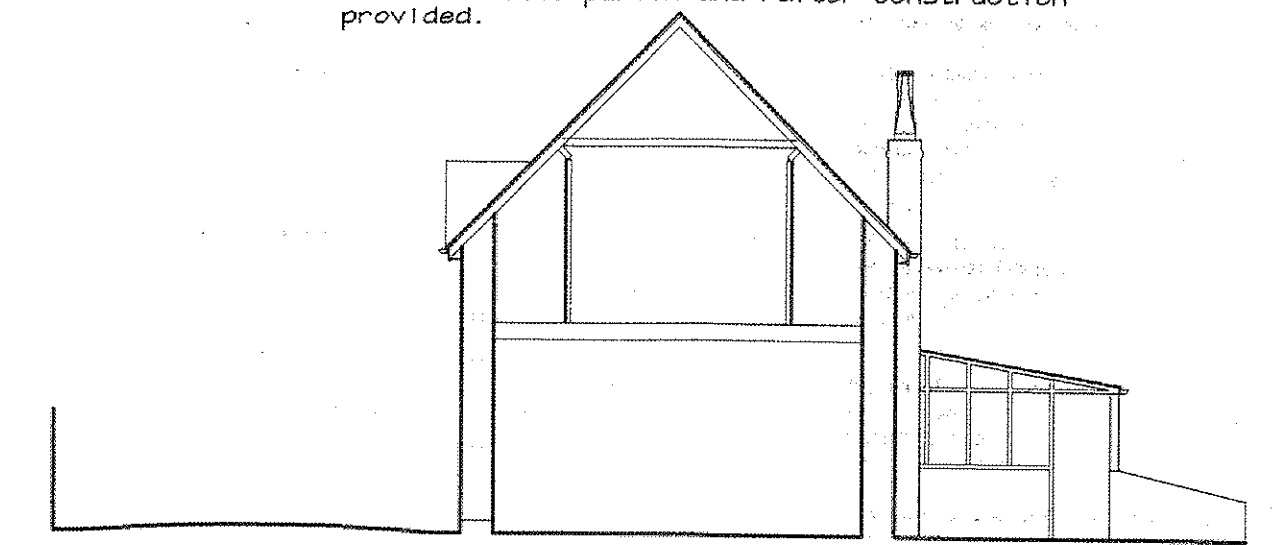
REAR ELEVATION

Built in stone and render, with red brick detailing and a slate roof, has windows within the front and side elevations, orientated towards Rectory Lane and its private courtyard. To the side. The main building, which has received a single storey rear timber greenhouse extension, is in a state of disrepair with roof damage in several places, windows boarded up and joinery in need of repair/replacement.

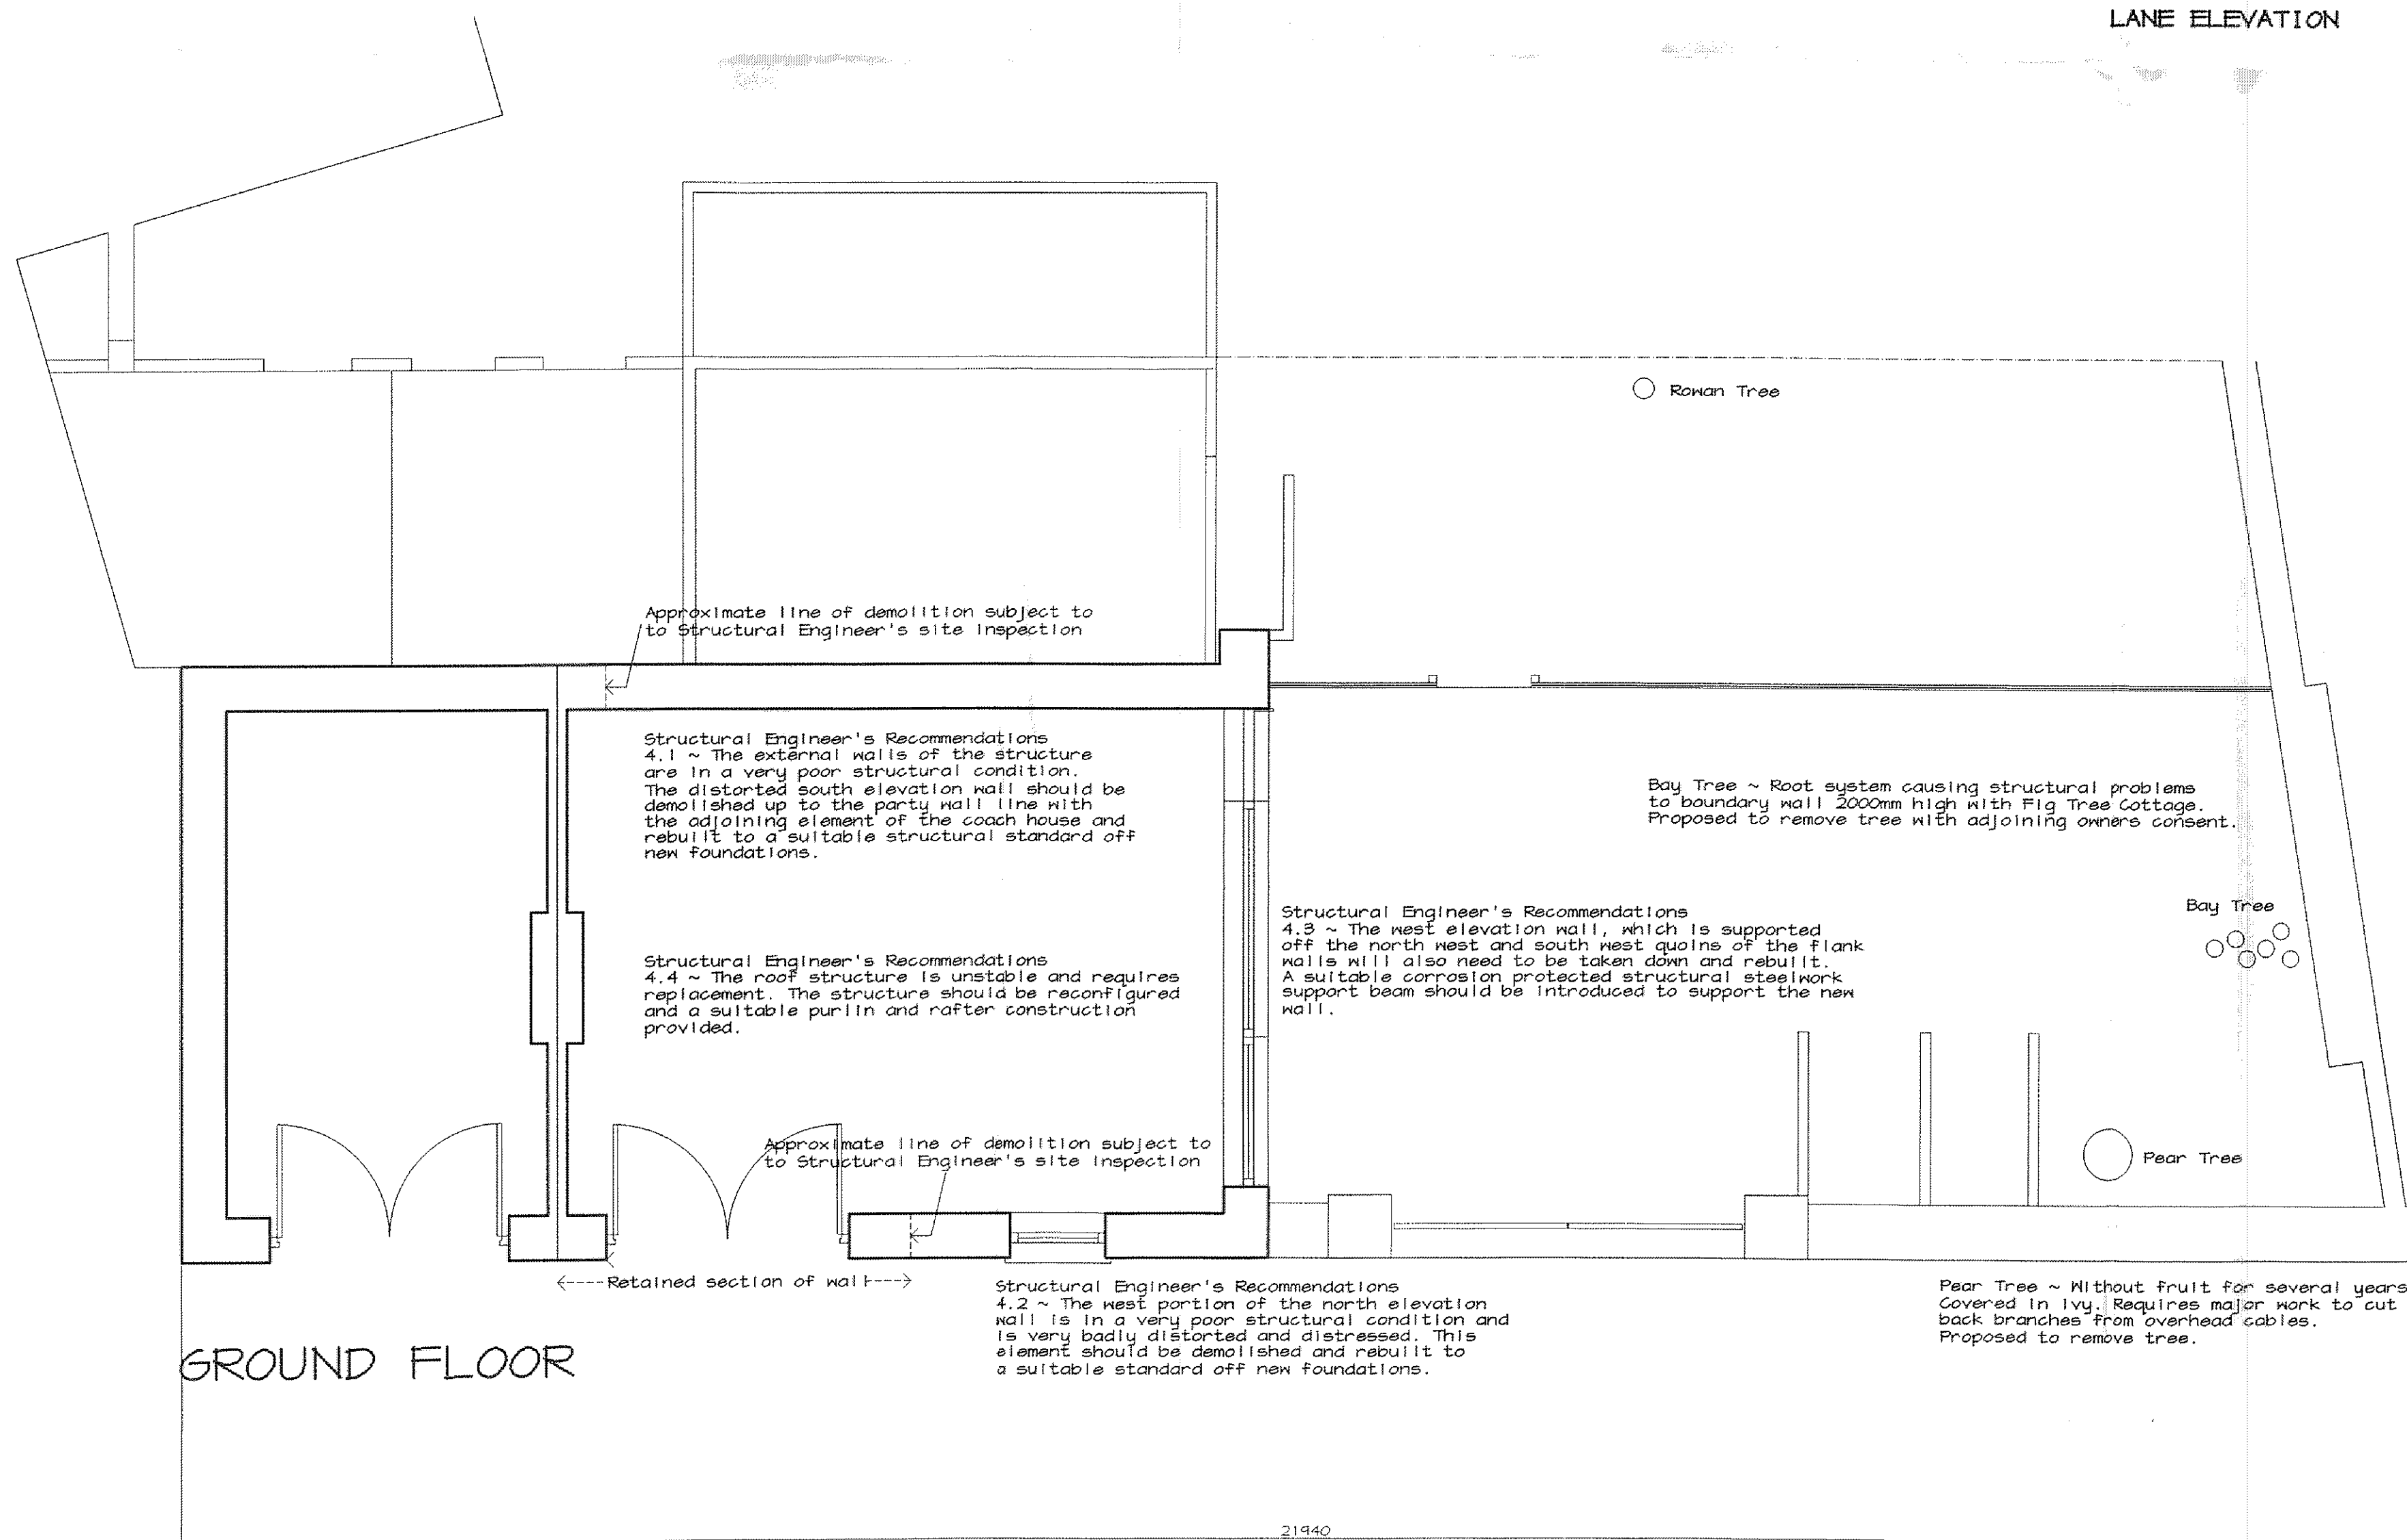
Approximate line of demolition subject to  
to Structural Engineer's site inspection

Structural Engineer's Recommendations  
4.1 ~ The external walls of the structure are in a very poor structural condition. The distorted south elevation wall should be demolished up to the party wall line with the adjoining element of the coach house and rebuilt to a suitable structural standard off new foundations.

Structural Engineer's Recommendations  
4.4 ~ The roof structure is unstable and requires replacement. The structure should be reconfigured and a suitable purlin and rafter construction provided.

Structural Engineer's Recommendations  
4.3 ~ The west elevation wall, which is supported off the north west and south west girds of the flank walls will also need to be taken down and rebuilt. A suitable corrosion protected structural steelwork support beam should be introduced to support the new wall.

Structural Engineer's Recommendations  
4.2 ~ The west portion of the north elevation wall is in a very poor structural condition and is very badly distorted and distressed. This element should be demolished and rebuilt to a suitable standard off new foundations.
