Bryneithen, Dinas Powys BS5837 2012 Tree Information

Mr D Loosemore

Bryneithen
St Andrew's Road
Dinas Powys

Data Sheets - site survey carried out January 2015

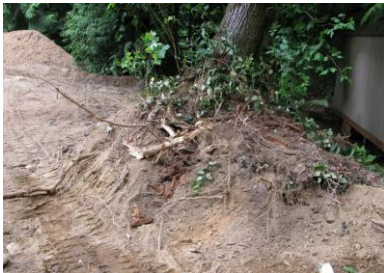
This photo shows a combination of damage. The roots have been severed or damaged in such a way that stability has been lost and this tree was felled. If the same damage had not led to an immediate tree failure the tree would have been sent into an irreversible spiral of decline.

The loss of roots will have caused a lack of structural support, loss of moisture take up, loss of oxygen take up and a means of the tree storing energy as starch within root structures. This type of root damage causes a slow decline in tree foliage known as crown die back.
