PARC BUSNES PORTH CYMRU MODEL FARM, RHOOSE, BARRY

Tree Survey & Impact Assessment Report

JSL3282 | Tree Survey Report | 10 June 2019

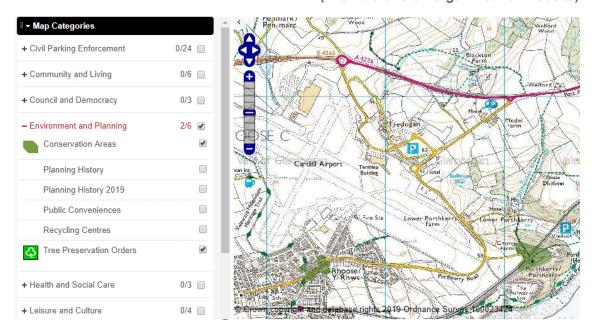
(The Vale of Glamorgan Council website)

- 4.12 The Vale of Glamorgan interactive mapping website confirmed on 12/04/19 that there are no Tree Preservation Orders relevant to the site and that the site is not within a conservation area. Screenshot attached at Appendix A.

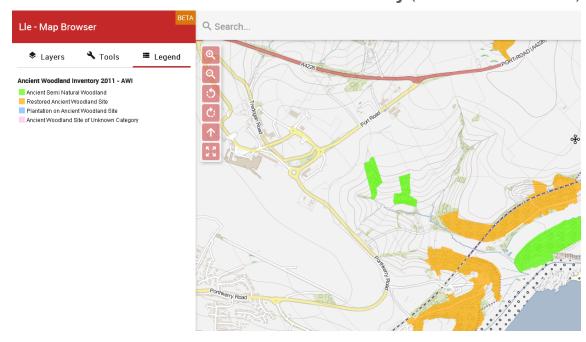
Ancient Woodland Inventory (Natural Resources Wales)

- 4.13 The Natural Resources Wales interactive mapping website records the woodland group 8 and 9 as Ancient Semi-Natural Woodland. Screenshot attached at Appendix A.
