## **Land at Upper Cosmeston Farm, Lavernock Road, Penarth**

### **Ecology Update Note**

#### **edp5187\_r004c**

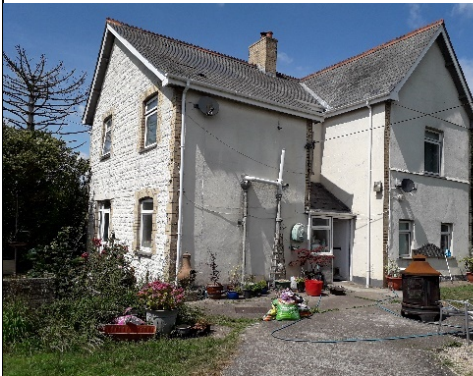
Photograph and Building Reference Number	Description of Features Suitable/Unsuitable for Roosting Bats	Bat Roost Potential
<p><b>B1:</b> Farmhouse Building</p>

<p>Two storey main farmhouse building with natural slate tiles and clay ridge tiles. Building located along the northern edge of the Lower Cosmeston Farm. Some of the roof slate tiles are partly raised, providing potential access points for bats. The walls are made of partly rendered brick and stone in good condition. The eaves are closed with a timber plate. There is a narrow gap running along the western gable end where the eve plates join the external wall render. The building has one chimney which is well preserved with tightly fitted lead flashing. The roof valley is also fitted with lead with gaps between the lead and adjacent slate tiles.</p> <p>One swallow nest was recorded within the eaves of the building.</p> <p>No internal access.</p> <p>No signs of bats were recorded.</p>	<p>Moderate summer roosting and low hibernation potential.</p>

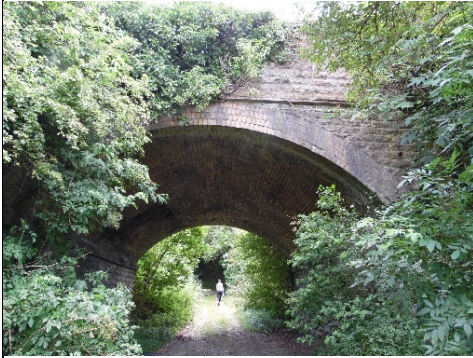
<p><b>B2:</b> Bridge</p>

<p>Four crevices were recorded within the north-west wing of the stone bridge.</p> <p>A bird nest was recorded within one of the crevices.</p> <p>No signs of bats were recorded.</p>	<p>Low summer roosting and hibernation potential.</p>

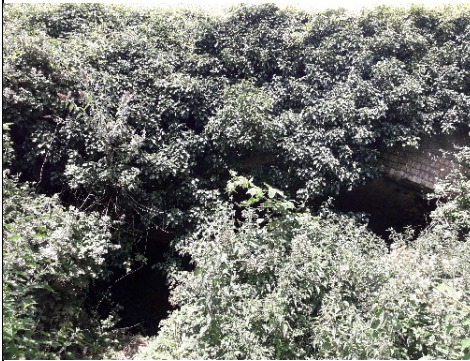
<p>The bridge is made of brick which is in good condition. However, dense ivy is overgrowing the bridge on both sides and providing some limited opportunities for roosting bats.</p> <p>One crevice was observed under the arch ring, however, after an inspection with endoscope, it was ruled out as suitable roosting feature.</p> <p>No signs of bats were recorded.</p>	<p>Low summer roosting and negligible hibernation potential.</p> <p>Confirmed roost during 2017 and 2019.</p>

- 4.6 On 15 May 2019, a possible emergence of a single common pipistrelle from **B8** was recorded. Dense vegetation surrounding the bridge did, however, obscure activity. Results are, however, consistent with previous survey effort during 2017 where a possible common pipistrelle emergence was identified at this location.

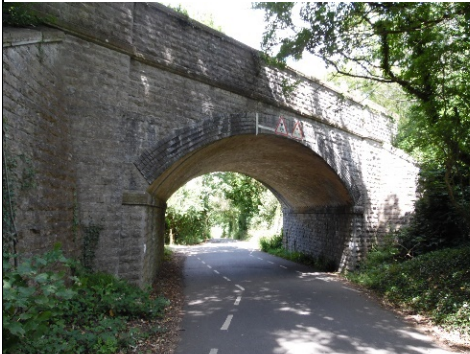
<p><b>B9: Bridge</b></p>

<p>The bridge is made of brick and overall in a good state of repair.</p> <p>The north-western wing has a long split approximately 2m in length, where the mortar has failed and is providing potential bat roosting and bird nesting areas.</p> <p>No signs of bats were recorded.</p>	<p>Low summer roosting and low hibernation potential.</p>

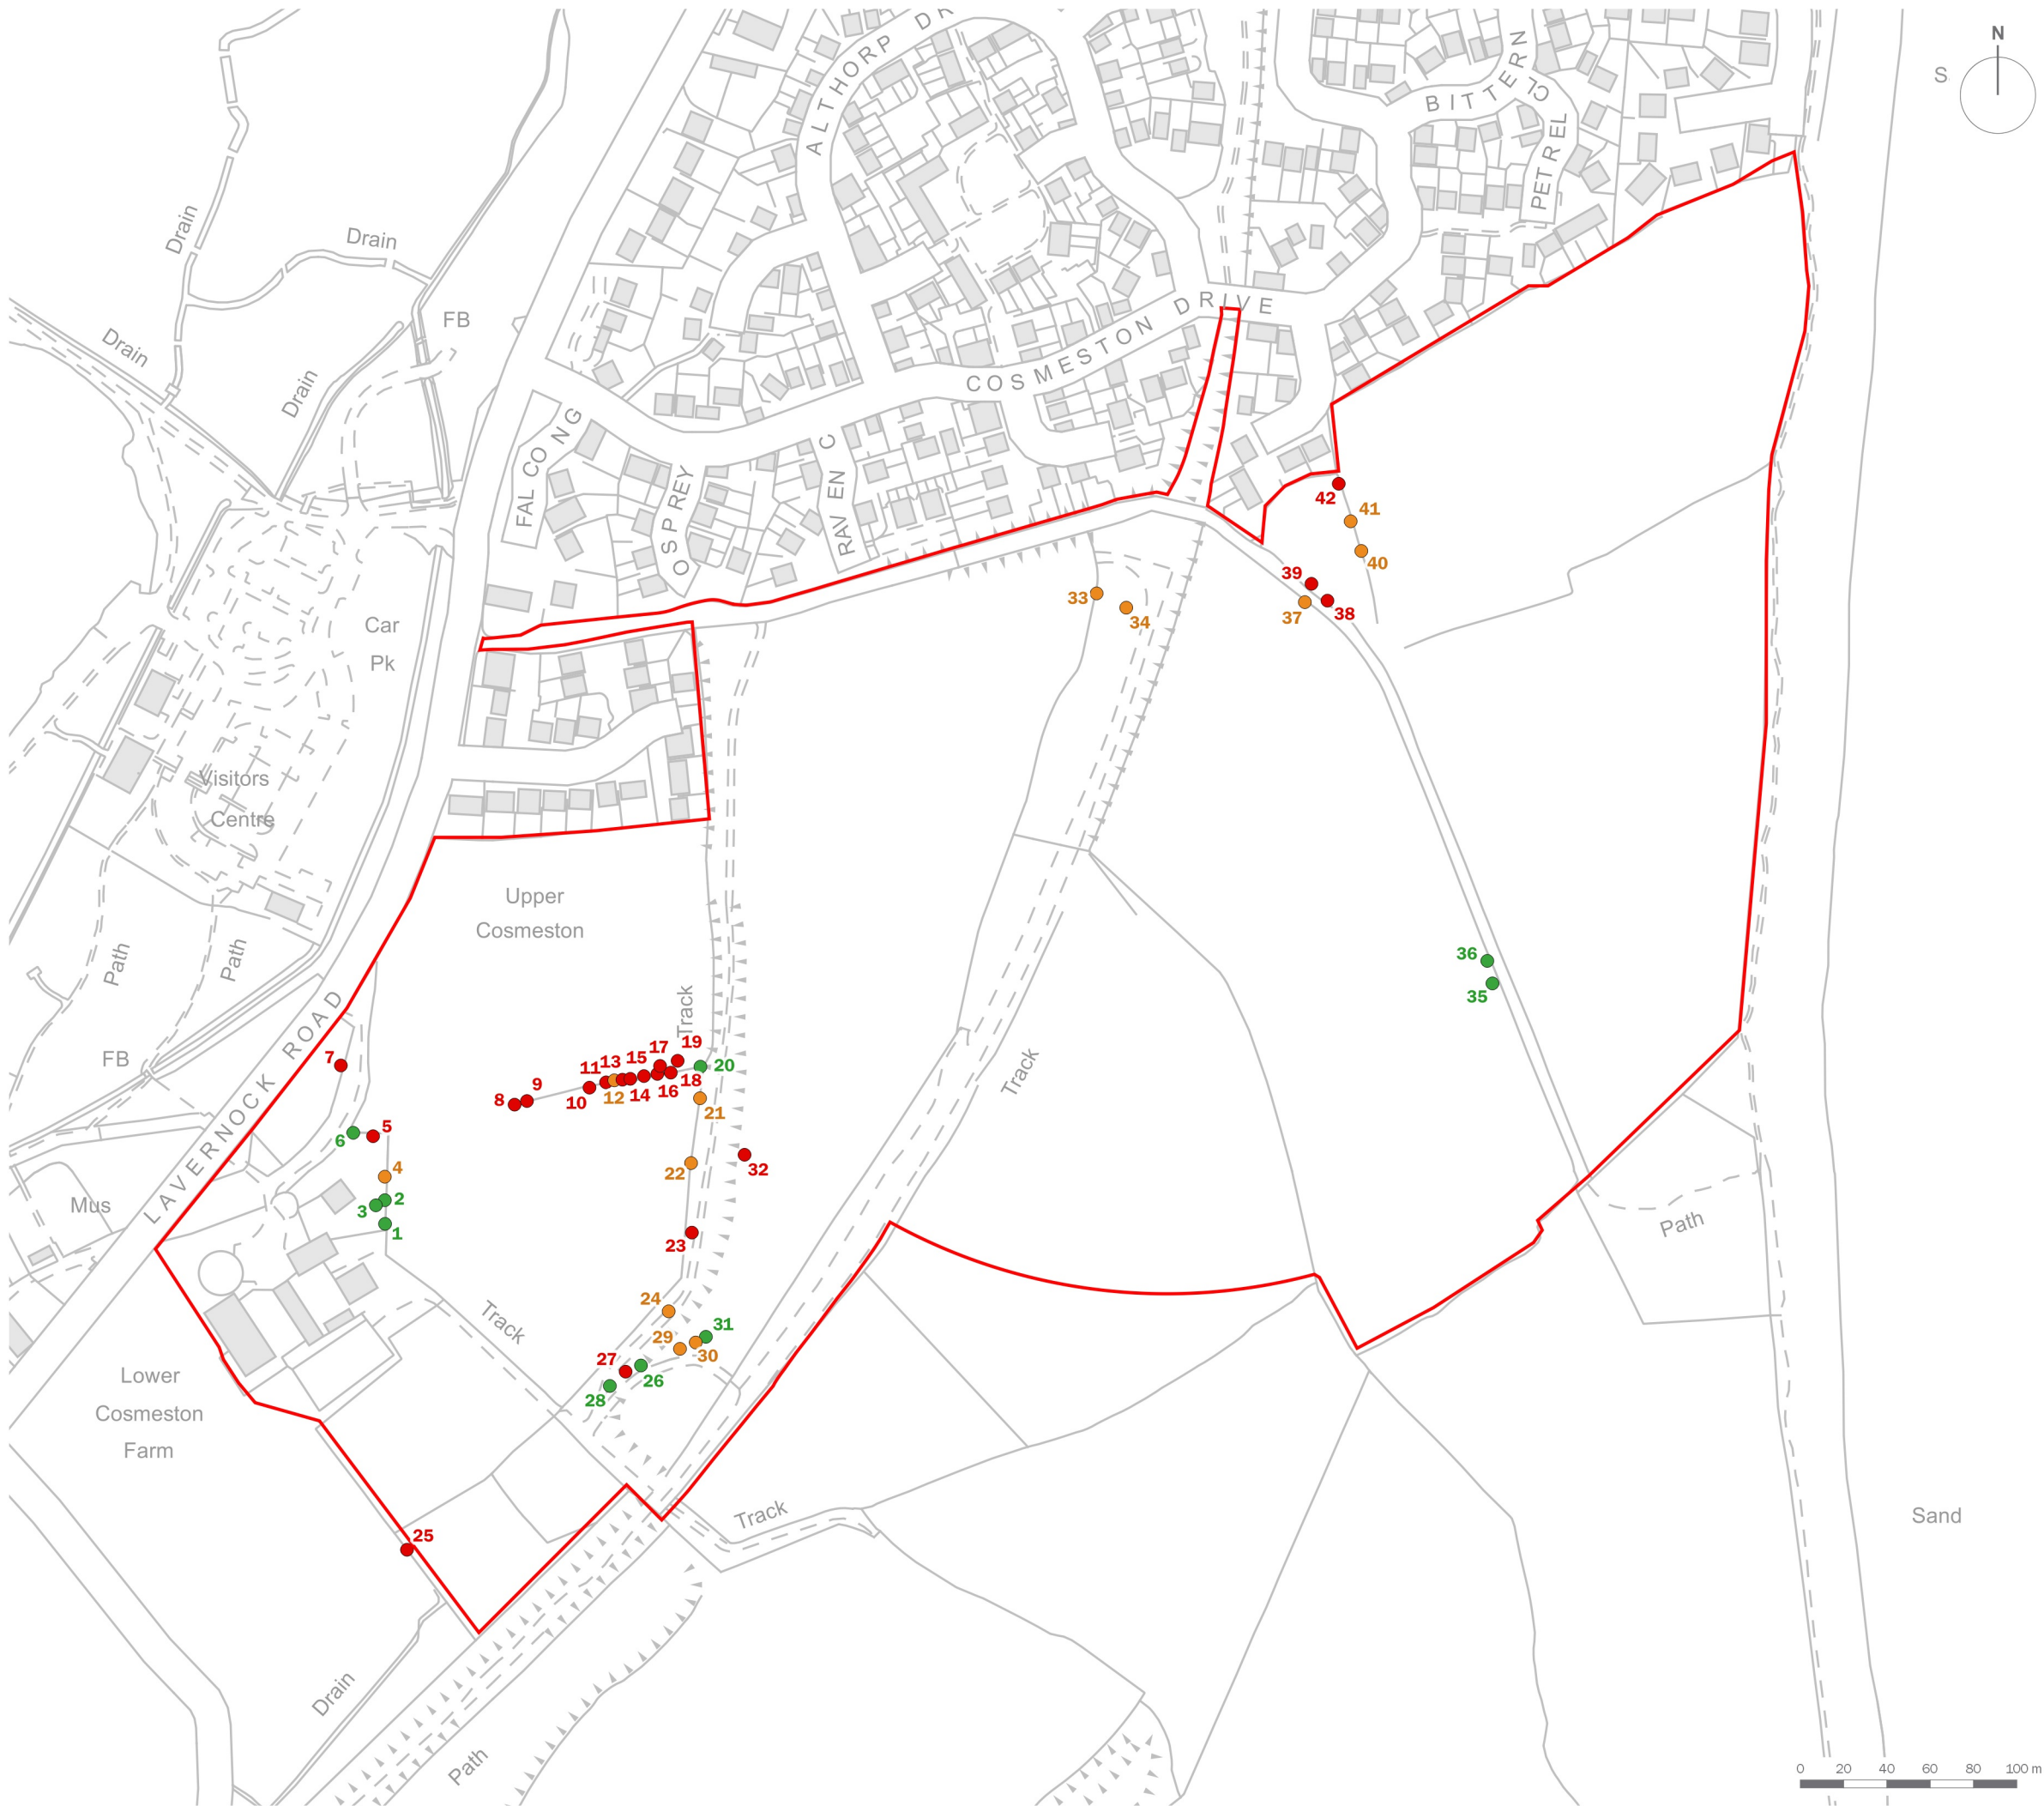
drawing title  
**Plan EDP 1: Assessment of Bat Roosting Potential - Trees**

- 5.6 With respect to onsite trees, total of 42 trees were assessed as having bat roosting potential, including 20 with high potential, 12 with medium potential and ten with low potential .

- 5.11 With respect to any trees to be felled/subject to tree pruning to facilitate development, these will be subject to an update ground-level inspection by a suitably qualified ecologist to determine their current potential to support roosting bats. Where trees are identified as having moderate or greater potential, then such trees will be subject to a further detailed aerial inspection, whereby all suitable roosting features will be checked at height for the presence of bats. Aerial surveys will be undertaken by a suitably qualified and NRW bat licensed ecologist, arboricultural contractor with a NRW bat survey licence, or with experience of working with bats and under the supervision of a NRW bat survey license holder.

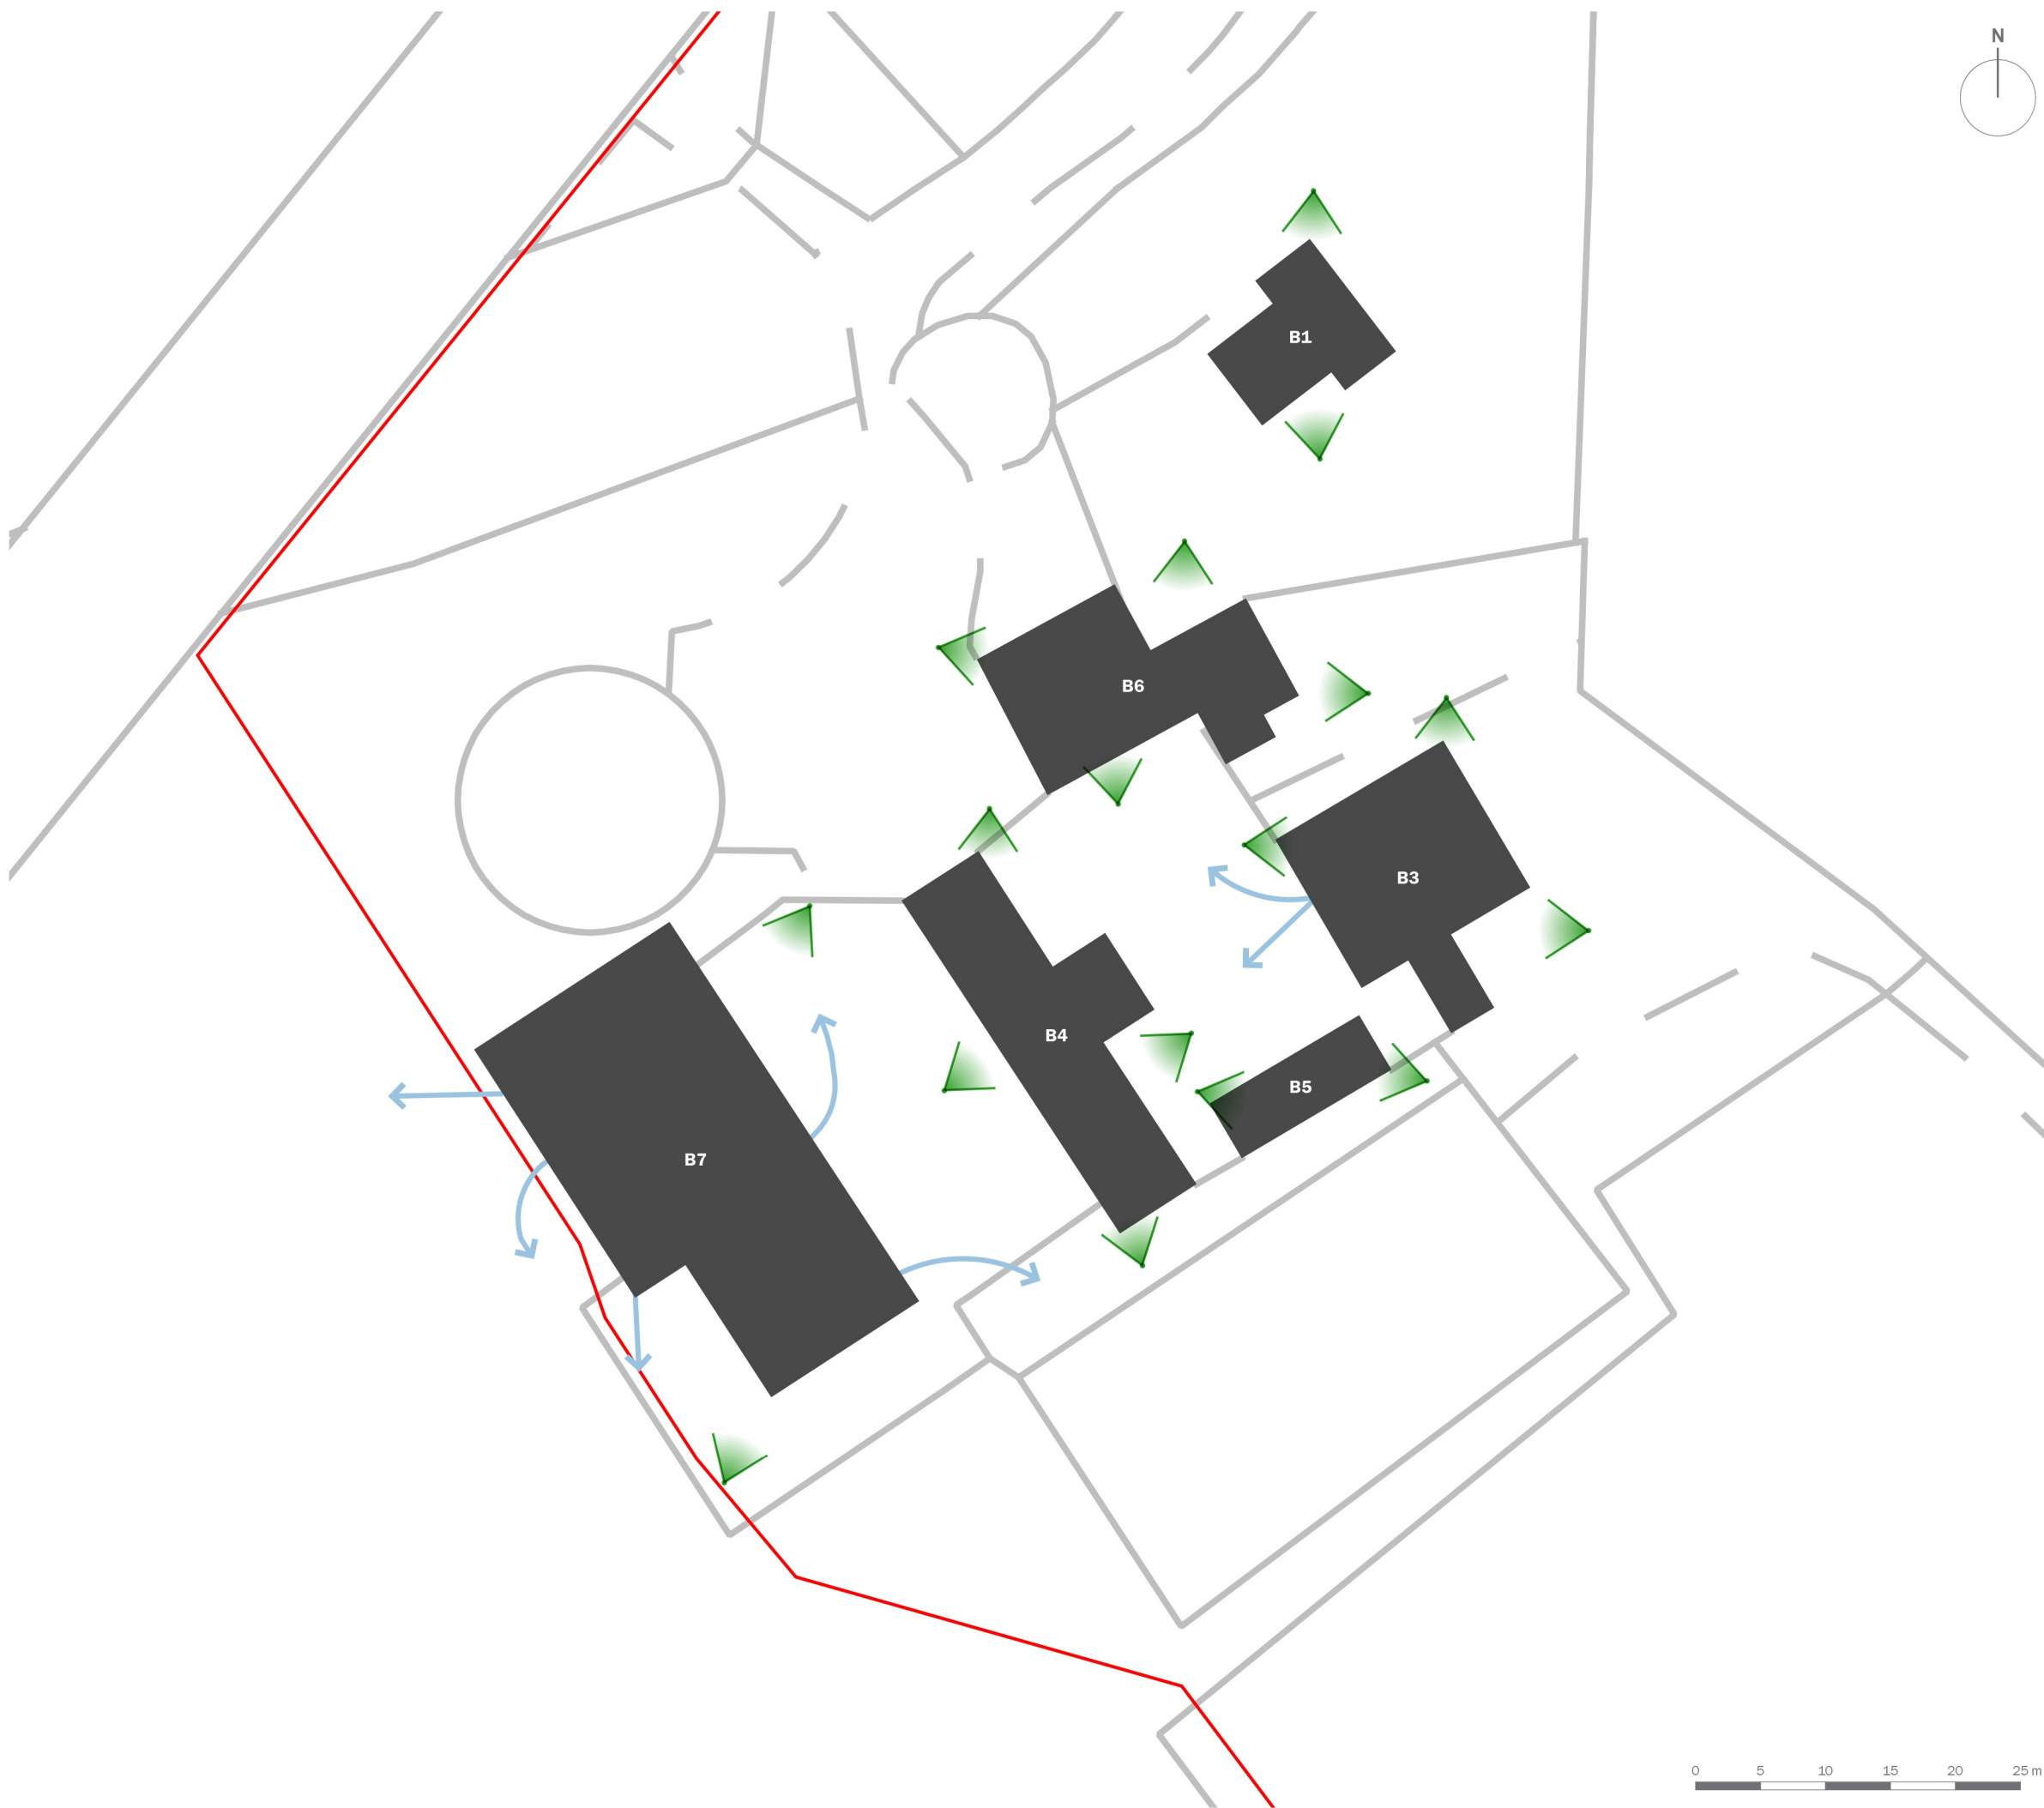
drawing title  
**Plan EDP 2a: Dusk Emergence Survey Results - May 2019**

4.5 During the dusk emergence surveys of Upper Cosmeston Farm in May 2019 three common pipistrelle bats were seen emerging from the open barn door of Building **B3** at 21:26 followed by an emergence of a single common pipistrelle (*Pipistrellus pipistrellus*) from the same building at 21:32.

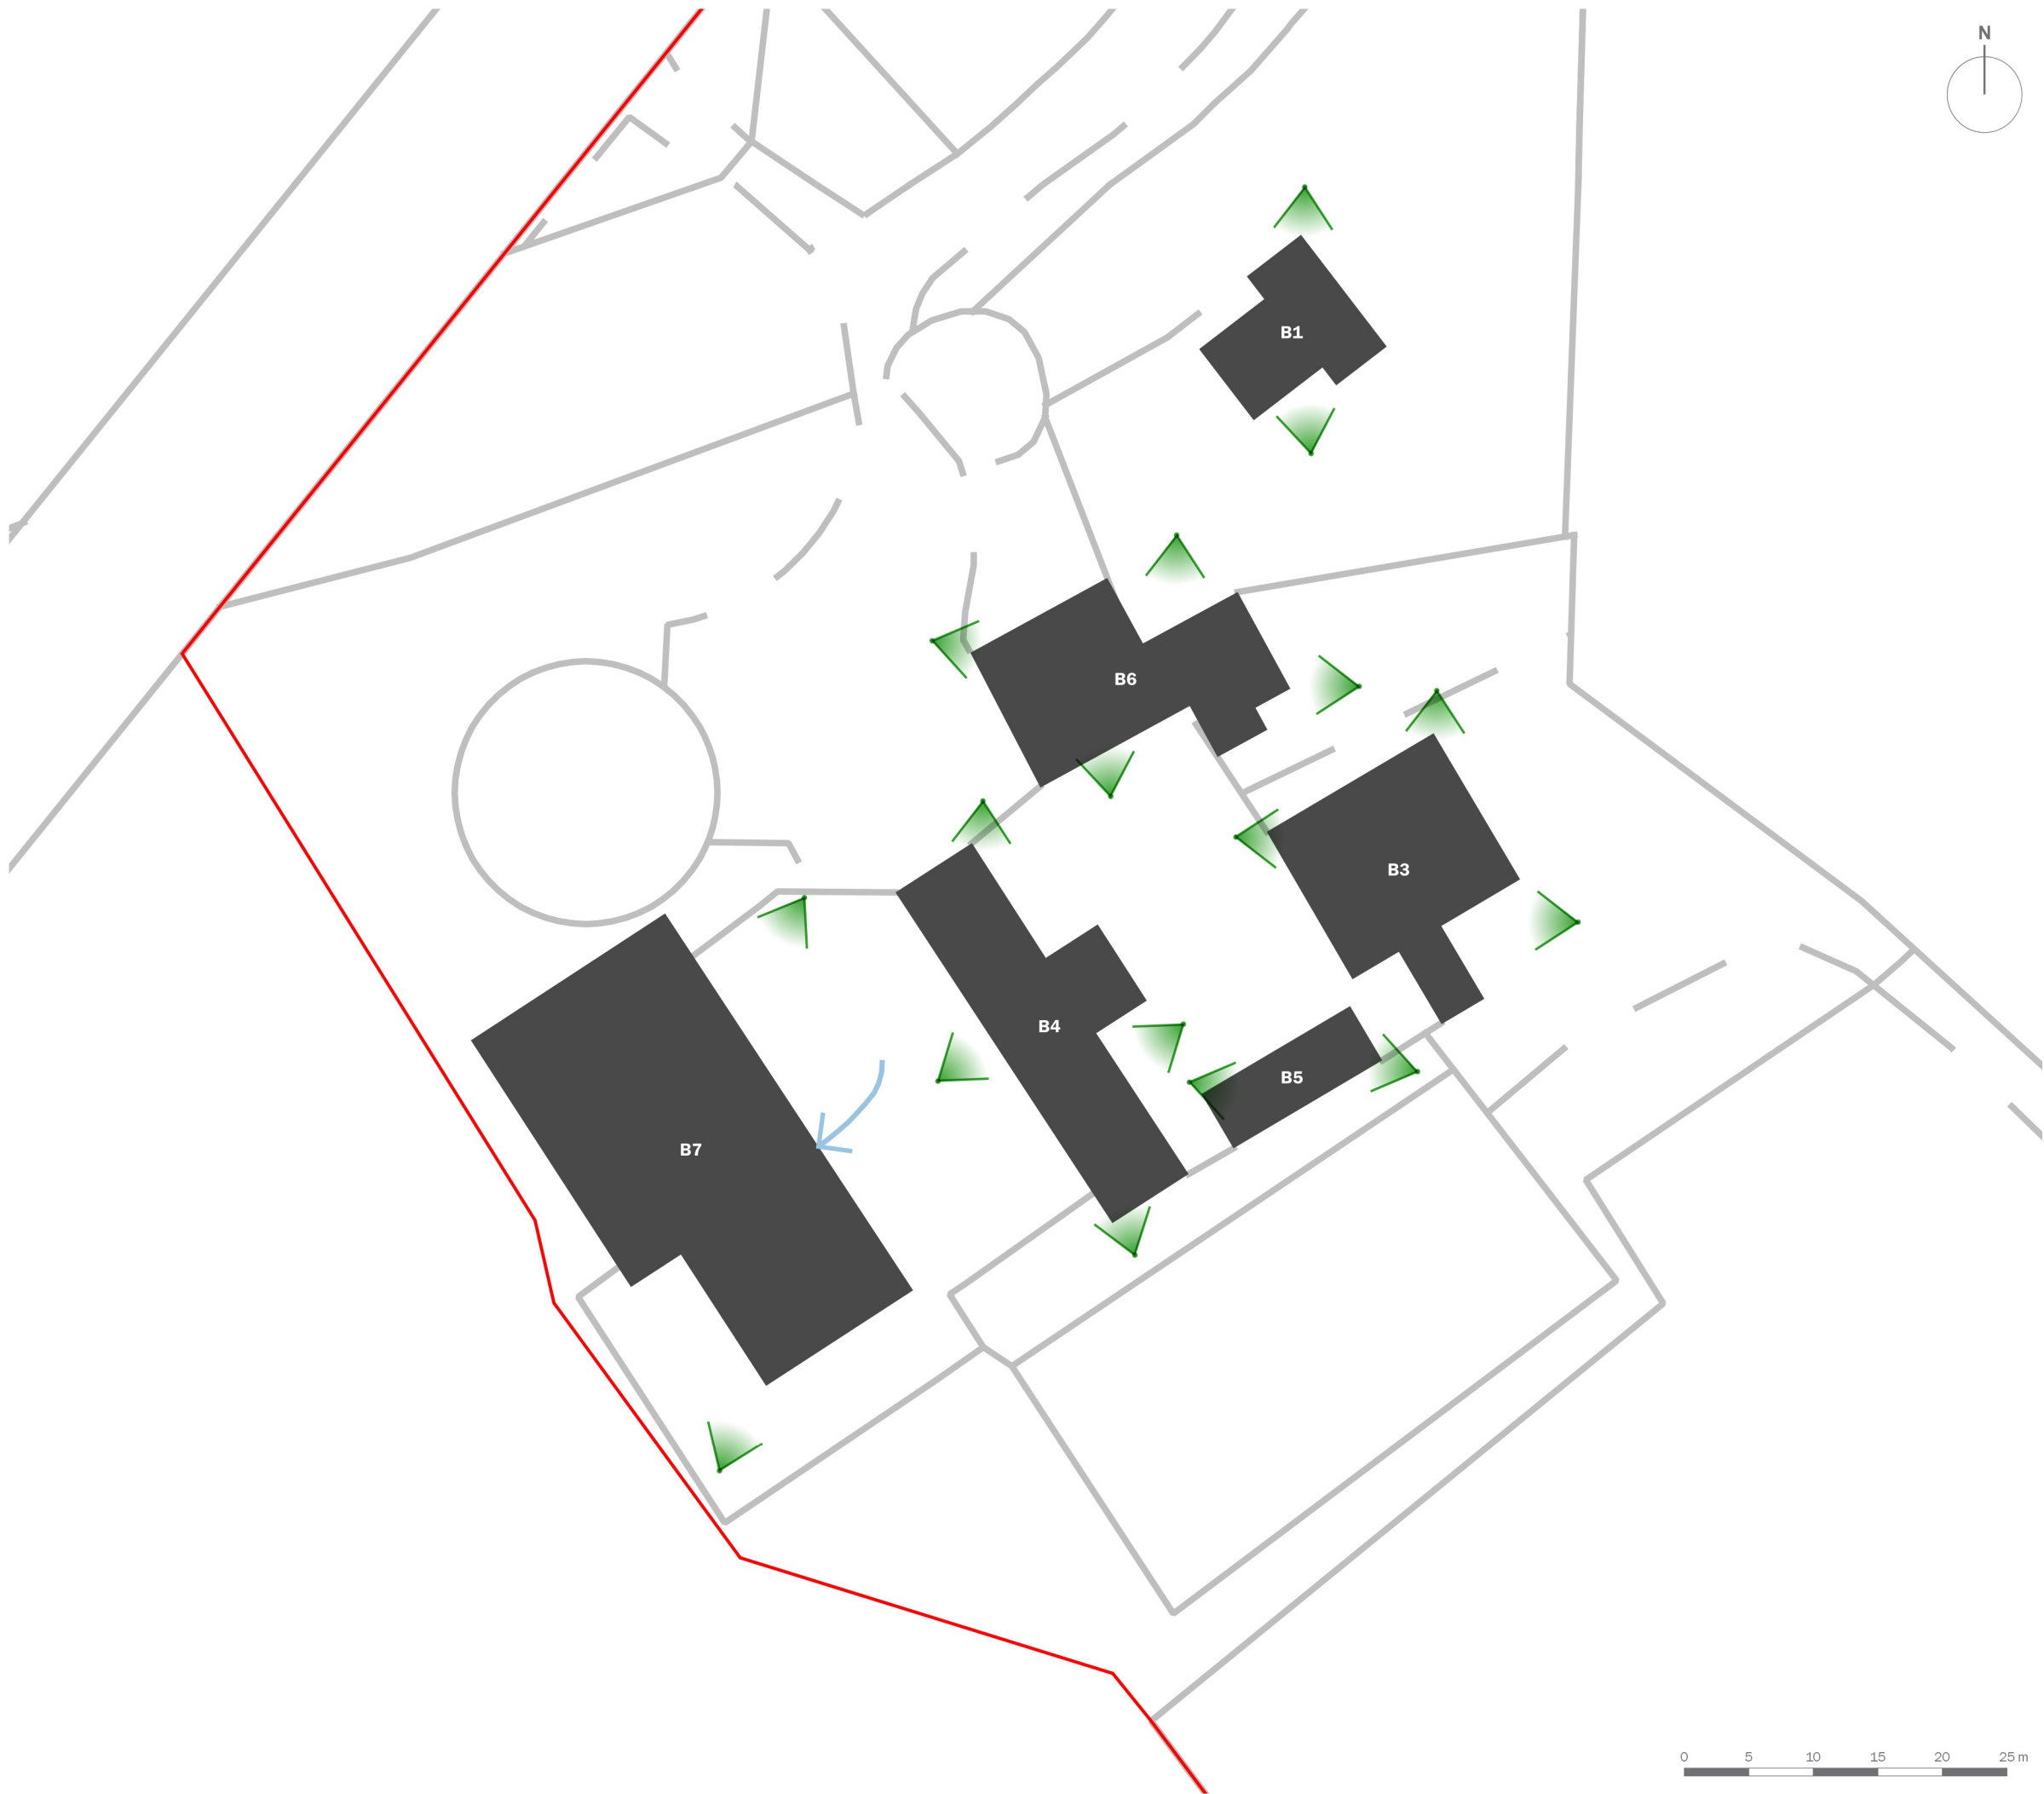
drawing title  
**Plan EDP 2e: Dawn Re-Entry Survey Results – July 2019**

- 4.8 During the dawn re-entry survey of building **B7** during July 2019, three common pipistrelle bats were observed to re-enter the middle compartment of the barn through the open gates along the north-eastern elevation of the building. Based on the emergence and re-entry survey results as well as internal inspection of the building, it is highly likely that the bats are utilising crevices between timber rafters and asbestos sheeting of the roof.
