Appendix C Site Walkover Photographic Log

Client Name: Vale of Glamorgan Council		Site Location: Llanmaes Village, Vale of Glamorgan, South Wales, NGR 297856, 169884	Project No. 60160078
Photo No. 001	Date: 19/03/21	 	
Direction Photo Taken: Facing south-southwest			
Description: Small stream flowing in a southwesterly direction through Llanmaes Village.

Appendix D Preliminary UXO report

Appendix E Previous Ground Investigation

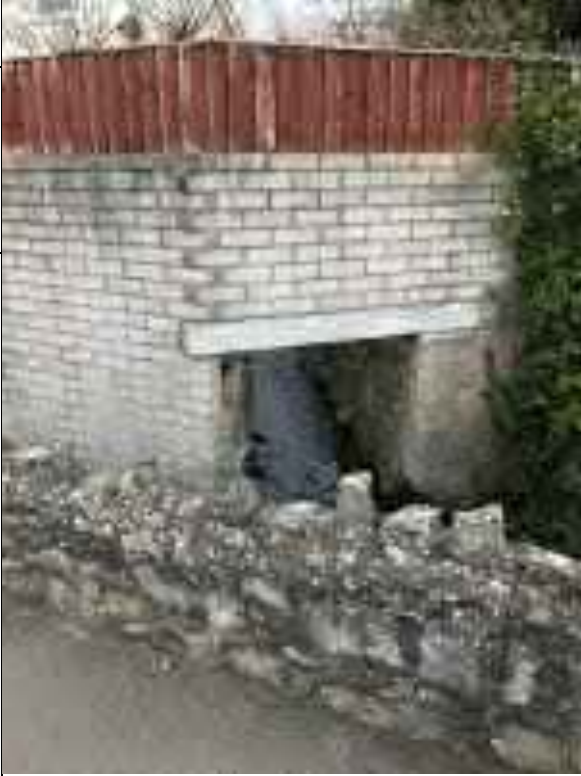
Photo No. 002	Date: 19/03/21

Direction Photo Taken: Facing north-northeast			
Description: Small stream flowing in a southwesterly direction through Llanmaes Village.

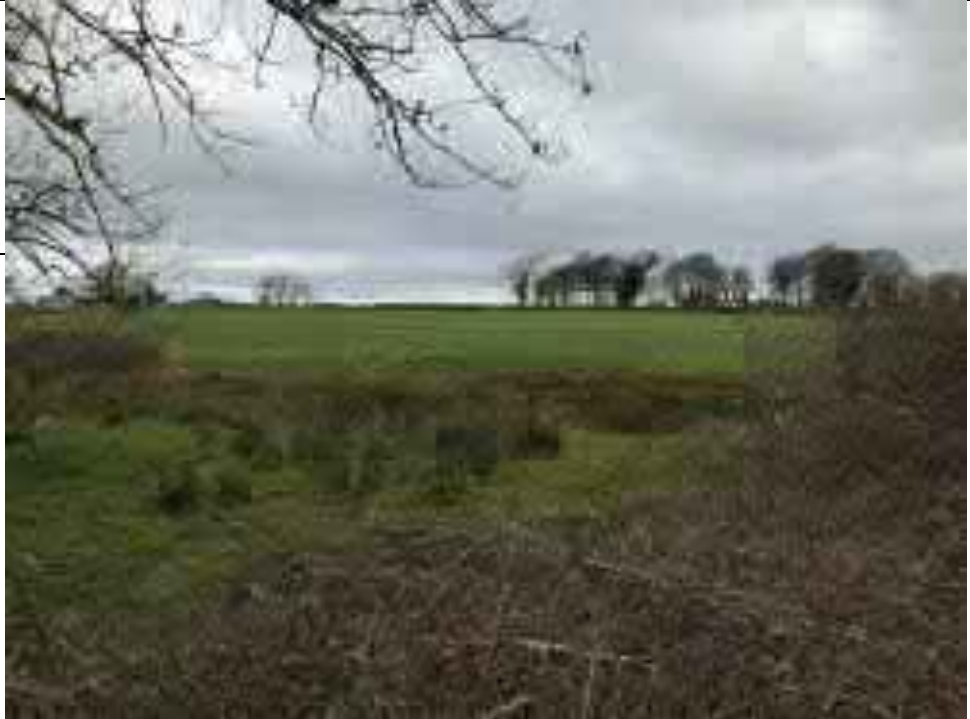
**Photo
No.**
003

View of proposed
location of ditch 3.

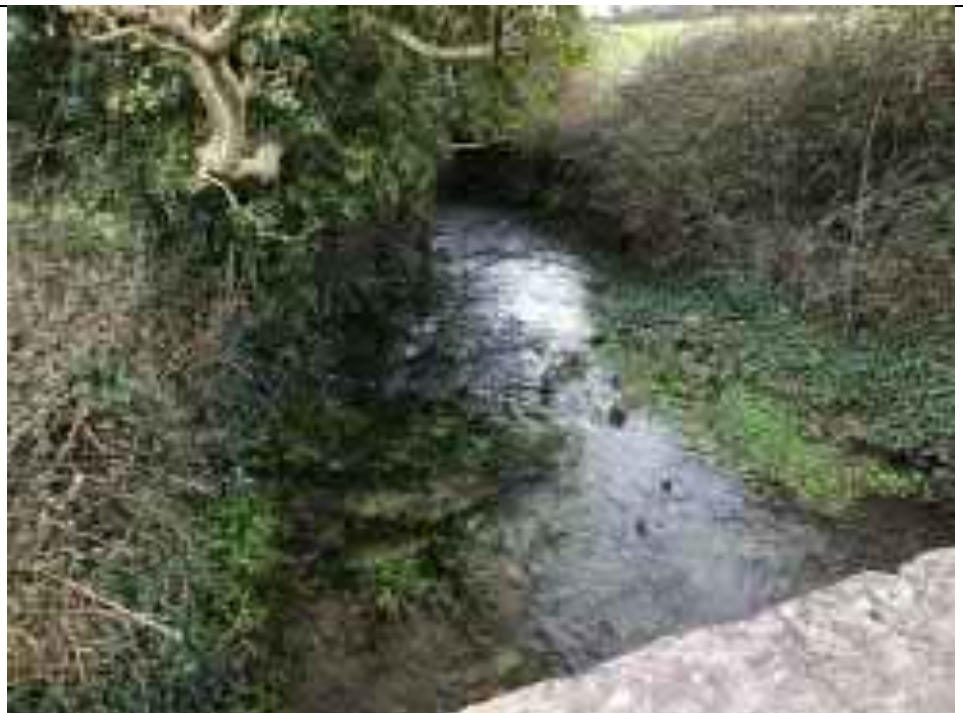
**Photo
No.**
004

Llanmaes Brook
(flowing southeast)

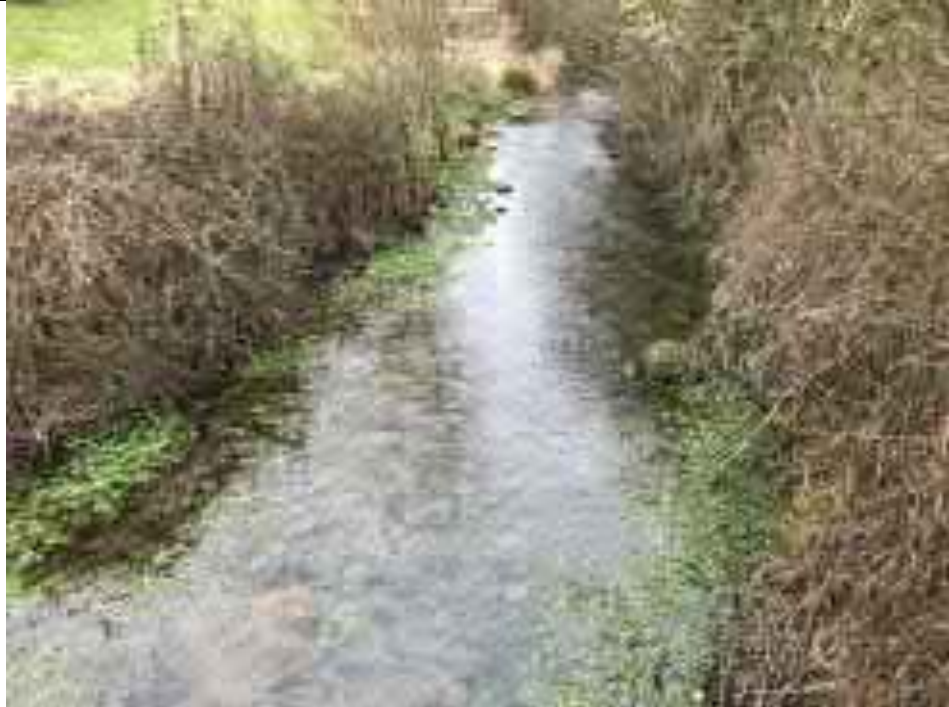
Photo No.
005

Llanmaes Brook
(flowing southeast)

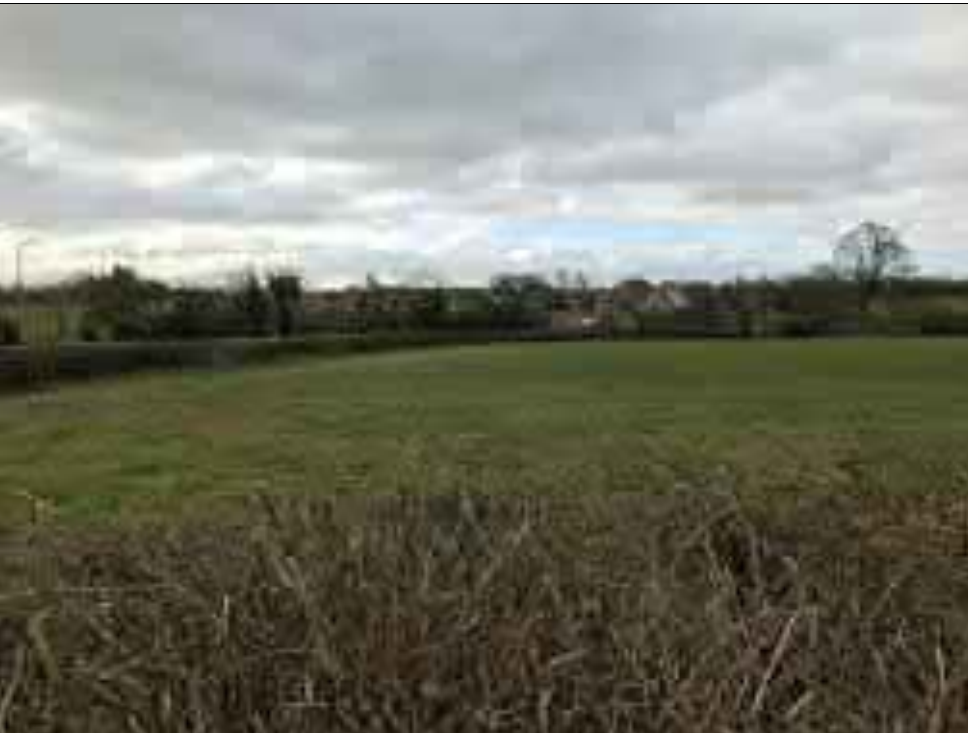
Photo No.
006

View of proposed
location of ditch 3.

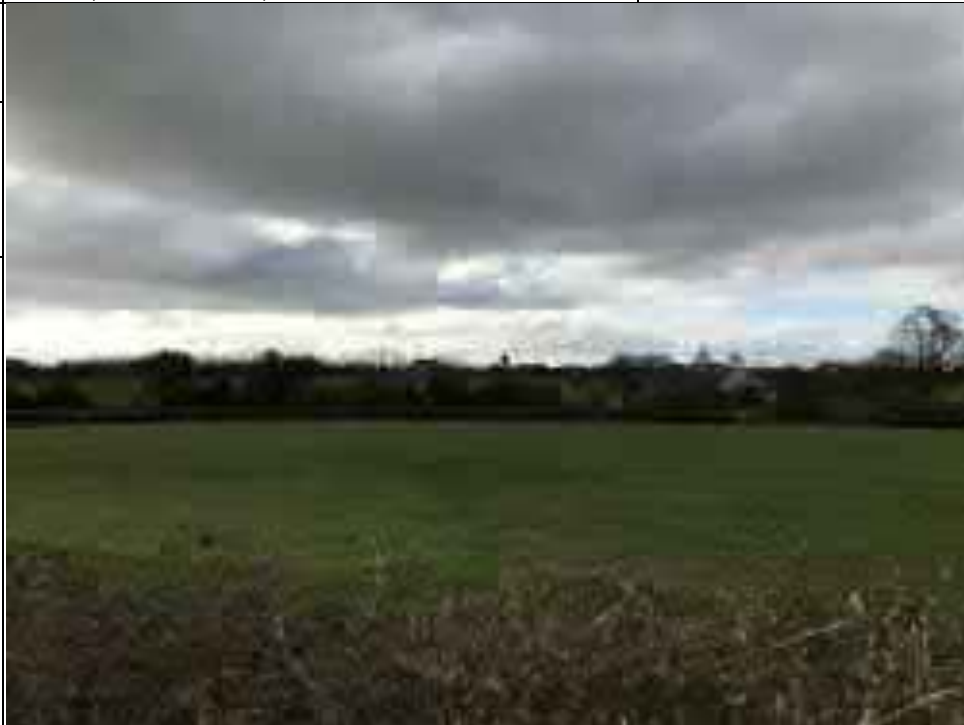
Photo No.
007

View of proposed location of ditch 3.

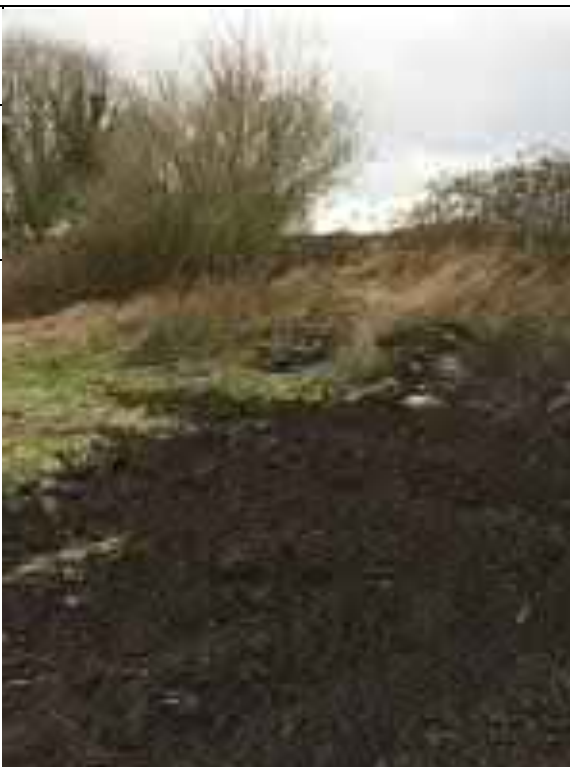
Photo No.
008

Burning in background, south of proposed ditch 1.

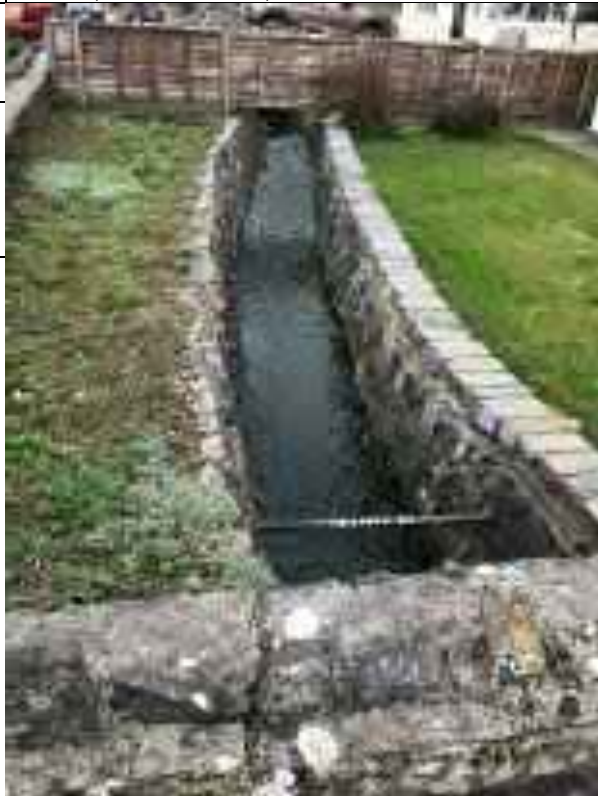
**Photo
No.**
011

Small stream
flowing southwest
adjacent to
residential
properties within
Llanmaes Village.

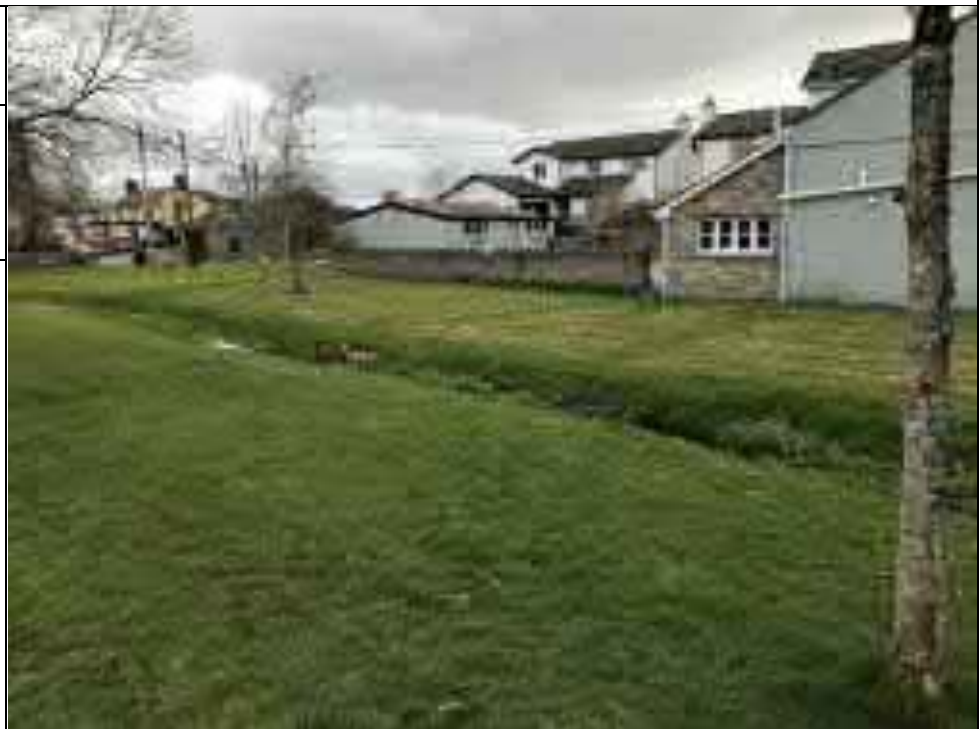
**Photo
No.**
012

View of proposed
village green ditch
1 location. Small
stream currently
flows through the
area.

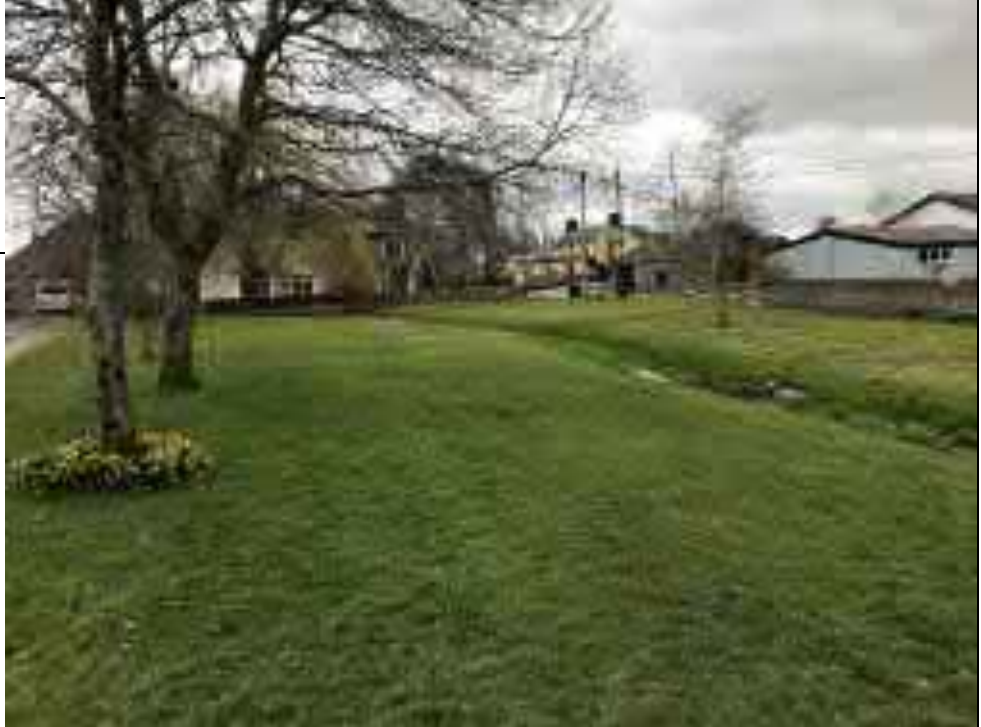
**Photo
No.**
013

View of proposed
village green ditch
1 location. Small
stream currently
flows through the
area.

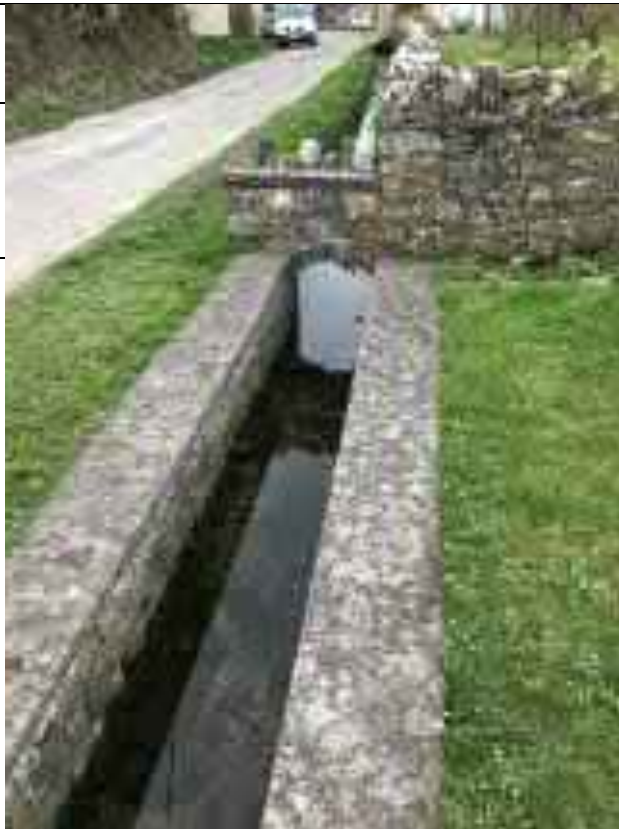
**Photo
No.**
014

Small stream
flowing southwest
through Llanmaes
Village

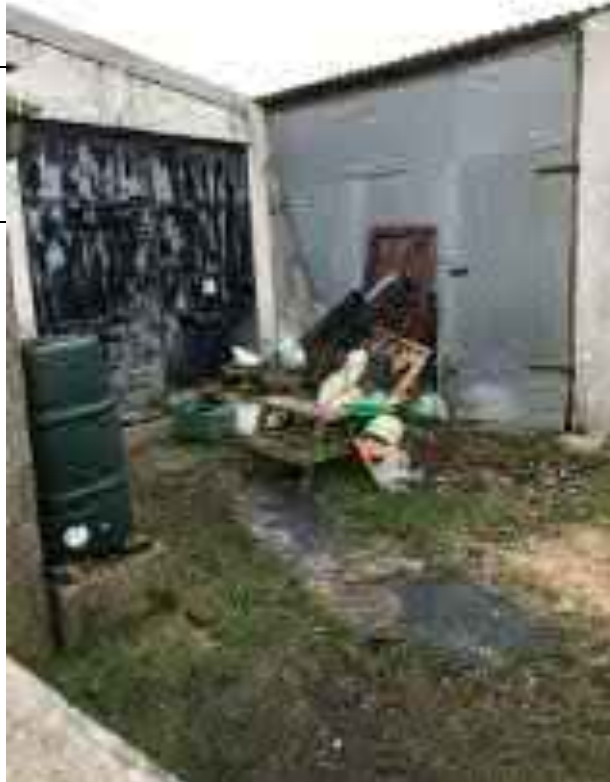
Photo No.
015

Storage of materials in Llanmaes Village. No visible evidence of potential contamination.

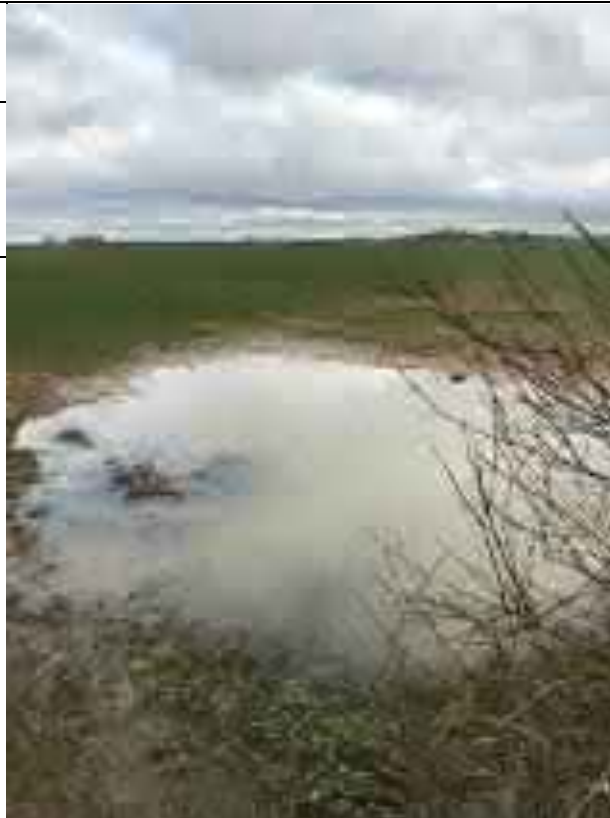
Photo No.
016

View towards the proposed flood bund 4 area. Visible surface water pooling adjacent to West Road.

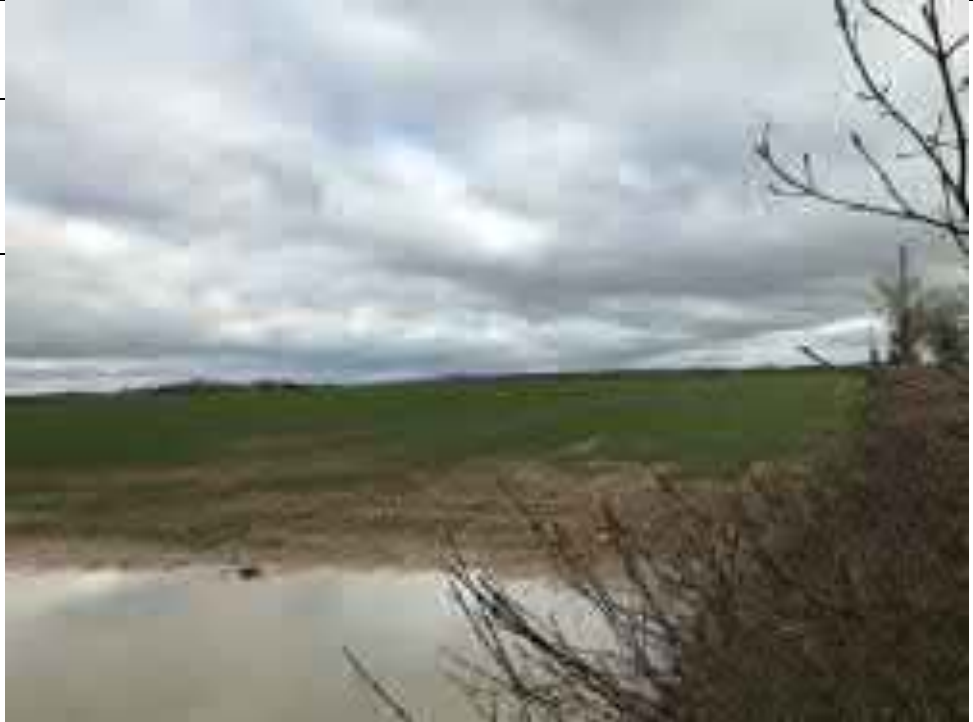
Photo No.
017

View towards the proposed flood bund 4 area. Visible surface water pooling adjacent to West Road.

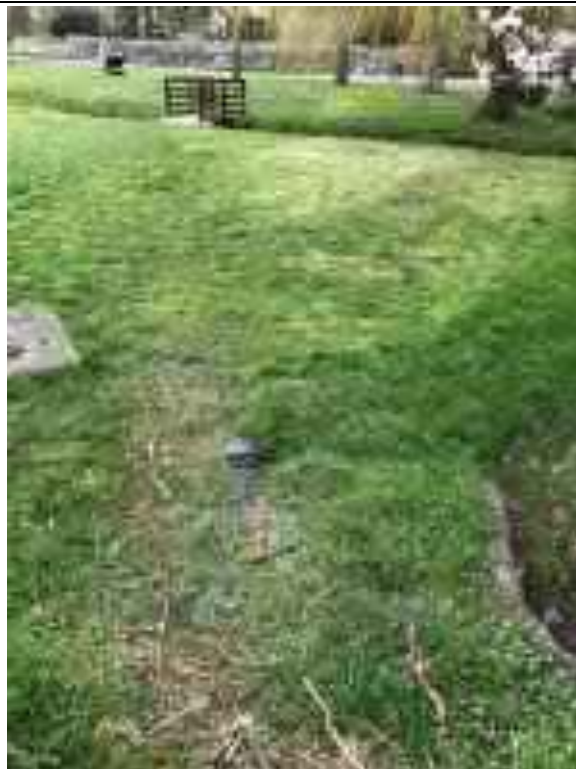
Photo No.
018

Small culverted section of the stream (black pipework in foreground) within the Village Green.

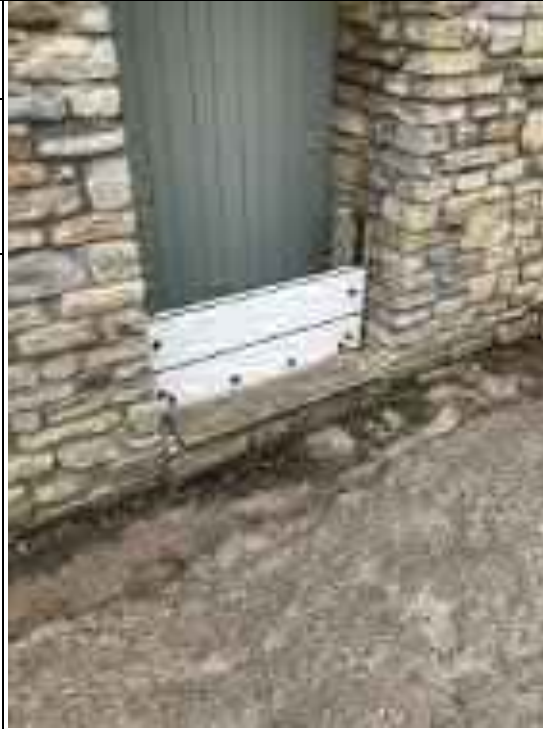
**Photo
No.**
019

Flood defences
visible at
residential
properties in
Llanmaes Village.

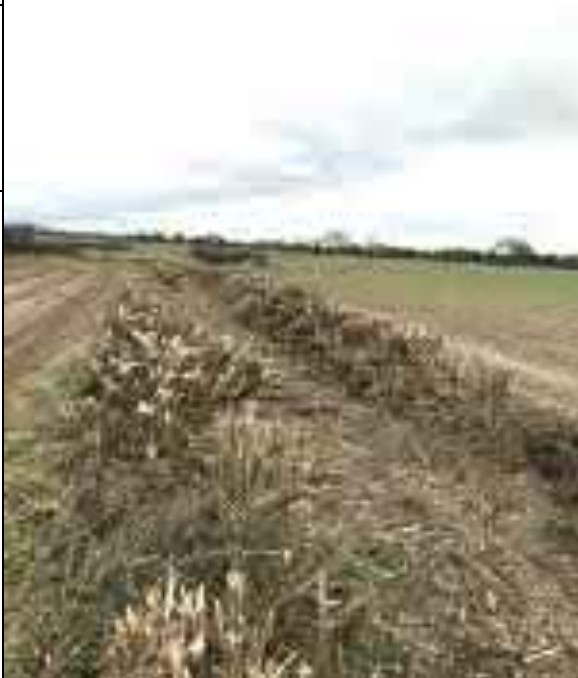
**Photo
No.**
020

Location of
proposed ditch 2.

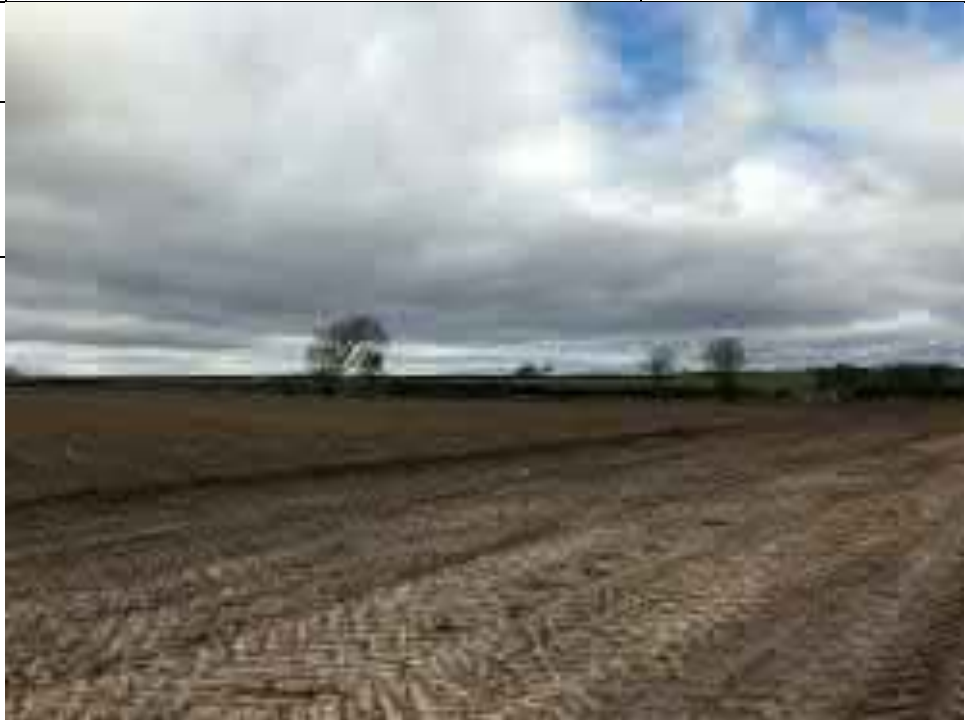
**Photo
No.
021**

View towards the
proposed location
of flood bund 1.

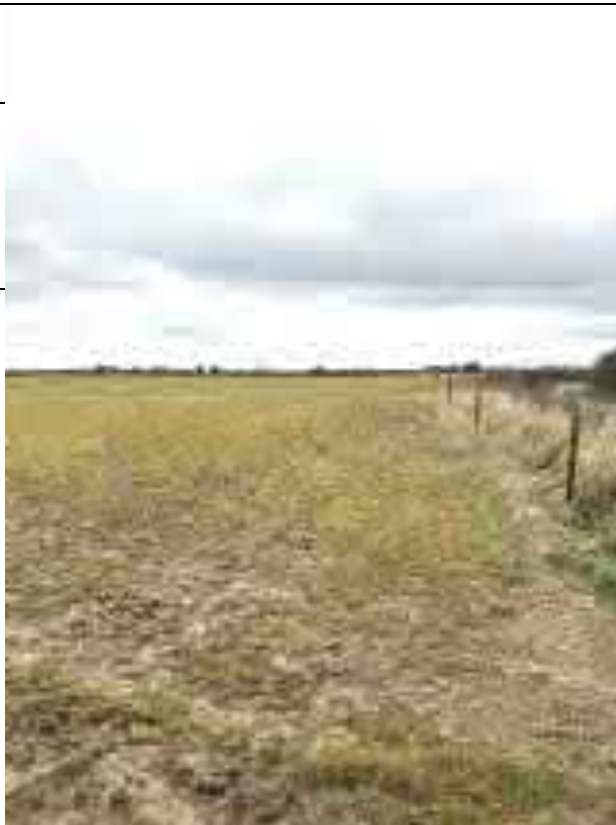
**Photo
No.
022**

View of the
northernmost
extent of proposed
ditch 1.

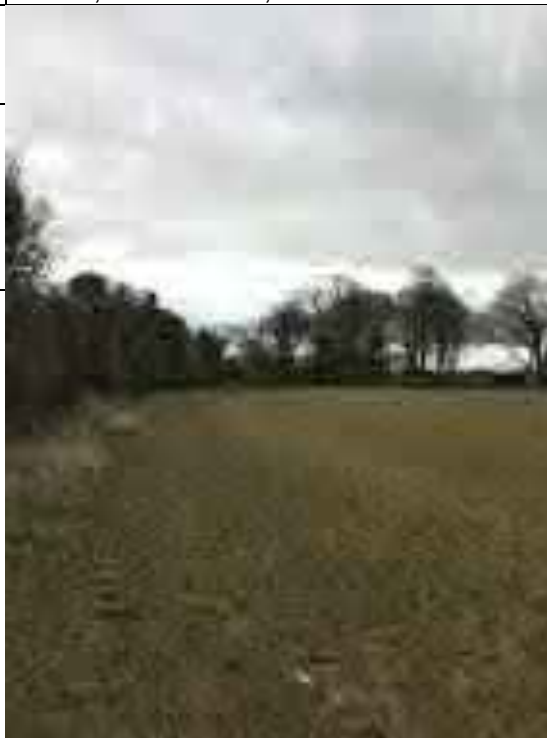
Photo No.
023

View of proposed ditch 1 area.

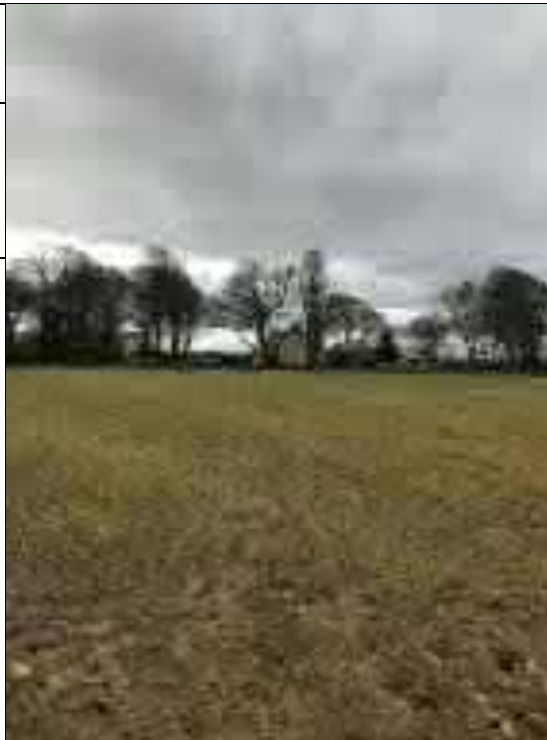
Photo No.
024

View of proposed ditch 1 area, adjacent residential property in background.

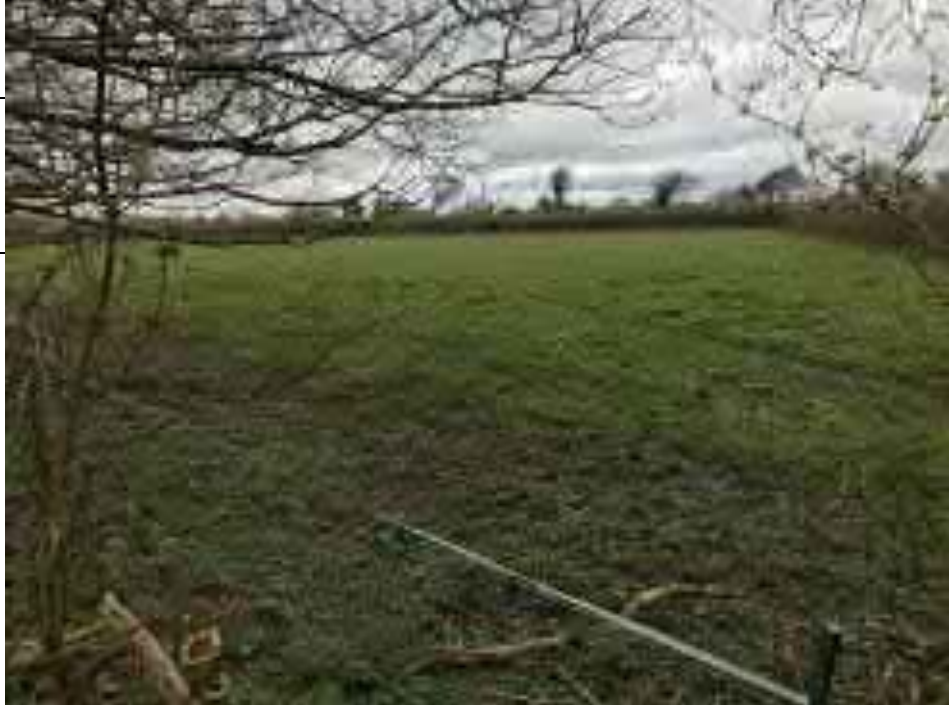
**Photo
No.**
025

View of proposed
overspill bund 1
location.

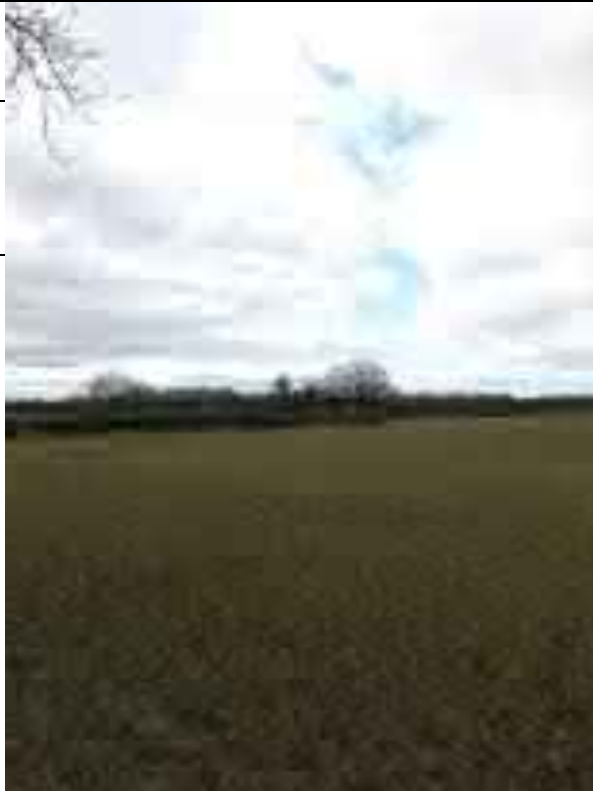
**Photo
No.**
026

View of proposed
ditch 1 area.
