Barry Waterfront

**Environmental Statement
Chapter G**

Archaeology

August 2009

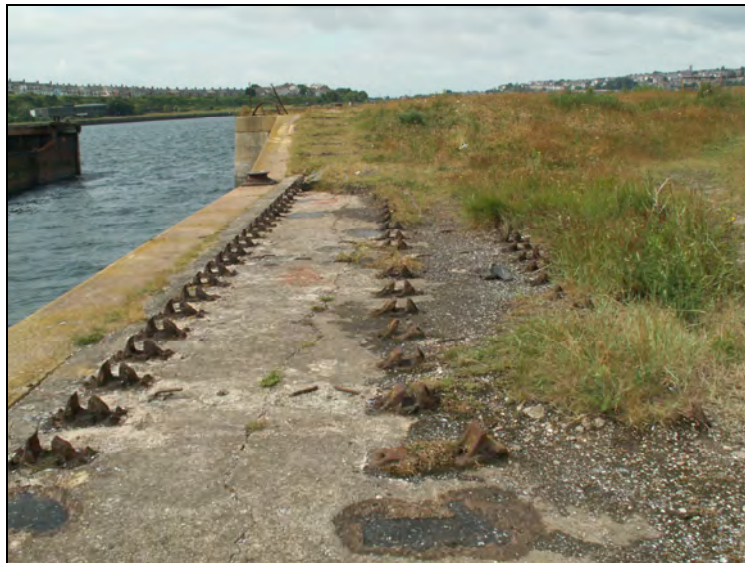
Plate G2: View to southwest of Travelling Crane Remains at East Quay

- 4.53 During the walkover survey remnants of railway chairs for the travelling crane were identified at NGR ST1223767474, along the northern edge of the remaining graving dock (Plate G2, Appendix G2). Four rows were noted, and a number of wooden planks were situated at the base of a stepped ramp. A large metal circular feature possibly associated with the pumping house was also observed to the north of the chairs, the mark 'Stanley' was embossed on the lip (Plate G4, Appendix G2). A series of metal plates were also located near NGR ST1230967503 (Plate G3, Appendix G2).

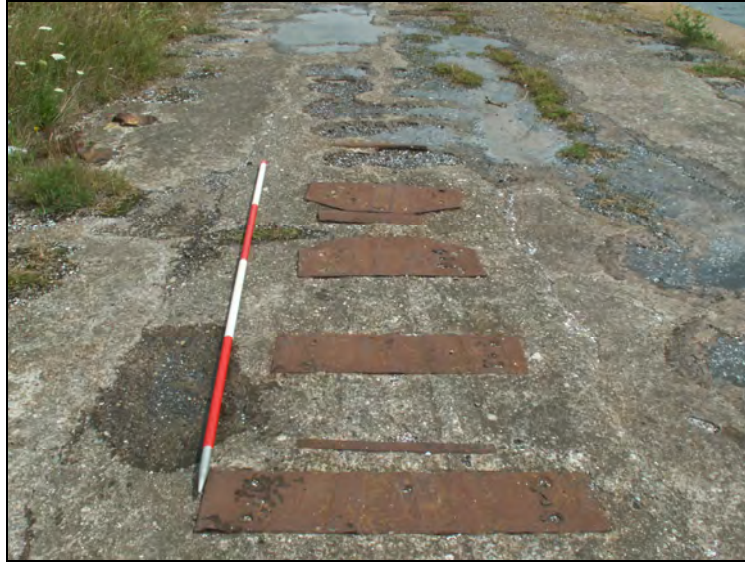
Plate G3: View to northeast of Metal Plates at East Quay

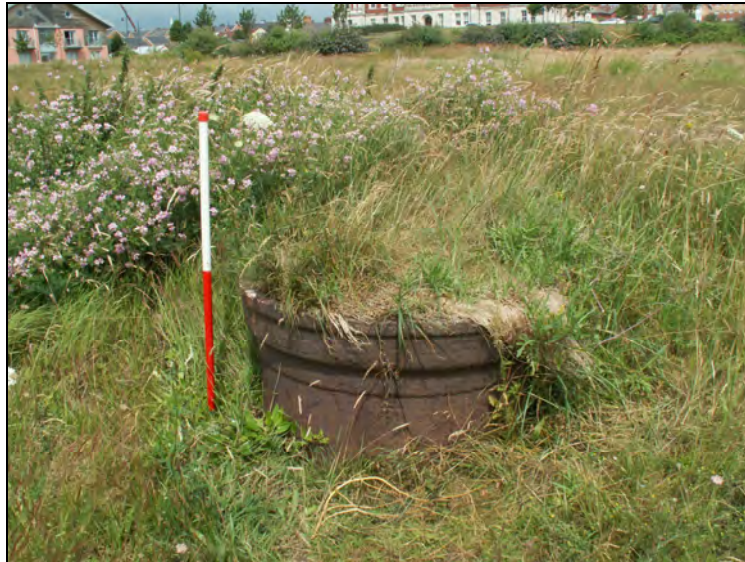
Plate G4: View to northwest of Metal pipe at East Quay

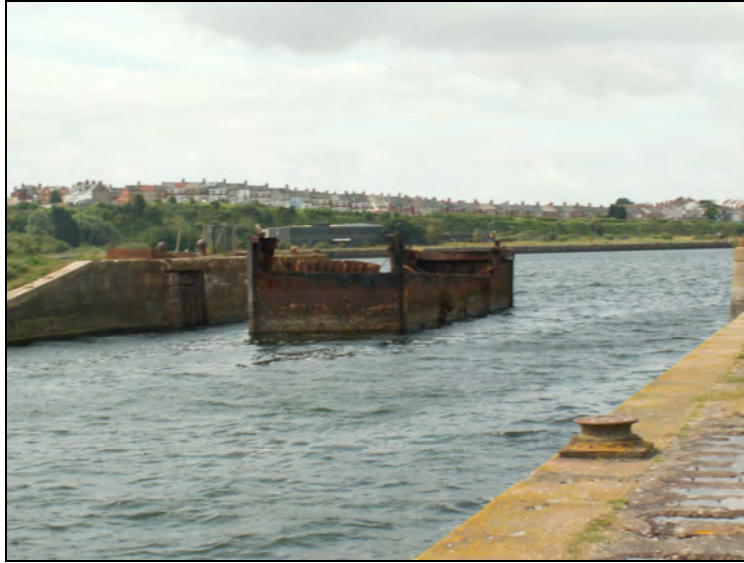
Plate G5: View to southwest Pontoon at East Quay

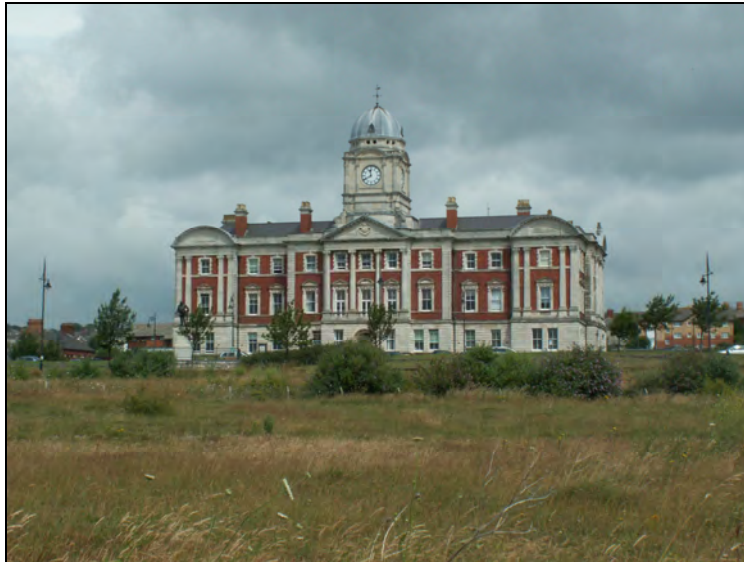
Plate G6: View to northwest Barry Docks Board Office

- 4.3 The East Quay area is divided by a stretch of Cory Way to the east. The Docks Office (O2152s/34235/LB13443) is situated to the northeast overlooking the area (Plate G6, Appendix G2). Two graving docks and a pump house (BW01) were originally located in the area. The southern graving dock still remains, with a heavily corroded metal pontoon at the dock mouth (Plate G5, Appendix G2). There is a slight visible raise in the ground level where the pump house was located, and a distinct flat area where the northern dock was located. The ground level of the area to the south of the remaining dock is higher than that to the north.

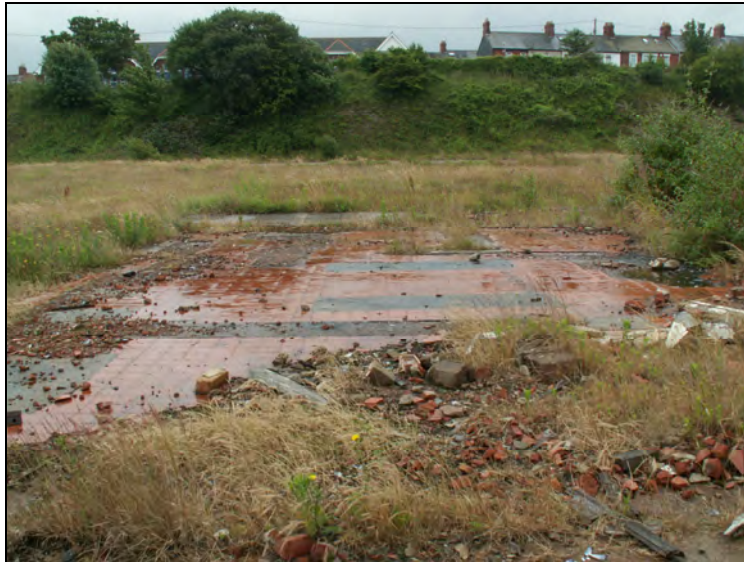
Plate G10: View to south of Floor slab of Oil Storage Terminal

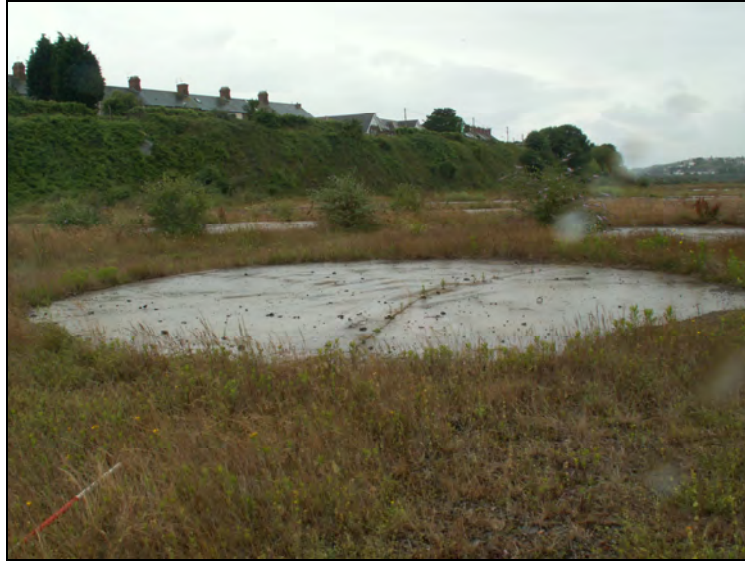
Plate G11: View to southwest of concrete tank base of Oil Storage Terminal

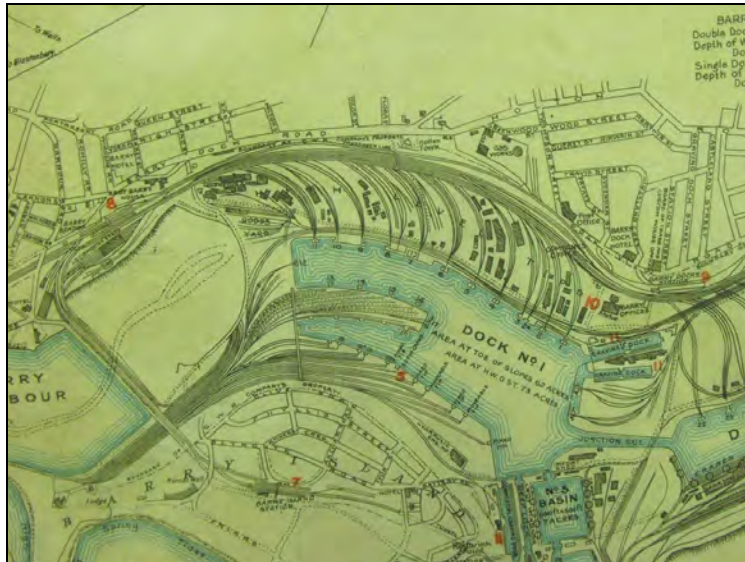
Plate G14: Great Western Railway Engineers Plan of Barry Docks, c1929 (Glamorgan Record Office)
