VERIFICATION REPORT

Remedial Works at West Pond, Barry Waterfront
Development

20/06/2014

Cuddy Group

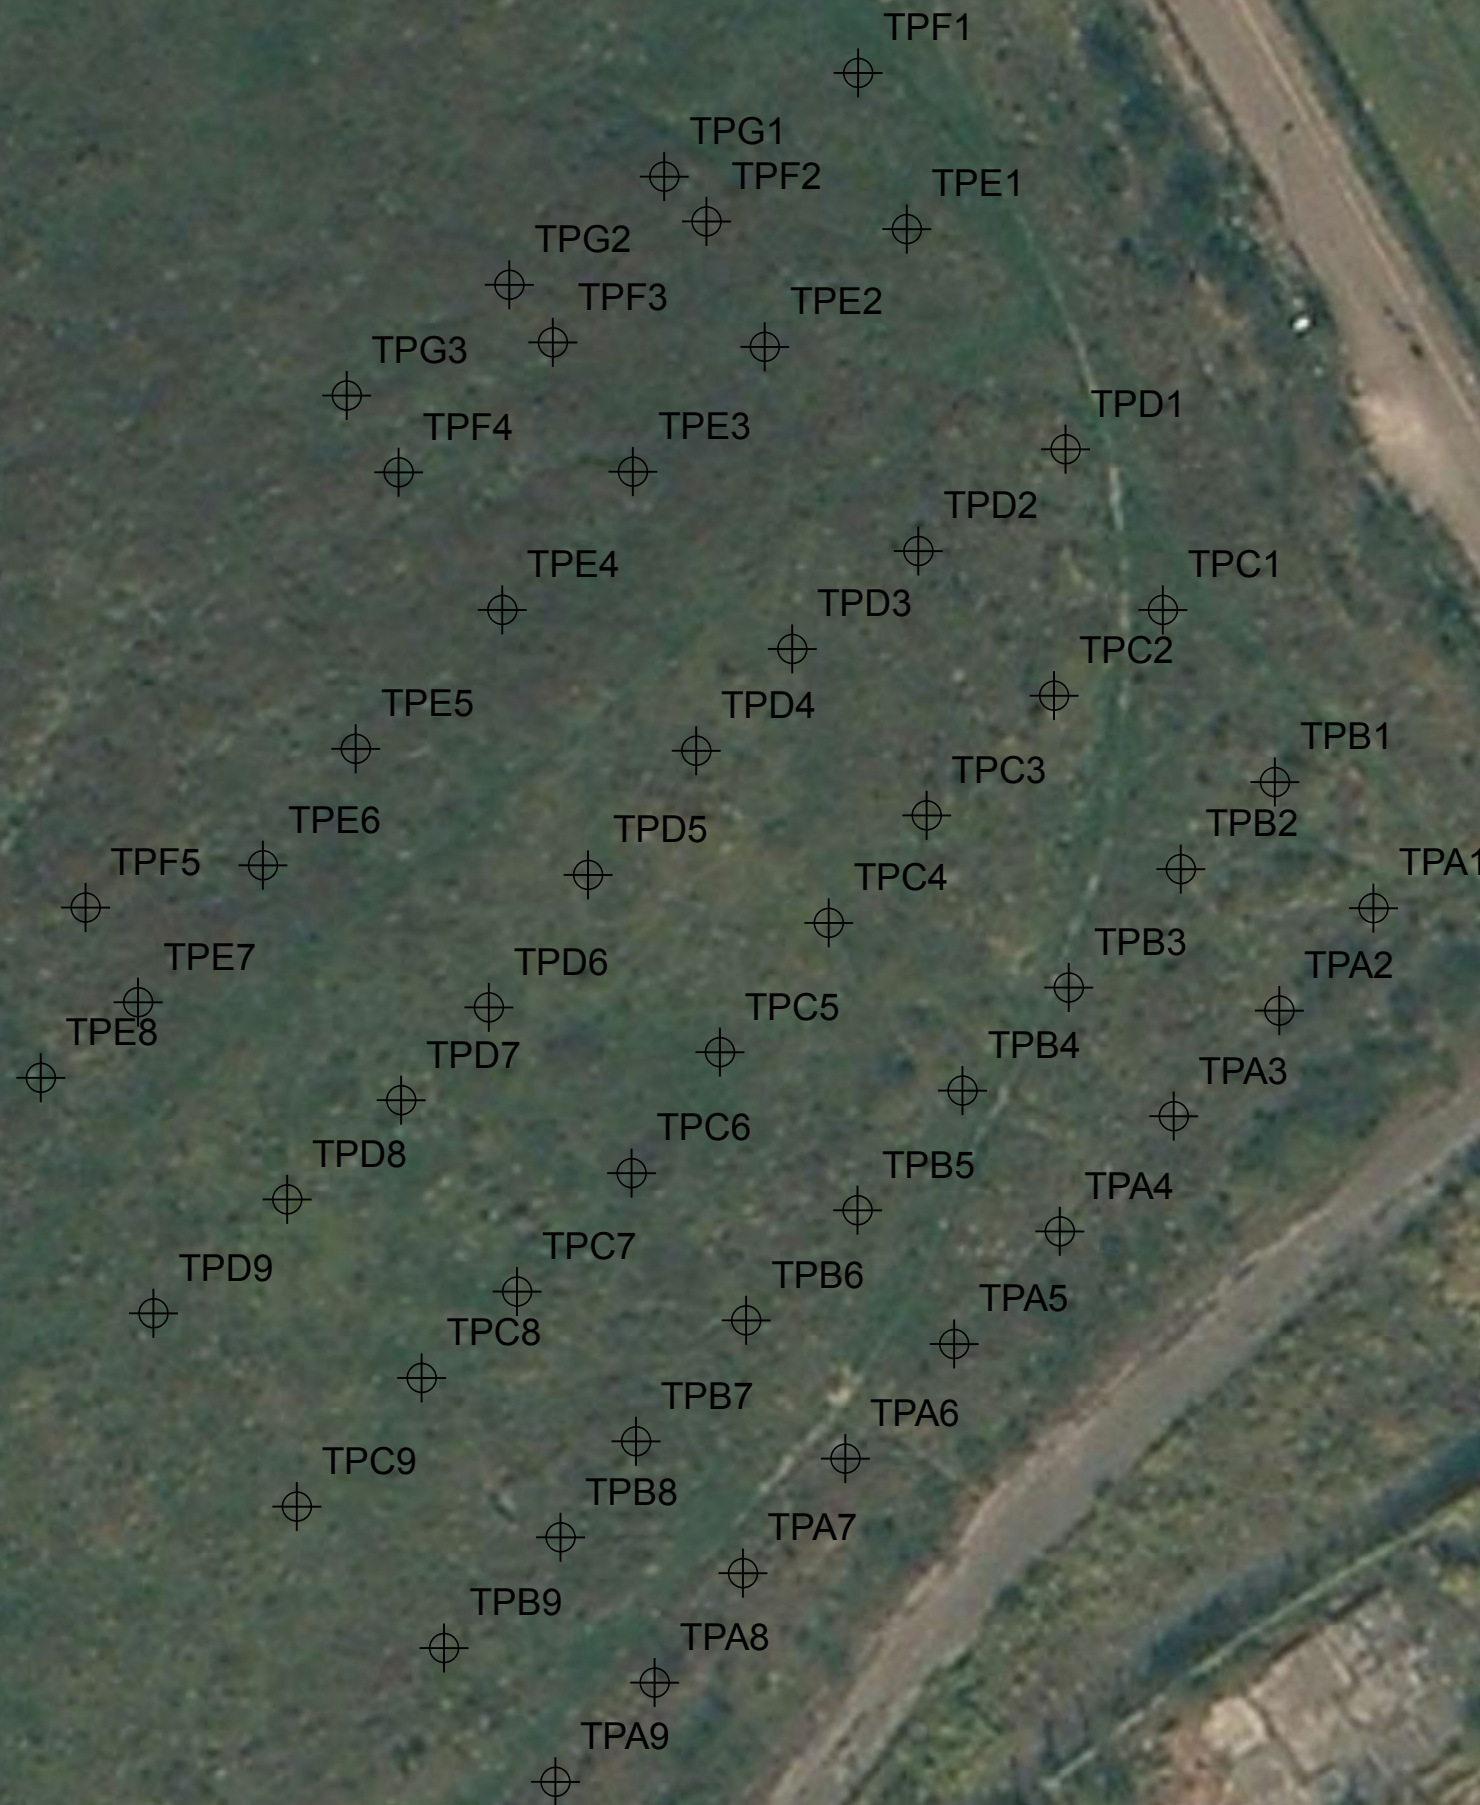
FIGURE No:
FIGURE 1

TITLE:
WSP Trial Pit Locations

WSP undertook the first phase of works between 18th and 26th June 2013, which comprised the excavation of 52no. trial pits on a circa 10m grid to approximately 5m bgl. Ground conditions encountered were consistent with those previously reported, and comprised variable clayey sandy and gravelly made ground. Following the identification of gross contamination, an LNAPL skimmer and a groundwater treatment plant was deployed to recover contaminants direct from trial pits and open excavations. Further details of these works are presented below.
