ASBESTOS GROUND CONTAMINATION INVESTIGATION SOUTH QUAY THE BARRY WATERFRONT CONSORTIUM AGC-17633-12-198 JANUARY 2013

ASBESTOS GROUND CONTAMINATION INVESTIGATION SOUTH QUAY THE BARRY WATERFRONT CONSORTIUM AGC-17633-12-198

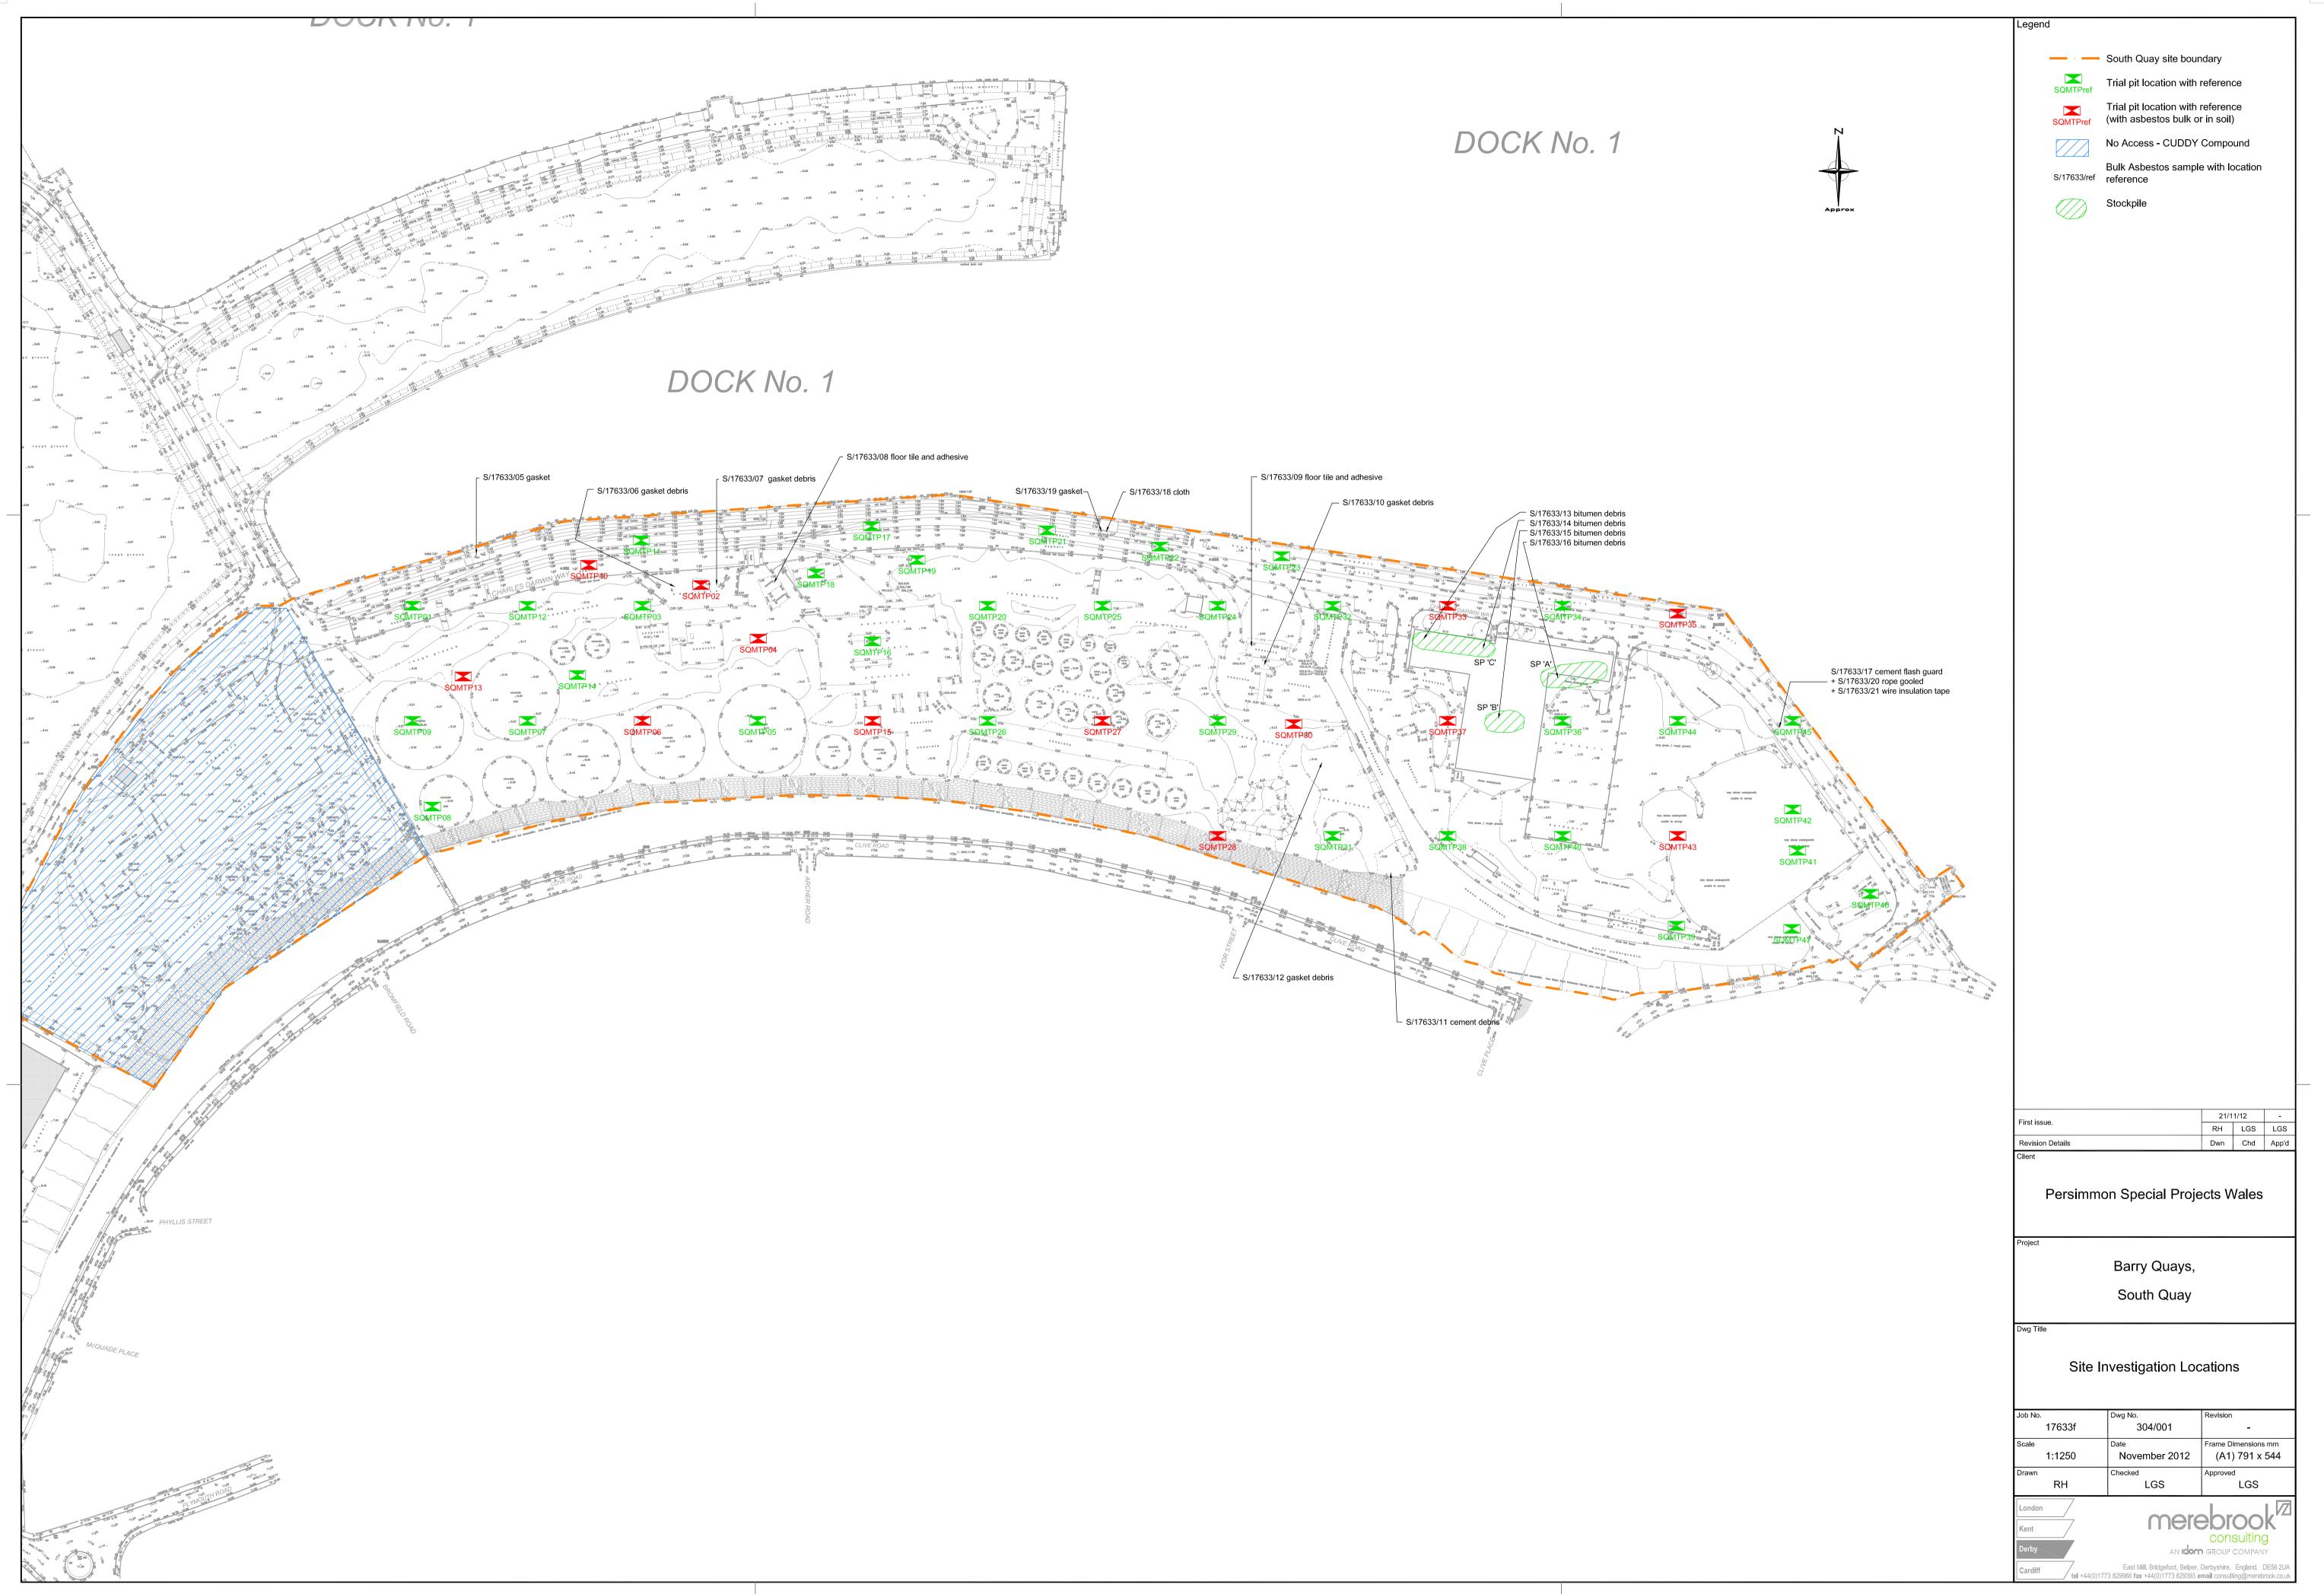
Drawing 304-001 Site Investigation Locations

- 2.3 Trial pits were advanced slowly at each marked location and arisings were inspected for the presence of suspected ACMs. The location of the trial pits is shown on drawing 304-001 provided in Appendix 1.

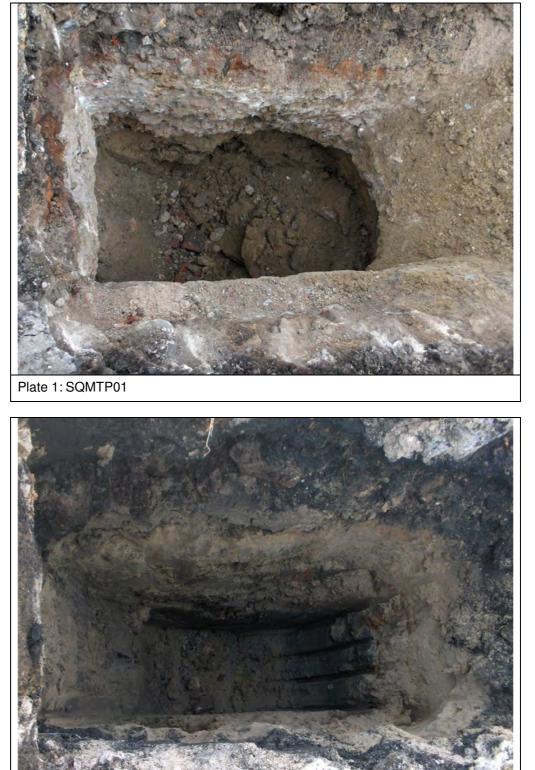
Plate 2: SQMTP02

0.10		MADE GROUND S/17633/01 (: concrete slab GASKET DEBRIS			
0.30	D		(0.50)	0.60		MADE GROUND coarse angular b	: black slightly ashy sandy rick, concrete, clinker, slag			-

- 4.2.1 Bulk items of known or suspected ACMs on the site can be removed by hand picking. The nature of the items and duration of the picking will determine whether removal needs to be conducted by a licensed contractor following a statutory notification period; by non-licenced operatives following a statutory notification period; or by non-licenced operatives without a statutory notification period. One isolated clump of lagging was found during trial pitting, however, unless further quantities of lagging or similarly friable material are found, it is considered that any removal could be undertaken as notifiable non-licensed work.

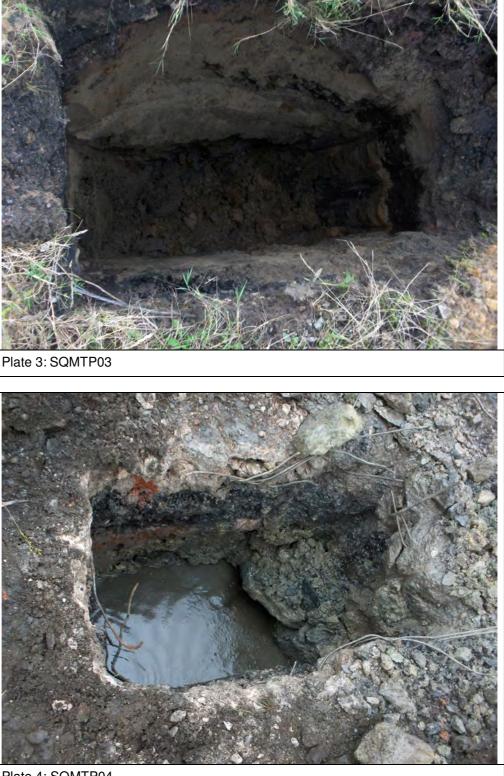
Plate 4: SQMTP04

Trial Pit ID and Depth	ACM Type Detected	PLM Result	Total % Asbestos in Sample
SQMTP04 0.05m	Free Fibres	Amosite	0.006
SQMTP06 0.20m	Free Fibres	Amosite	0.006
SQMTP10 0.80m	Free Fibres	Chrysotile	0.008
SQMTP13 0.30m	Loose Insulation	Amosite	0.024
SQMTP27 0.10m	Free Fibres	Chrysotile	0.005

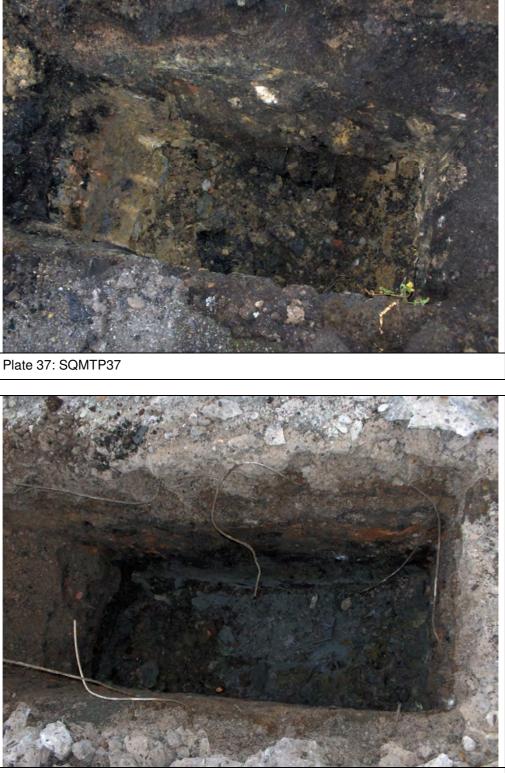
Plate 38: SQMTP38

Sample Number	ACM	Typical Asbestos Content ¹	Туре	Location
S/17633/04	Cement and Lagging	Cement: 10-15% Lagging: varies 6-85%	Cement: Chrysotile (white) Lagging: Amosite (brown) and Crocidolite (blue)	SQMTP37

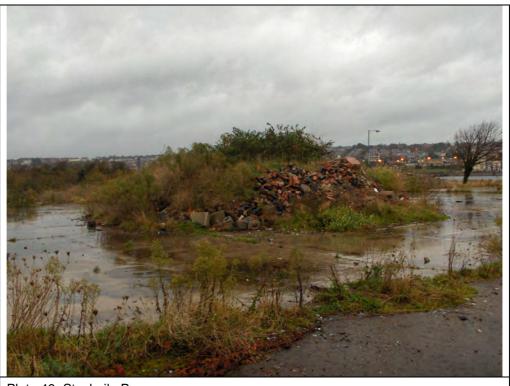
Plate 49: Stockpile B

3.3 Of the four samples taken from the demolition stockpiles, none tested positive for asbestos content. The results are summarised in Table 3 below and the results are provided in Appendix 4.

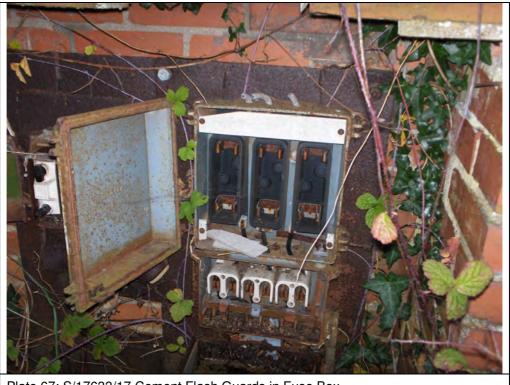
Plate 67: S/17633/17 Cement Flash Guards in Fuse Box

Result: Chrysotile
