**GEO-TECHNICAL &
GEO-ENVIRONMENTAL REPORT
PROPOSED RESIDENTIAL RHOOSE
POINT, VALE OF GLAMORGAN**

Report No. 11621

REPORT TITLE : **Geo-Technical & Geo-Environmental
Report – Proposed Residential
Development, Rhoose Point, Vale of
Glamorgan**

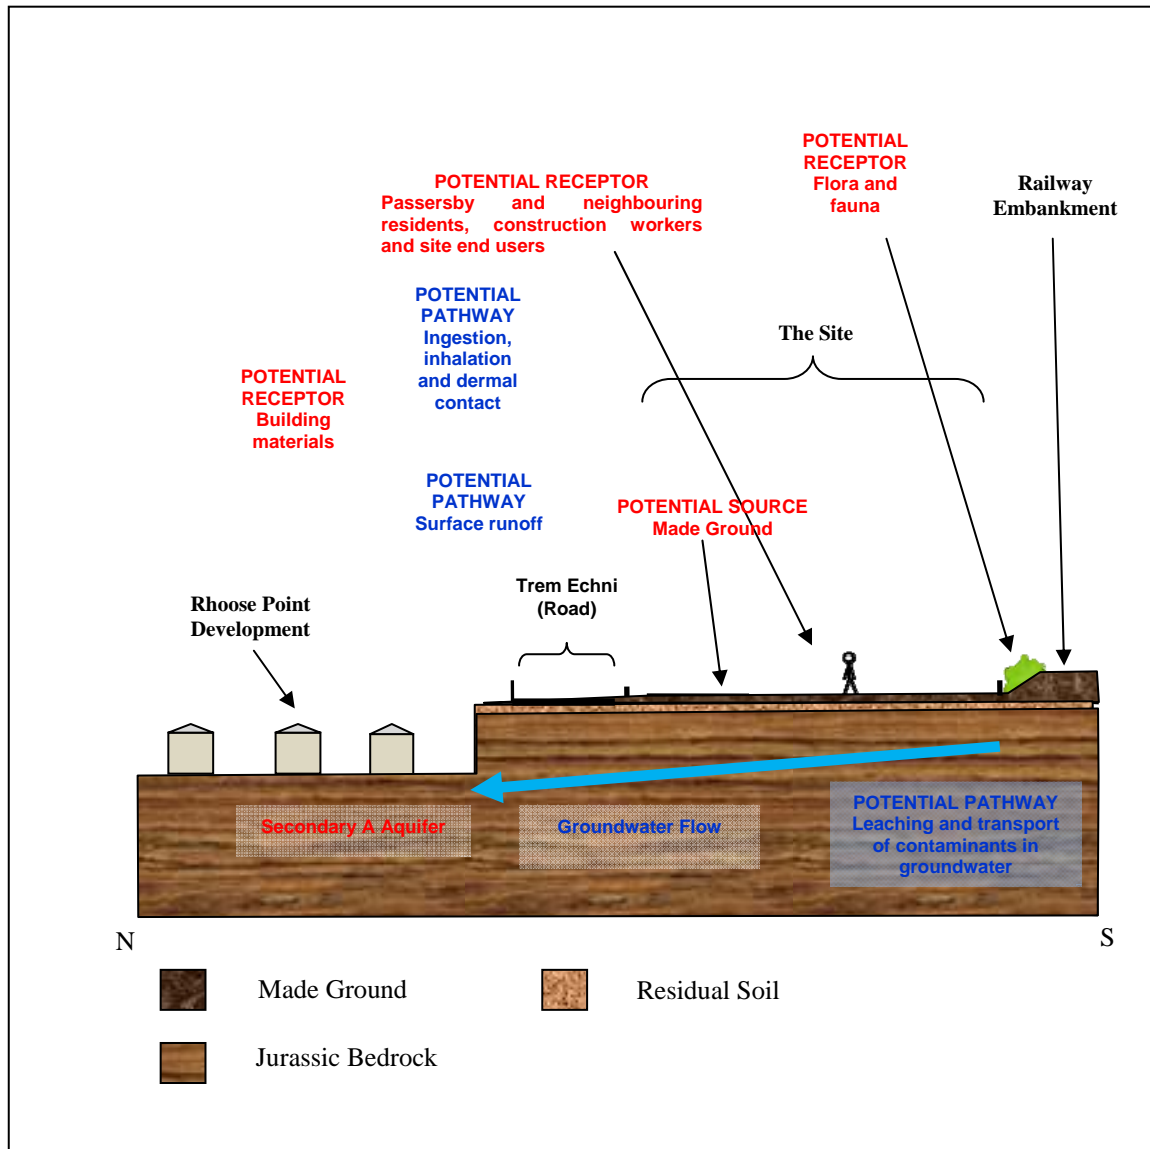
The ground conditions at the site are likely to comprise a thin layer of Made Ground overlying residual soils, further underlain by Jurassic Limestones and Mudstones.

The dominant direction of groundwater flow is likely to be towards the watercourse on the southern boundary of the site.

A preliminary site conceptual model is presented below. It should be noted that the SCM is generalised and not to scale.

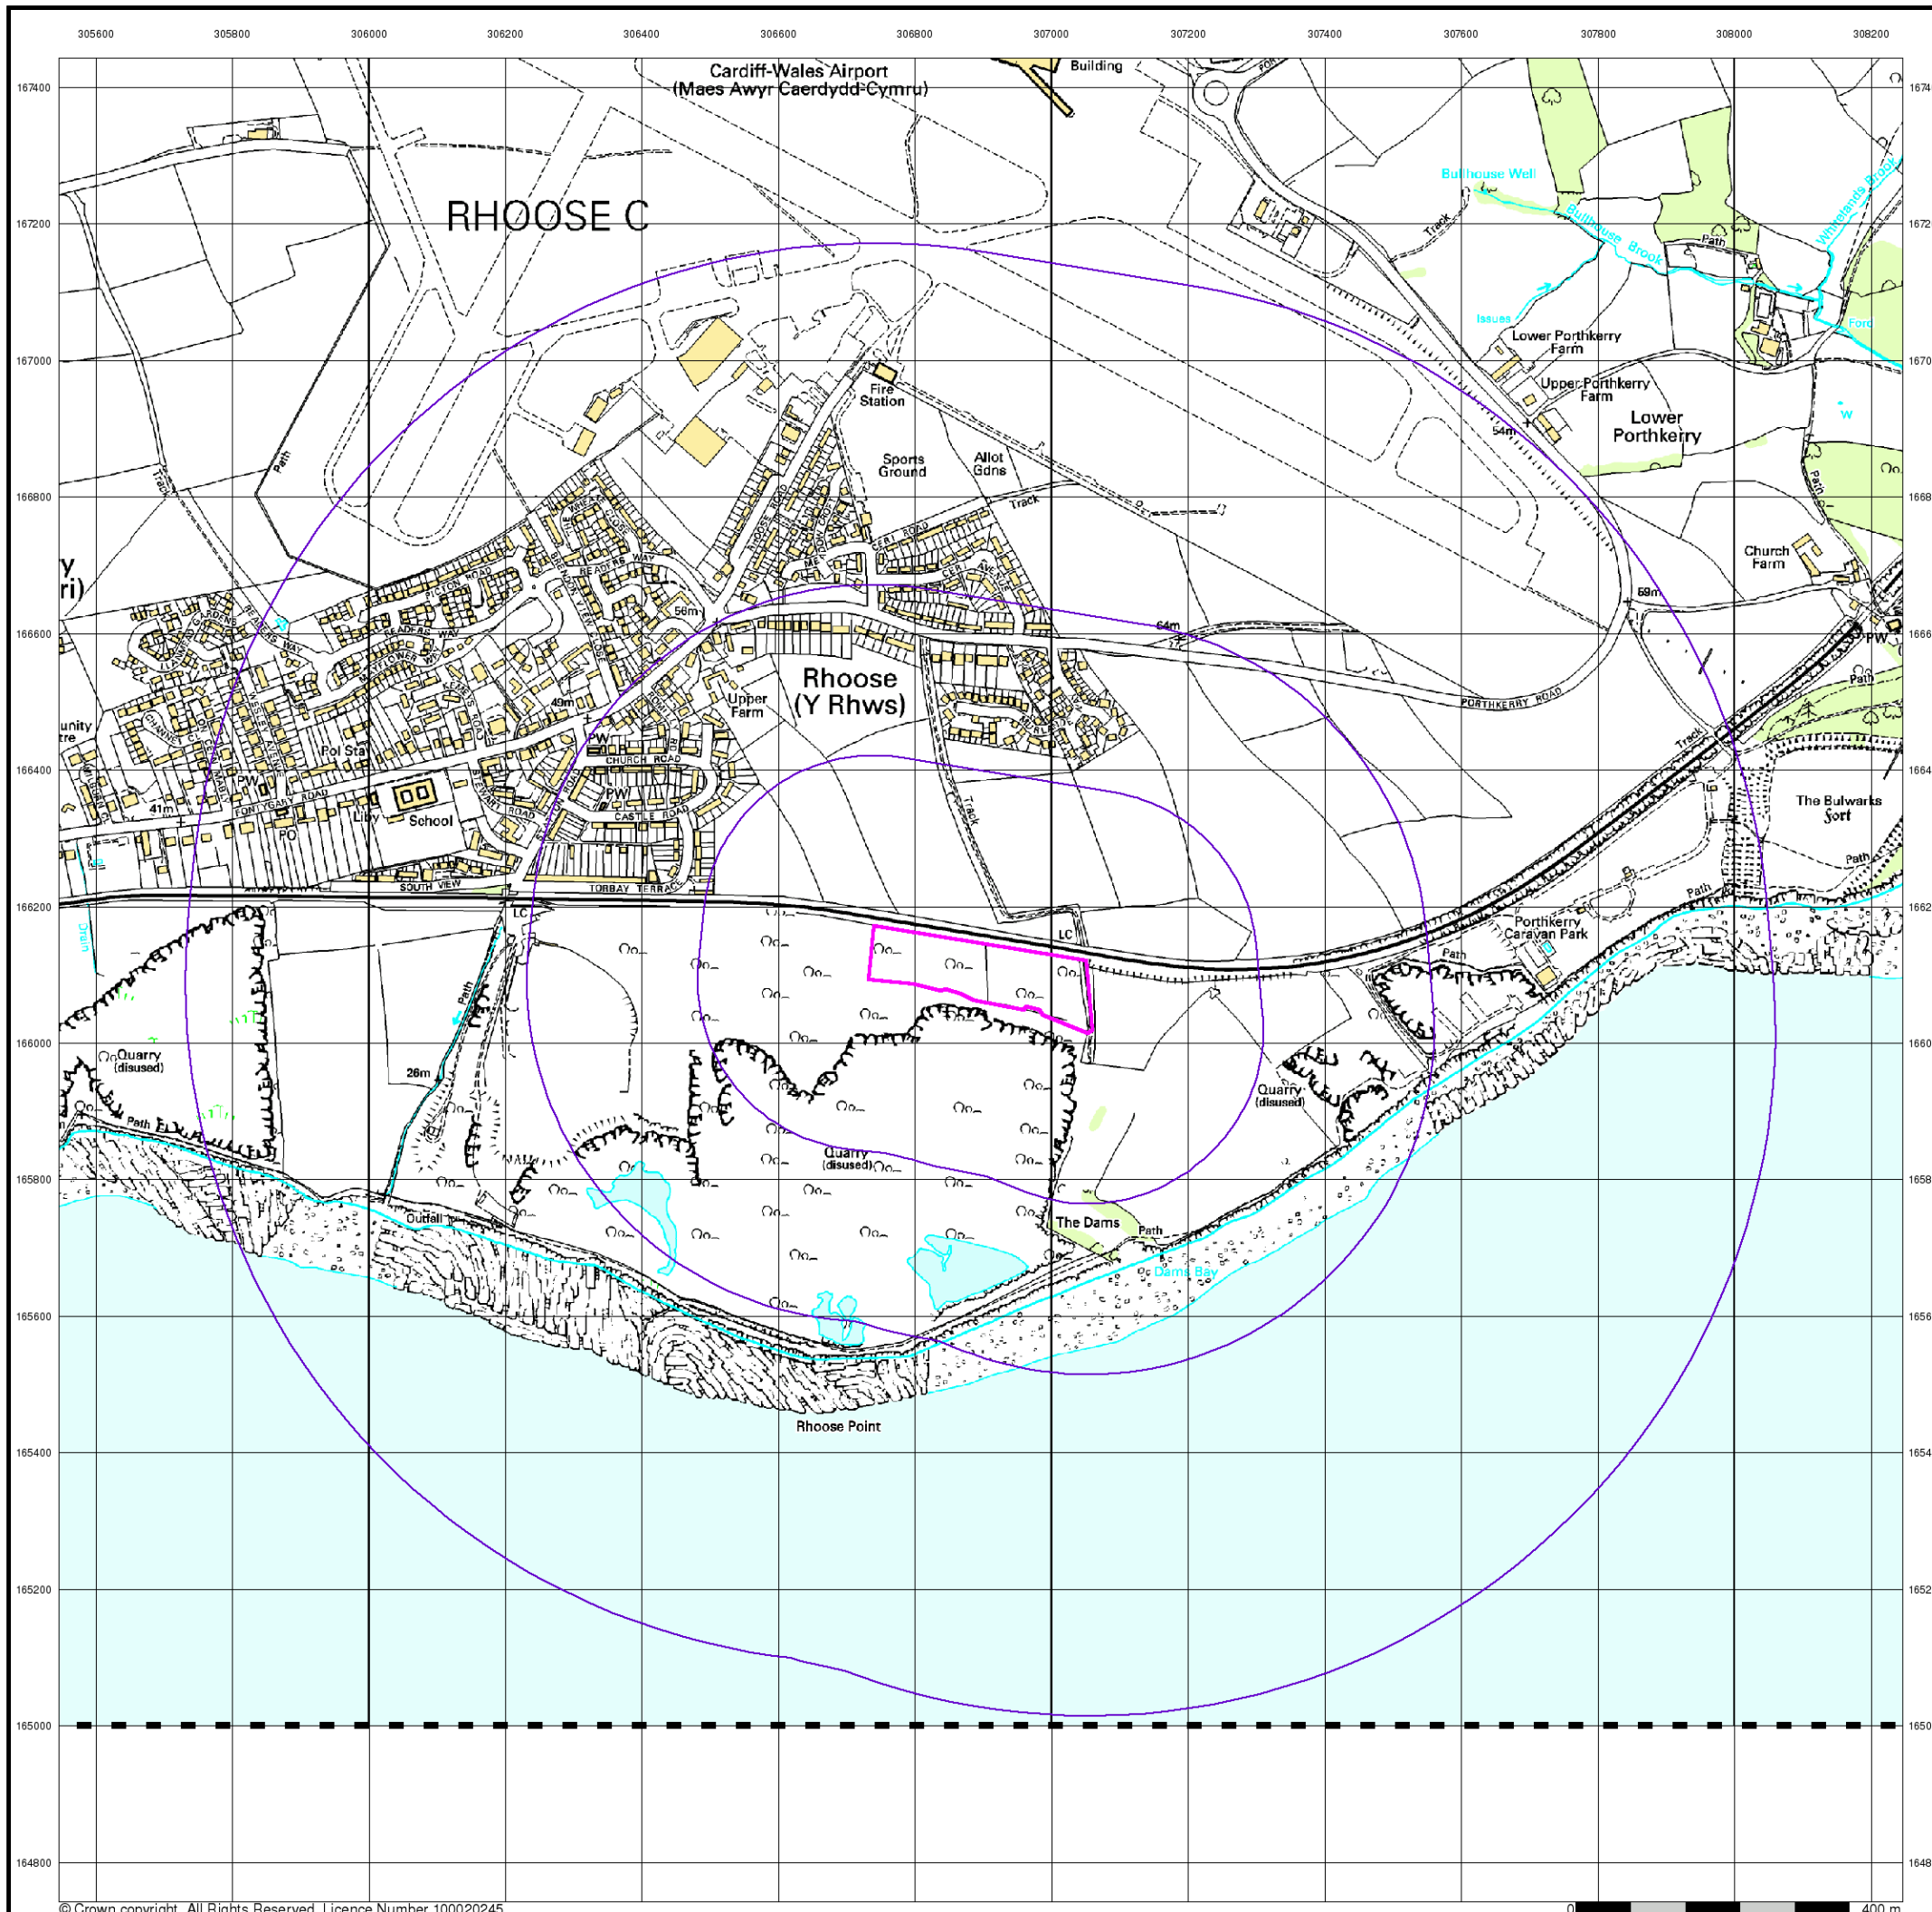
10k Raster Mapping

The historical maps shown were produced from the Ordnance Survey's 1:10,000 colour raster mapping. These maps are derived from Landplan which replaced the old 1:10,000 maps originally published in 1970. The data is highly detailed showing buildings, fences and field boundaries as well as all roads, tracks and paths. Road names are also included together with the relevant road number and classification. Boundary information depiction includes county, unitary authority, district, civil parish and constituency.
