**Land to the North  
of the Railway  
Line (West)**

**Bat Survey Report**

Prepared by:  
**The Environmental  
Dimension  
Partnership (EDP)**

April 2014  
Report Reference  
**EDP2127\_02b**

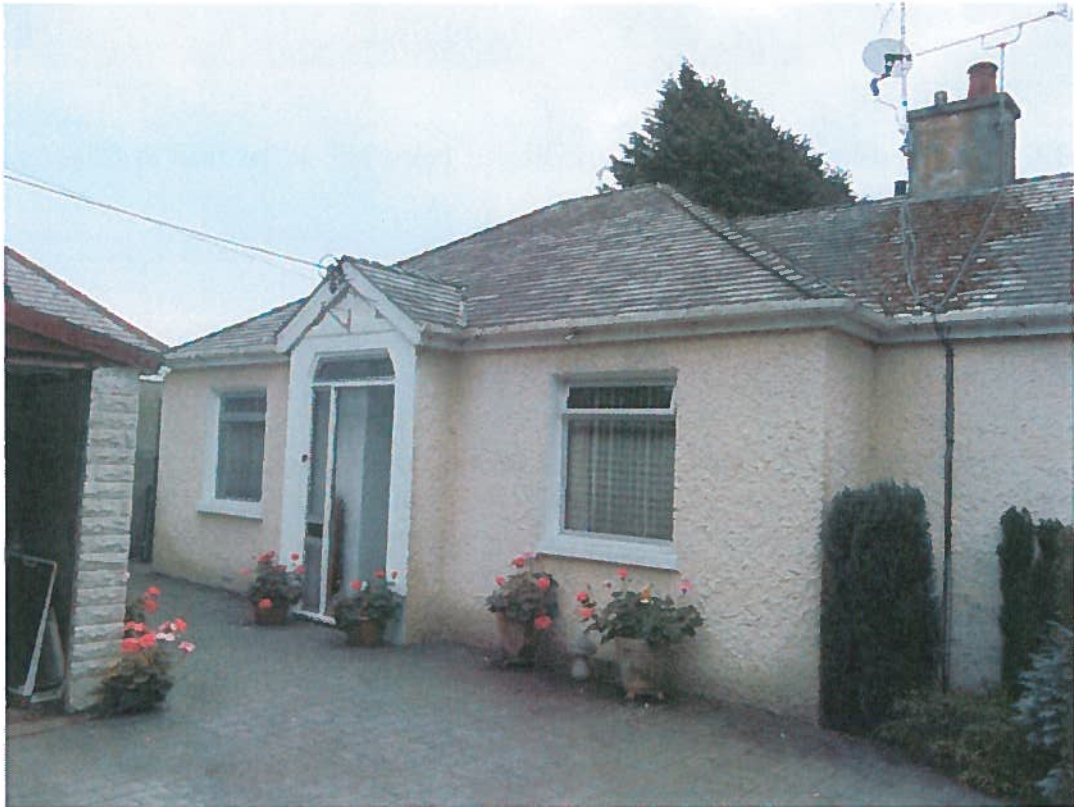
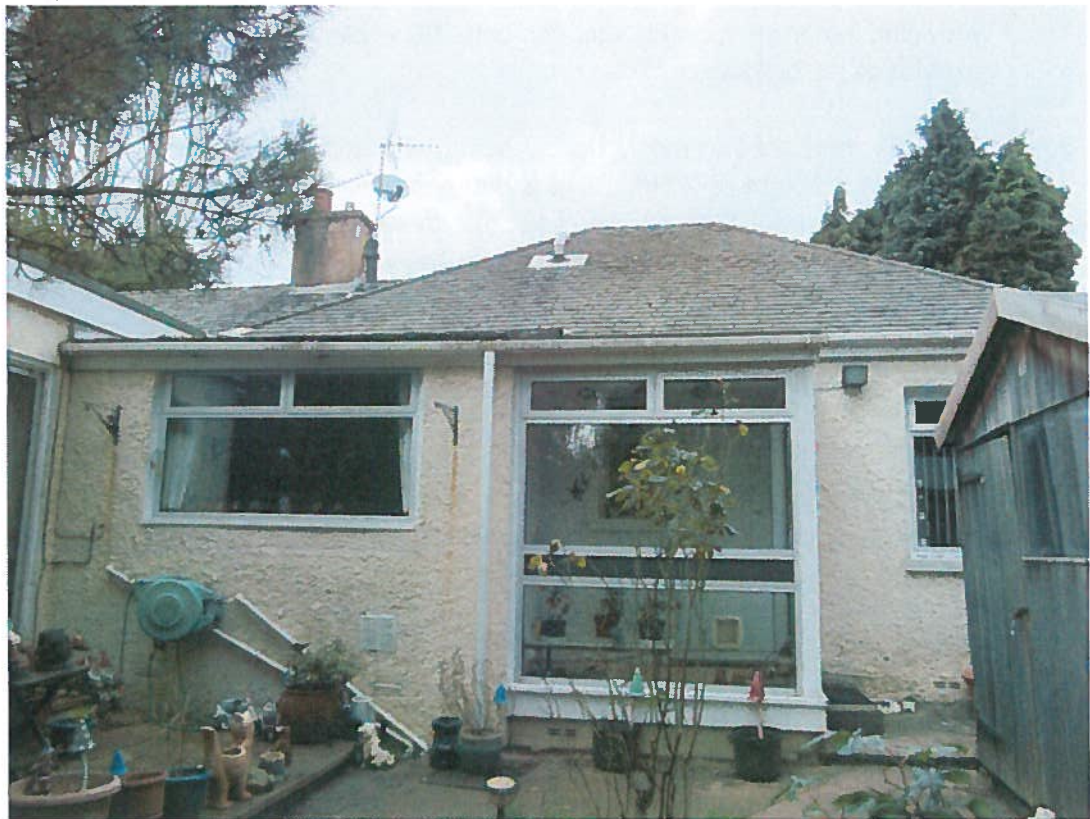
- 3.2 As illustrated in **Image EDP 1-3** Building 1 is a single-storey bungalow which is currently inhabited. The walls are most likely constructed from brick or block work, although this was not confirmed due to the external render. The majority of the roof is pitched, covered by wooden shingles, although there are two small sections of flat roof covered by a bitumen based felt.

- 3.3 The walls are in good condition with no gaps which would offer potential for bats to roost. The roof is semi-complex with the main section being hipped. To the west there is a gabled extension and to the south and south west there are two flat roofed sections. The roof is in good condition and on-the-whole is tight-fitting, although gaps beneath curled shingles, ridge shingles as well a gap along the western wall were noted as providing potential roosting sites for bats. No evidence of bats was recorded on the exterior of the building.

- 3.5 Based on the daytime internal/external inspection the bungalow is considered to offer low potential for crevice dwelling bat species.

**Image EDP1:** Building 1: Bungalow

**Image EDP 2:** Building 1: Bungalow

- 4.3 From the survey work, no bat roosts have been identified in any of the buildings. No further survey work is considered necessary and demolition of the buildings would not require a European Protected Species licence. In the unlikely event that bats are encountered during demolition works all work should halt immediately and an ecologist contacted for further advice.

- 4.4 Given that the buildings offer bird nesting opportunities, demolition should be undertaken outside the bird breeding season (March to August inclusive), especially building 5, where some evidence of previous nesting birds was found and the bungalow, for which there was an incidental record of blue tit (*Cyanistes caeruleus*) entry, possibly for nesting under the eaves on the southern wall of the house.

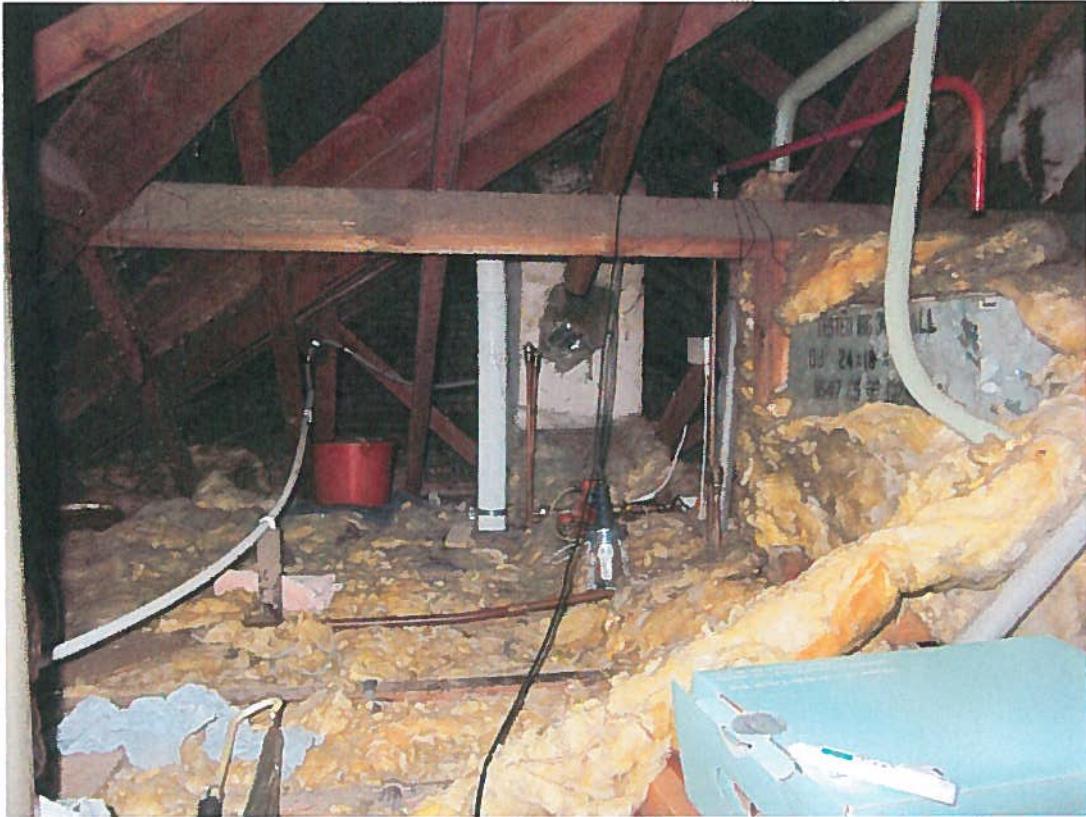
- 3.4 Internally there are two roof voids measuring approximately 8m by 7m and 5.5m by 5m with a ridge height of 2.5m. There is bitumen based roofing felt beneath the shingles and fiberglass insulation at ceiling level. The main void is used for storage, although this is limited to the area around the loft hatch. The void was dark, with no visible gaps. The ridge line of the main void was densely covered by cobwebs, whereas the smaller void is entirely covered by cobwebs. No evidence of bats was recorded within the roof voids.

**Image EDP 3:** Building 1: Bungalow roof void

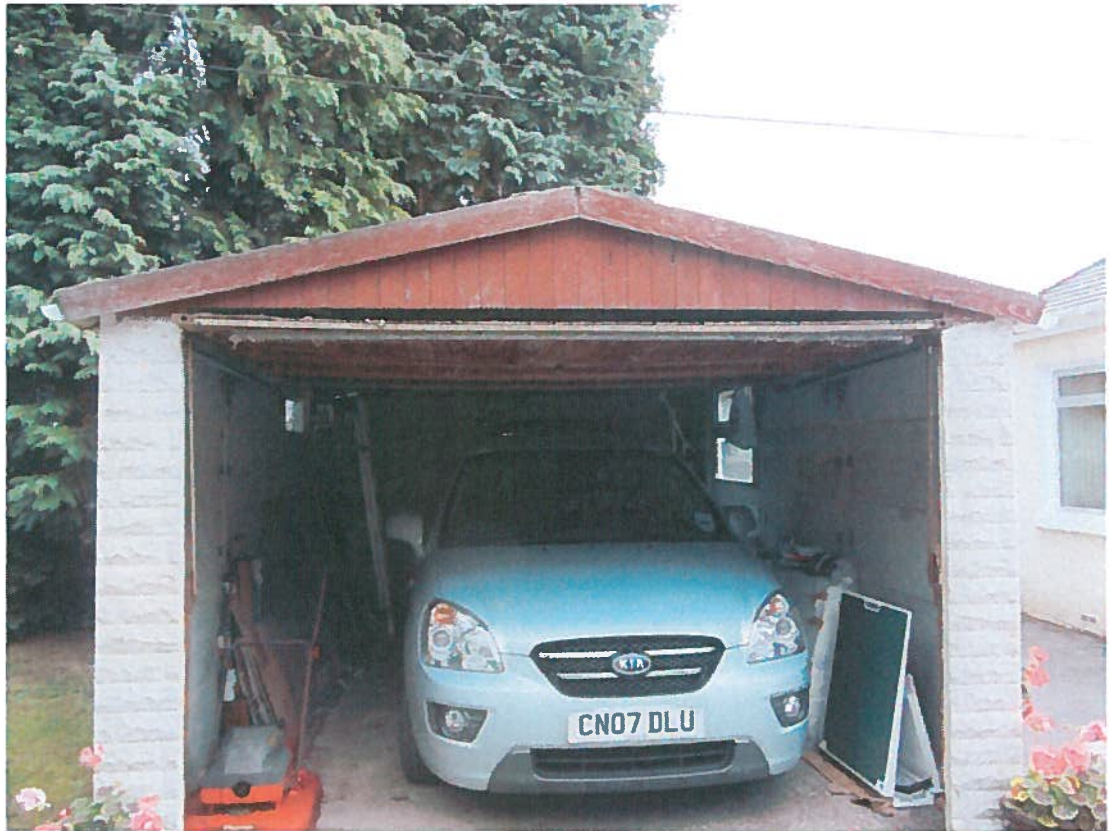
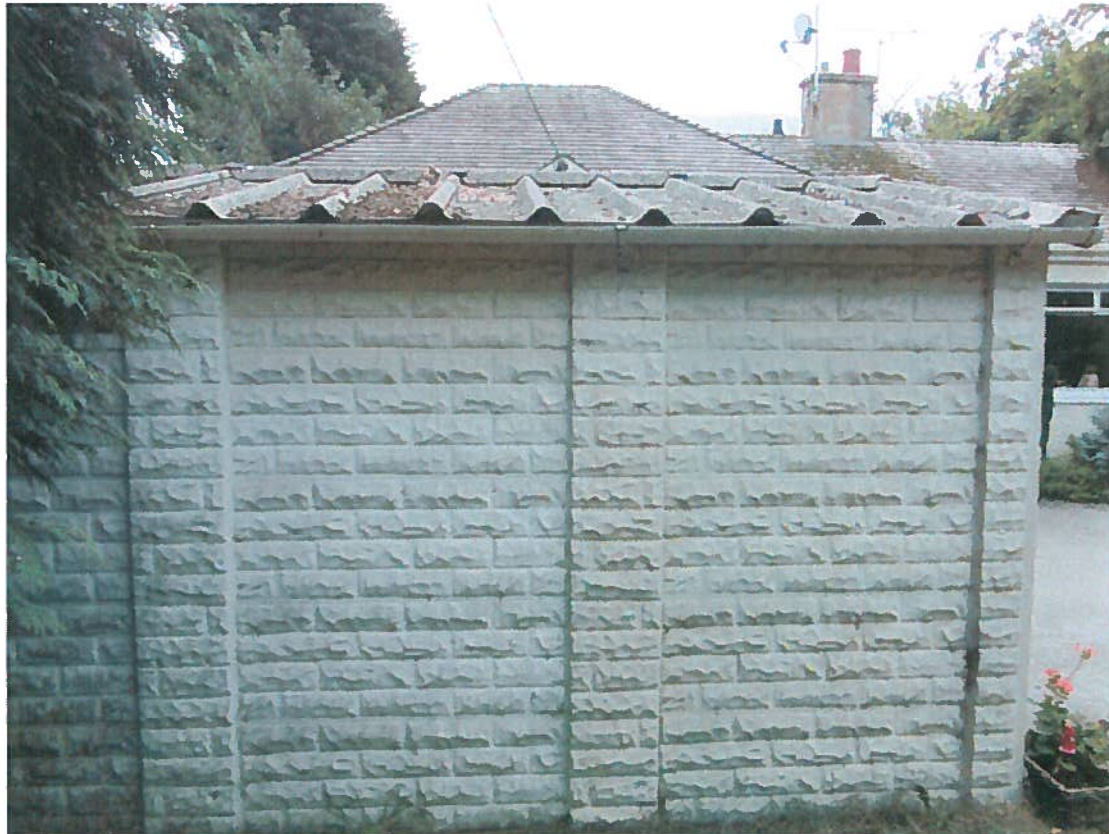
- 3.6 As illustrated in **Image EDP 4-6** the garage is a simple, single storey pre-fabricated structure constructed from concrete slabs. The roof is pitched and covered by corrugated asbestos/cement roofing sheets with wooden barge and weather boarding at either gable end.

- 3.7 Overall this building offers negligible potential for roosting bats due to its construction, which lacks any suitable roosting features. The only exception is the ridge line which contains a small number of gaps beneath. Although a gap exists at this location, due to the limited size of the gap as well as the construction of these sheets, which would result in large temperature fluctuations, it is considered that the likelihood of bats roosting within these gaps is very limited. No evidence of bats was recorded on the exterior or interior of this building.

- 3.8 Based on the daytime internal/external inspection the garage is considered to offer low-negligible potential for crevice dwelling bat species.

**Image EDP 4:** Building 2: Garage

**Image EDP 5:** Building 2: Garage

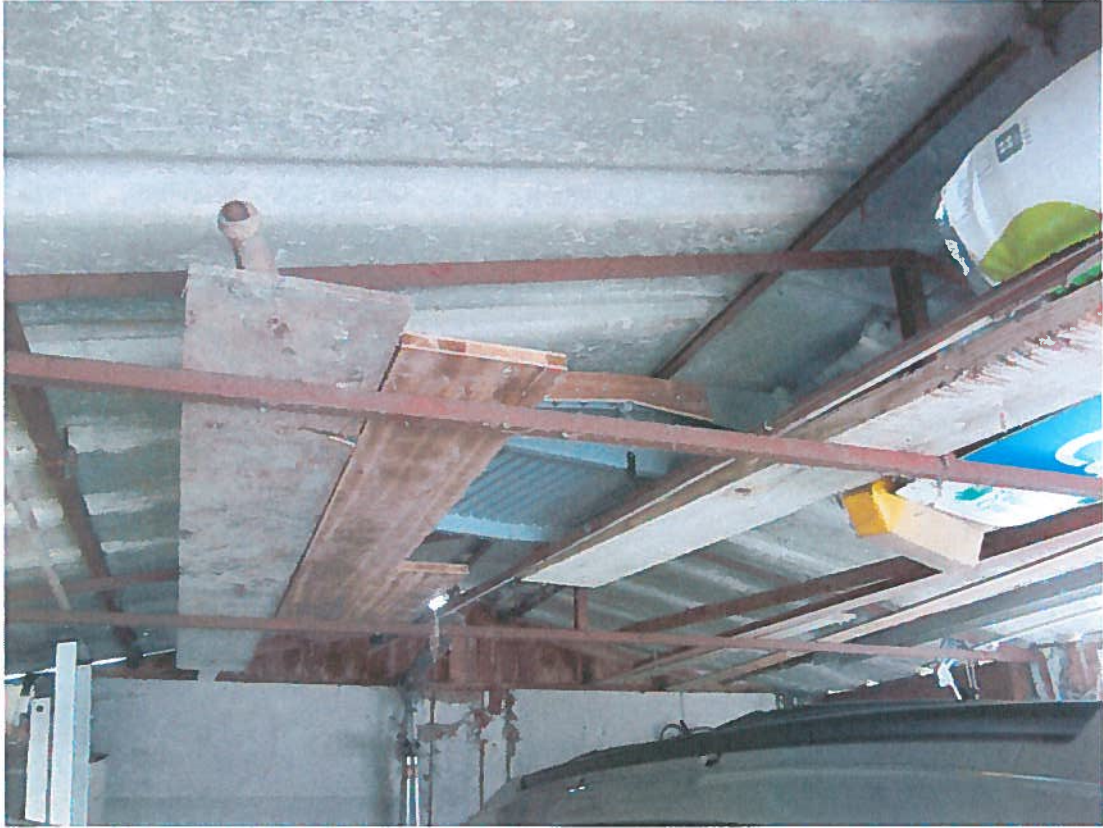
**Image EDP 6:** Building 2: Garage Interior

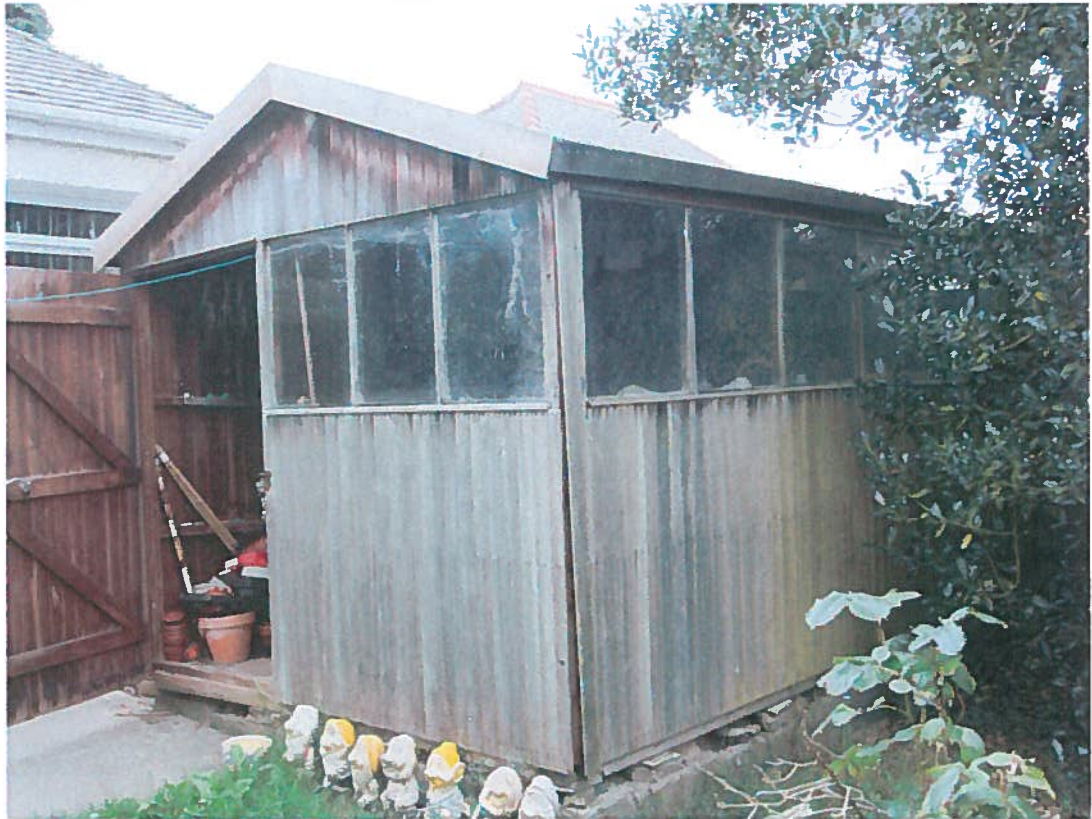
- 3.9 In the rear garden of the bungalow is a wooden shed (**Image EDP 7**). Due to its construction, which lacks any suitable roosting features, this building is considered to offer negligible roosting potential for bats.

**Image EDP 7:** Building 3: Wooden Shed

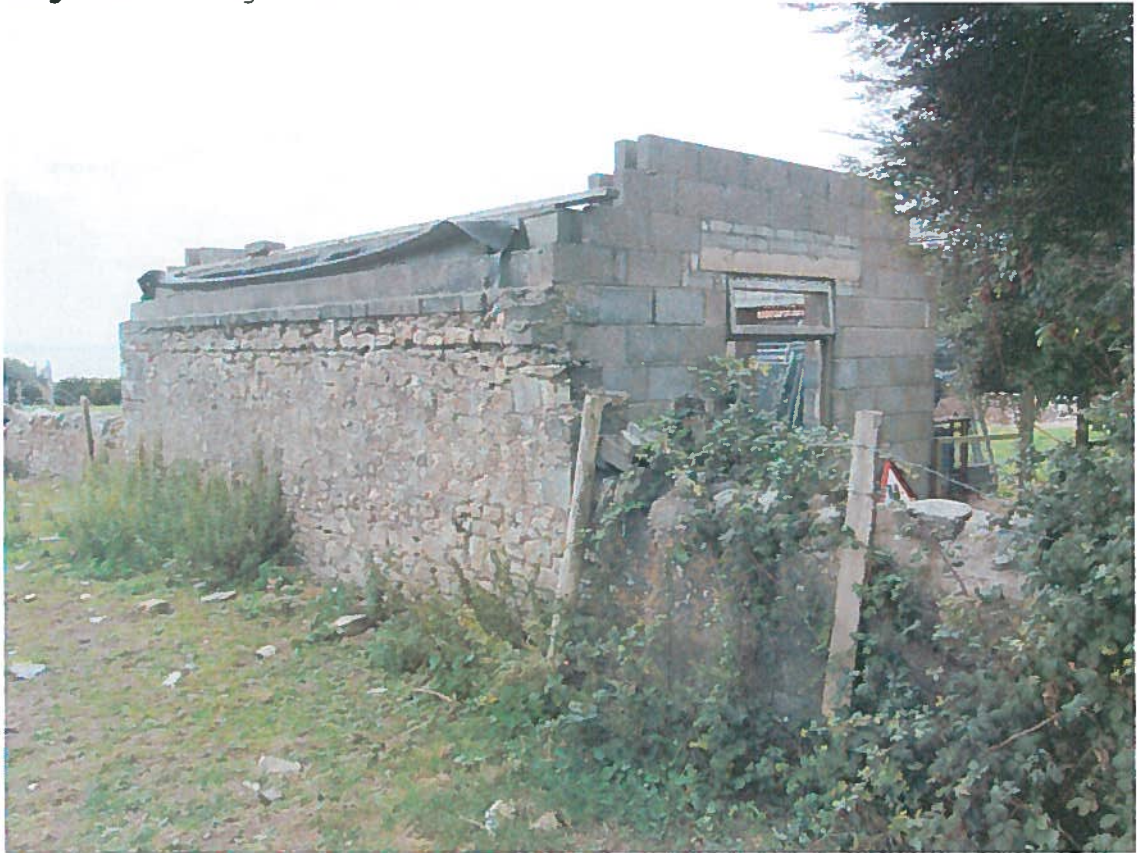
- 3.10 This building has been constructed on an old stone boundary wall, with new additions constructed from breezeblock as illustrated in **Image EDP 8**. This building lacks any form of roof structure.
- 3.11 There are some small gaps in the old stone boundary wall, however these are largely superficial and, upon inspection, contained no evidence of bats.
- 3.12 No evidence of bats was found on the exterior or interior of this building and it is considered that this building has negligible bat roosting potential.

**Image EDP 8:** Building 4: Concrete Shed

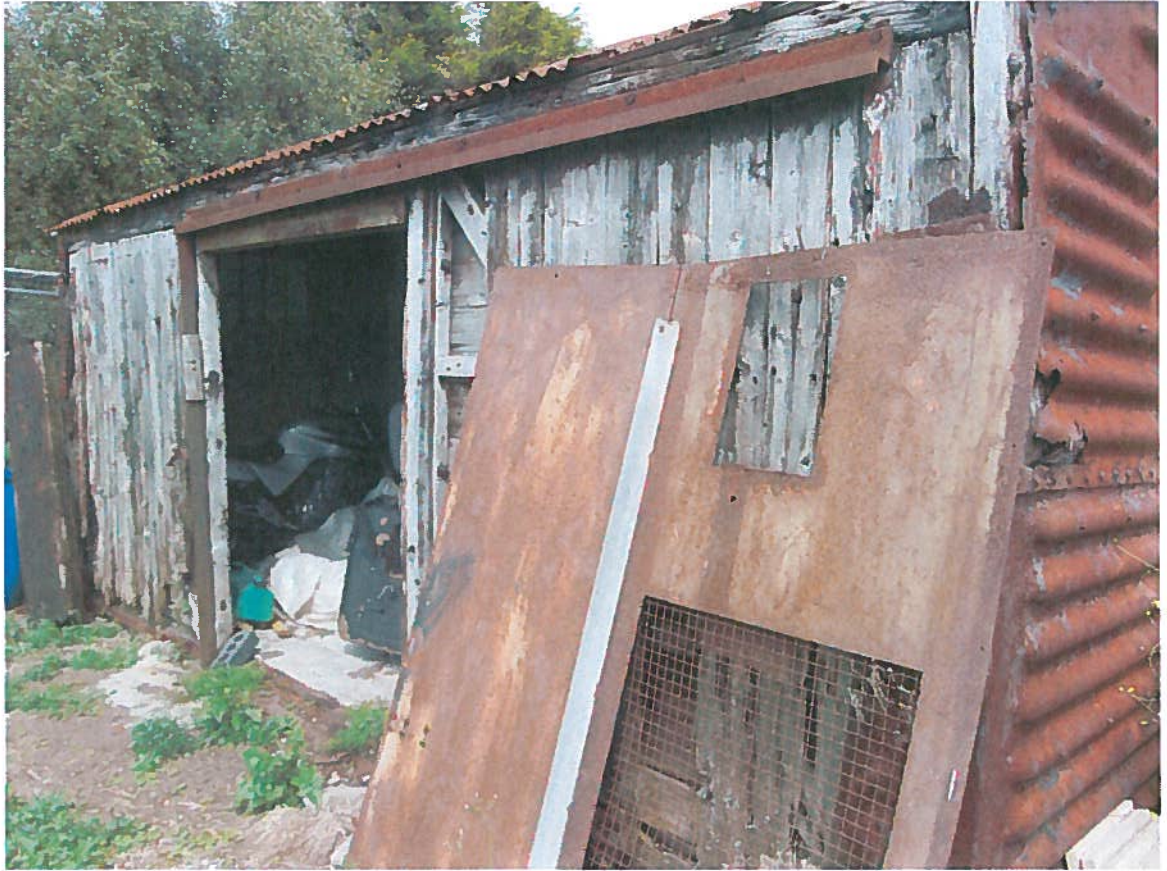
- 3.13 This railway carriage is constructed from a timber frame clad in mixture of corrugated metal sheeting and wooden weather boarding (**Image EDP 9**). There are some gaps between the metal sheeting and wooden boarding as well as between two layers of wooden boarding. However, these gaps are considered to offer negligible potential for roosting bats due to the construction, which is likely to be subject to large temperature fluctuations.
- 3.14 No evidence of bats was found on the exterior or interior of this railway carriage and it is considered that this railway carriage has negligible bat roosting potential.

**Image EDP 9:** Building 5: Railway Carriage

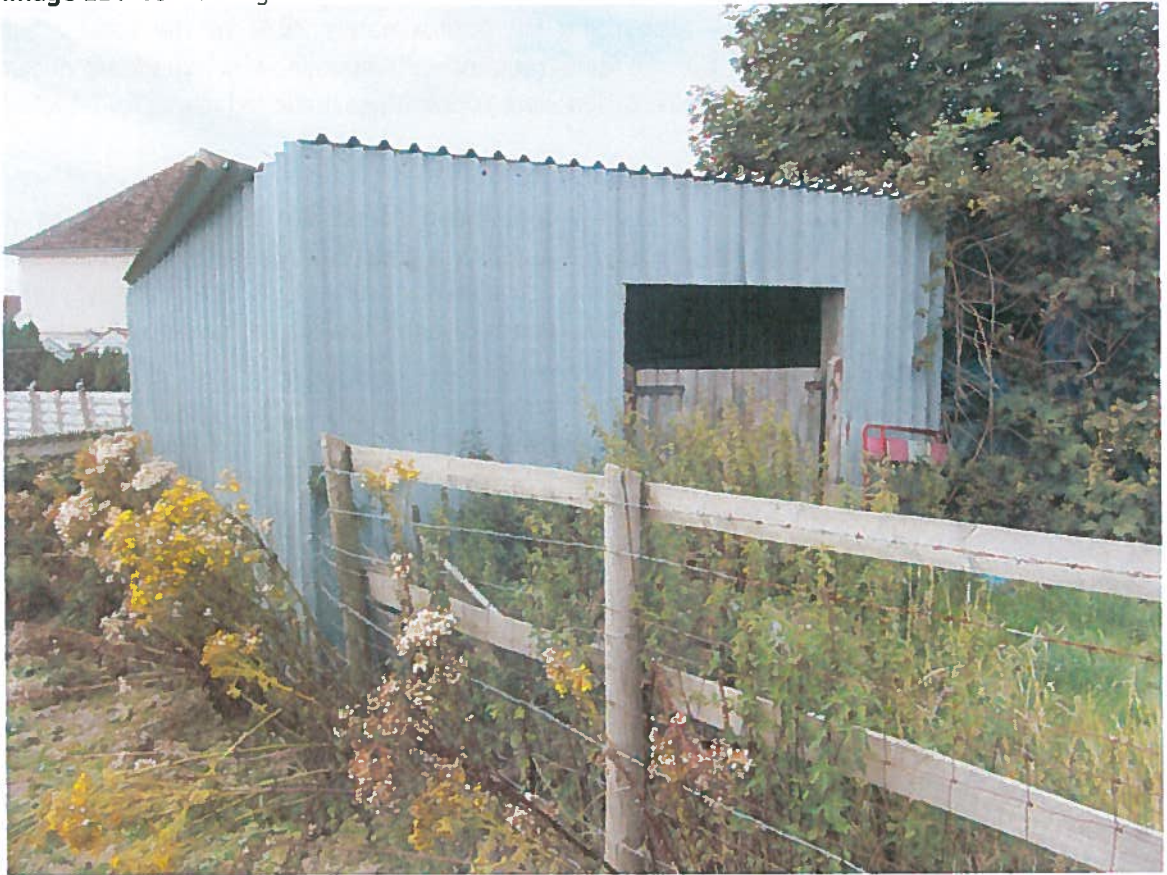
- 3.15 This metal shed has a timber frame which is clad by corrugated metal sheeting (see **Image EDP 10**). Due to its construction, which lacks any suitable roosting features, this building is considered to offer negligible roosting potential for bats.

**Image EDP 10:** Building 6: Metal Shed
