Land at Upper House Farm, Rhoose

Site Investigation Report

11164/DH/13

CLIENT: Lambert Smith Hampton

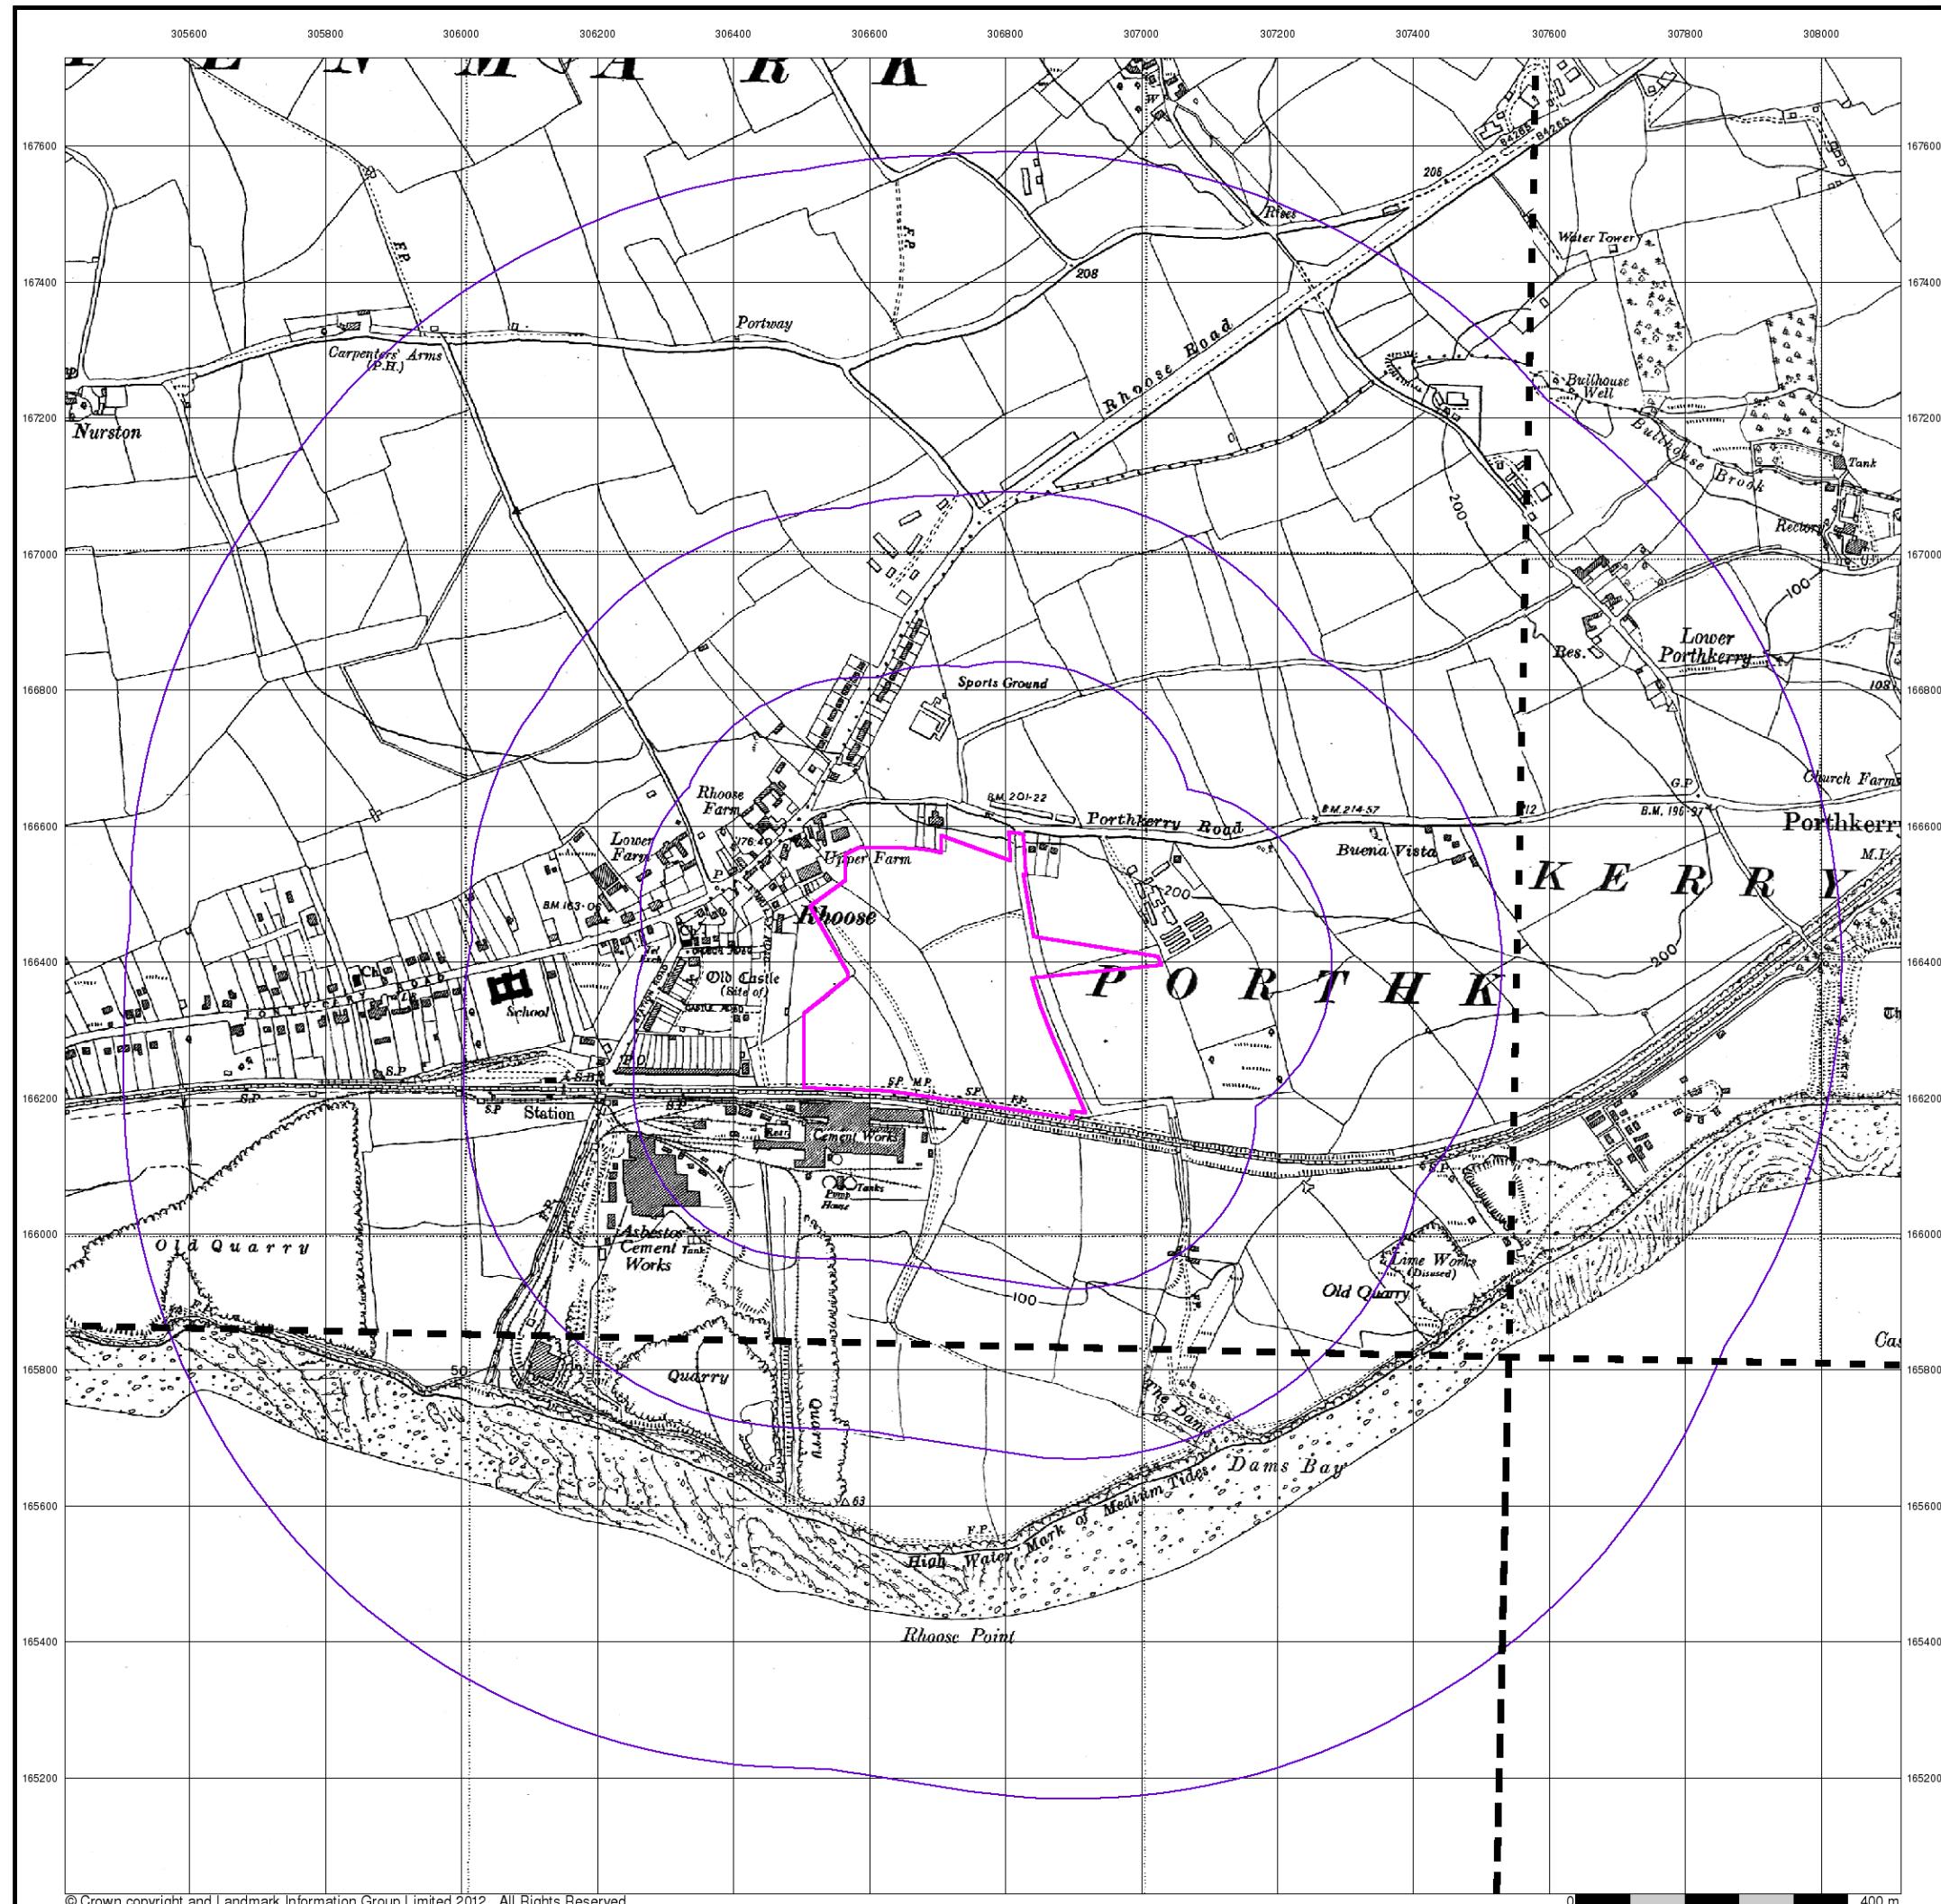
Historical Aerial Photography

Published 1947

The Historical Aerial Photos were produced by the Ordnance Survey at a scale of 1:1,250 and 1:10,560 from Air Force photography. They were produced between 1944 and 1951 as an interim measure, pending preparation of conventional mapping, due to post war resource shortages. New security measures in the 1950's meant that every photograph was re-checked for potentially unsafe information with security sites replaced by fake fields or clouds. The original editions were withdrawn and only later made available after a period of fifty years although due to the accuracy of the editing, without viewing both revisions it is not easy to spot the edits. Where available Landmark have included both revisions.

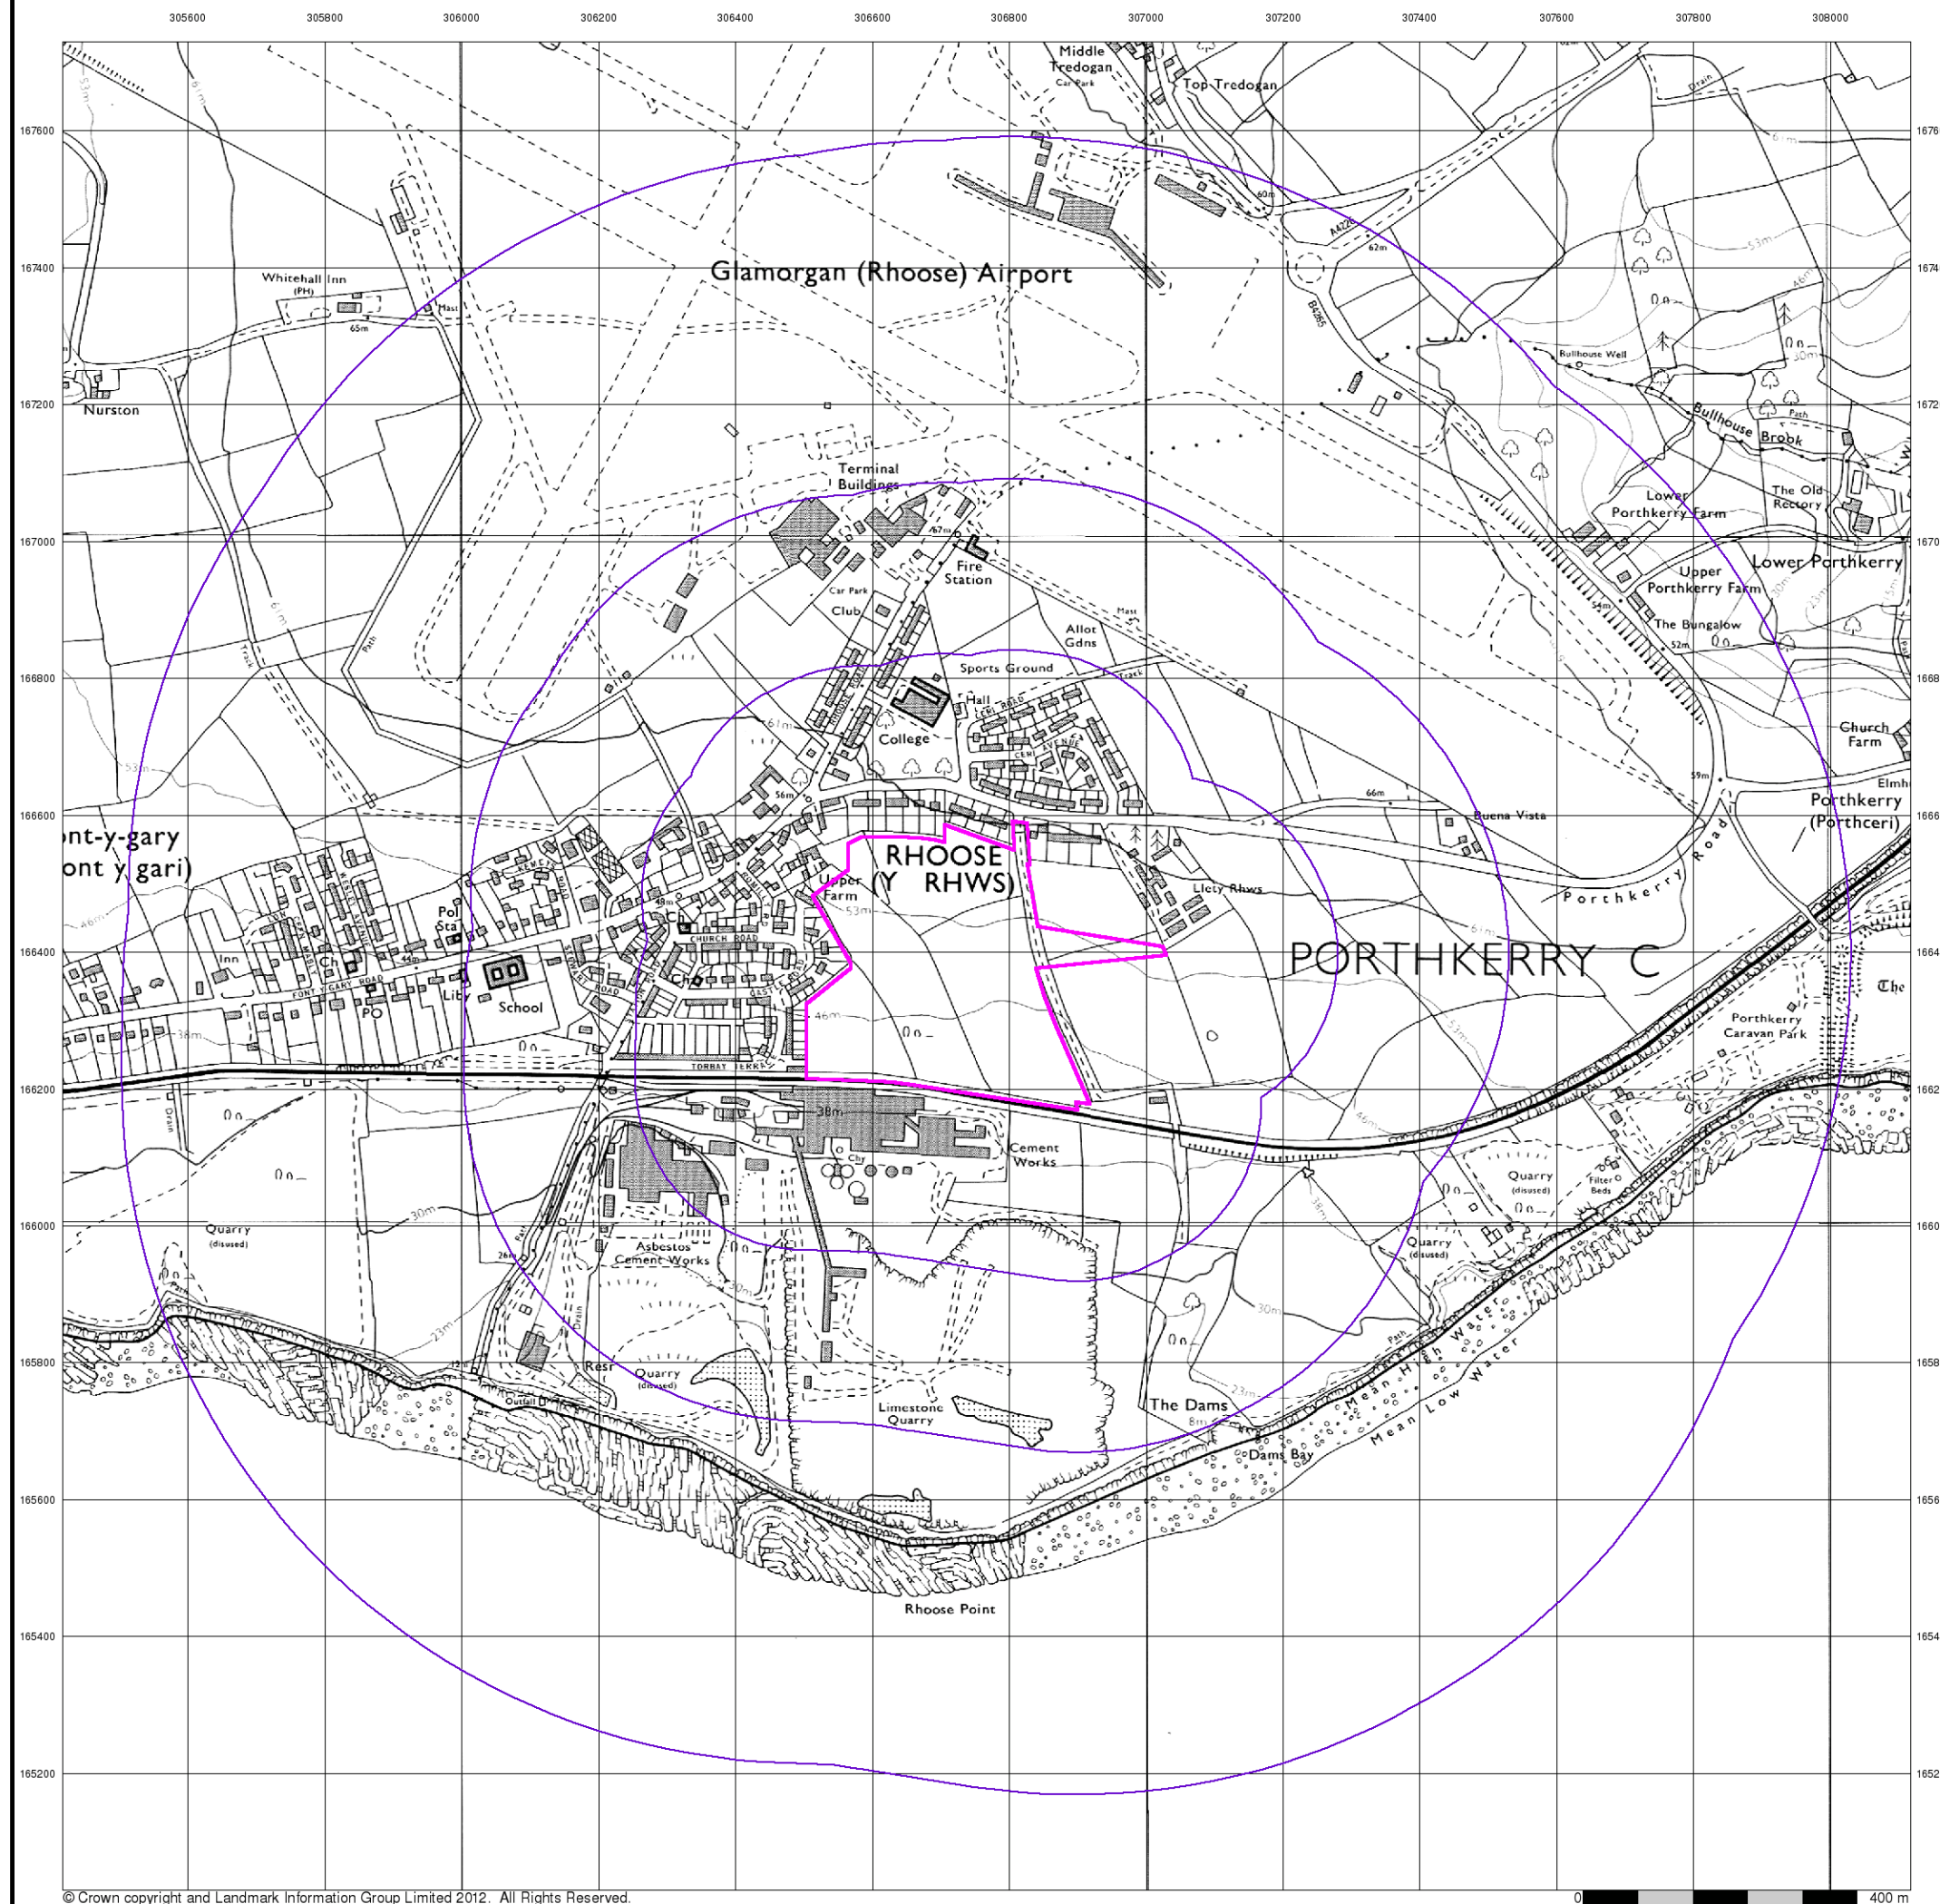
Ordnance Survey Plan

Published 1982

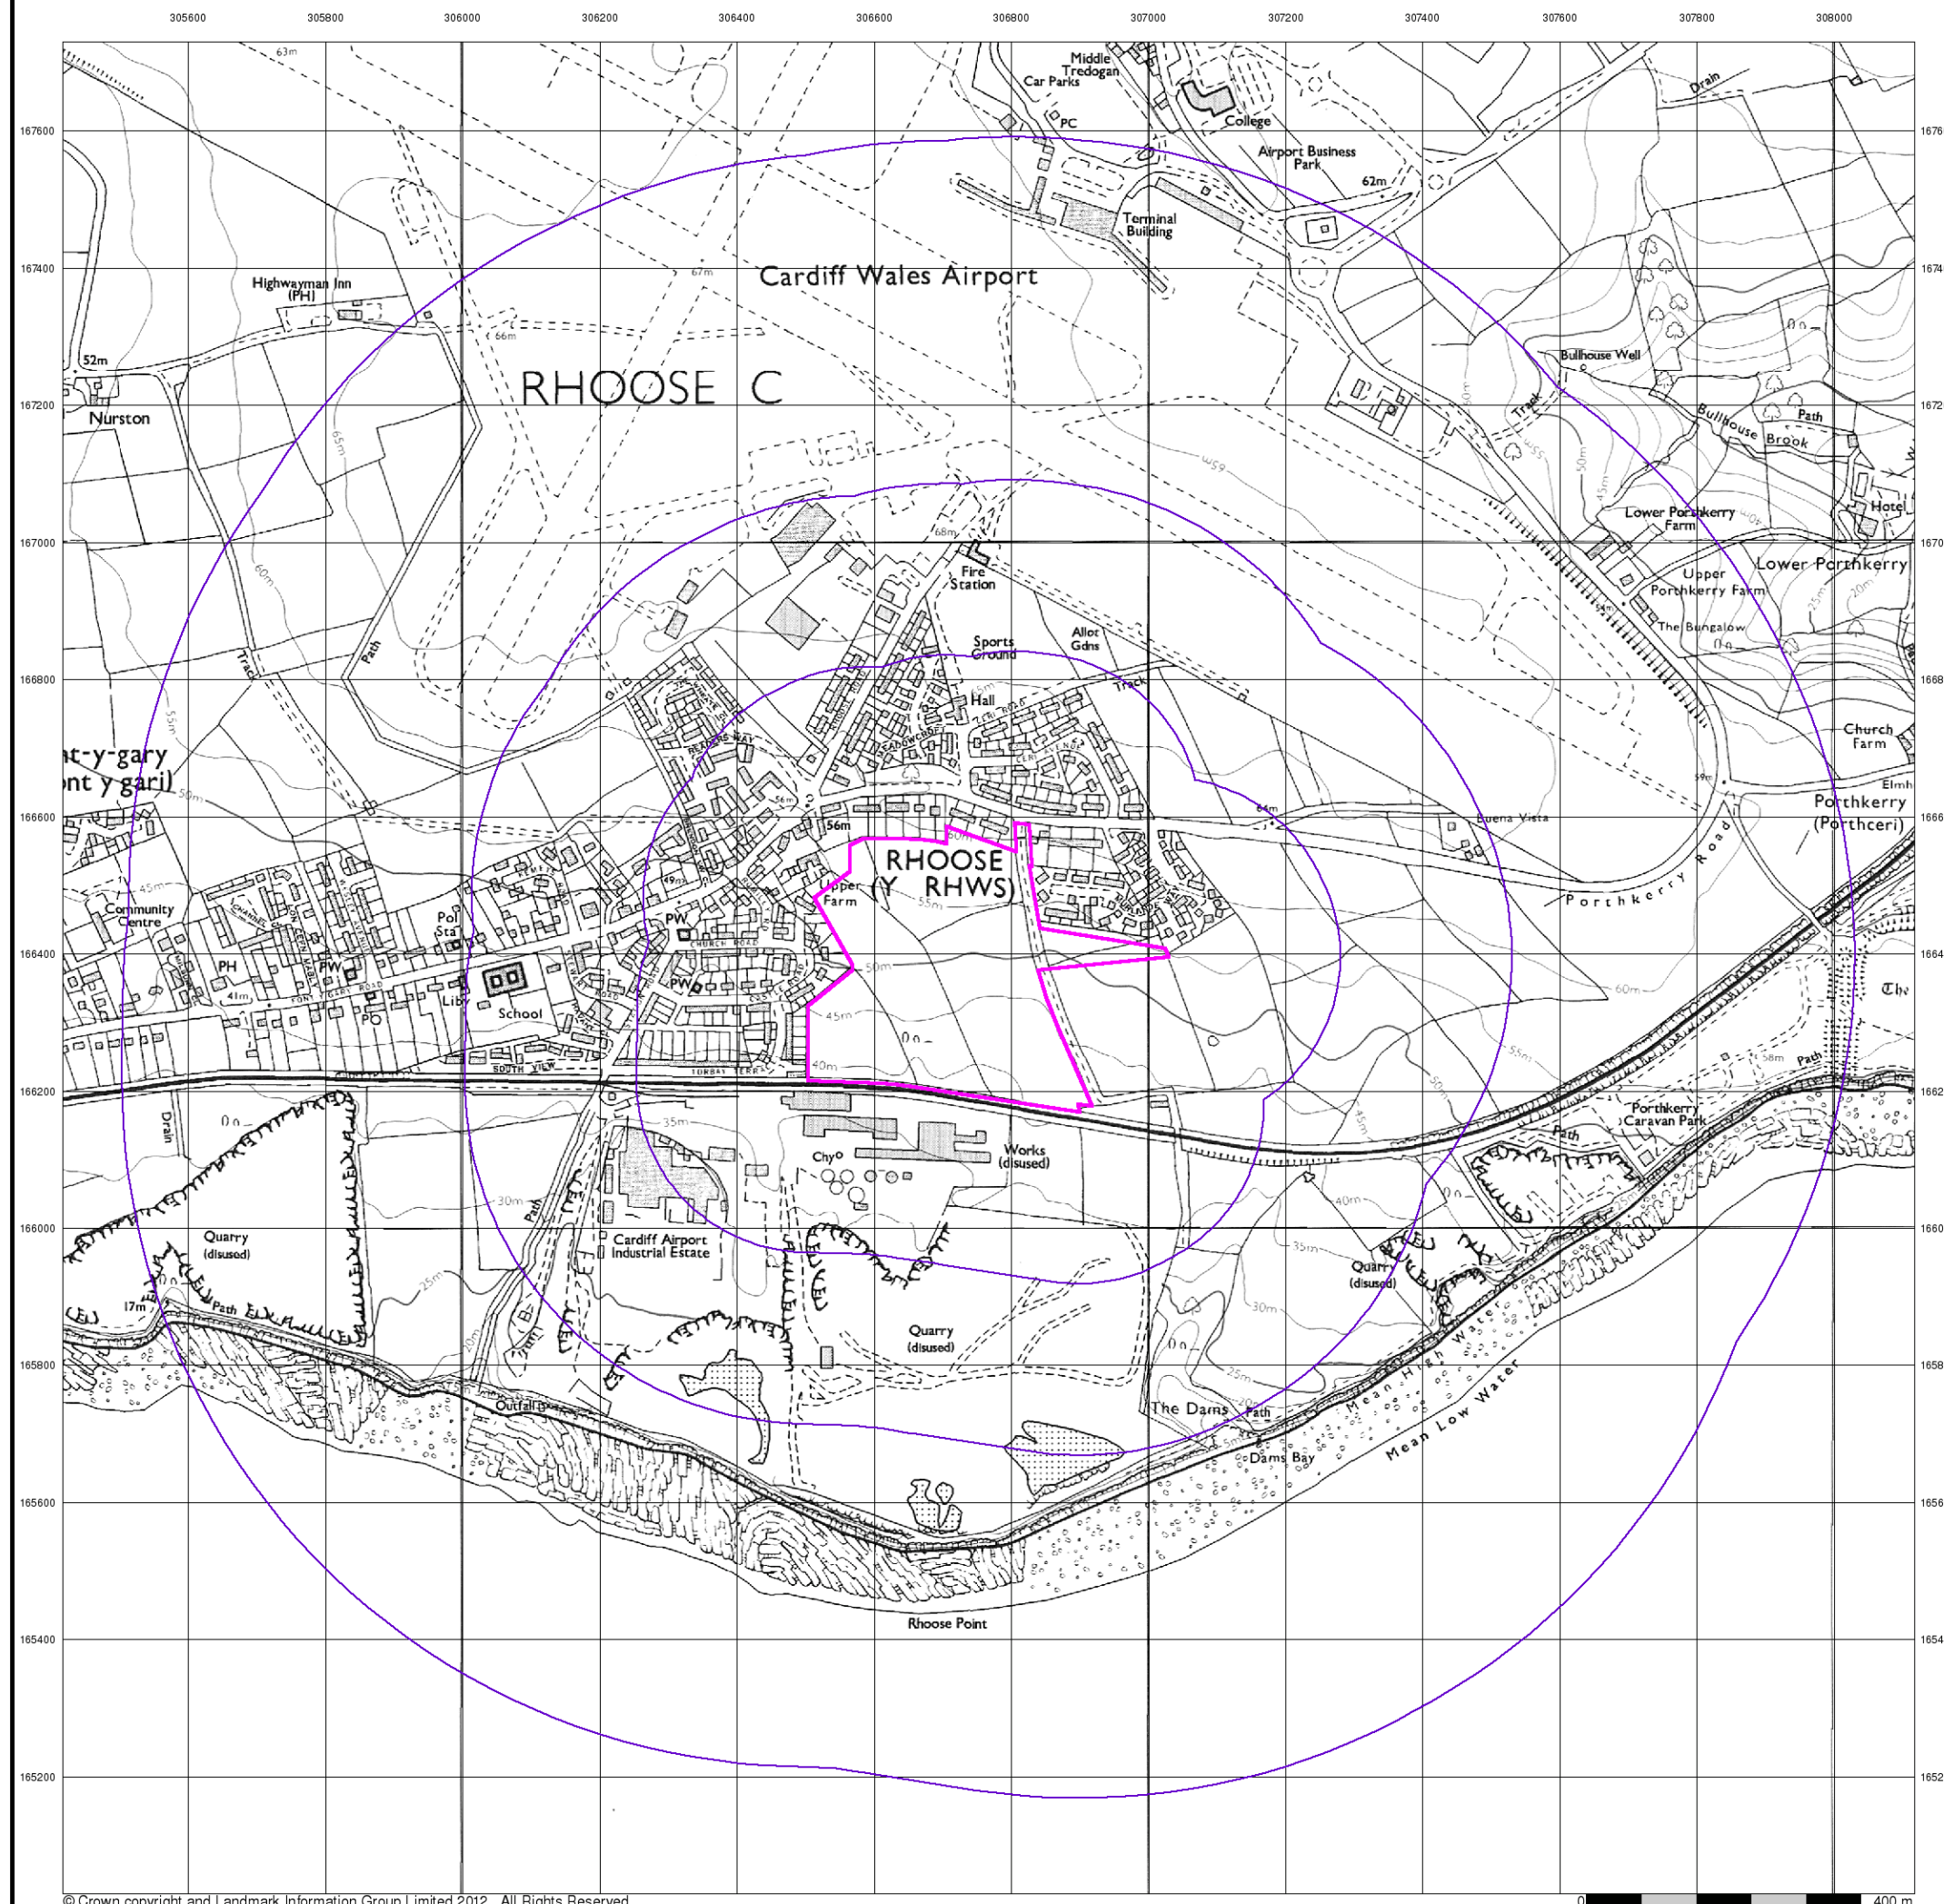
10k Raster Mapping

The historical maps shown were produced from the Ordnance Survey's 1:10,000 colour raster mapping. These maps are derived from Landplan which replaced the old 1:10,000 maps originally published in 1970. The data is highly detailed showing buildings, fences and field boundaries as well as all roads, tracks and paths. Road names are also included together with the relevant road number and classification. Boundary information depiction includes county, unitary authority, district, civil parish and constituency.
