Ref: A085825

Date: 22nd May 2014

## **Mortuary Building, Hayes Point, Sully, CF64 5XU: Bat Survey Report**

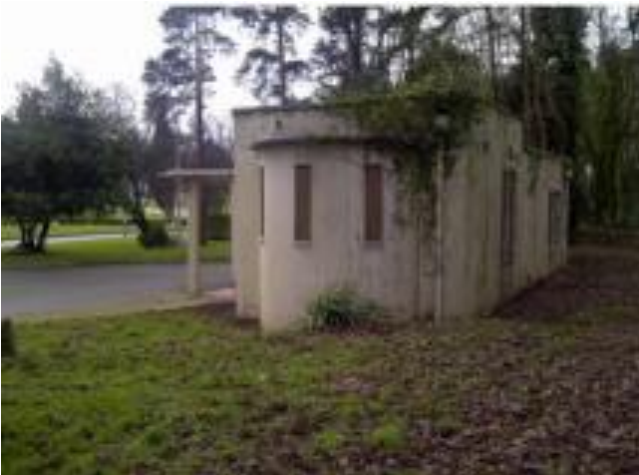
**Plate 1: SE and NE Elevation**

The building is a single storey former mortuary that was built in the inter-war period (see Plate 1 and 2). The roof is flat at different levels and there are a number of holes/gaps which provide potential access for bat to the building.

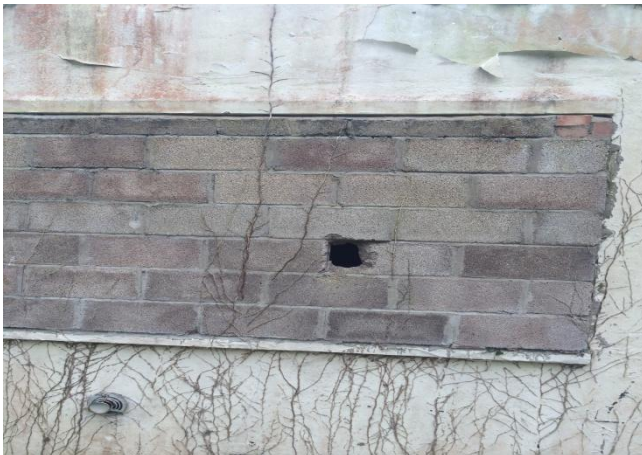
**Plate 3: Hole in concrete blocks**

The external roost assessment identified several gaps which provide potential access to the inside of the building. On the north-east side of the building, there is a hole in a concrete block where a window used to be (see Plate 3). A mass of small mammal droppings, the majority likely to be mouse droppings, were found on the inner window sill and on the floor beneath the entrance hole, two of which appeared to be old bat droppings (see Plate 4).
