14 01163 FUL

## Report on scoping survey for Bat Roost sites

In  
Garage and Out building  
At  
The Heritage Coast Centre,  
Dunraven Bay,  
Southerndown,  
Vale of Glamorgan.

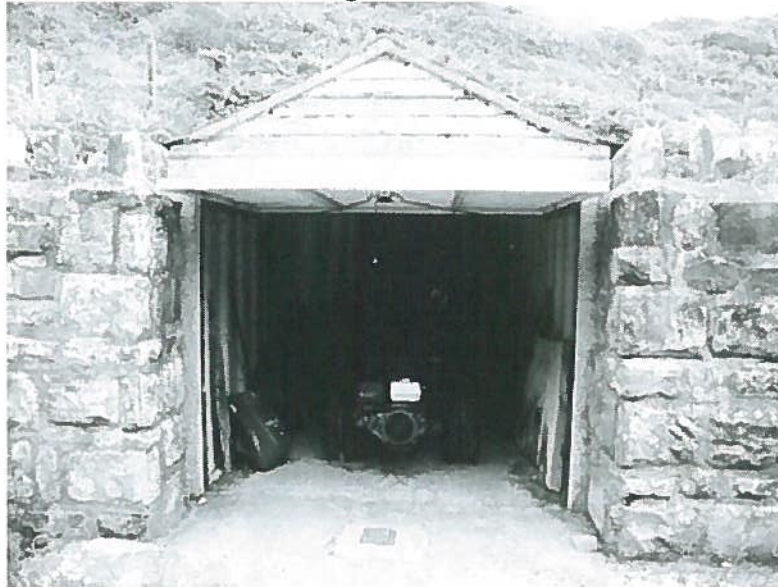
**Garage entrance**

- 5.3 The garage is constructed out of pre-cast concrete and measures 4m x 2m x 2.1m. With a tile roof, with under felt and no insulation. The garage is accessed via a metal up and over door to the west elevation.

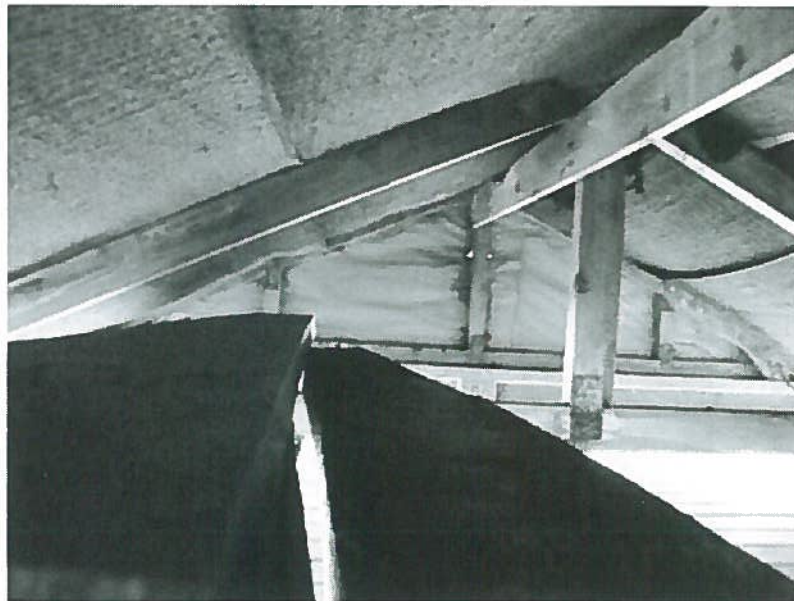
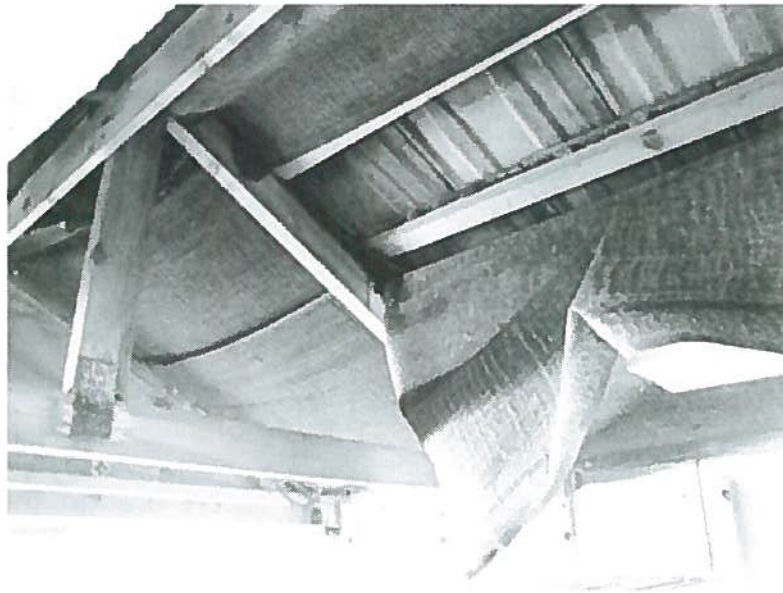
**Roof void**

- 5.4 As previously mentioned a detailed inspection was made of the buildings and **no evidence** was found to suggest that the site is currently used by bats.

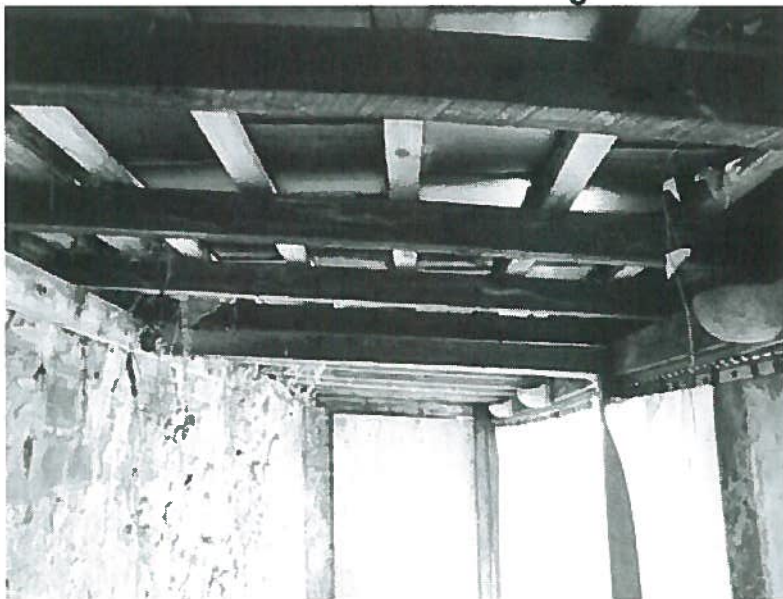
**Roof void of out building**

- 5.2 The out building is 6.25m x 1m x 1.75m with a slate roof with no under felt and no insulation. The building is open to the west elevation and has a wooden framed structure. The building is tied into a retaining wall to the west elevation.

- 11.2 No evidence of other e.g. single or small numbers of bats were found.
- 11.3 The out building is unsuitable with regard to roosting locations for bats as it is open to the elements and provide little or no cover. The garage has low potential as a roosting location and no further exploration will be required.
