Bat Roost and Emergence Survey

Coed y Colwn Barn | Llanbethery | Vale of Glamorgan |

Report on survey for Bat Roost sites

Coed y Colwn Barn Llanbethery Vale of Glamorgan

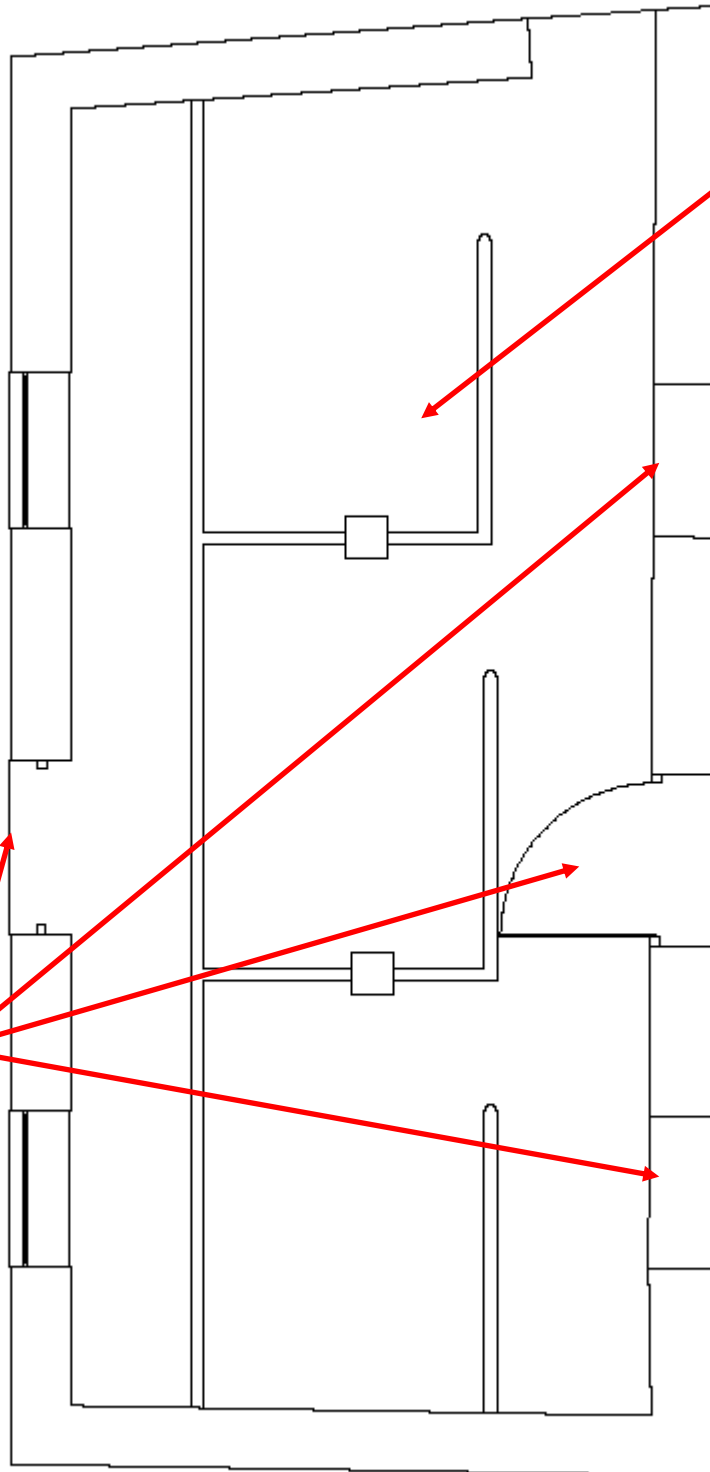
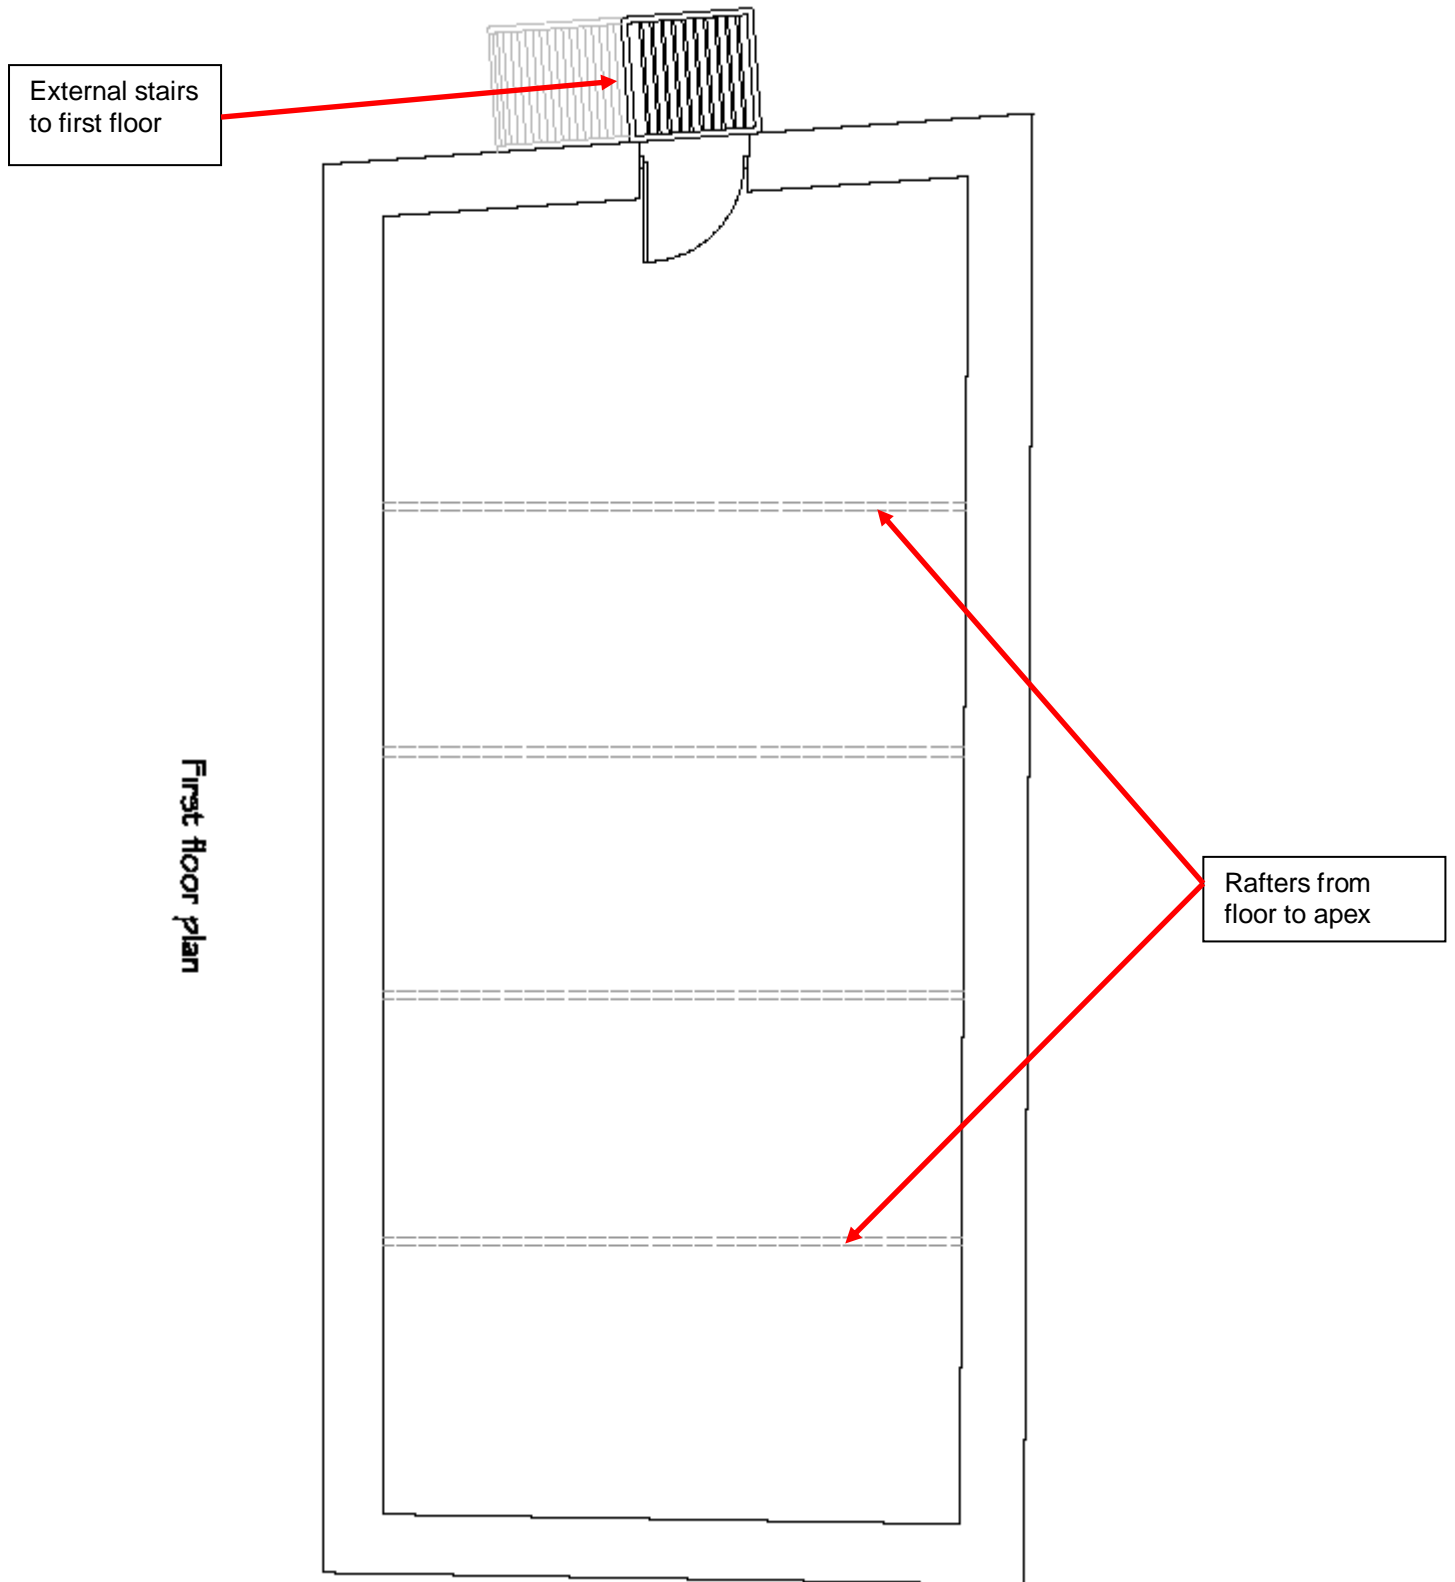
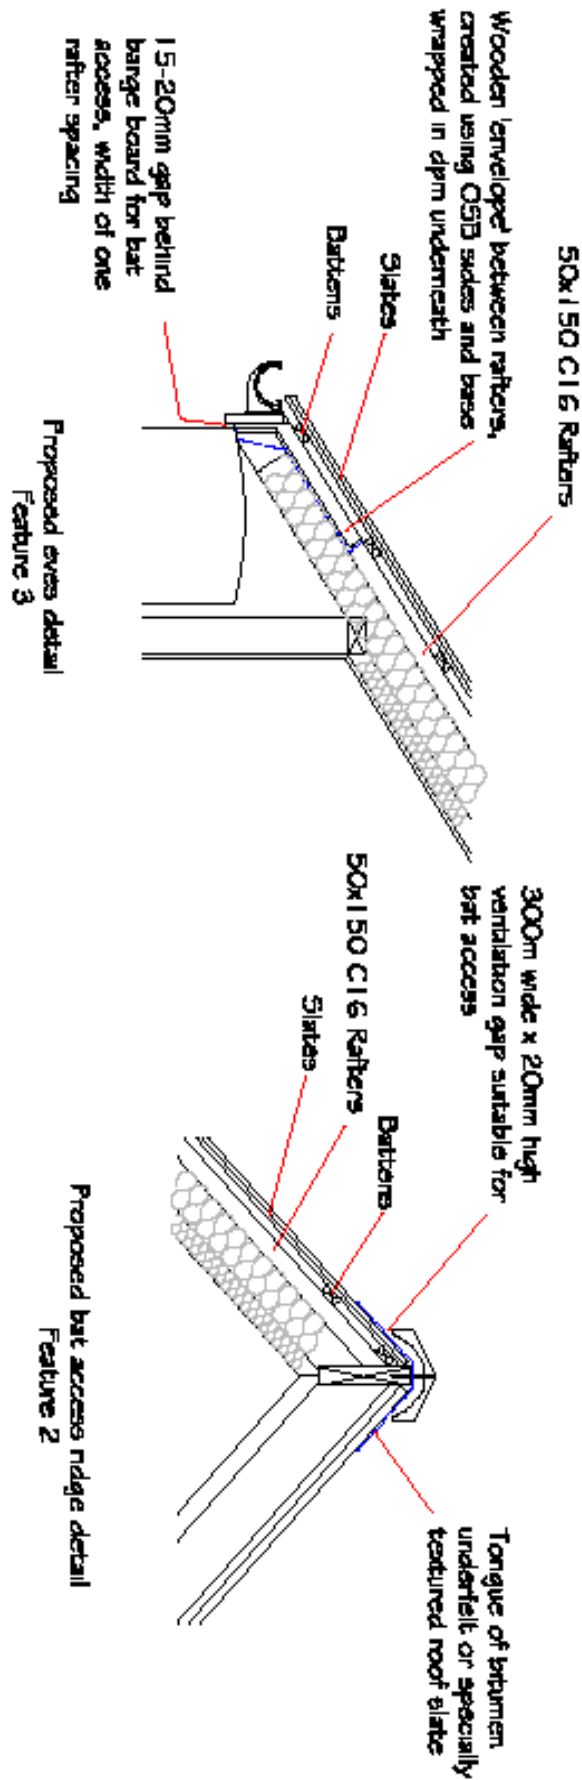
Appendix 1. Plan of the building & proposed bat access points

Ground floor plan

Door and Window
apertures with
missing
windows and doors

Animal
Enclosures

12.2 Specific gaps, such as around soffit boards and between roofing felt and roofing tiles should be created to allow access for crevice roosting species such as Pipistrelle. Any new barge boards, gutter plates and fascias could be left with a gap of 15mm- 20mm along the lower edge, allowing access to bats behind the board.

12.6 In any future building development at the site, a number (2) of ridge tiles could be left un-mortared to allow access for crevice dwelling bats and a bat tile inserted in the roof covering of each aspect.

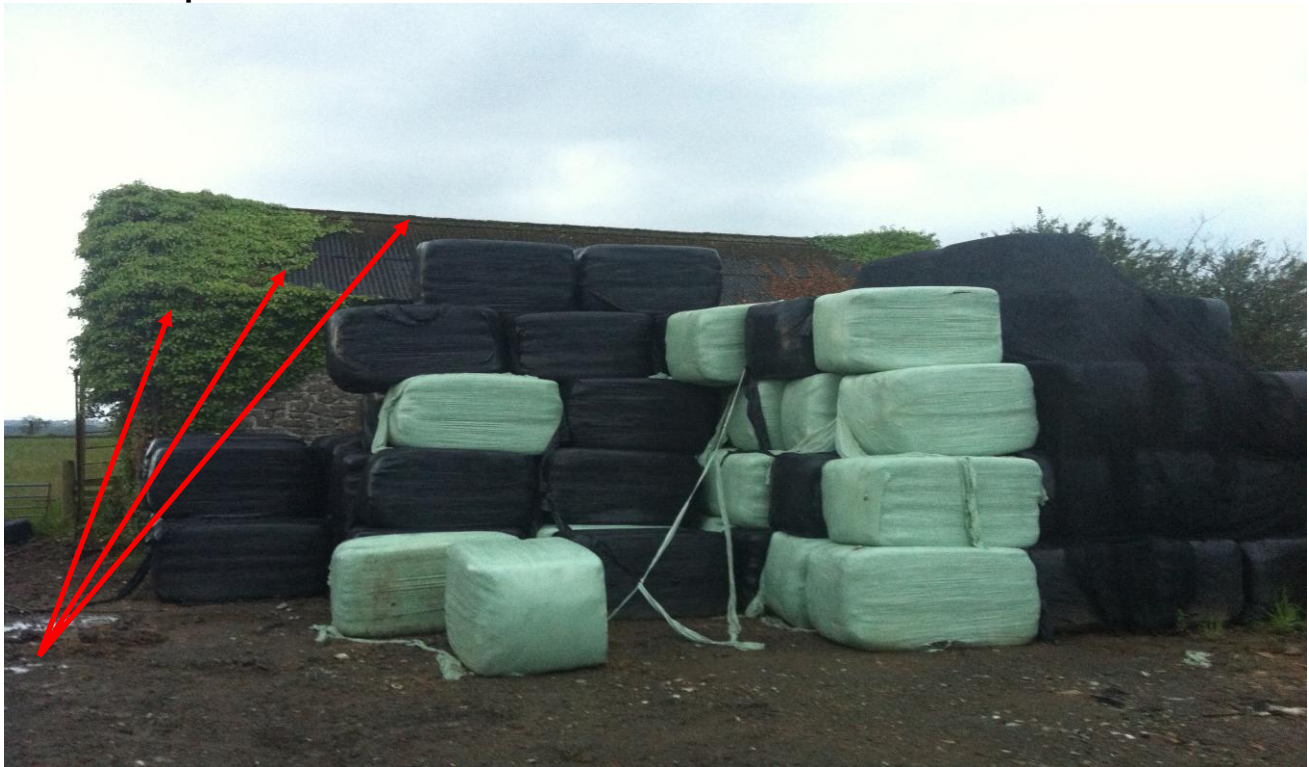
Northern Aspect

1.3 The barn however was found to contain the numerous features with potential for use by bats. These included gaps in and under roof panels and ridge tiles, cracks and gaps in masonry and around all window and doorways, holes and gaps in soffits and gaps between the roof eaves and external walls. It should also be noted that all windows and doors had long since decayed and only 1 partial door remained leaving the building open to the elements.

Appendix 2. Photographs of the building. The identified potential access points and roosting opportunities have been indicated with a red arrow.

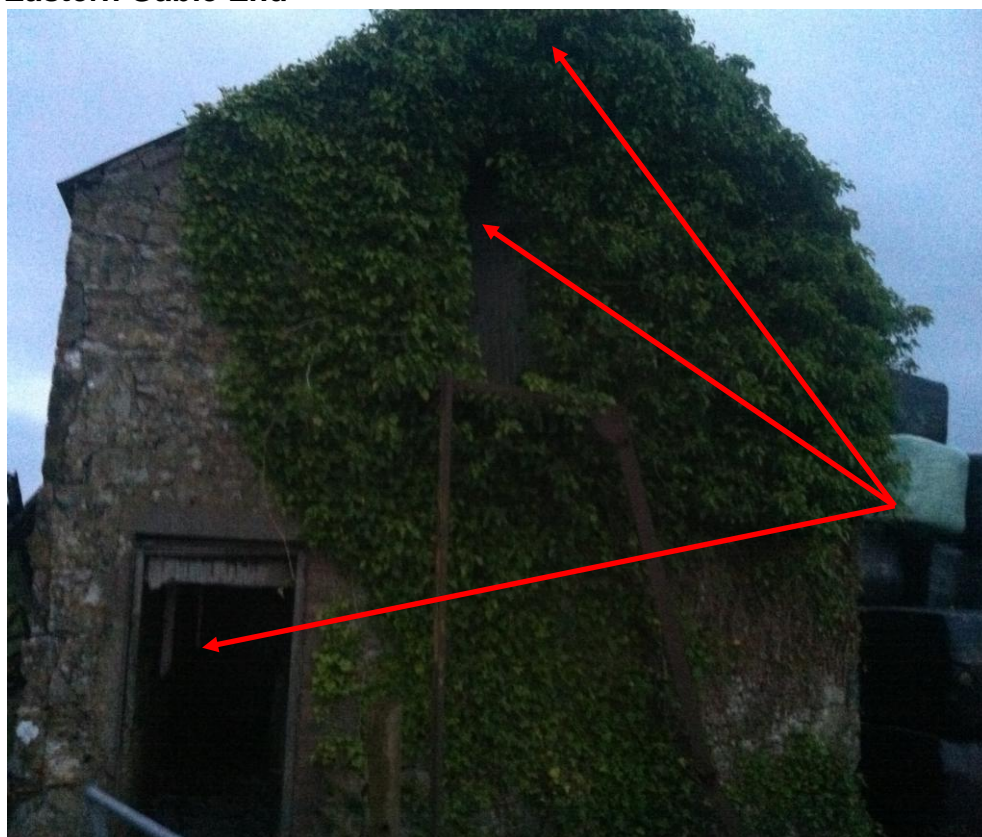
Eastern Gable End

3.2 The poor condition of some elements of the building and a covering of Ivy on the east and west gable ends imposed limitations on how thoroughly various features could be investigated. Such inaccessible features included the ridge tiles and the western gable end, which is in poor repair and has potential for roosting bats. Although these areas could not be investigated at close hand due to the overriding health & safety concerns, the potential external access points to the interior were noted and investigated as far as possible with the additional use of a high powered spot-lamp, close focusing monocular and electronic 'see-snake' endoscope.
