**12 PARK ROAD, PENARTH, VALE OF GLAMORGAN
SITE INSPECTION FOR BATS AND NESTING BIRDS**

**VALE OF GLAMORGAN COUNCIL
DISCHARGE OF CONDITIONS**

January 2015

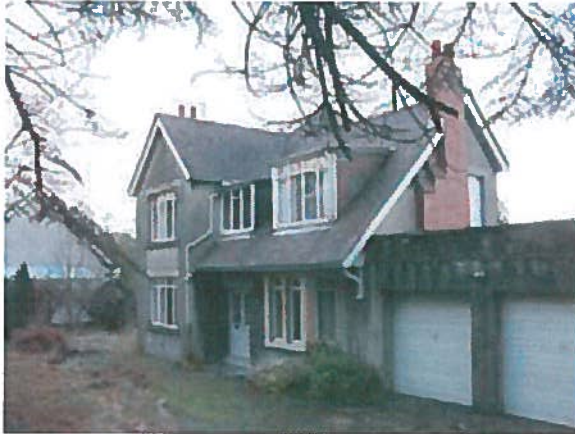
Front (west) elevation of the house

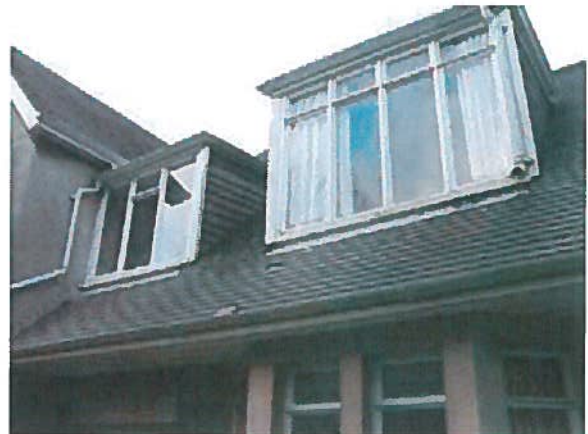
- 4.2 No evidence of use by roosting bats was found during the present survey however, potential access points suitable for bats were noted around the exterior of the building. A few slipped tiles were present on the east and west pitches of the roof. A gap between the fascia and chimney on the southern elevation was also observed. These gaps could provide access to potential roosting opportunities for crevice dwelling bats such as pipistrelle bats. The gaps are few in number and were present during the previous scoping survey of the building in May 2012.

Dormer windows with slipped tiles visible

- 5.1 It is recommended that features which are identified as having an elevated potential for bats to be present, such as fascias, barge-boards, soffits and ridge-tiles etc are stripped by hand under ecological supervision between October and March inclusive. The ecologist will supervise the works until they are satisfied bats are unlikely to be present.

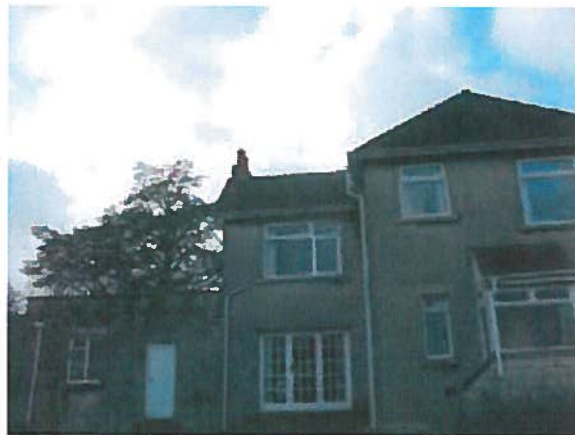
Rear (east) elevation of the house

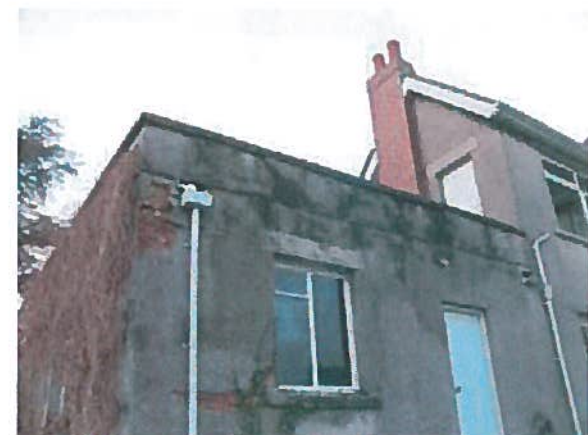
- 3.2.2 The separate garage and single storey extension are considered to have negligible potential for bats as no suitable access points or roosting areas were observed. The two wooden sheds were also assessed as having negligible potential for bats.

Adjoining garage present on south elevation

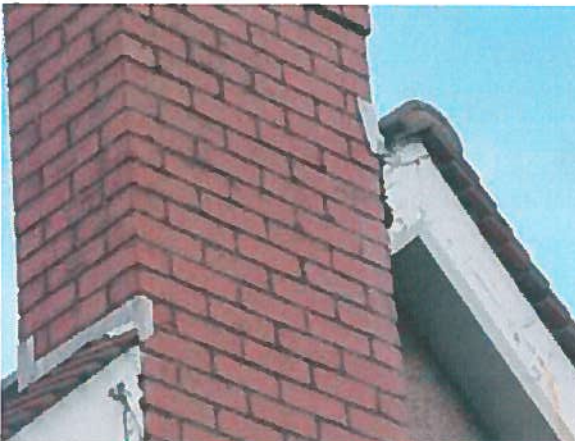
- 3.2.1 Some slipped and missing slates were visible across the roof which could provide access for bats. The ridge line and hip tiles of the roof look sound with no gaps noted. The majority of the fascia and soffit boards appeared sound and well fitting. The only gap visible was on the south elevation where the fascia board meets the chimney. All mortar fillets on the gable ends of the roof appeared to be intact with no gaps visible.

Gaps between fascia and chimney

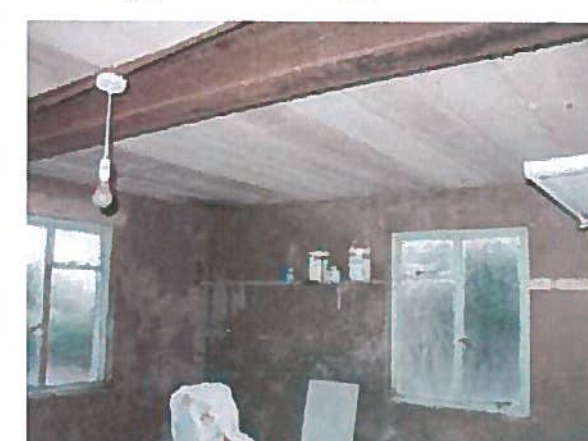
Interior of garage

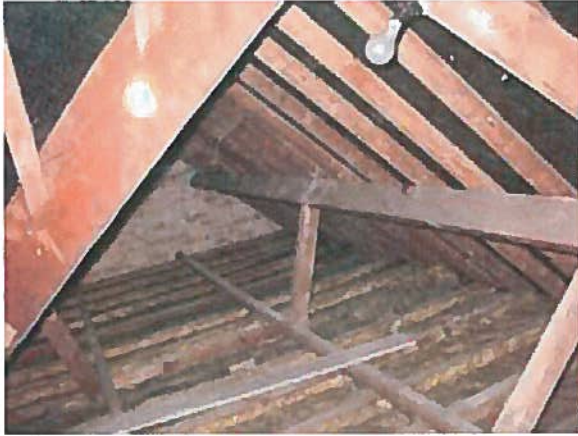
- 3.2.3 Internally, the roof voids are suitable for bats to use as they are dark, spacious and relatively uncluttered. The roofing membrane appeared sound with no rips visible. A number of abandoned and presumably treated wasp nests were present in the roof void. Although the roof voids appear suitable for use by bats no evidence of their presence was found, it is thought likely bats could utilise the gaps between the roof tiles and roofing membrane and roost along the wall tops.

- 4.3 Given the presence of the roofing membrane any potential bat droppings present between the roofing tiles and felt are unlikely to be visible during any internal inspection. Bats could also be potentially roosting on the wall tops. Although no evidence was found, given the potential access points the presence of bats cannot be ruled out.

Interior of roof void
