STOURBRIDGE HOUSE, LLYSWORNEY
Full Bat Survey
July 2014

MBS has been commissioned by the client to survey the building for use by Bat Species and recommend mitigation, compensation and enhancement if required.

It is the intention of the client to demolish the existing dwelling and replace it with a new-build, while retaining some of the natural stone used in the current building to blend the new dwelling into its surroundings and ensure it is in-keeping with the character of the village.

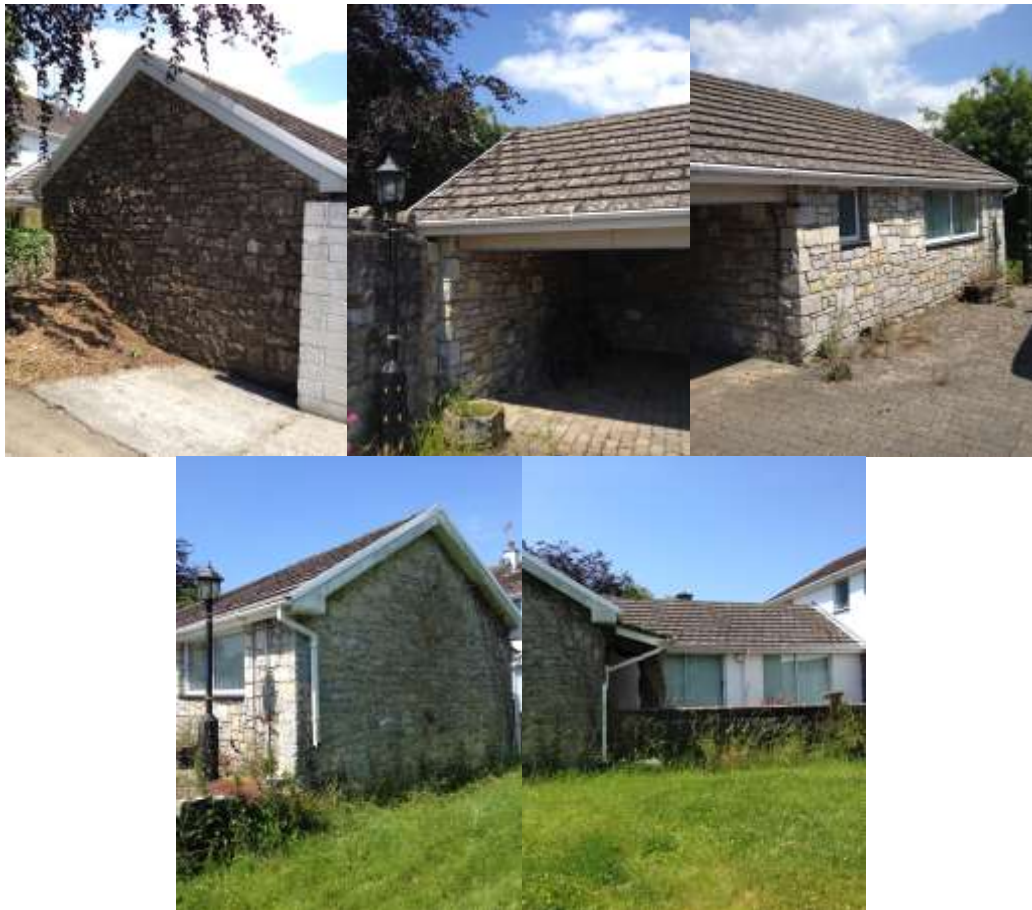
Fig. 3-7 Garage/parking bay and single-storey extension

3.1.1 The building under survey is a detached two-storey house built in 1978, with an unusual layout. An adjoining open fronted garage/car-port and living accommodation and a single-storey building link the garage to the main two storied house. Overall, the building appears to be in very good condition with little apparent potential for bat access.

3.1.2 However, the garage/car-port looks to have the most likely sites of potential bat access; the walls are faced with natural stone which creates an uneven surface against which the soffits and bargeboards sit.

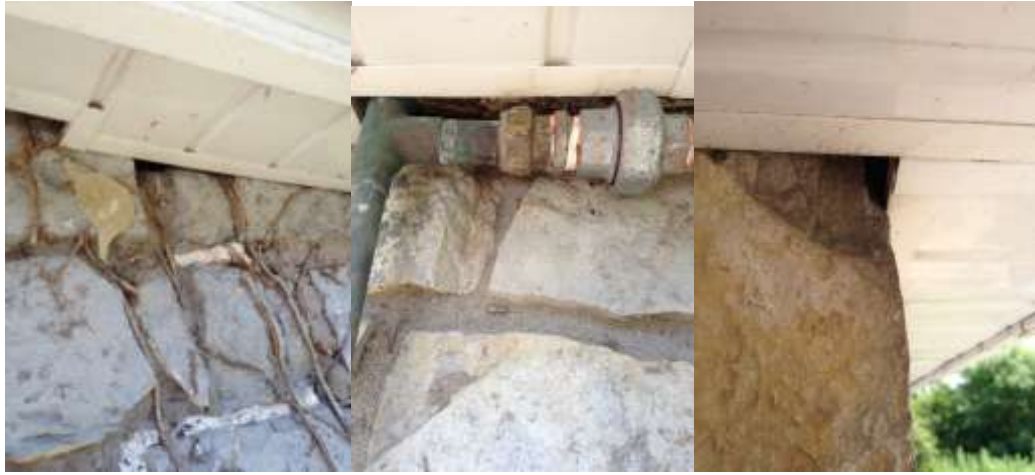
Fig. 8-10 Potential bat access points into soffits of garage/extension

3.1.4 There are a number of potential bat access points into the uPVC soffit boxes and behind the uPVC gable bargeboards and gable trim at each gable end.

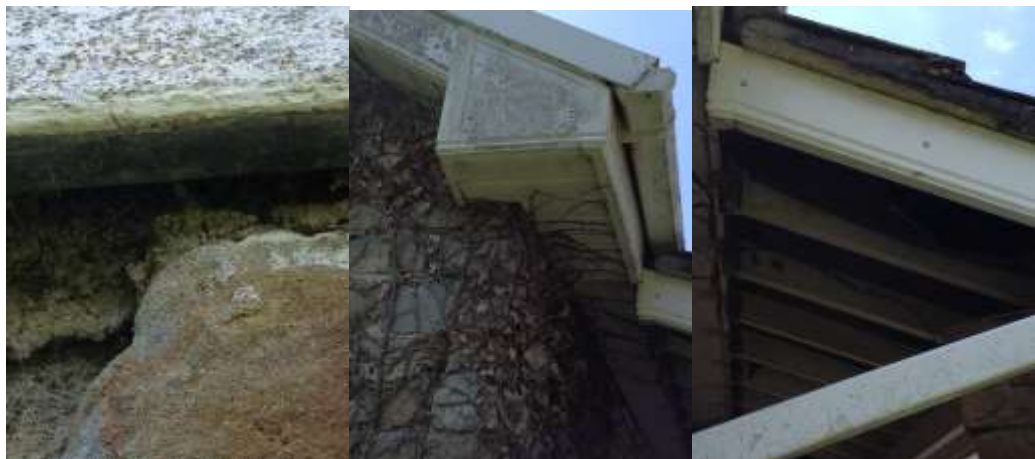
Fig. 11-13 Potential access points on the garage extension/veranda

3.1.5 The rear of the garage extension has a veranda to a small terrace; this is the only part of the building which has fallen into disrepair; the sarking of the veranda is ripped and displaced allowing potential bat access directly into the space between the remaining sarking and the clay tiles. The gable end of this side of the extension has a covering of ivy which has grown up into the gaps between the stone walls and the box soffits.

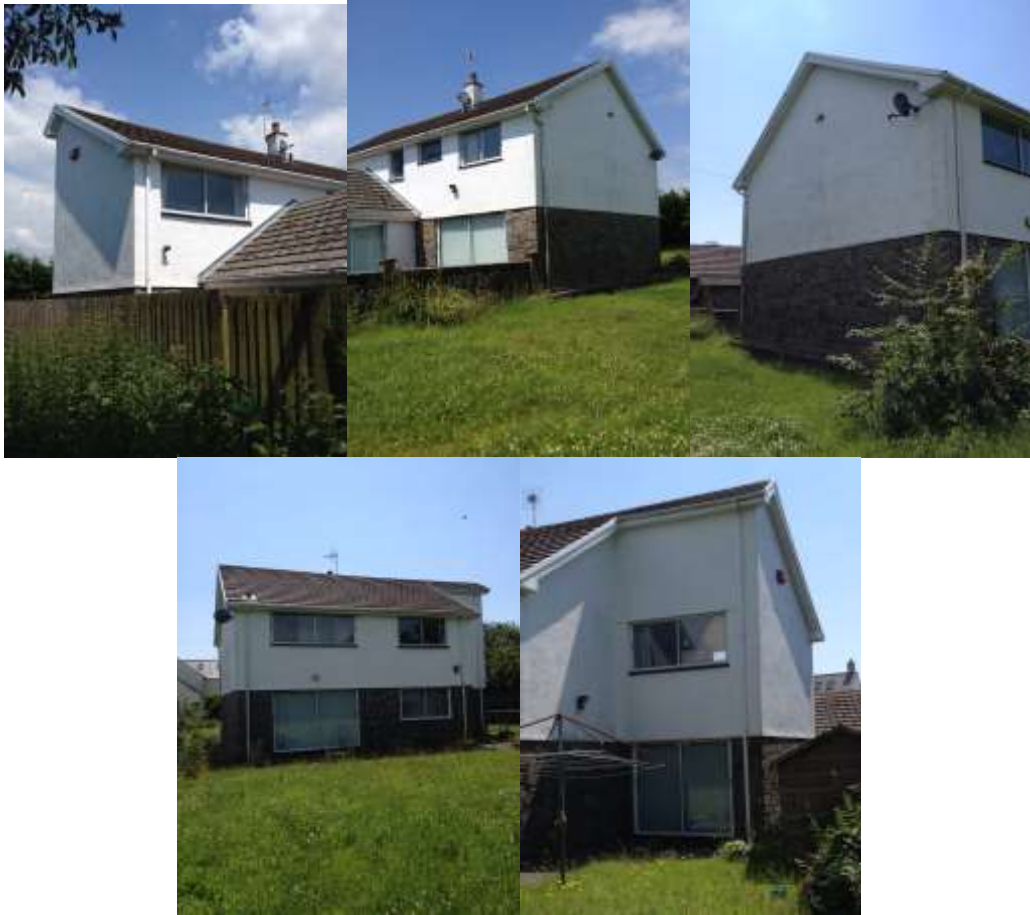
Fig. 14-18 Views of main section of house

3.1.6 The upper half of the main section of the house is cement rendered and painted white while the lower half is faced with natural stone (see Fig. 14 to 18). All of this rendering is in excellent condition. The windows and doors are uPVC and are in good order; there are no gaps around the edges and the glass panes are intact.

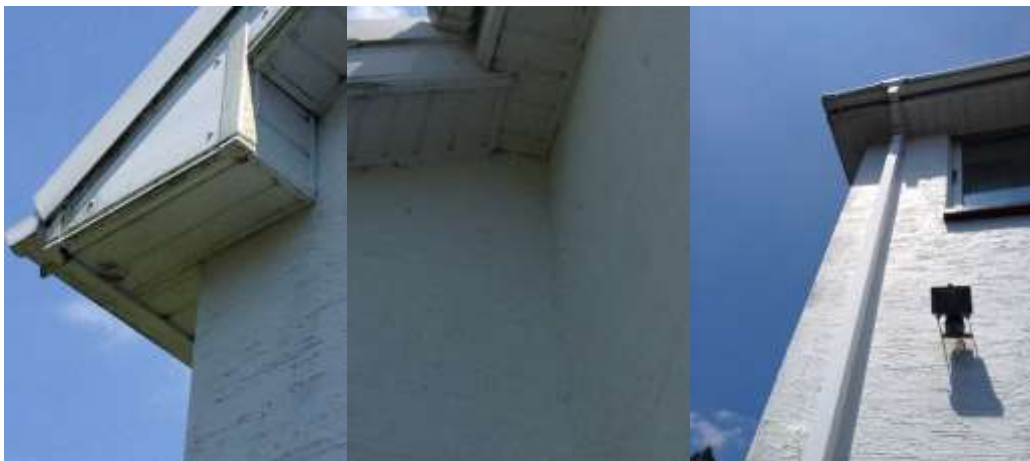
Fig. 19-21 Close fitting box soffits

3.1.7 The soffits, bargeboards and fascias are uPVC with plastic guttering and downpipes. All are in good order. The box soffits are large and would allow ample roosting space for bats; however, the soffits appear close-fitting to the rendered walls with little apparent potential for bat access.

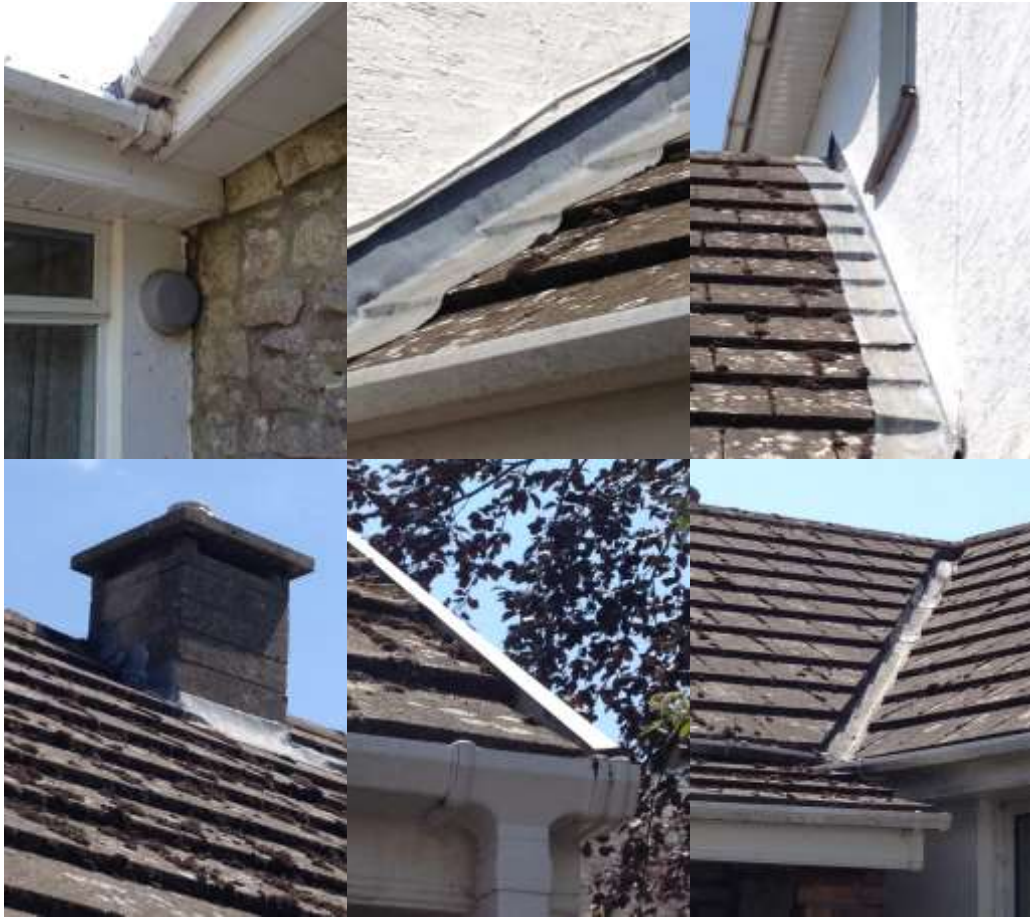
Fig. 22-27 Ridge and roof tiles in good order

3.1.8 The roof of the building is in good order; the clay roof and ridge tiles are intact and close-fitting with little potential for bat access. There are some small gaps underneath the lead flashing where it does not quite sit flush with the tiles and there are some potential access points at the edges of the roof behind the gable trim (Fig. 26). The chimney on the

roof of the extension has slits which have been faced with metal mesh on the inside to prevent bat and bird access.

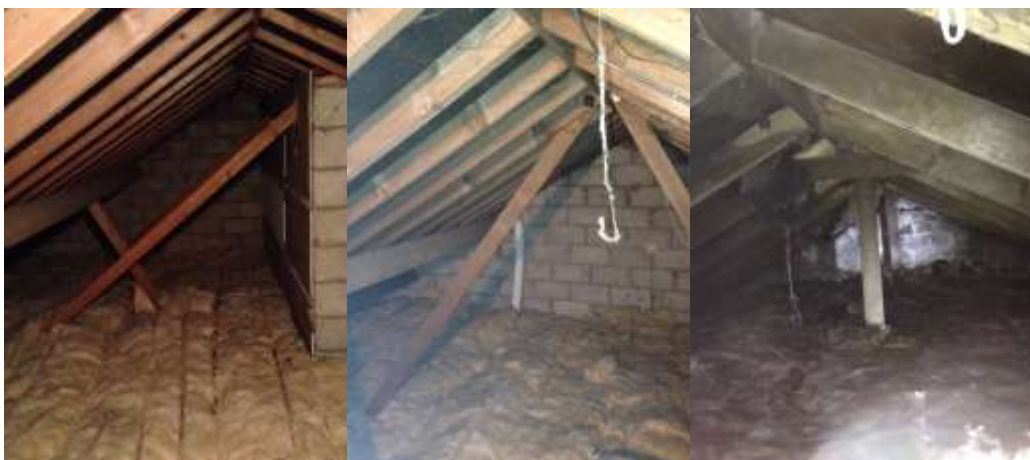
Fig. 28-30 Roof beams and sarking in good order

3.2.2 The attic is accessible via a trap door from the upstairs corridor. The soft wood roof beams and bitumen felt sarking are in excellent condition. There is a substantial and continuous layer of fiberglass insulation lining the attic floor.

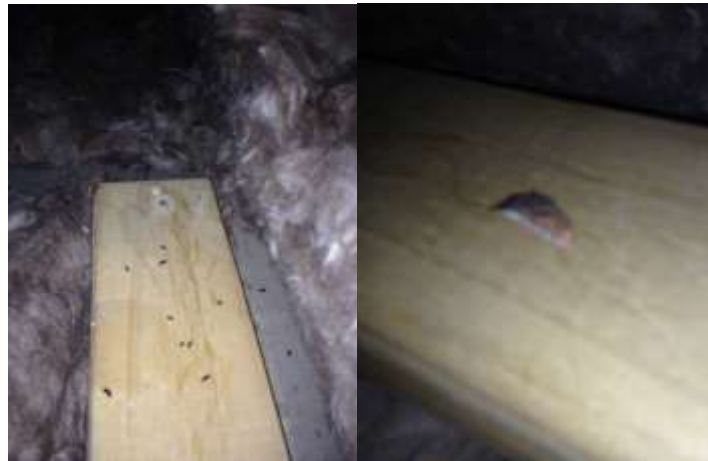
Fig. 31 & 32 Mouse Droppings and Herald Moth Wing

3.2.3 What initially appeared to be a scattering of bat droppings and possible feeding remains were found on a plank on the floor the attic space during the daytime search of the building. However, closer examination proved all the droppings to be mouse droppings! Furthermore there were no tooth marks on the moth wing, therefore suggesting predation by spider instead of bat.

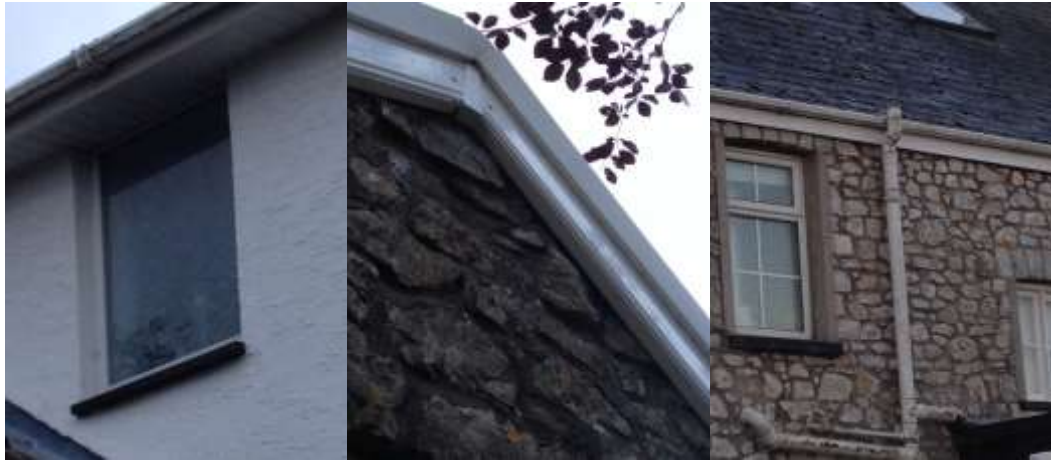
Fig. 34-36 Sites of three bat roosts at Stourbridge House and neighbouring property

- iv. Approximately halfway through the first survey a Soprano Pipistrelle exhibited swarming behaviour in front of an upstairs window where a security light was situated (Fig. 34), then landed on the side of the window and stayed there for a short while before crawling up into the seemingly close-fitting box soffit above the window. Approximately 13 minutes later the bat emerged and continued foraging around the property.

- vii. A single Soprano Pipistrelle was observed exhibiting swarming behaviour around the area where entry and re-emergence had previously occurred (Fig. 34), before entering the west gable end of the garage of the property via the right-hand bargeboard (Fig. 35).

- viii. Swarming behaviour was also noted at the neighbouring property and a single Common Pipistrelle entered the property at the eaves via the fascia board by the down pipe (Fig. 36).

- iii. There must be no exterior lighting on to the entrance of the any areas set aside as bat roost site/s. Dark routes must also be retained from the property to areas of foraging. Any security lights installed on site must be low intensity and low level to maintain these dark routes, for example from the bat tube entry point to the rear of the new garage out to the adjacent shared drive/lane with the neighbouring

- v. When planning has been granted the clients will need to apply for a Derogation Licence for European Protected Species from NRW in order to proceed with the proposed demolition of the building. The license application will require a detailed method statement to support the Derogation License application. MBS can provide a suitable method statement when required. A temporary translocation site for any bats found must be identified. The adjacent property already has suitable bat boxes on the gable end wall. It may be possible for the clients or their agents to negotiate the usage of these bat boxes with the neighbours. Failing agreement a suitable bat box must be provided and sited before demolition commences.

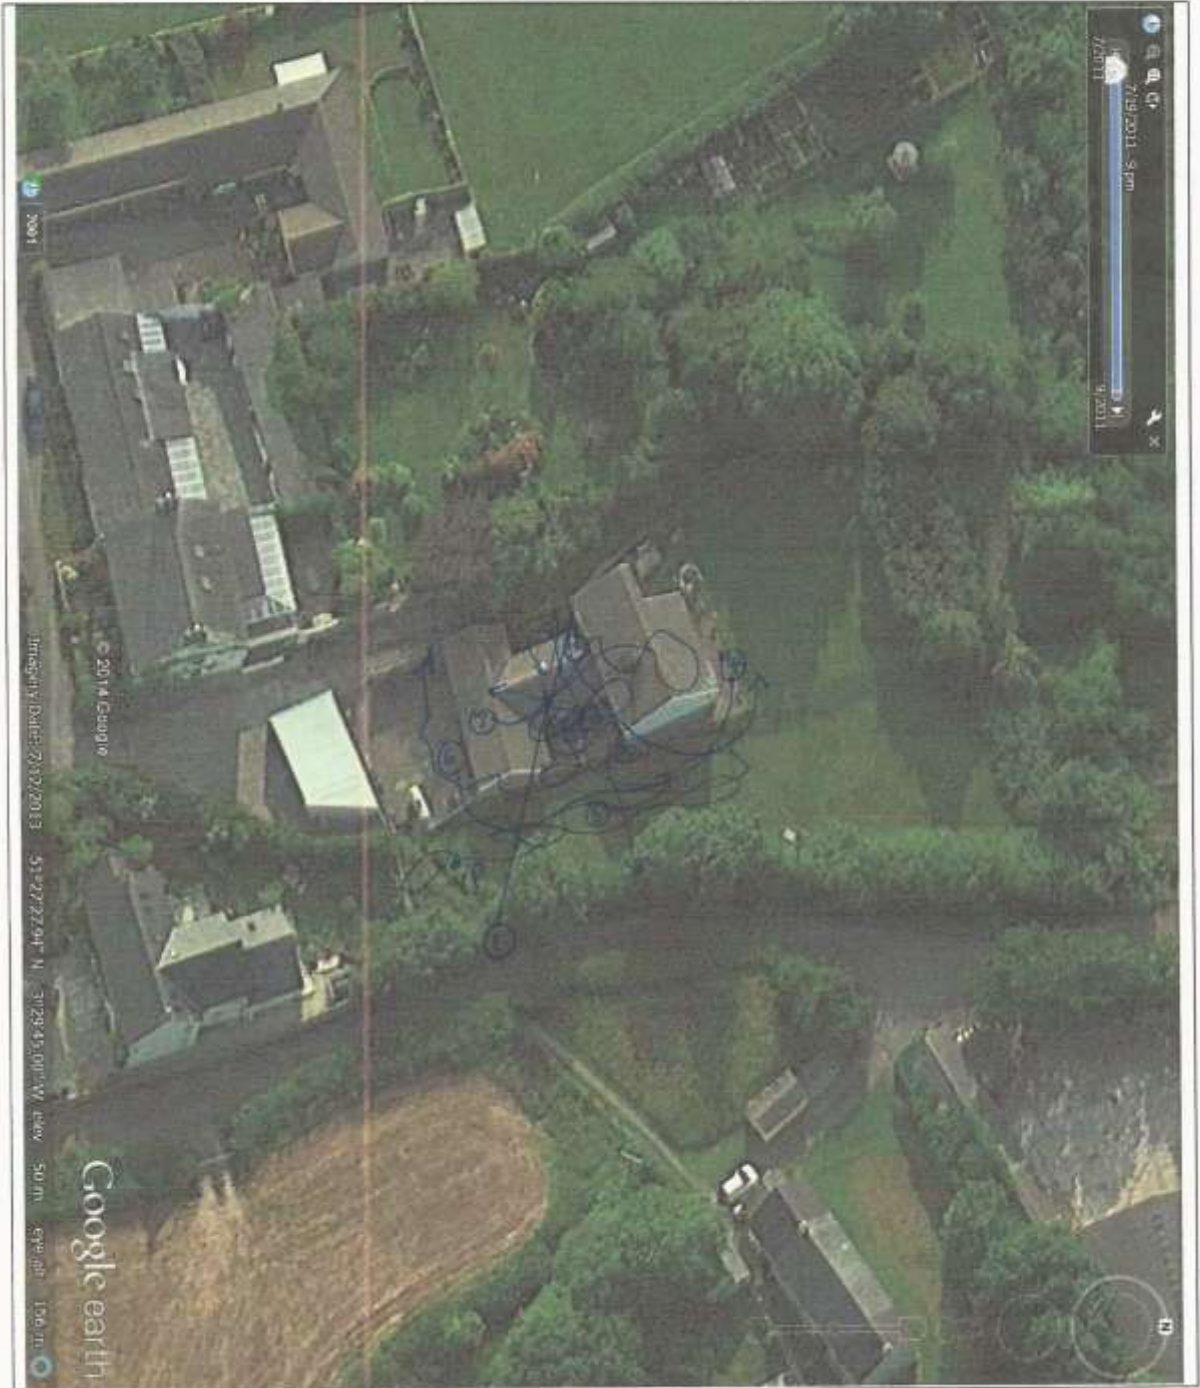
Site: Stourbridge House, Llyswoyney <i>S Thomas</i>	Date: 09/07/2014	Time: Dusk	Weather: 14°C. 100% clear sky. Intermittent NE breeze. Insects flying.
	VP number: 16	From 9.15 To 11.15

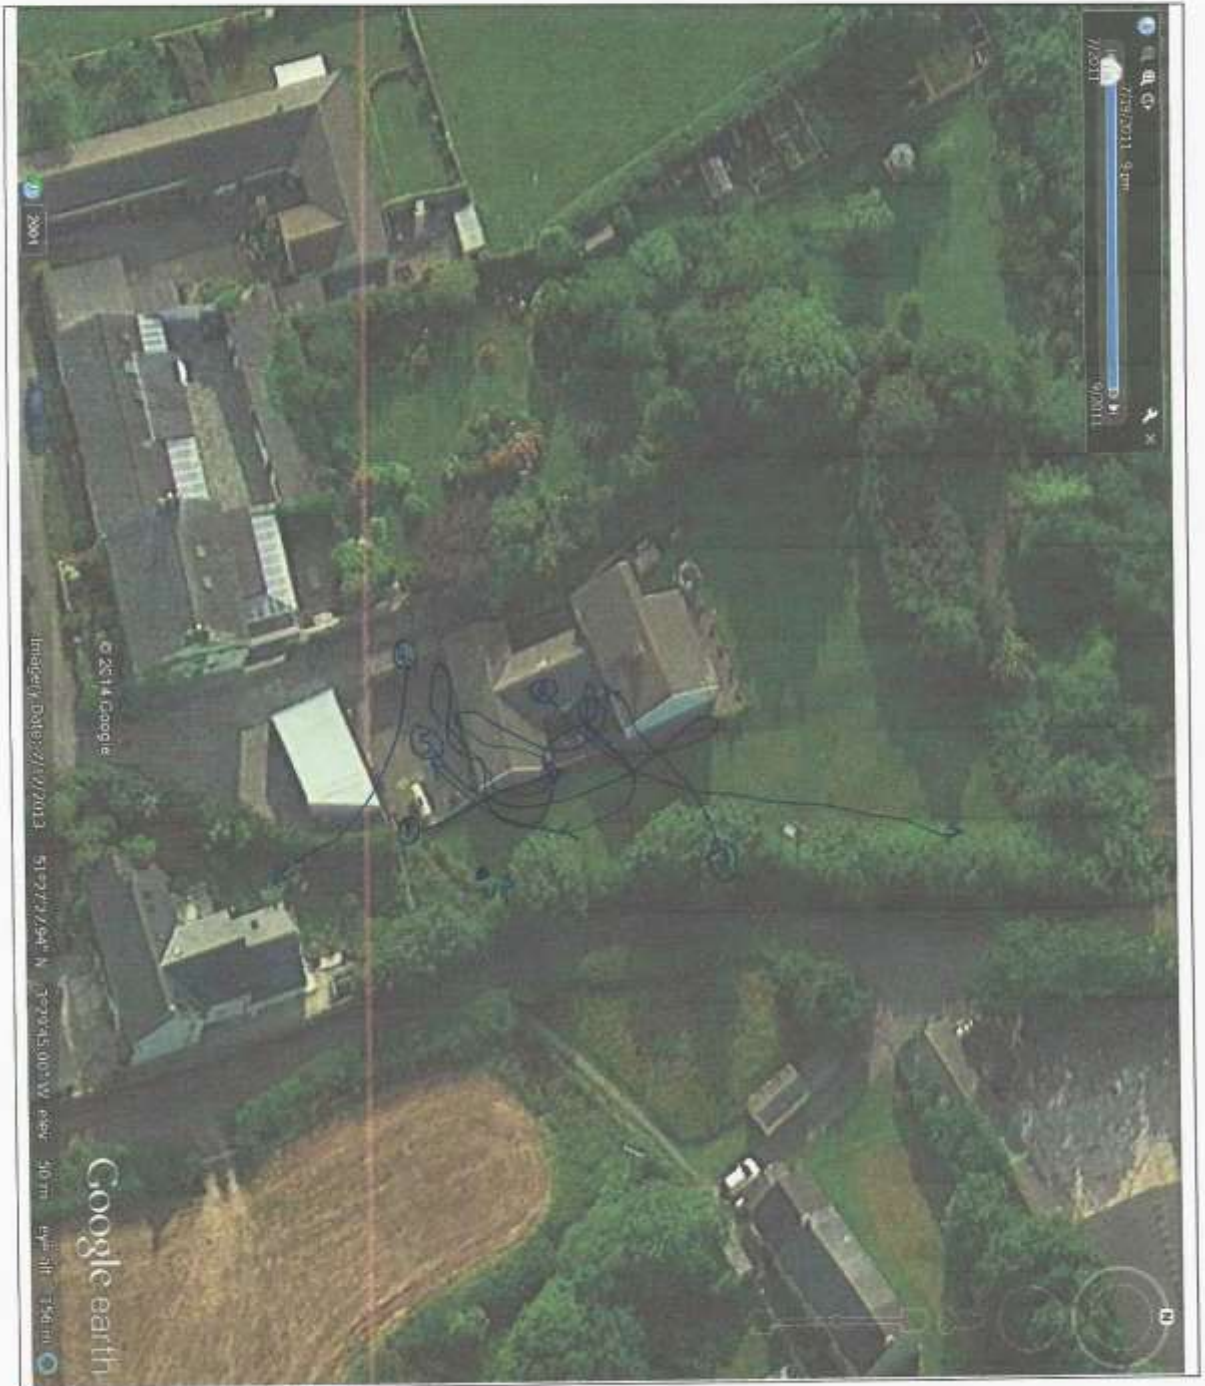
Site: Stourbridge House, Llysworney <i>S. Thomas</i>	Date: 10/07/2014	Time: Dawn From 3.15 To 5.15	Weather: 9°C. Nobreeds . 100% clear/sky. Insects flying.
	VP number: 26

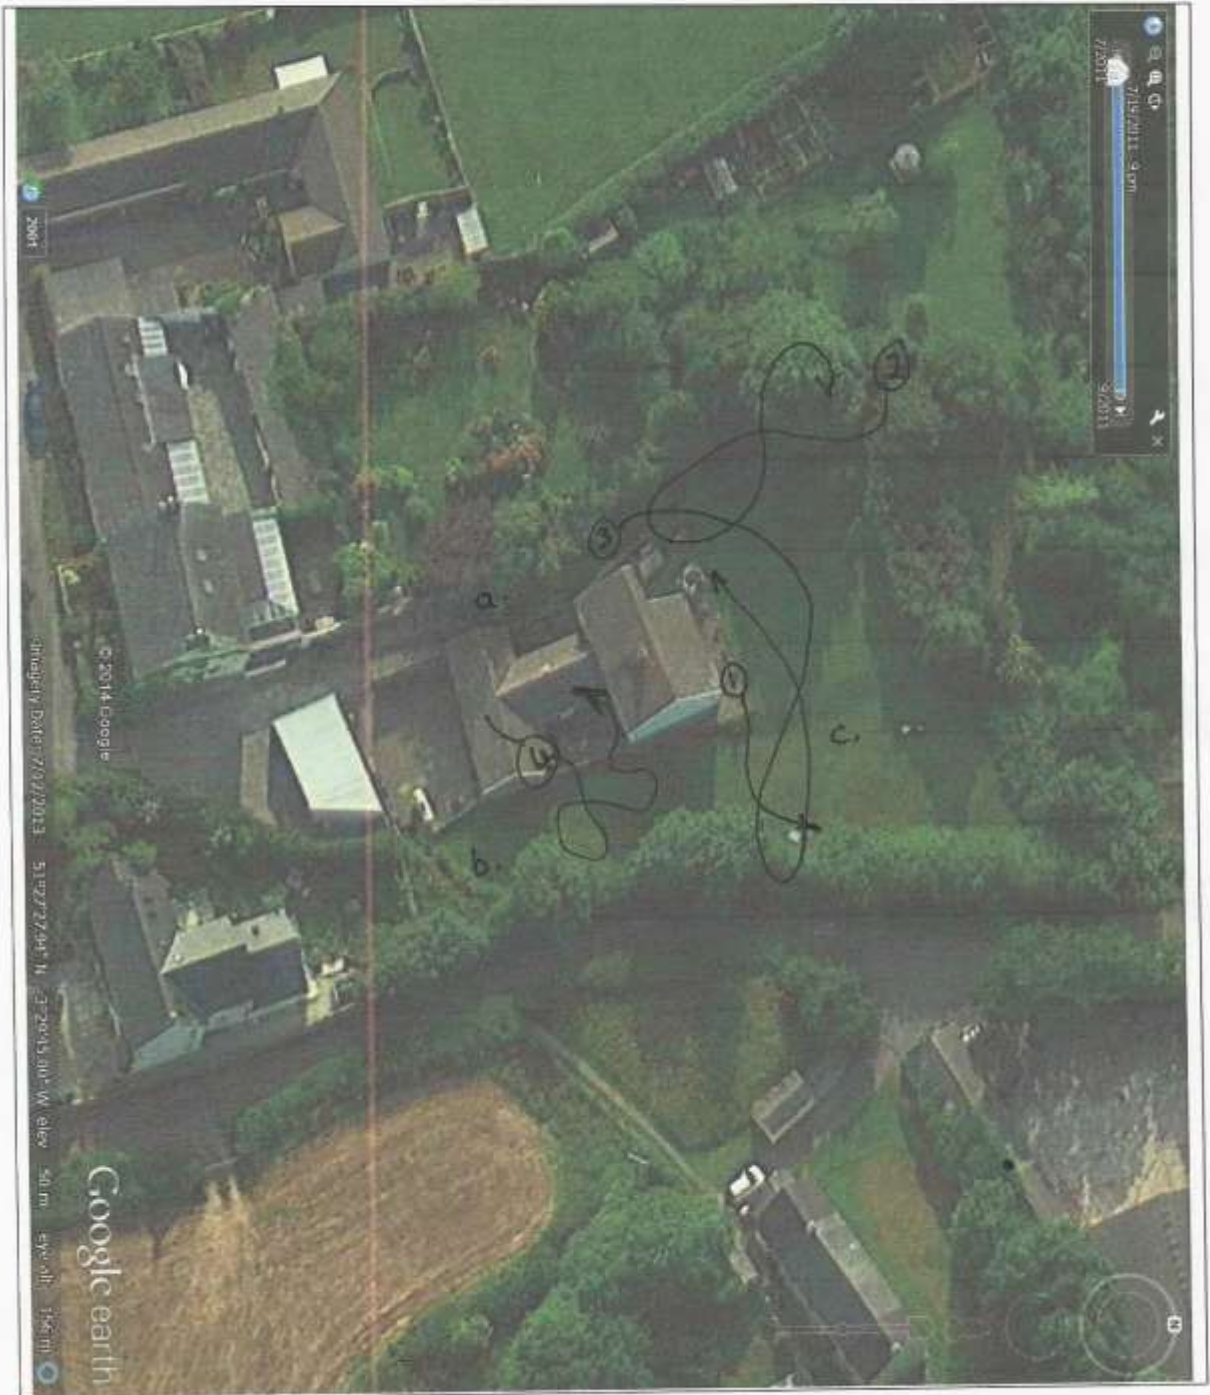
Site: Stourbridge House, Llysworney G.F. Thomas	Date: 10/07/2014	Time: Dawn From 3.15 To 5.15	Weather: No breeze. 9°C. 100% clear sky. Insects flying.
	VP number: 2C

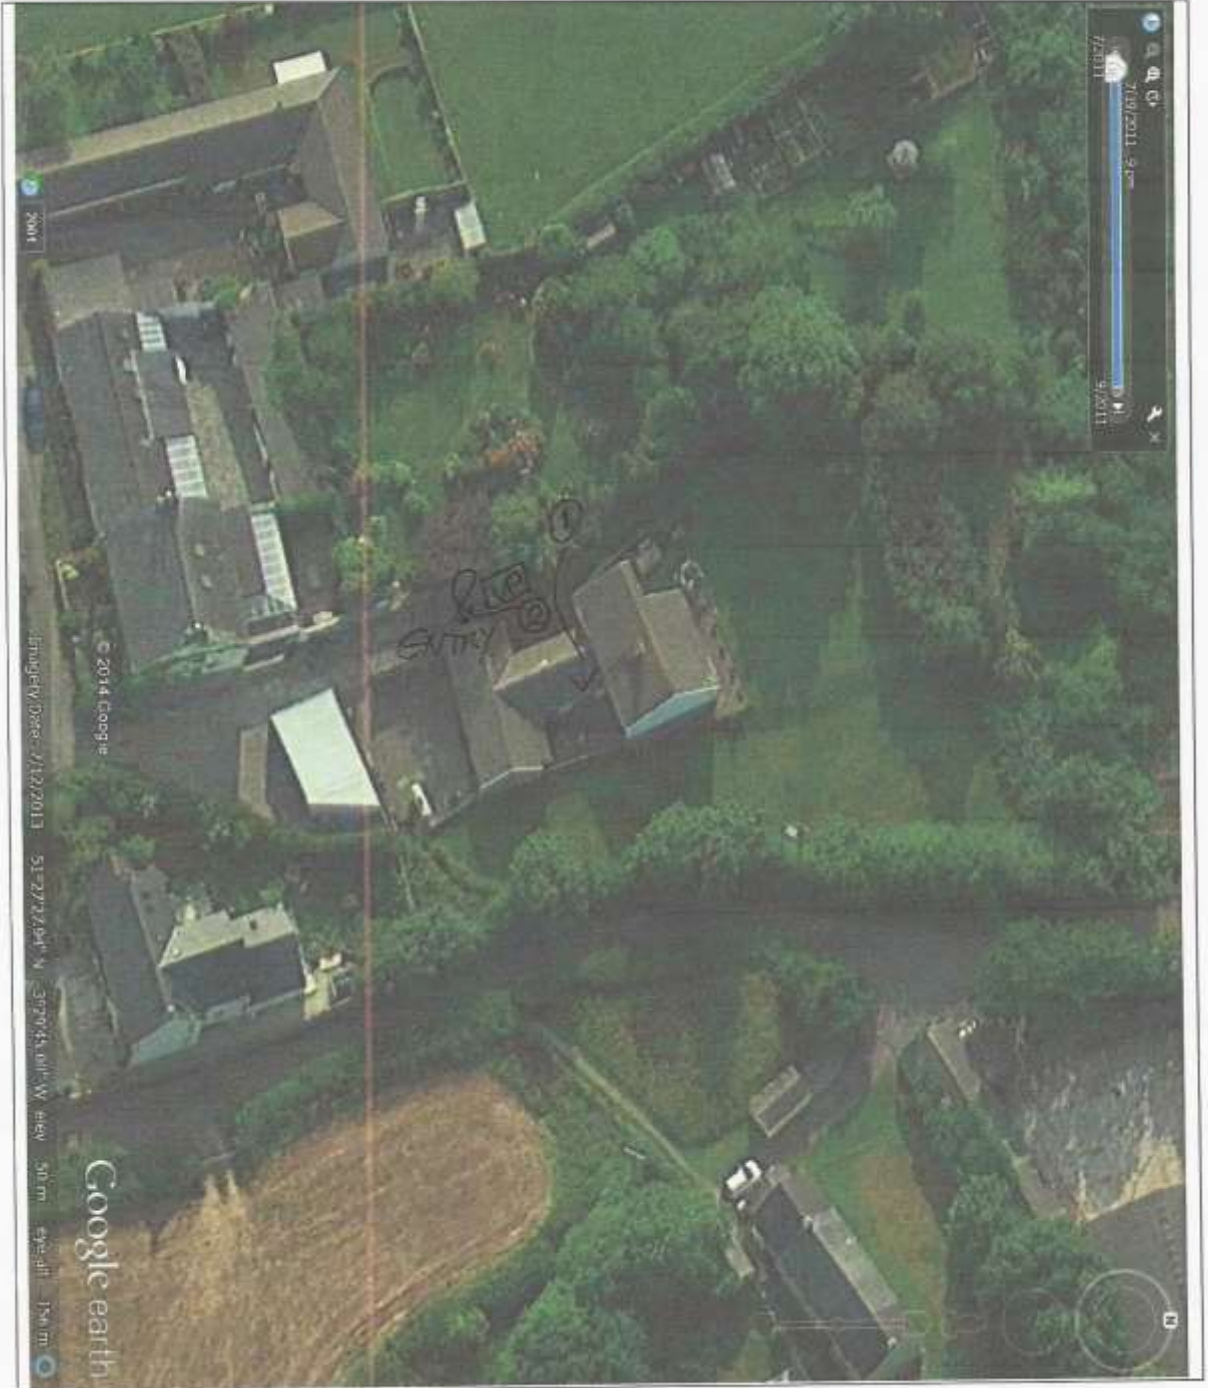
Site: Stourbridge House, Llysworney H. Brookes	Date: 15/07/2014	Time: Dawn From 03:15 To 05:15	Weather: 7/8 CLOUD FORCE 4-5. No PREC. 5:15°C F:
	VP number: 3A

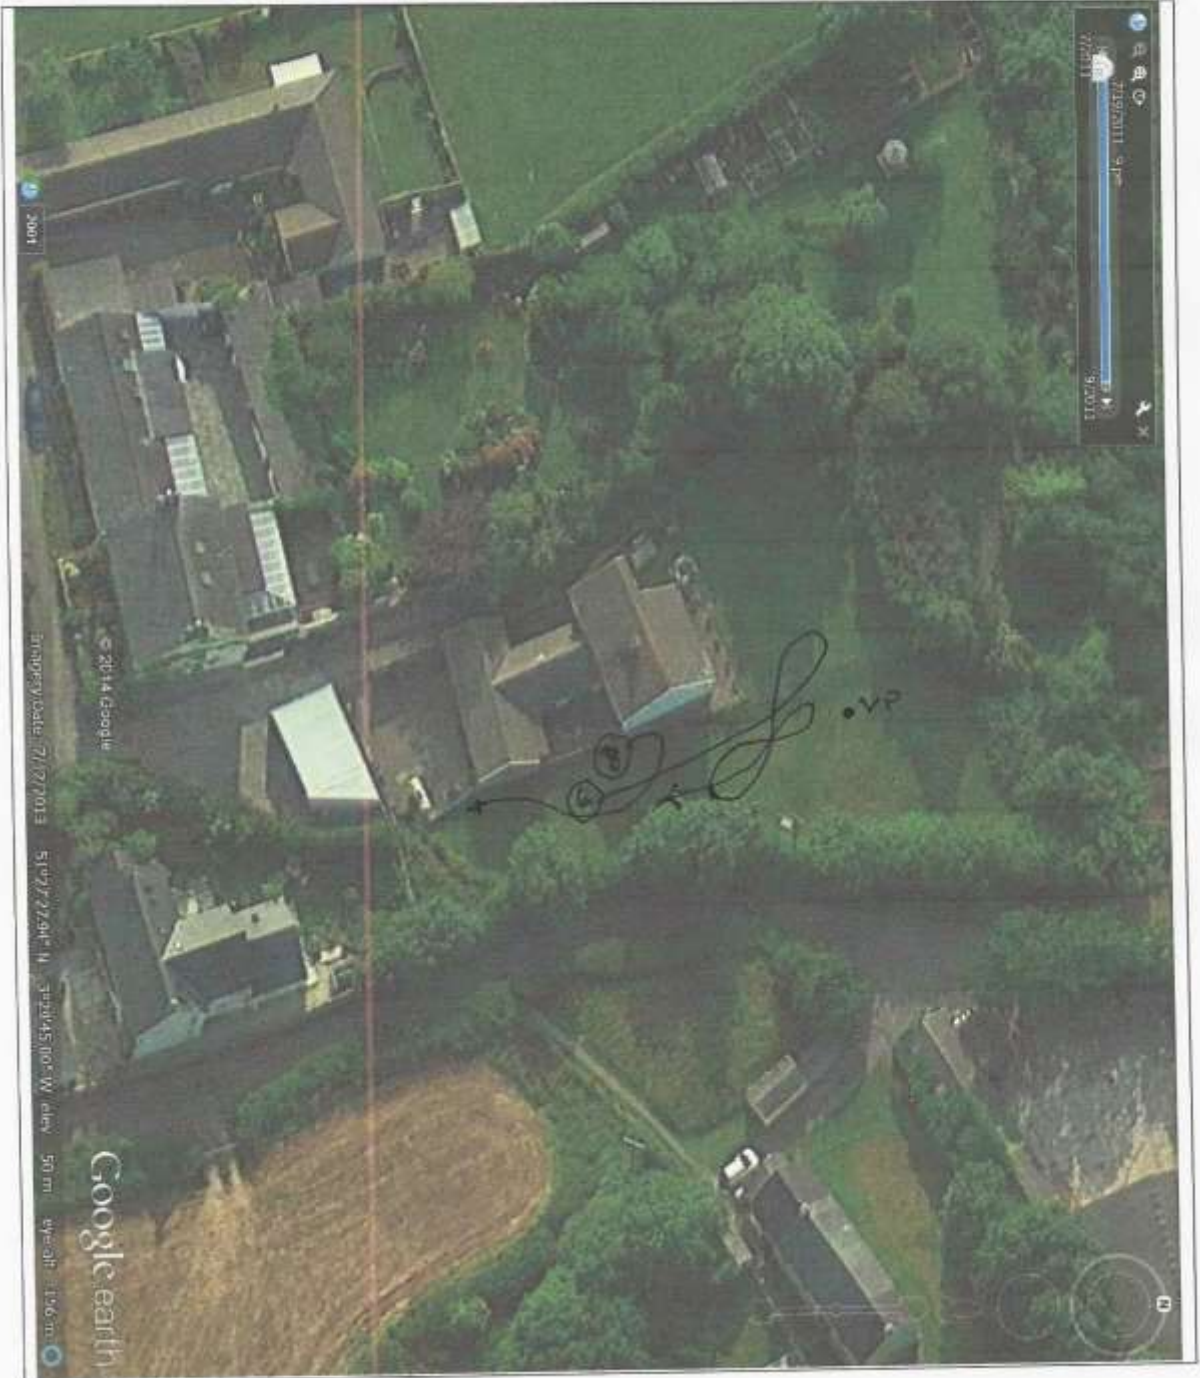
Site: Stourbridge House, Llyswoerney G.F. Thomas	Date: 15/07/2014 VP number: 3c	Time: Dawn From 3.15 To 5.15	Weather: 90% cloud cover No breeze @ start 15°C. Insects flying
---	--------------------------------------	------------------------------------	---
