**ARCHAEOLOGICAL EVALUATION  
AT  
STOURBRIDGE HOUSE,  
LLYSWORNEY, VALE OF GLAMORGAN**

**Cardiff Archaeological Consultants**  
Report 2014-15

**Report 2014/15**

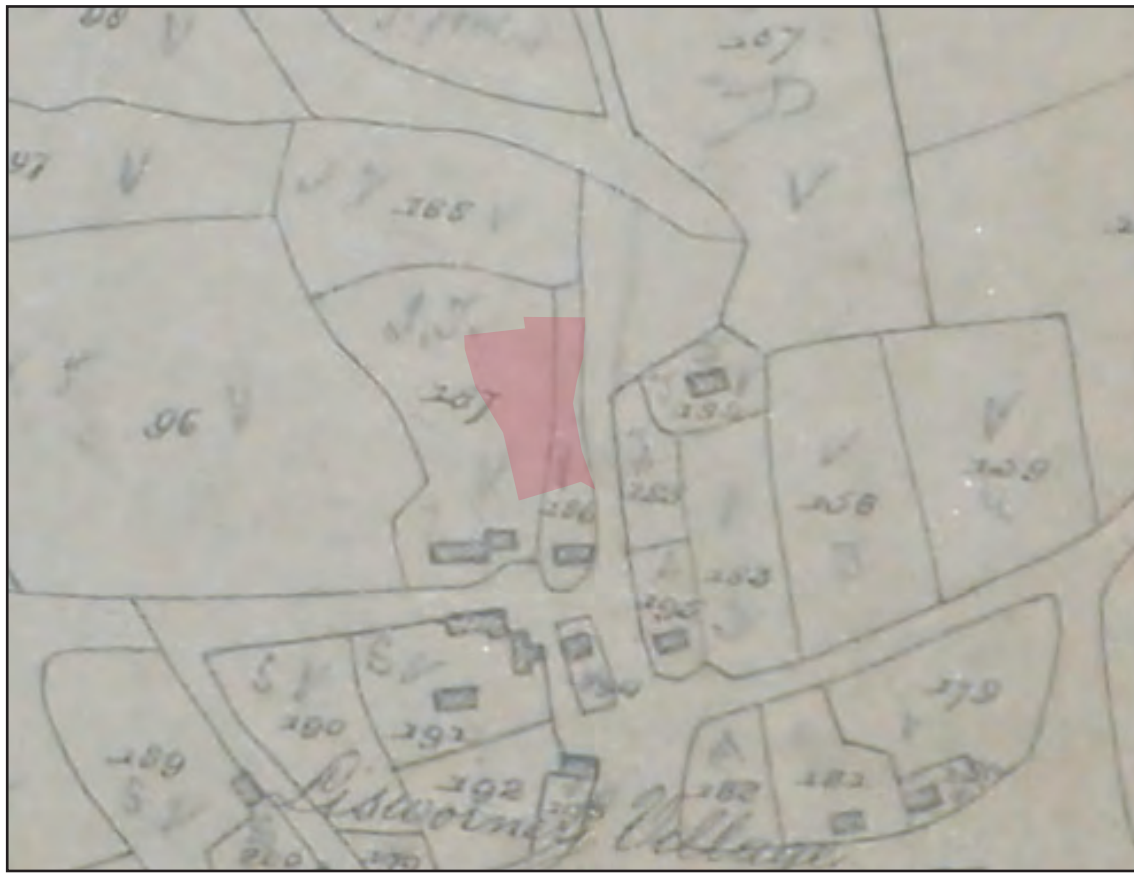
Figure 4: Stourbridge House between 1840 to 1919

Stourbridge House 1840 (Tithe map of the parish of Llysworney)

Stourbridge House 1877 (Glamorganshire XLV2, 1877 1/2500)

Stourbridge House 1919 (Glamorgan XLV2, 1919 1/2500)

**8.2** The artefacts recovered in the lower backfilling layer suggest that the quarry was abandoned and backfilled in the first half of the 19th century. The 1840 Tithe map of the parish of Llysworney does not record a quarry on the development site and the 1877 first edition Ordnance Survey map depicts a building that was incorporated in the existing building but no evidence for a quarry. The 1877 building was probably built over the backfilled quarry confirming the mid-19th-century date for its backfilling. The only potential clue as to the existence of a quarry is provided by an un-published 2 inches map held at the

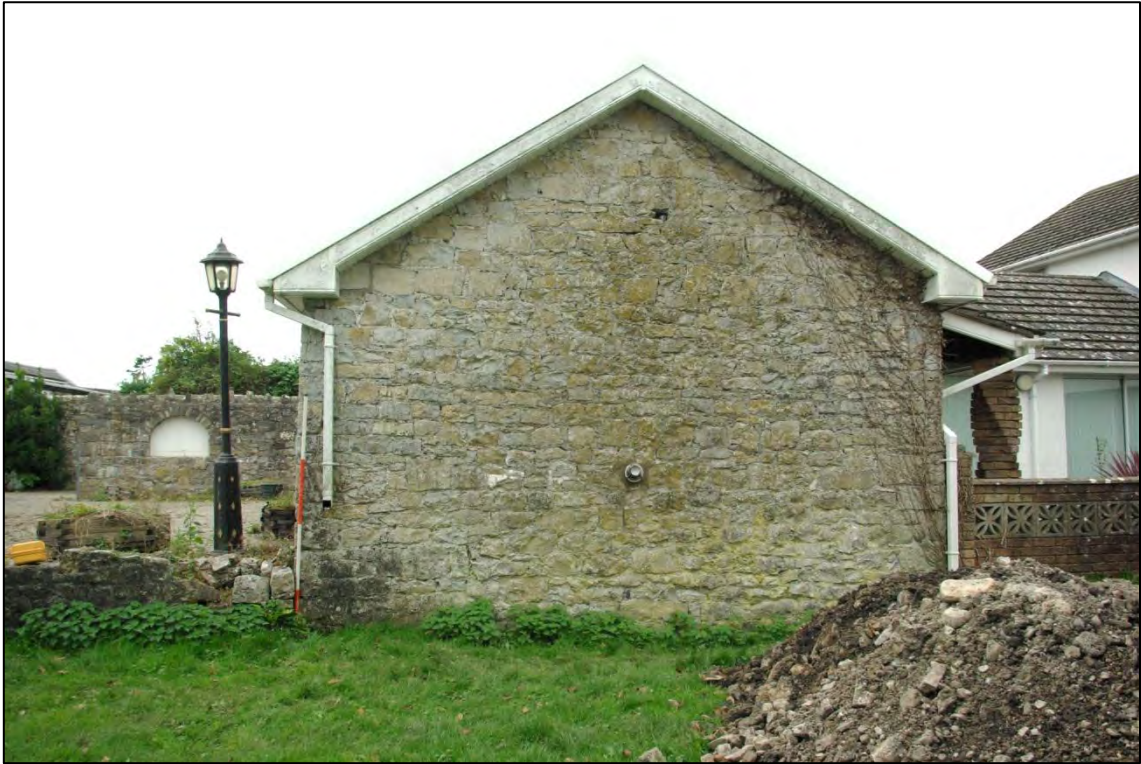
Plate 1: The eastern gable end wall of the 19th-century building from the east

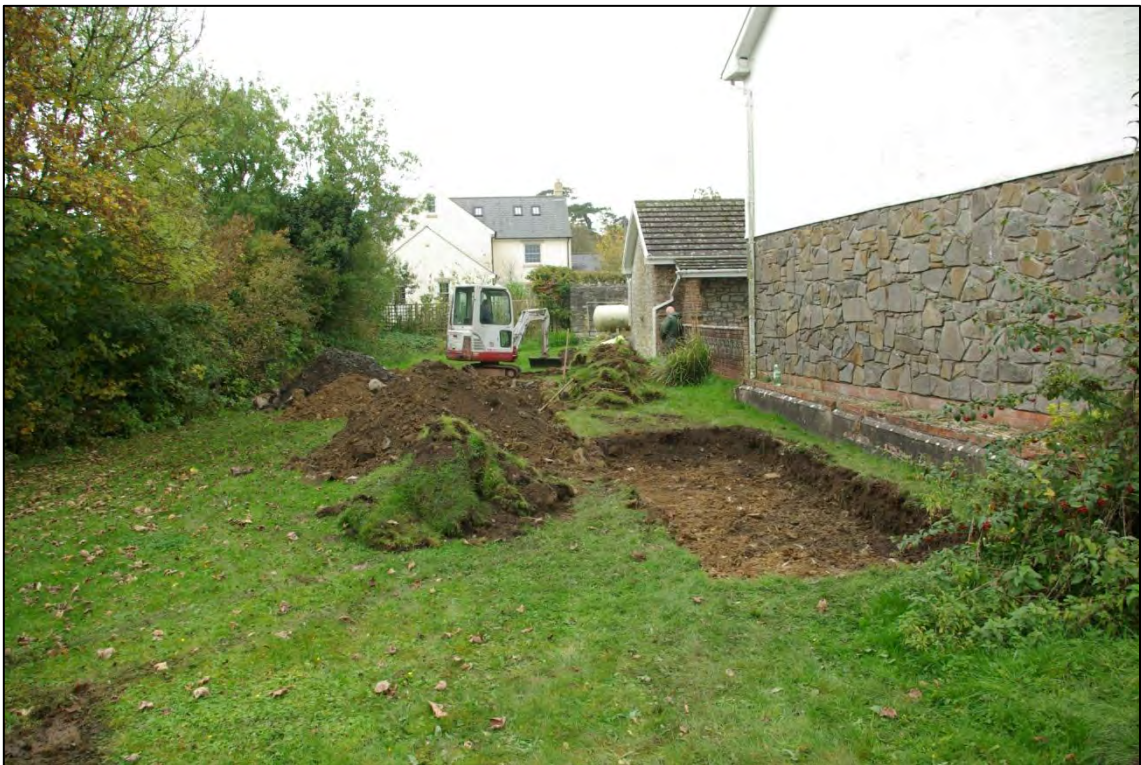
Plate 2: The evaluation area from the north

**5.1** The evaluation consisted of the mechanical and hand excavation of four 6m x 2m trenches (T1-T4) located within the footprints of the proposed new dwelling. (Figures 5, Plate 2). Trench T5, originally located in the footprints of the proposed garage, could not be excavated due to the location of a domestic gas tank and the position of existing services. The trenches were excavated to the top of the archaeological resource and limited excavation in the features recorded to ascertain their date and nature. The work was conducted by trained archaeological professionals to the standards set by the Institute for Archaeologists (1994-2013).

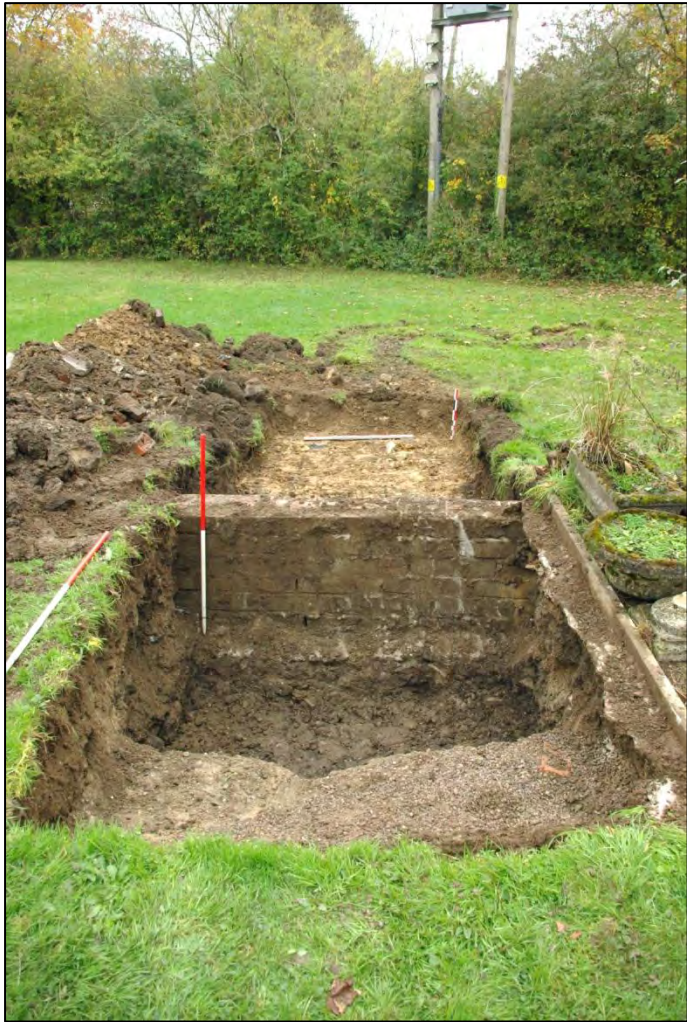
Plate 3: Trench T1 from the west

**6.3** The western end of T1 presented a different stratigraphy (Figure 6, Plates 3 and 4). Below the topsoil 01, a 0.80m thick of brown soil and building rubble (Context 02) formed the raised ground to the north-west of the existing building A modern trench cut (Context 03) filled with gravel (Context 04) was recorded in the upper layer of the deposit 02. The trench was for a drain pipe taking the rainwater to a soakaway to the north. The eastern edge of the bank was delineated by a breeze-block retaining wall built on concrete foundations (Context 07). Below the made-up ground 02 on the western side of the retaining wall, a 0.10m thick band of buried topsoil (Context 05) overlay a layer of light-brown to grey firm clayey soil with occasional stone and 19th-century domestic artefacts. The limited extend of the excavation did not permit a clear interpretation of this context but it is likely to be a buried subsoil layer or the fill of a 19th-century rubbish pit. The stratigraphy in T1 also clearly shows that the development site had been extensively landscaped at the time of the construction of the existing building with made-up ground 02 and the re-deposited natural clay 08.

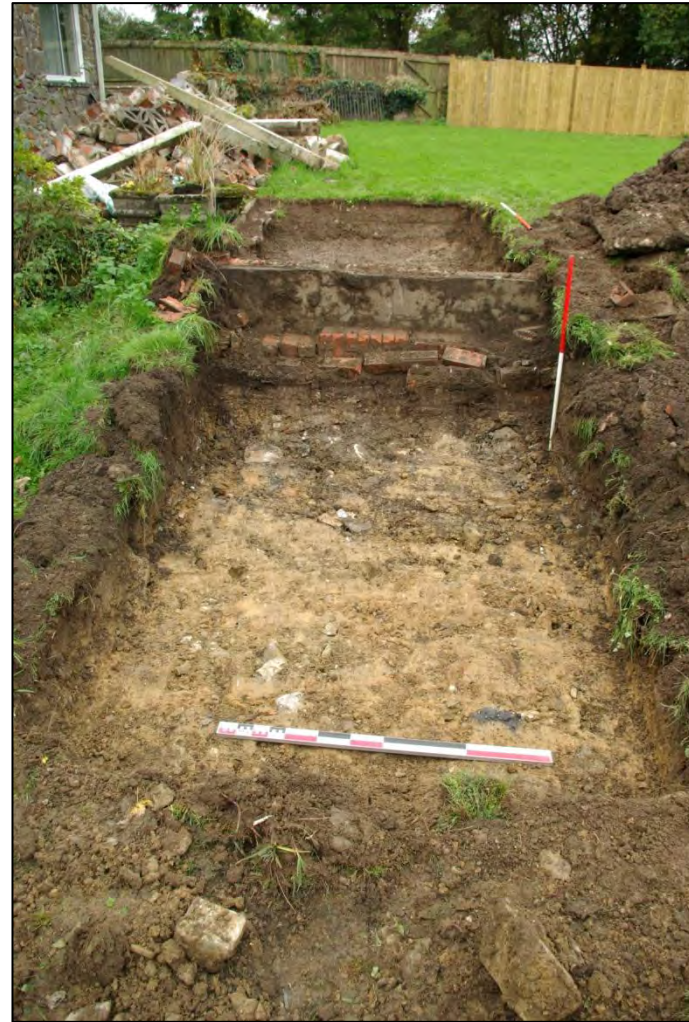
Plate 4: Trench T1 from the east

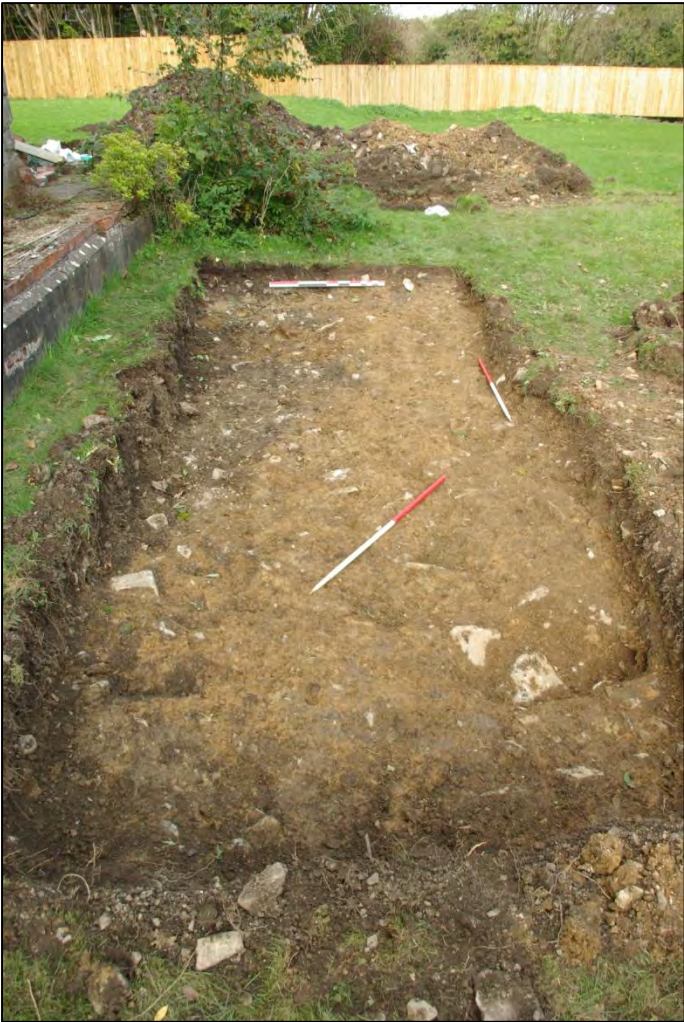
Plate 5: Trench T2 from the south

**6.4** In trench T2, an irregular cut (Context 14) was recorded along the western edge of the trench (Figure 7, Plate 5). It was filled with dark-brown soil with limestone fragments, frogged bricks and modern wall tiles and late 19th- to early 20th-century domestic artefacts (Context 15). It is likely that this feature was associated with the construction of the existing building.

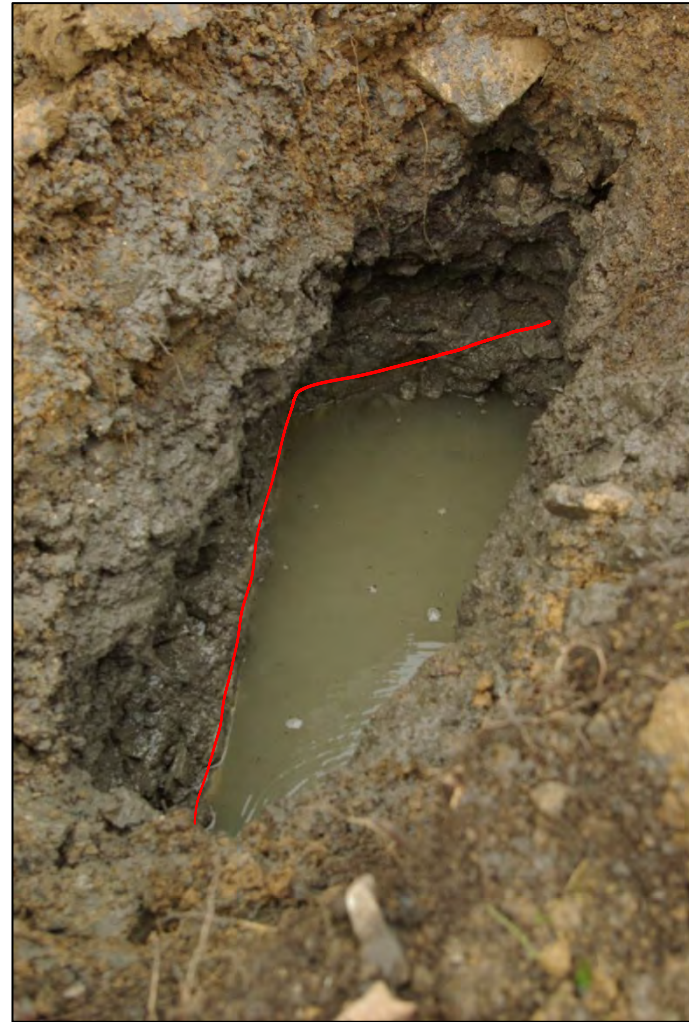
Plate 6: Trench T2, Cut 16 in bedrock from the south

The bedrock was recorded at a depth of 1m below ground level in T4, 1.90m in T2 and 2.40m in T1. A 0.50m high step in the bedrock (Context 16) was clearly visible in T2 (Plate 6). The step in the bedrock and the gradual increased depth of the bedrock provide evidence for the existence of a large quarry abandoned and backfilled during the 19th century under the evaluation area (Figure 10).

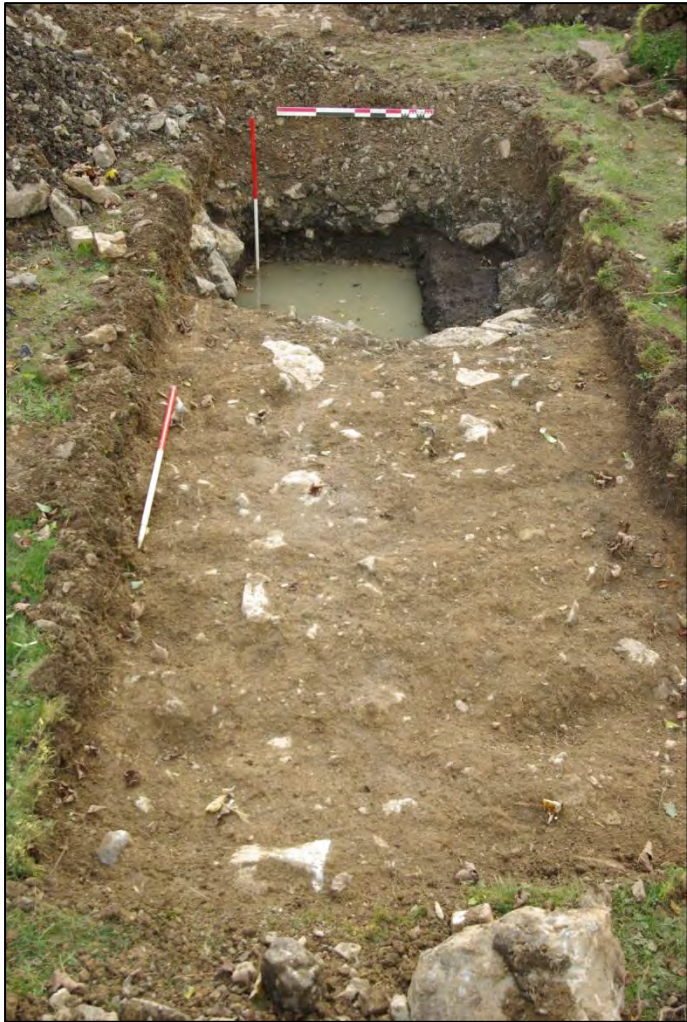
Plate 7: Trench T3 from the north

The general stratigraphy recorded was broadly similar in the four trenches with only localised differences in the western end of T1 and the western side of T2 (Figures 6 to 9, Plates 3 to 11). Below the thin topsoil (Context 01), a layer of clean re-deposited yellow-brown clay with occasional small to medium limestone rubble was recorded (Context 08). This layer was clear of any domestic or industrial artefacts and was, at first, thought to be natural. Its thickness varied from 0.10m in T3 and T4 and to 0.40m in T1 and T2 to the north. Below 08 was another layer of grey re-deposited clay with large limestone blocks and medium to large bitumen blocks (Context 09). The thickness of 09 varied from 0.16m in T1

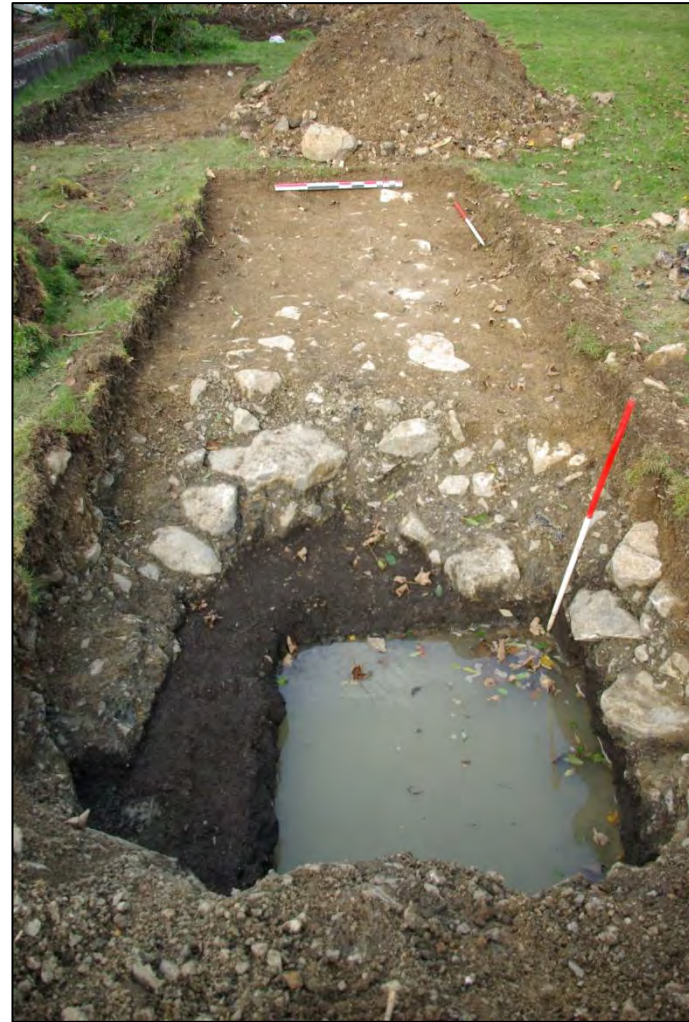
Plate 8: Trench T3 from the south

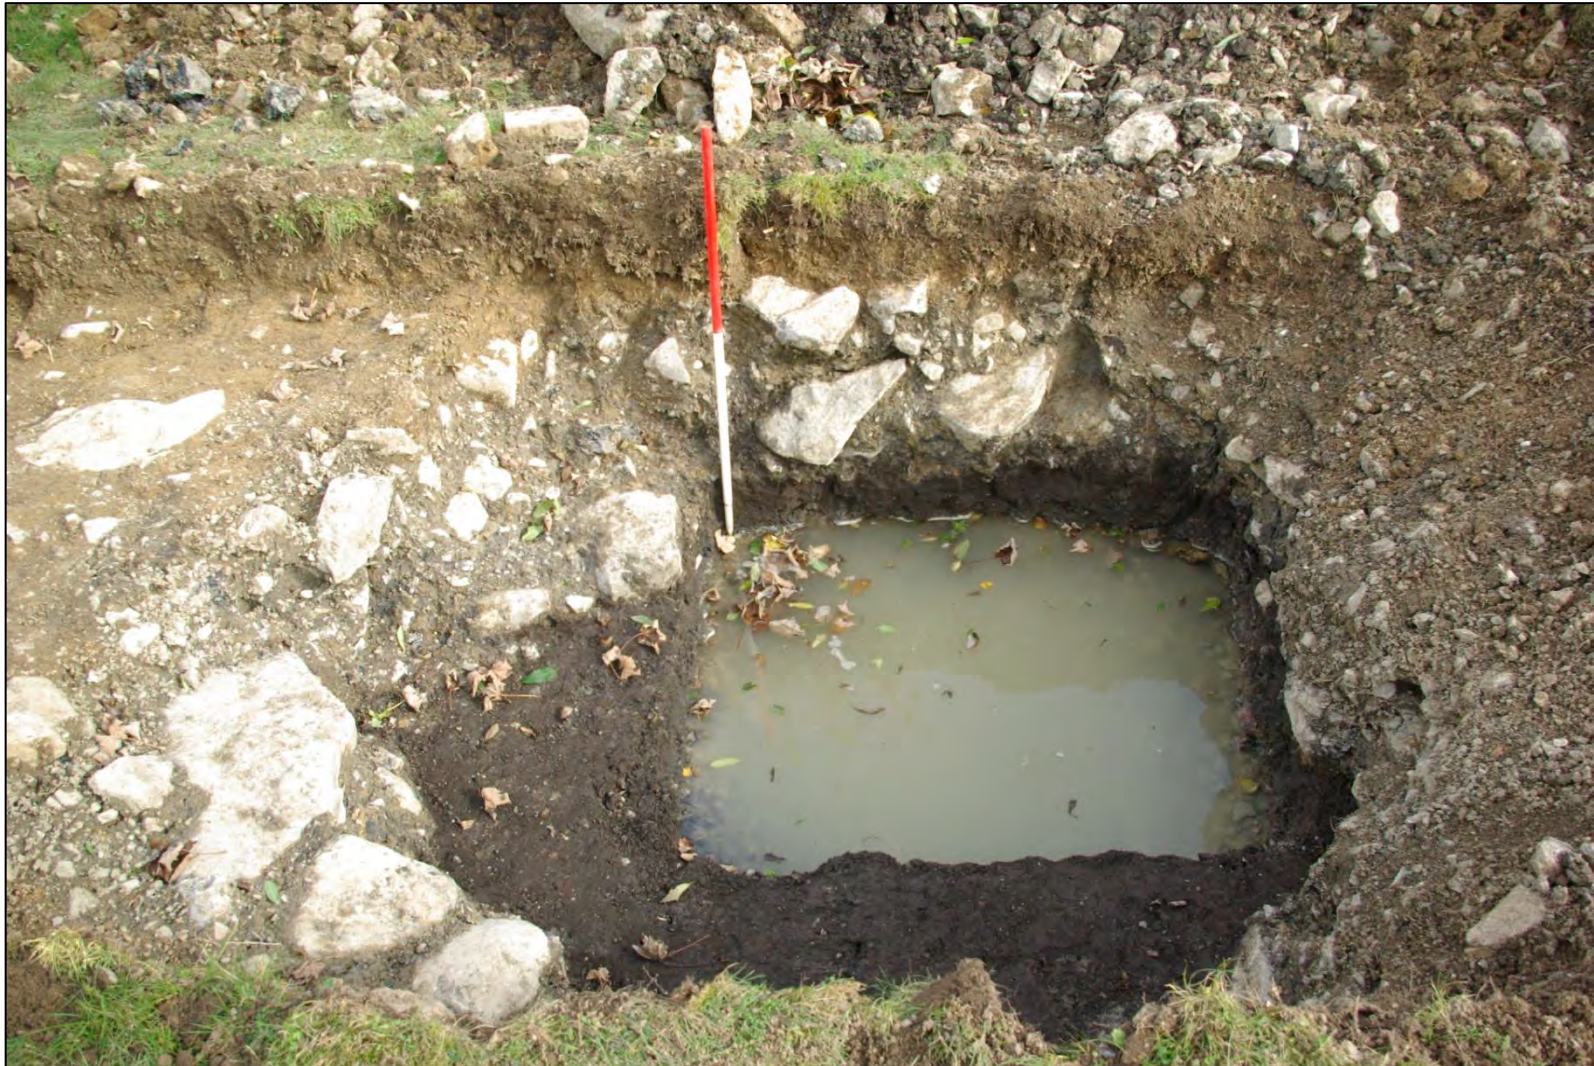
Plate 9: Trench T3, contexts 01, 08, 09, 10 in eastern section from the west

to 0.50m in T3. This layer overlay a dark-brown organic deposit with 19th-century domestic artefacts (Context 10). Its thickness also varied but only from 0.16m to the south to 0.30m to the north (Plates 9 and 11). Ground water started to fill the excavation in all the trenches at this level. Below 10, a layer of loose, wet and soft grey clay with abundant limestone chippings, small to medium rubble and 19th-century domestic artefacts (Context 11) was exposed. It overlay in T4 a 0.20m thick band of white to light-grey soft clay with no inclusions (Context 12) covering the limestone bedrock (Context 13). The thickness of deposit 11 increased from south to north and was recorded at 0.20m in T4 and 1.40m in T1. The presence of the clay layer 12 above the substratum could not be ascertained in T1 and T2. Water in the excavation and the depth and instability of the excavation side excluded any hand excavation.

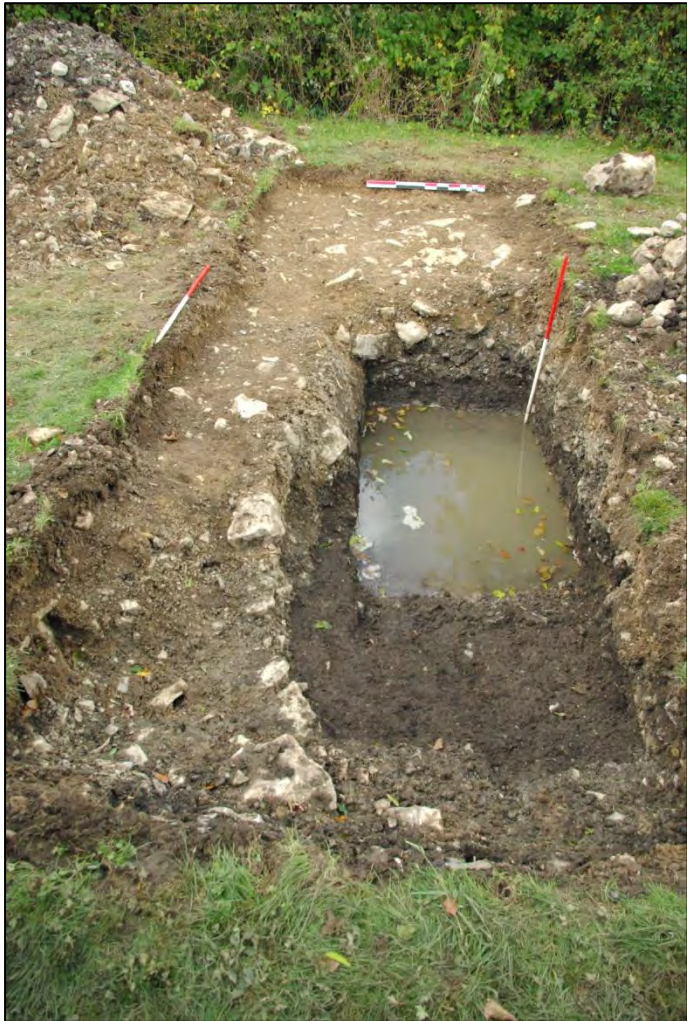
Plate 10: Trench T4 from the west

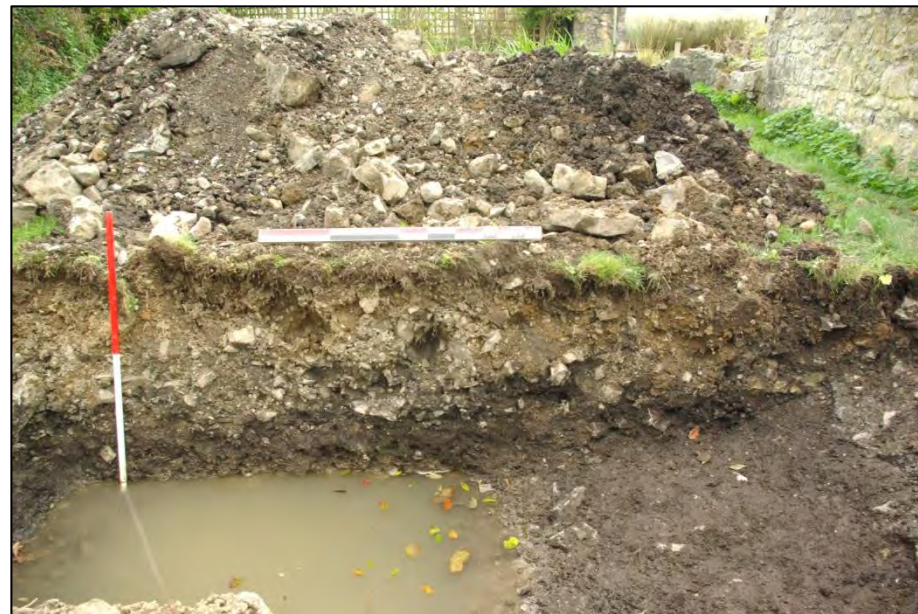
Plate 11: Trench T4, contexts 01, 08, 09, 10 in southern section from the west
