**ARCHAEOLOGICAL EVALUATION
AT
STOURBRIDGE HOUSE,
LLYSWORNEY, VALE OF GLAMORGAN**

Cardiff Archaeological Consultants
Report 2014-15

Jean-Yves Robic
November 2014

Report 2014/15

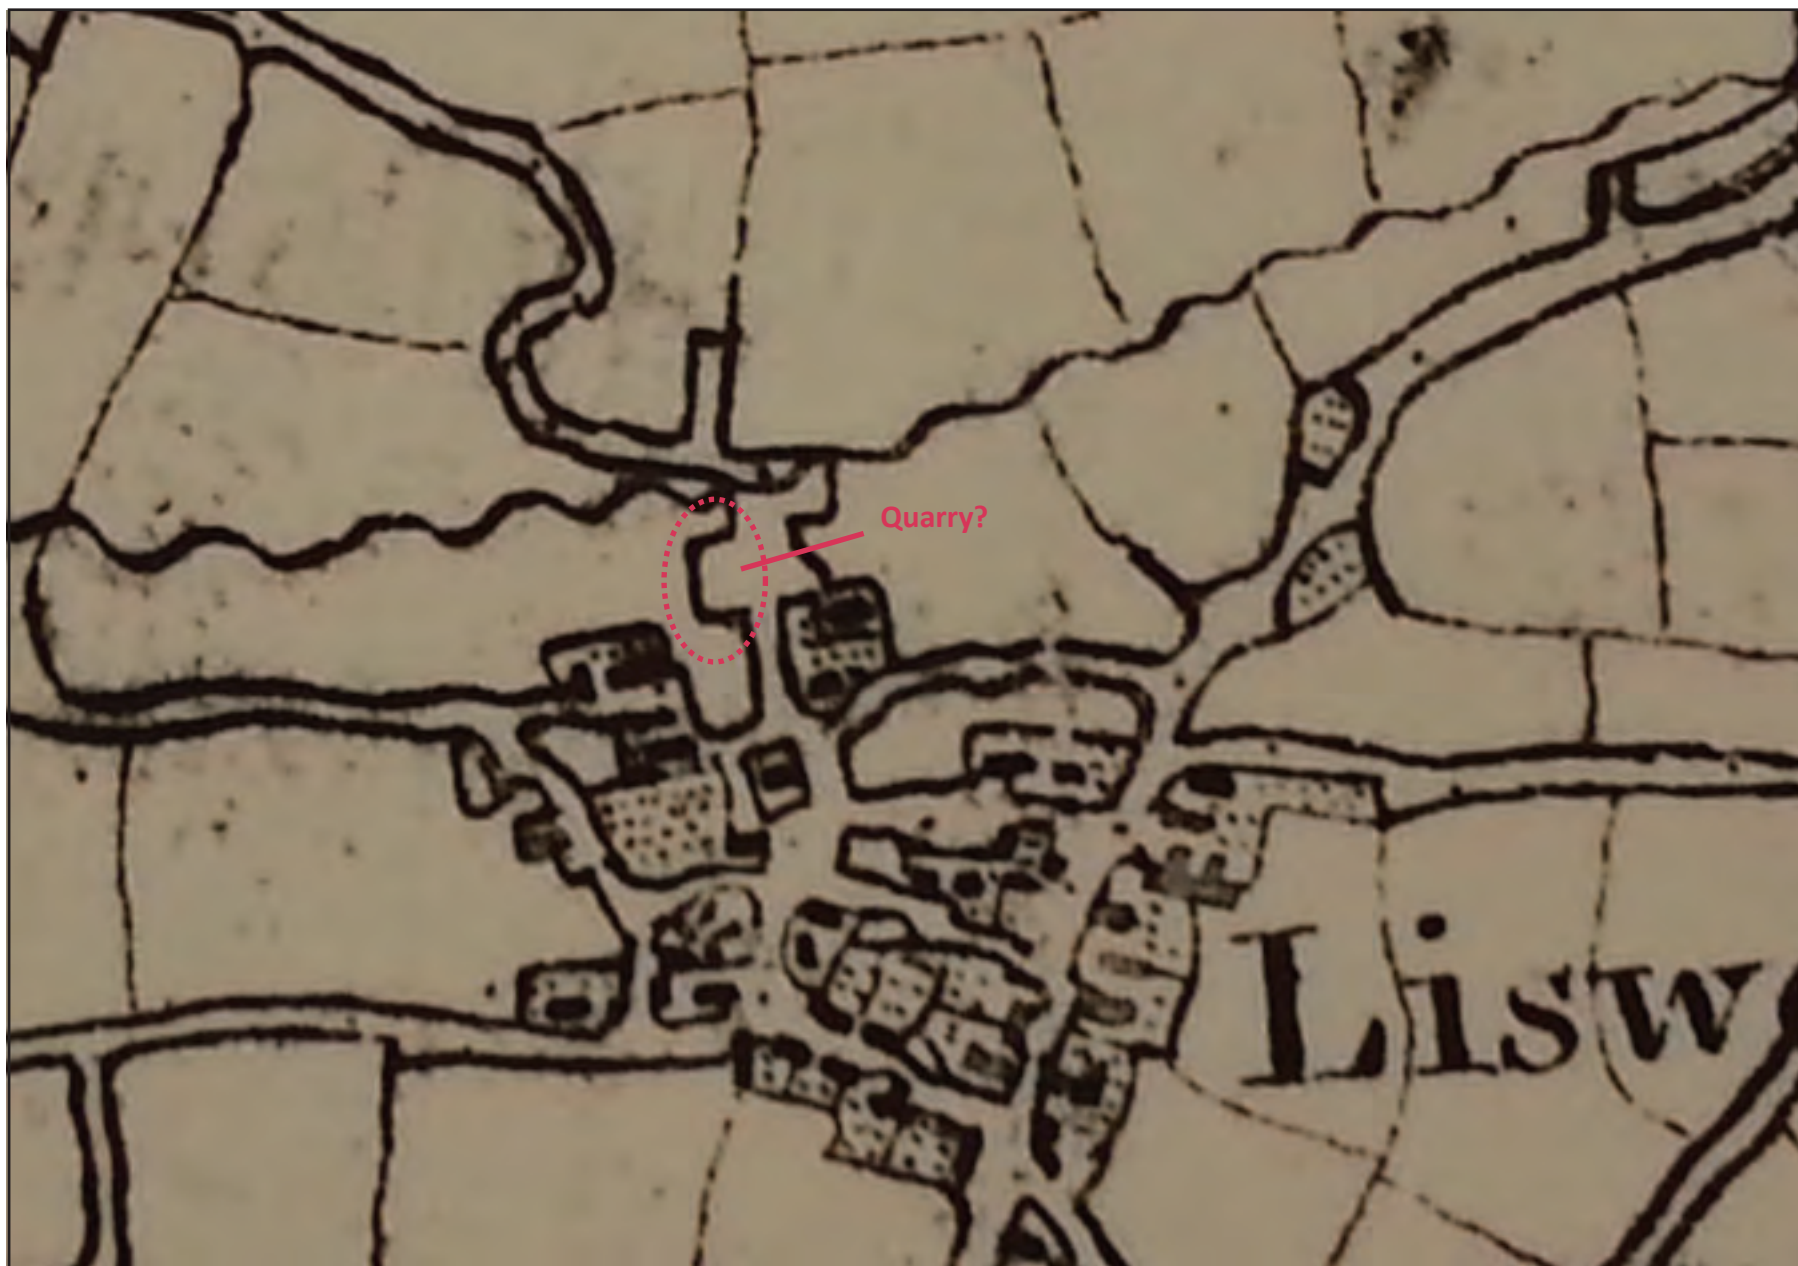
Figure 11: Stourbridge House 1813 (Un-published 1813 2 inches map)

..... Development site

Glamorgan archives that depicts a square-shaped boundary at the approximate location of the development site and a straight angular boundary to the north of Moat Farm (Figure 11). There is no annotation on the map to confirm the existence of a quarry but by the time of the 1840 Tithe map the angular boundaries are not visible in the development area (Figure 4). In the absence of any earlier cartographic document, dating the opening of the quarry remains difficult but a 17th- or 18th-century date cannot be excluded. All the pottery fragments and other domestic artefacts can be dated to the 19th century. The early fragment of yellow slipware dated to the 18th century was recovered from the organic layer 10 and appeared residual in this context. As the full extent of the quarry was not determined, it is also possible that the area of the quarry uncovered was the latest phase of its exploitation after earlier exploited areas had been abandoned.

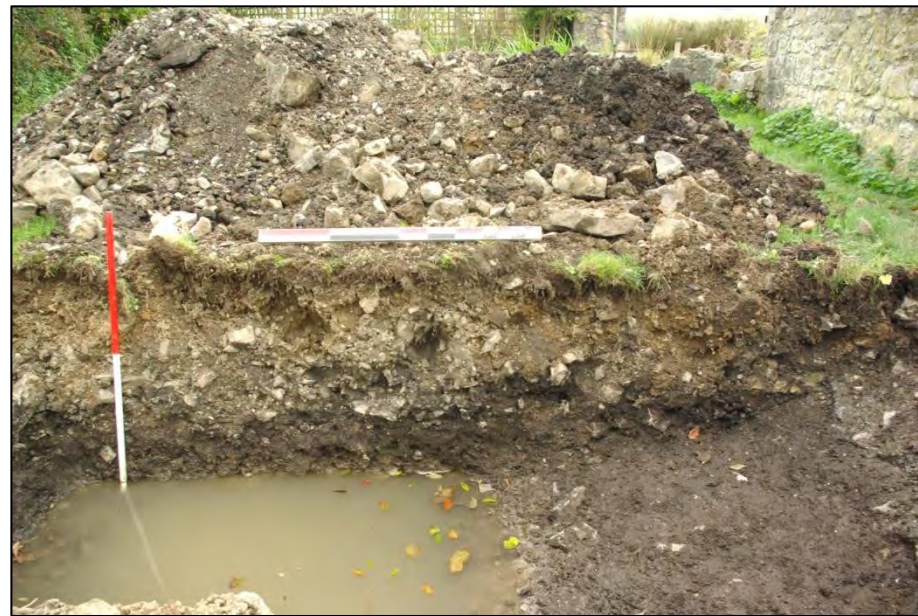
Plate 11: Trench T4, contexts 01, 08, 09, 10 in southern section from the west

to 0.50m in T3. This layer overlay a dark-brown organic deposit with 19th-century domestic artefacts (Context 10). Its thickness also varied but only from 0.16m to the south to 0.30m to the north (Plates 9 and 11). Ground water started to fill the excavation in all the trenches at this level. Below 10, a layer of loose, wet and soft grey clay with abundant limestone chippings, small to medium rubble and 19th-century domestic artefacts (Context 11) was exposed. It overlay in T4 a 0.20m thick band of white to light-grey soft clay with no inclusions (Context 12) covering the limestone bedrock (Context 13). The thickness of deposit 11 increased from south to north and was recorded at 0.20m in T4 and 1.40m in T1. The presence of the clay layer 12 above the substratum could not be ascertained in T1 and T2. Water in the excavation and the depth and instability of the excavation side excluded any hand excavation.
