**SOLAR PARK, BARRY**

**GEO-ENVIRONMENTAL RISK ASSESSMENT**

**SEPTEMBER 2014**

<b>PROJECT REF:</b>	<b>234-02-01</b>
<b>REPORT No.:</b>	234-02-01.R2

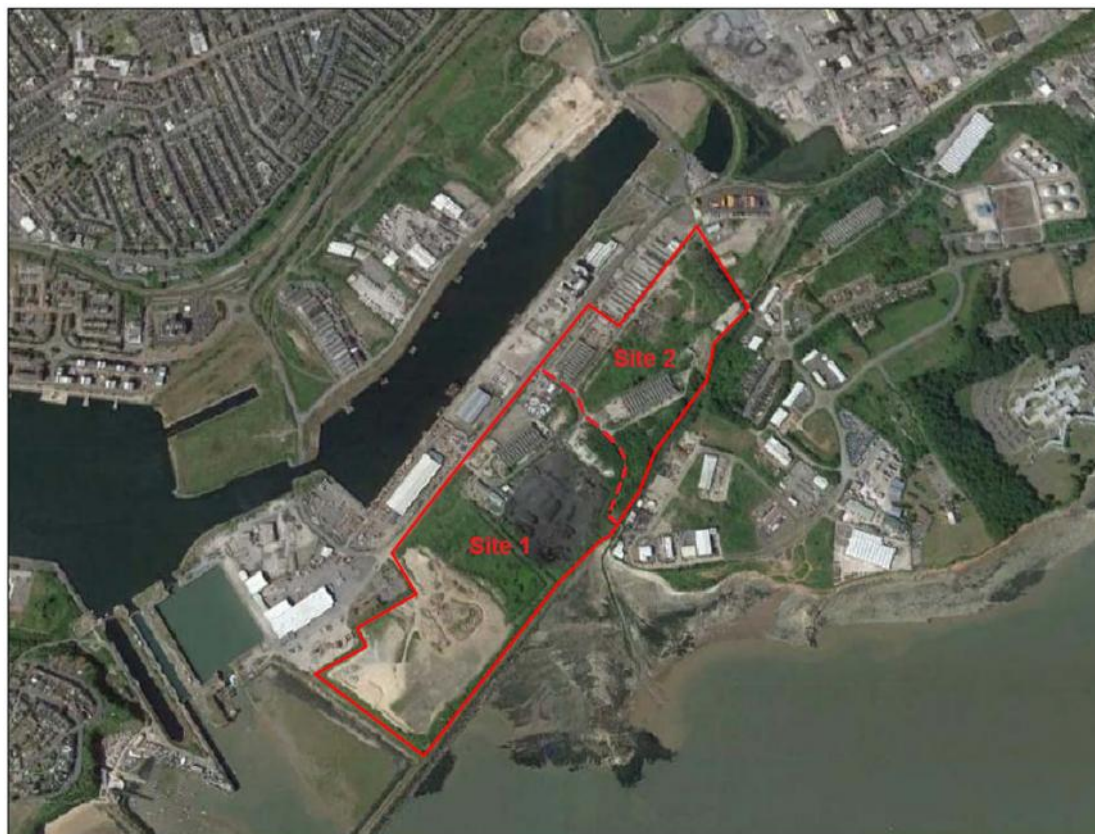
Figure 2.1 – Location Plan

Figure 2.1 shows the boundary of the study area within the setting of the Port.

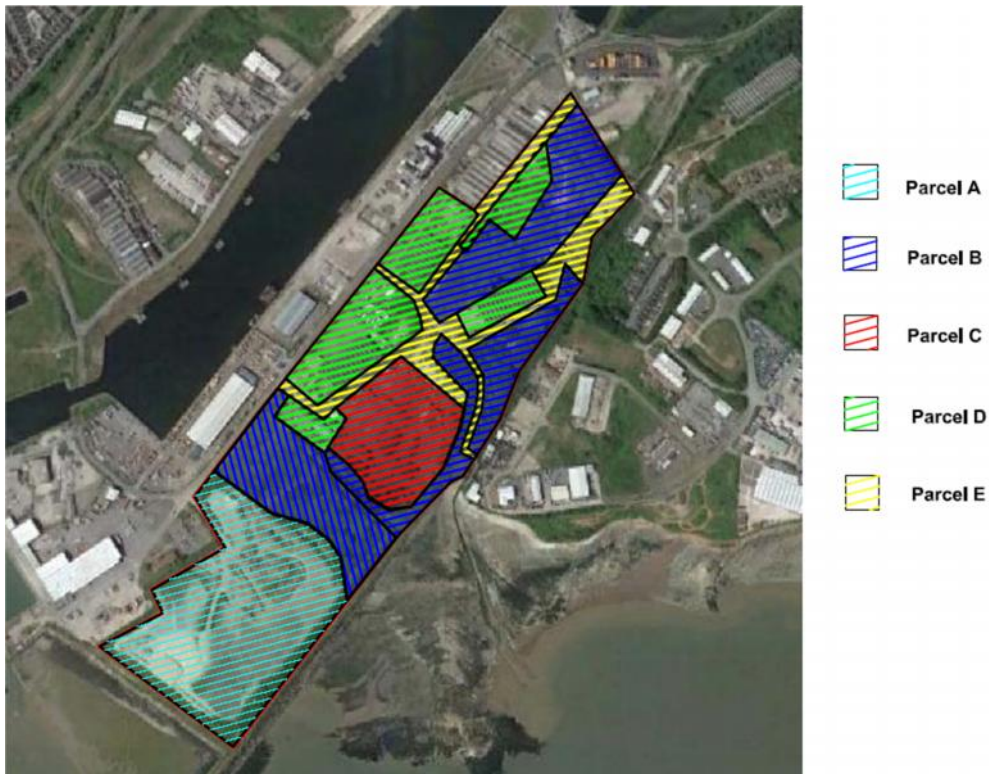
**Figure 2.3 Designations for parcels of land within the site boundary**

Topographical survey data, provided by ABP, and observations from our site team have been used to compile Figure 2.3, which provides a key to the description of the site.

**Parcel A** is formed by a relatively level plateau of inert fill material that is at an approximate elevation of 12m AOD which is up to 4m higher than the remaining area of the site to the north of it. The land is occupied by an inert material recycling facility. It is estimated that approximately 4m thickness of inert materials forms a capping to the site.

**Parcel B** is comprised of dense scrub and semi-improved neutral grassland and lies at an elevation of around 9m AOD.

**Parcel C** is covered by concrete hardstanding and was formerly a coal yard which lies at an elevation of between 8 and 9m AOD. The edge of the coal yard is surrounded by bunds up to 5m in height

**Parcels D** comprises buildings that are currently leased and used as industrial premises, or formerly contained industrial uses. The ground elevation is around 7.5 – 8 m AOD.

**Parcel E** comprises the remaining roads and paving within the development, the levels of which are in continuity with the surrounding parcels of land.

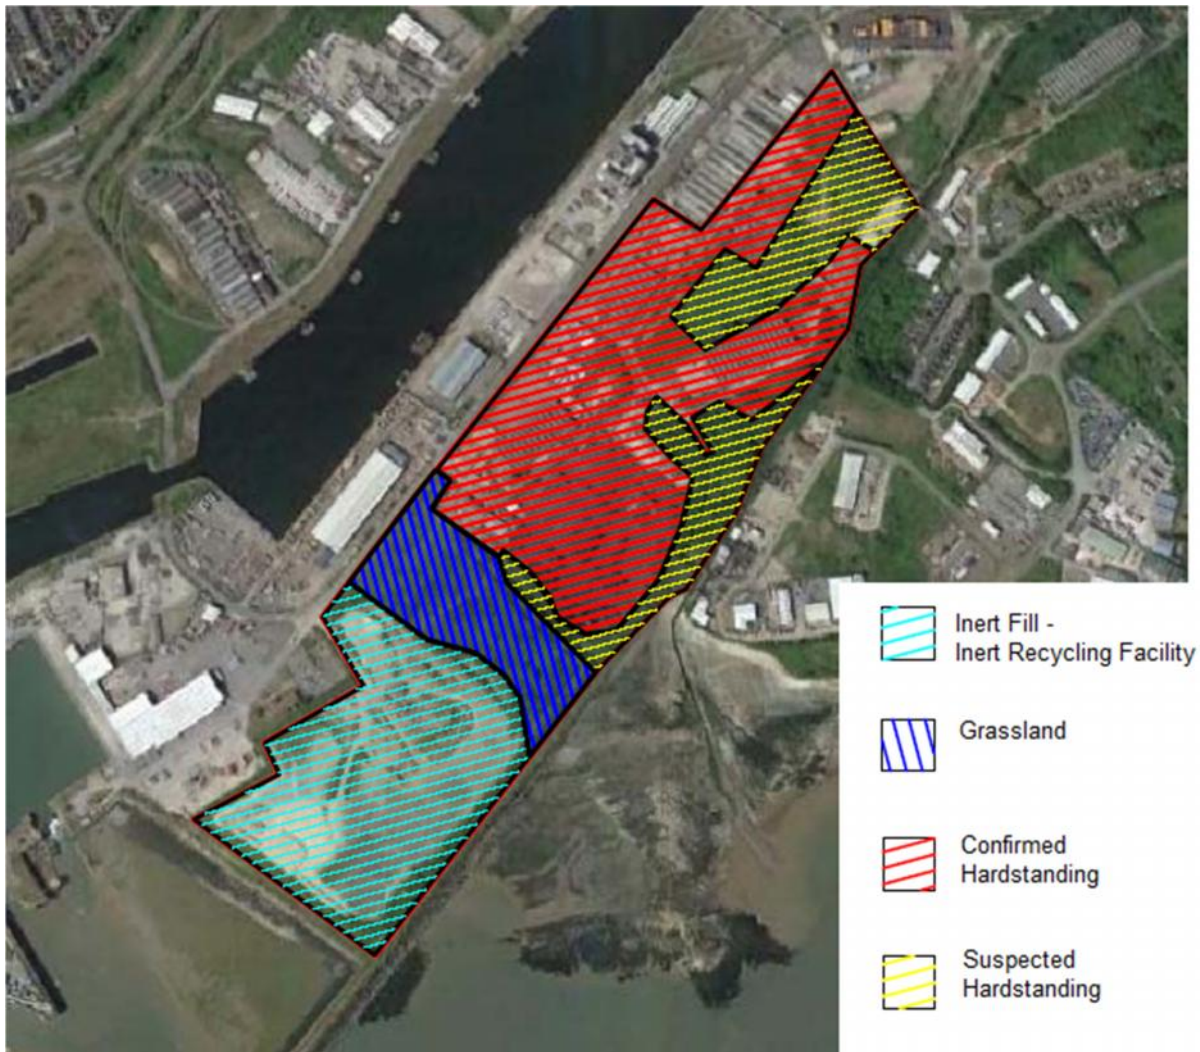
**Figure 4.3 – Surface Types**

The site inspection and targeted trial pit investigation confirmed the presence of hardstanding or inert soil cover in the locations indicated on Figure 4.3 below.

Hand dug trial pits were excavated through the very shallow soils in order to determine the approximate extent of hardstanding in the areas shown as suspected hardstanding in figure 4.3 above.

Hardstanding typically comprising compacted gravel was encountered below the shallow surface soils present in the investigation areas.

Following completion of the works above, the whole development site has been confirmed to comprise hardstanding at surface level, or just below shallow soils, where these are present.
