**GEOPHYSICAL SURVEY  
REPORT G1506**

**Culverhouse Cross to  
Cardiff International Airport / St  
Athan Enterprise Zone Link:  
Geophysical Survey**

## Culverhouse Cross to Cardiff International Airport/St Athan Enterprise Zone Link: Geophysical Survey

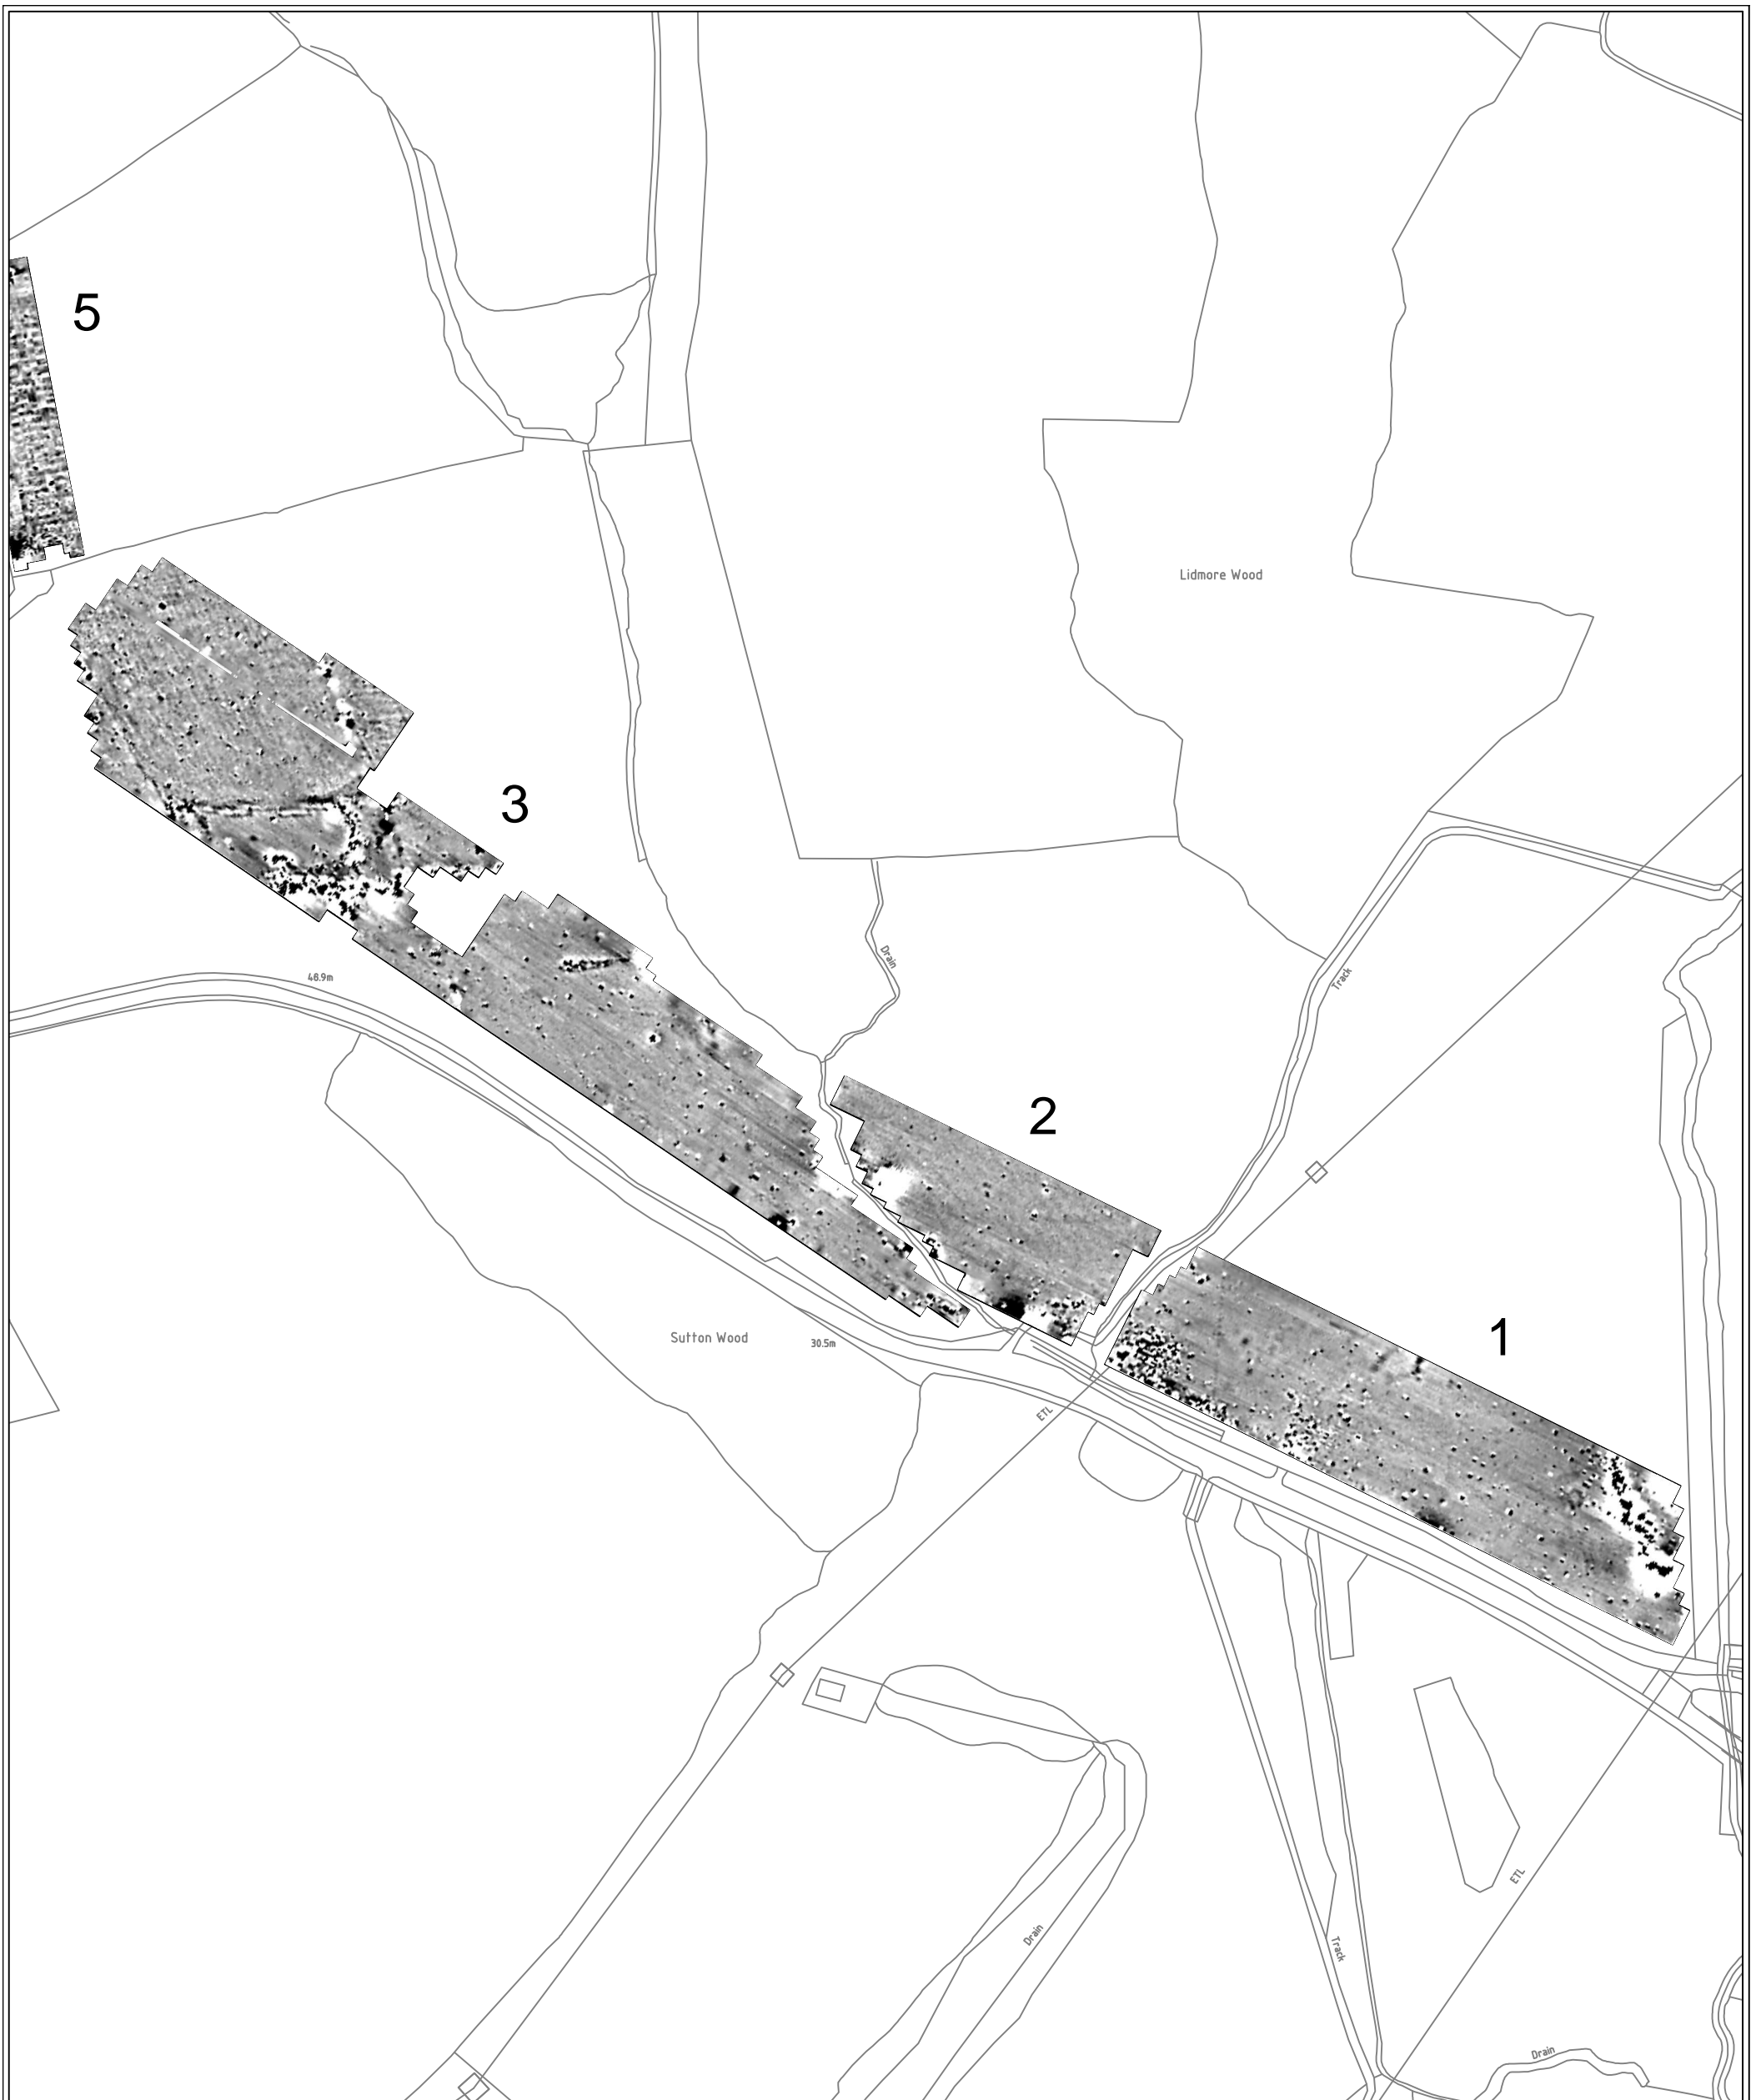
**Figure 3**

- 1.1 Apart from a few trends and responses of uncertain origin, there is little in the data of specific interest. While the uncertain responses could be archaeological they are more likely to be agricultural or natural geological effects; the responses lack any clear definition and are unlike the archaeological responses elsewhere in the dataset.
- 1.2 There is an old field boundary (OS 2015) visible in Area 3 and ploughing trends are recorded which stop at this former division.

**Title:** Magnetometer Survey: Greyscale Plot  
 (Areas: 1-3)

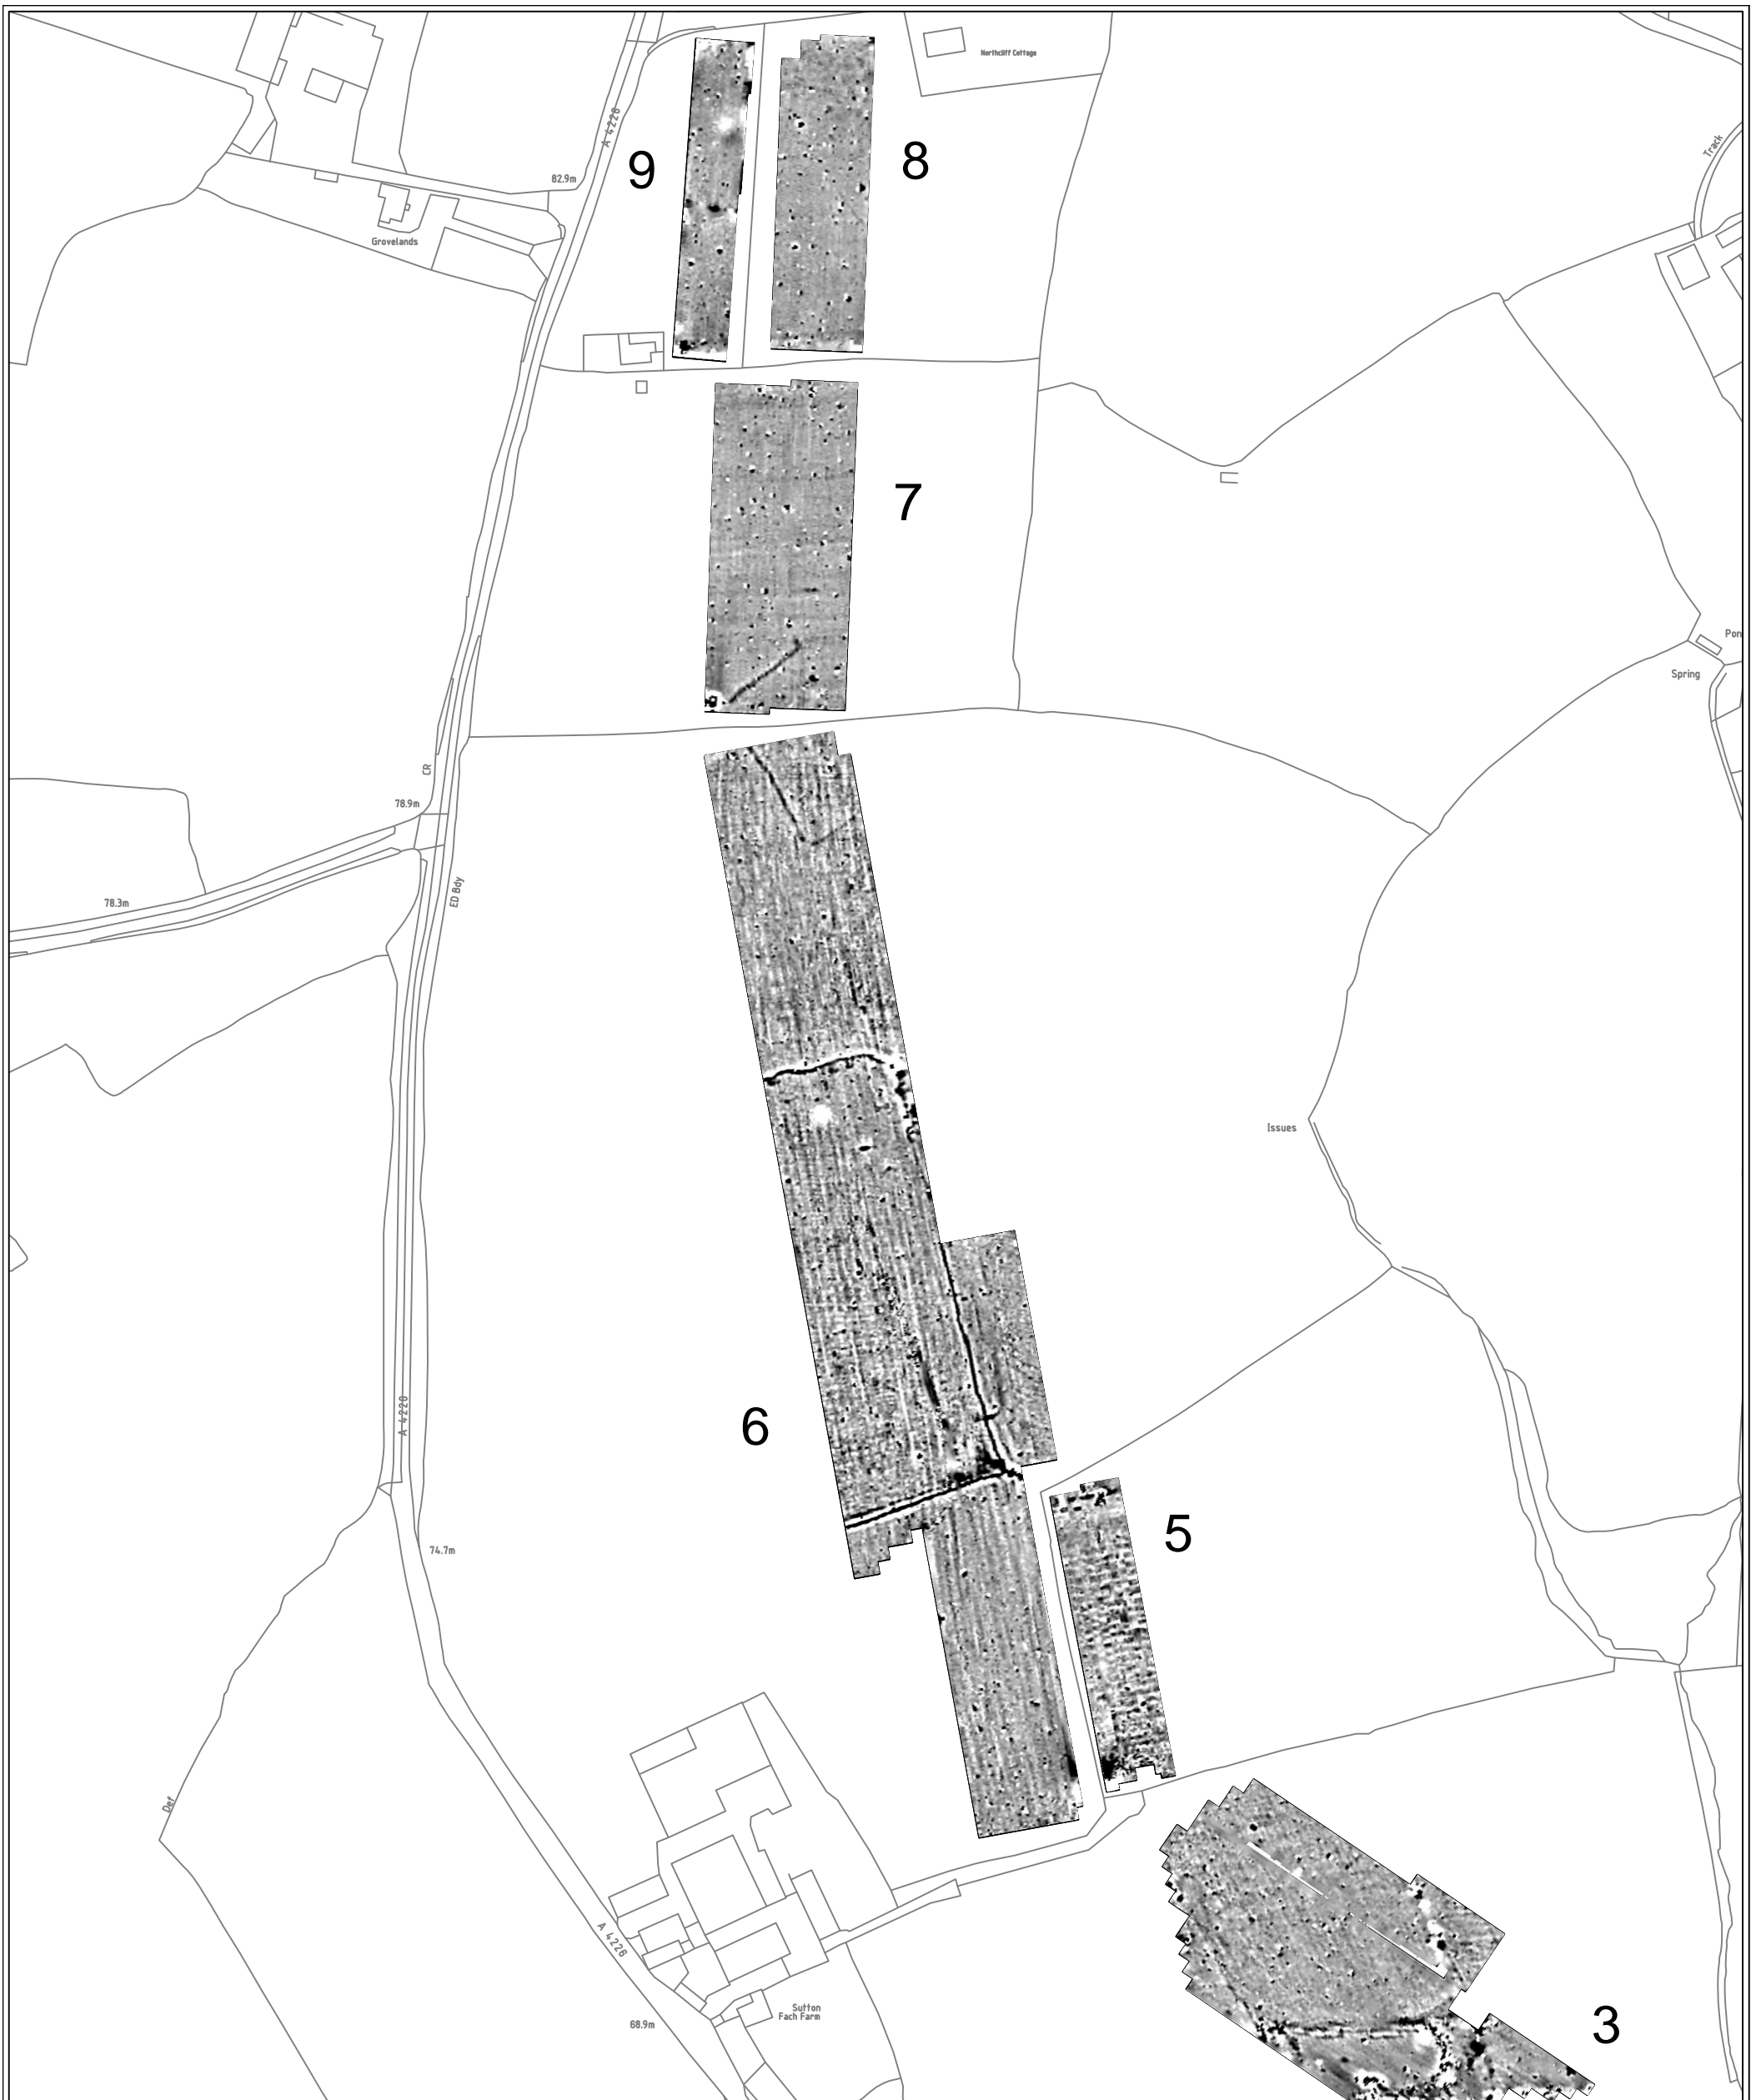
**Figure 5**

- 1.3 Straddling Areas 6 and 7 are three linear anomalies which appear to form an open-sided ditched enclosure with definite archaeological potential; it is unclear whether the features extend to the east, beyond the survey limits.

- 1.4 To the south of this 'enclosure', there are numerous uncertain responses in the data. For example, approximately 75m to the south of the 'enclosure' is a small 5m rectilinear feature and a similar sized irregular arc; their close proximity to the recorded archaeological features adds weight to their potential interest. Similarly in Area 7 there are several weak trends which appear to form rectilinear patterns which could be of interest, though in this instance they could easily be the result of ploughing.

- 1.5 In Area 6 there are well-defined linear anomalies which correspond to former boundaries visible on historic mapping (OS 2015). The narrow band of disturbance following a north-south alignment equates with vehicle ruts leading to a test borehole. There is a scatter of responses close to the corners of Areas 5 and 6 and these are thought to simply reflect the removal of the old boundaries.

- 1.6 Ploughing effects are visible in the data in most of the fields, though they are less prominent in Areas 7 – 9.

**Title:** Magnetometer Survey: Greyscale Plot  
 (Areas: 5 - 9)

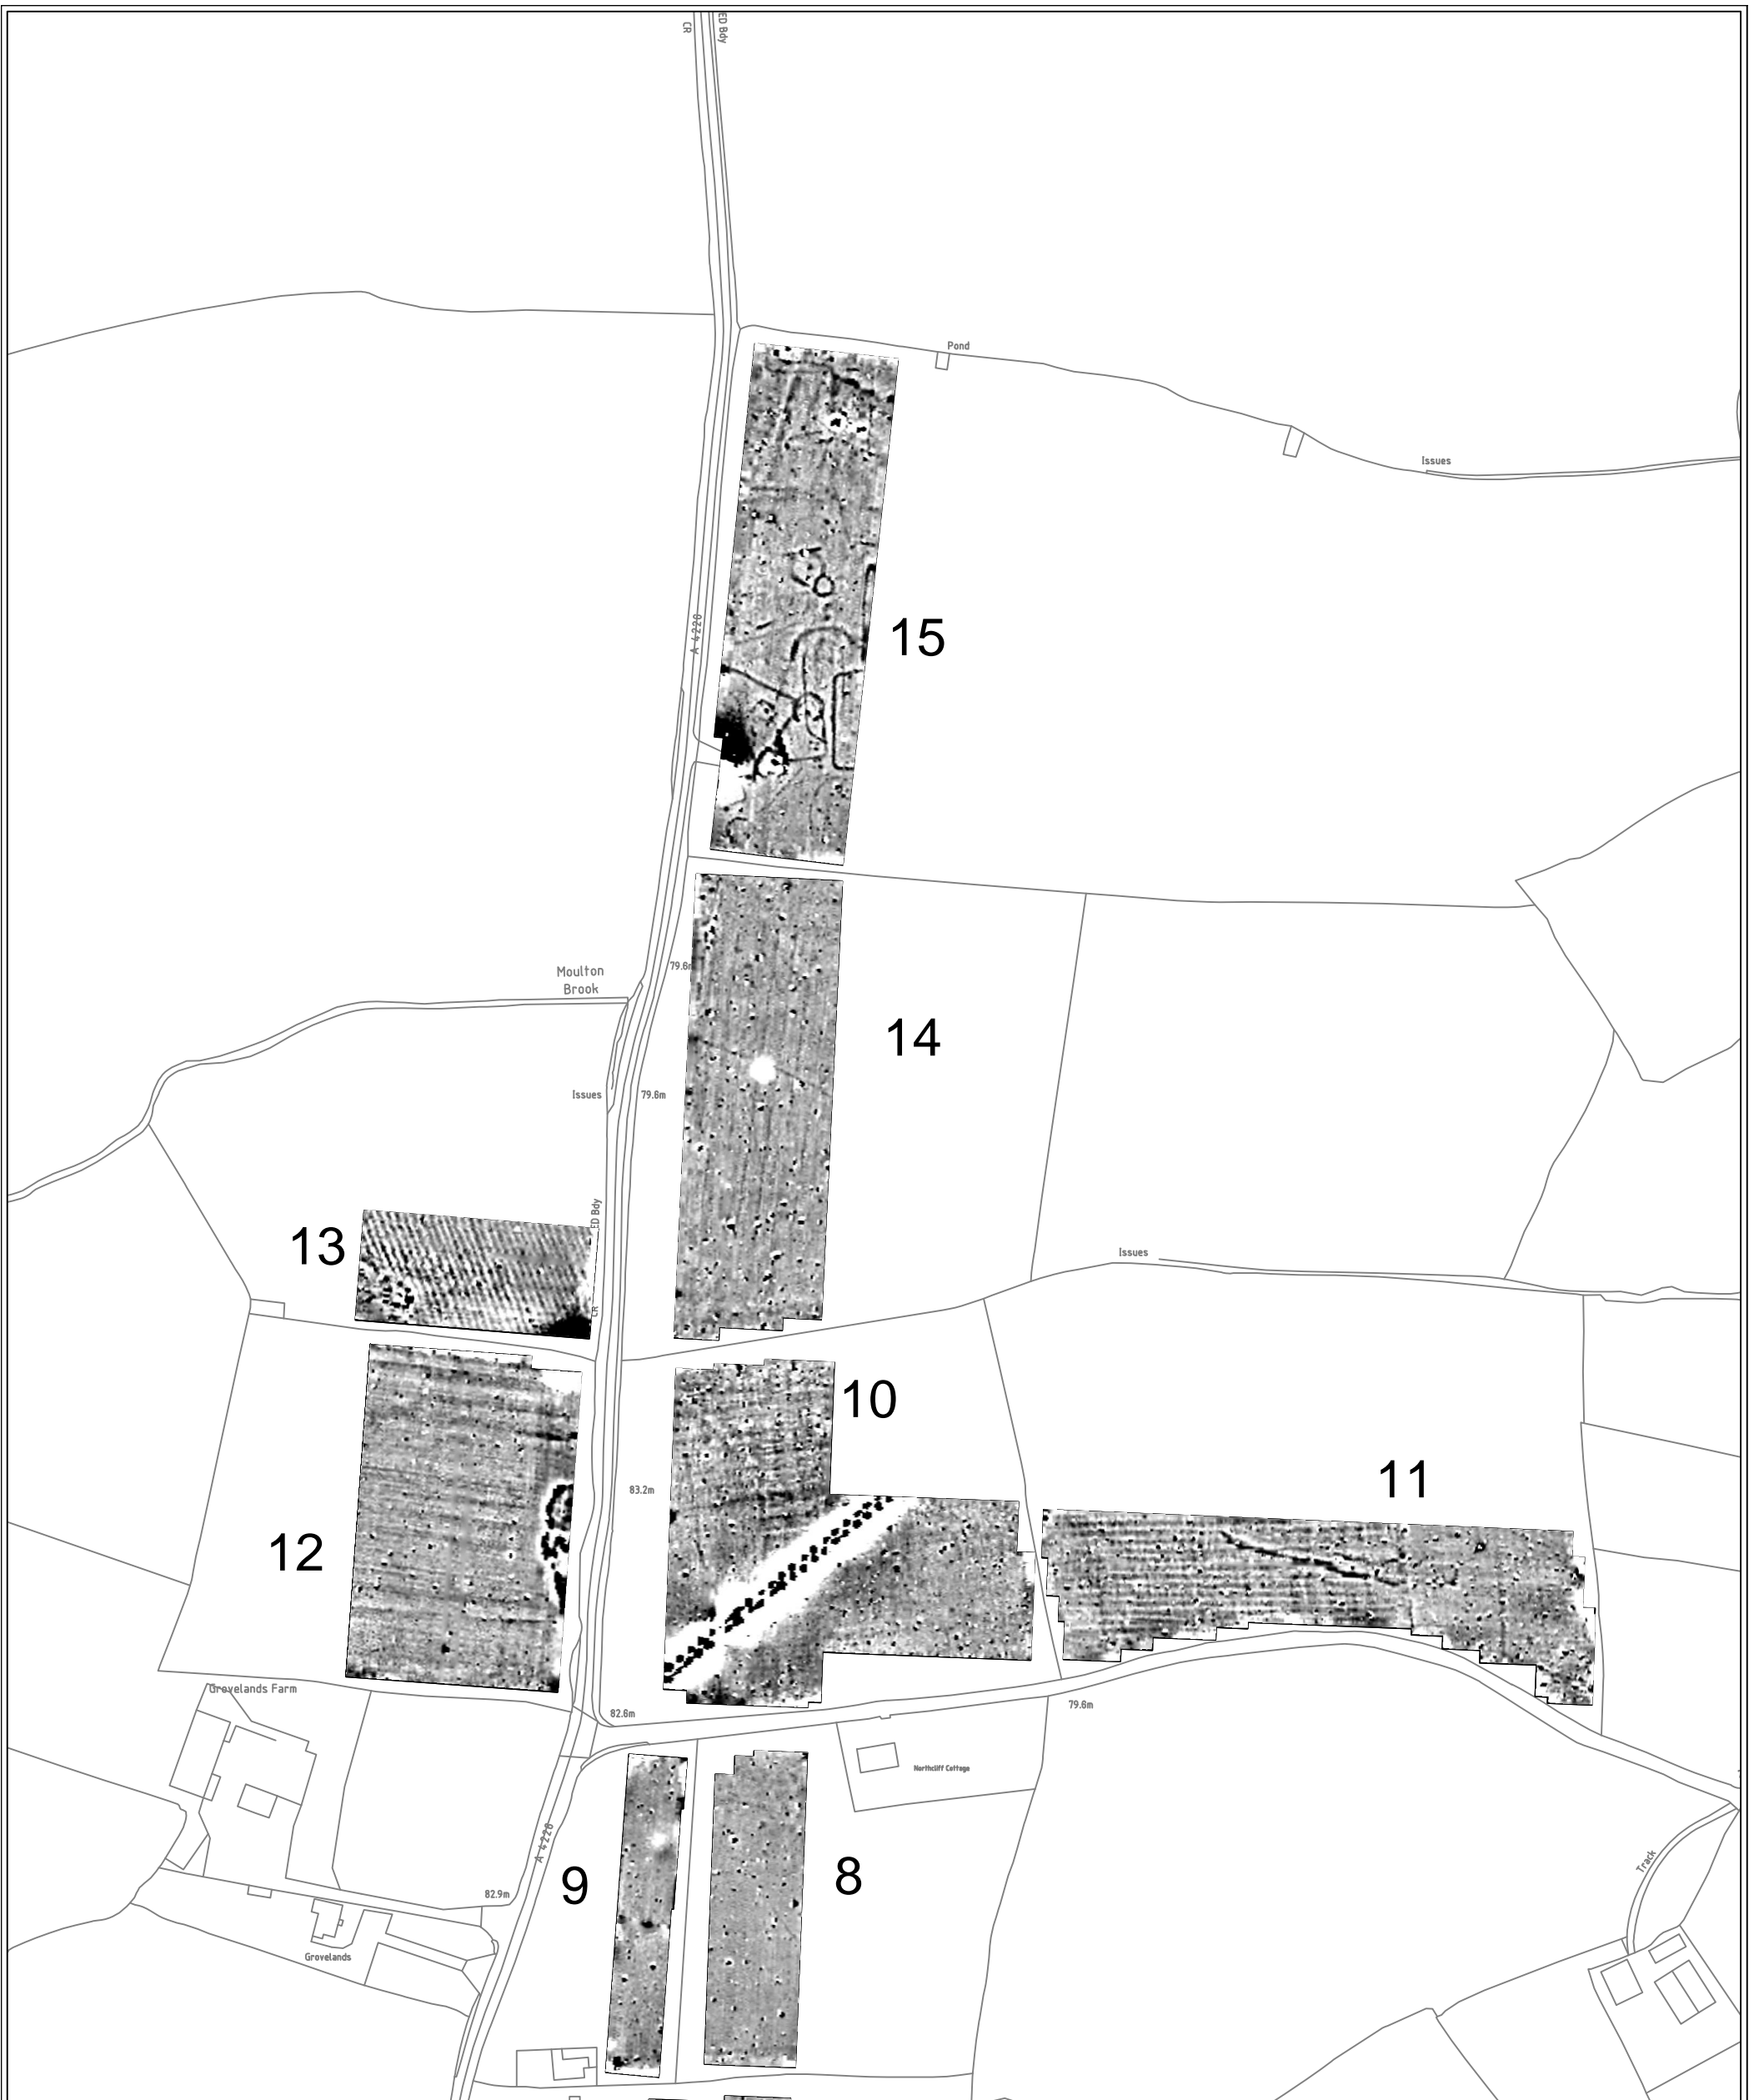
**Figure 7**

- 1.7 There are three clusters of anomalies which are difficult to interpret. In Area 11 there are linear responses and trends on differing alignments to the ploughing, in Area 12 are some strong anomalies immediately adjacent to the A4226, and in Area 13 there is a group of pit-like responses. In the absence of a known context an archaeological interpretation is perhaps unlikely but the responses do not appear strictly agricultural or natural in origin. Some anthropological explanation is therefore probable, but perhaps of a recent (modern) date.
- 1.8 Once again differing ploughing practices are visible in the data. Two pipes cross diagonally through Area 10.

- 1.9 There is a marked contrast between the results from this area compared with any of the other fields surveyed. There is a complex of responses associated with a number of features of archaeological interest. Ring ditches, some complete and some partial, are interspersed amongst rectilinear features and enclosures which clearly extend beyond the limits of the survey area. A few pits are also visible. Many of the anomalies appear to intersect with others and the results suggest multi-period activity. In the north of the field there may be two kiln-like features; a lime kiln is recorded in the field to the north. Given the known Roman villa in this field (Area 16 which

had previously been surveyed - GSB 2010 & 2010a) it is likely that many of the features are associated, though the ring ditches may be of an earlier date.

**Title:** Magnetometer Survey: Greyscale Plot  
 (Areas: 10 - 15)

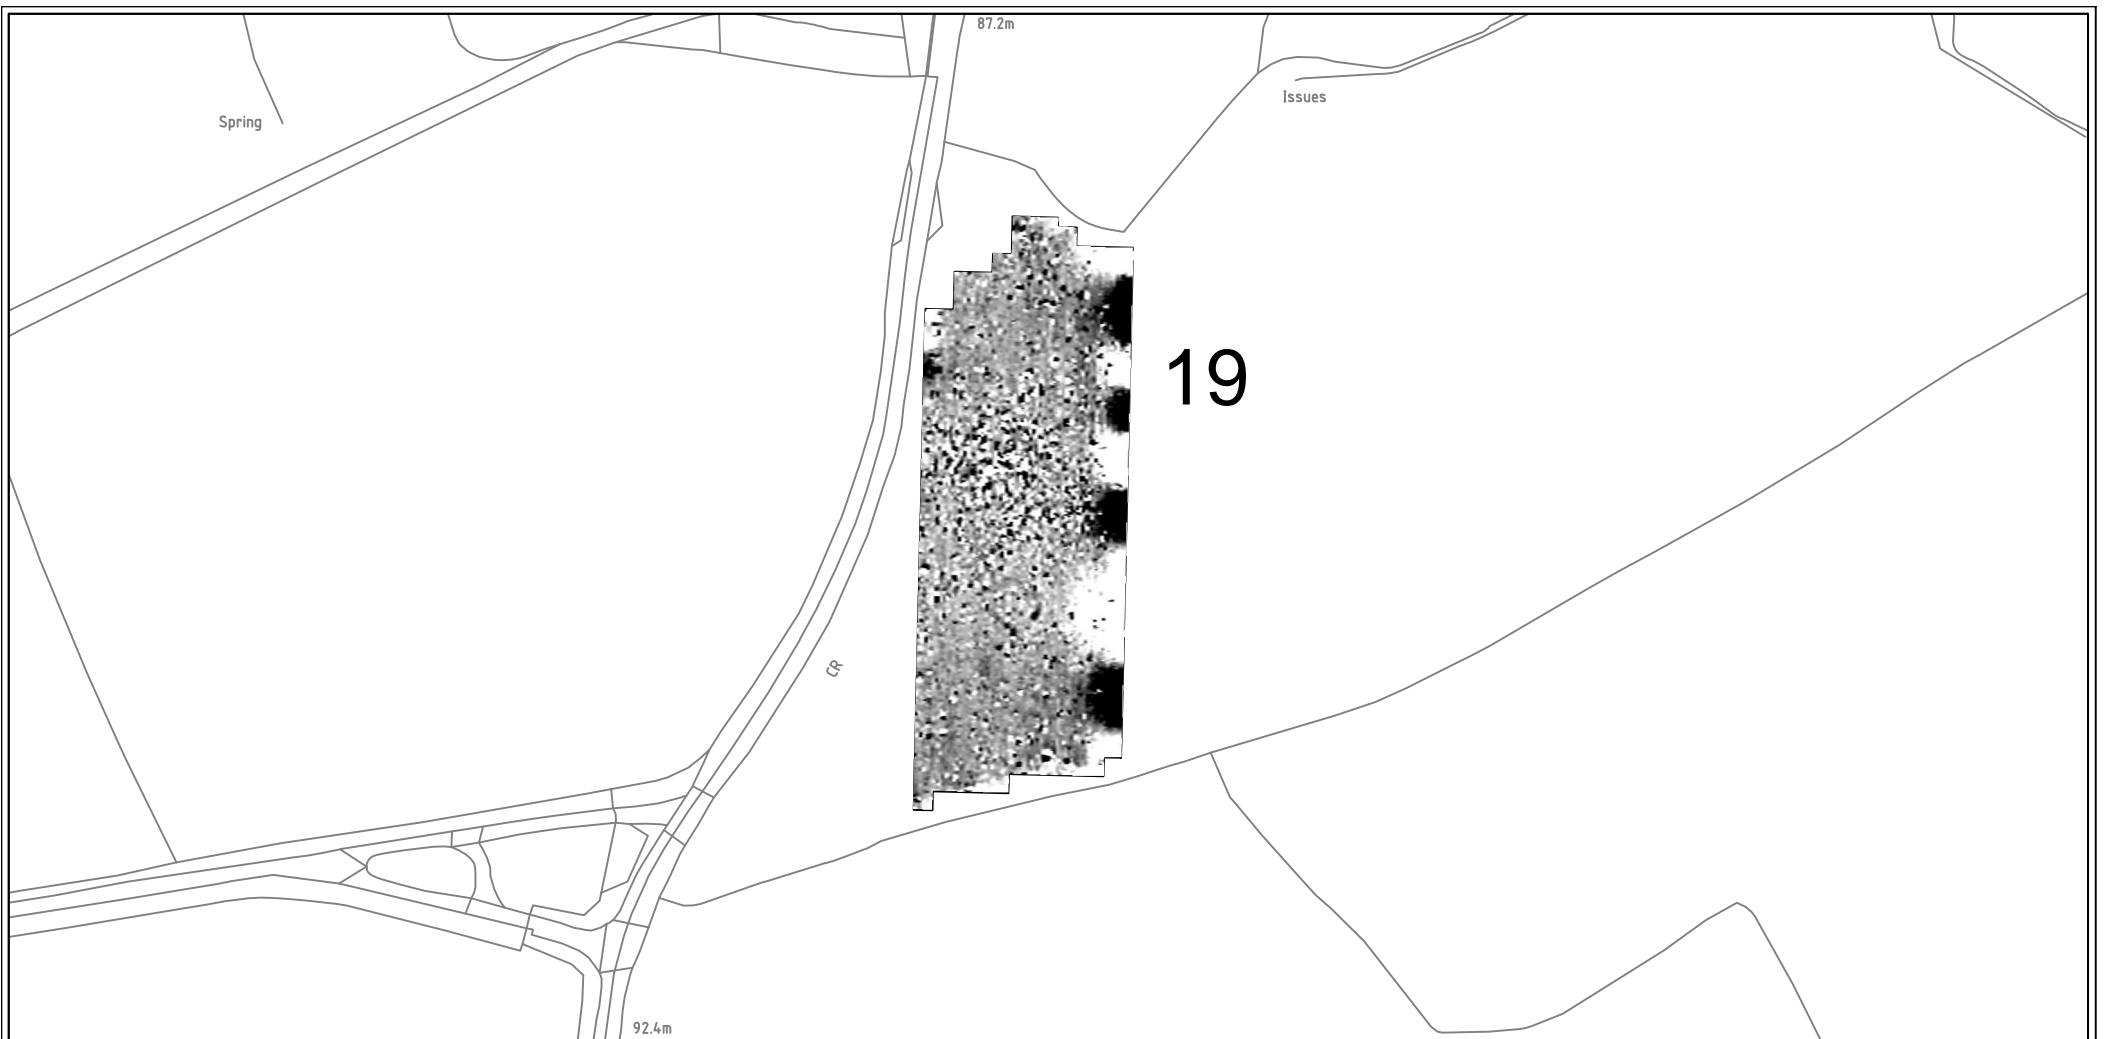
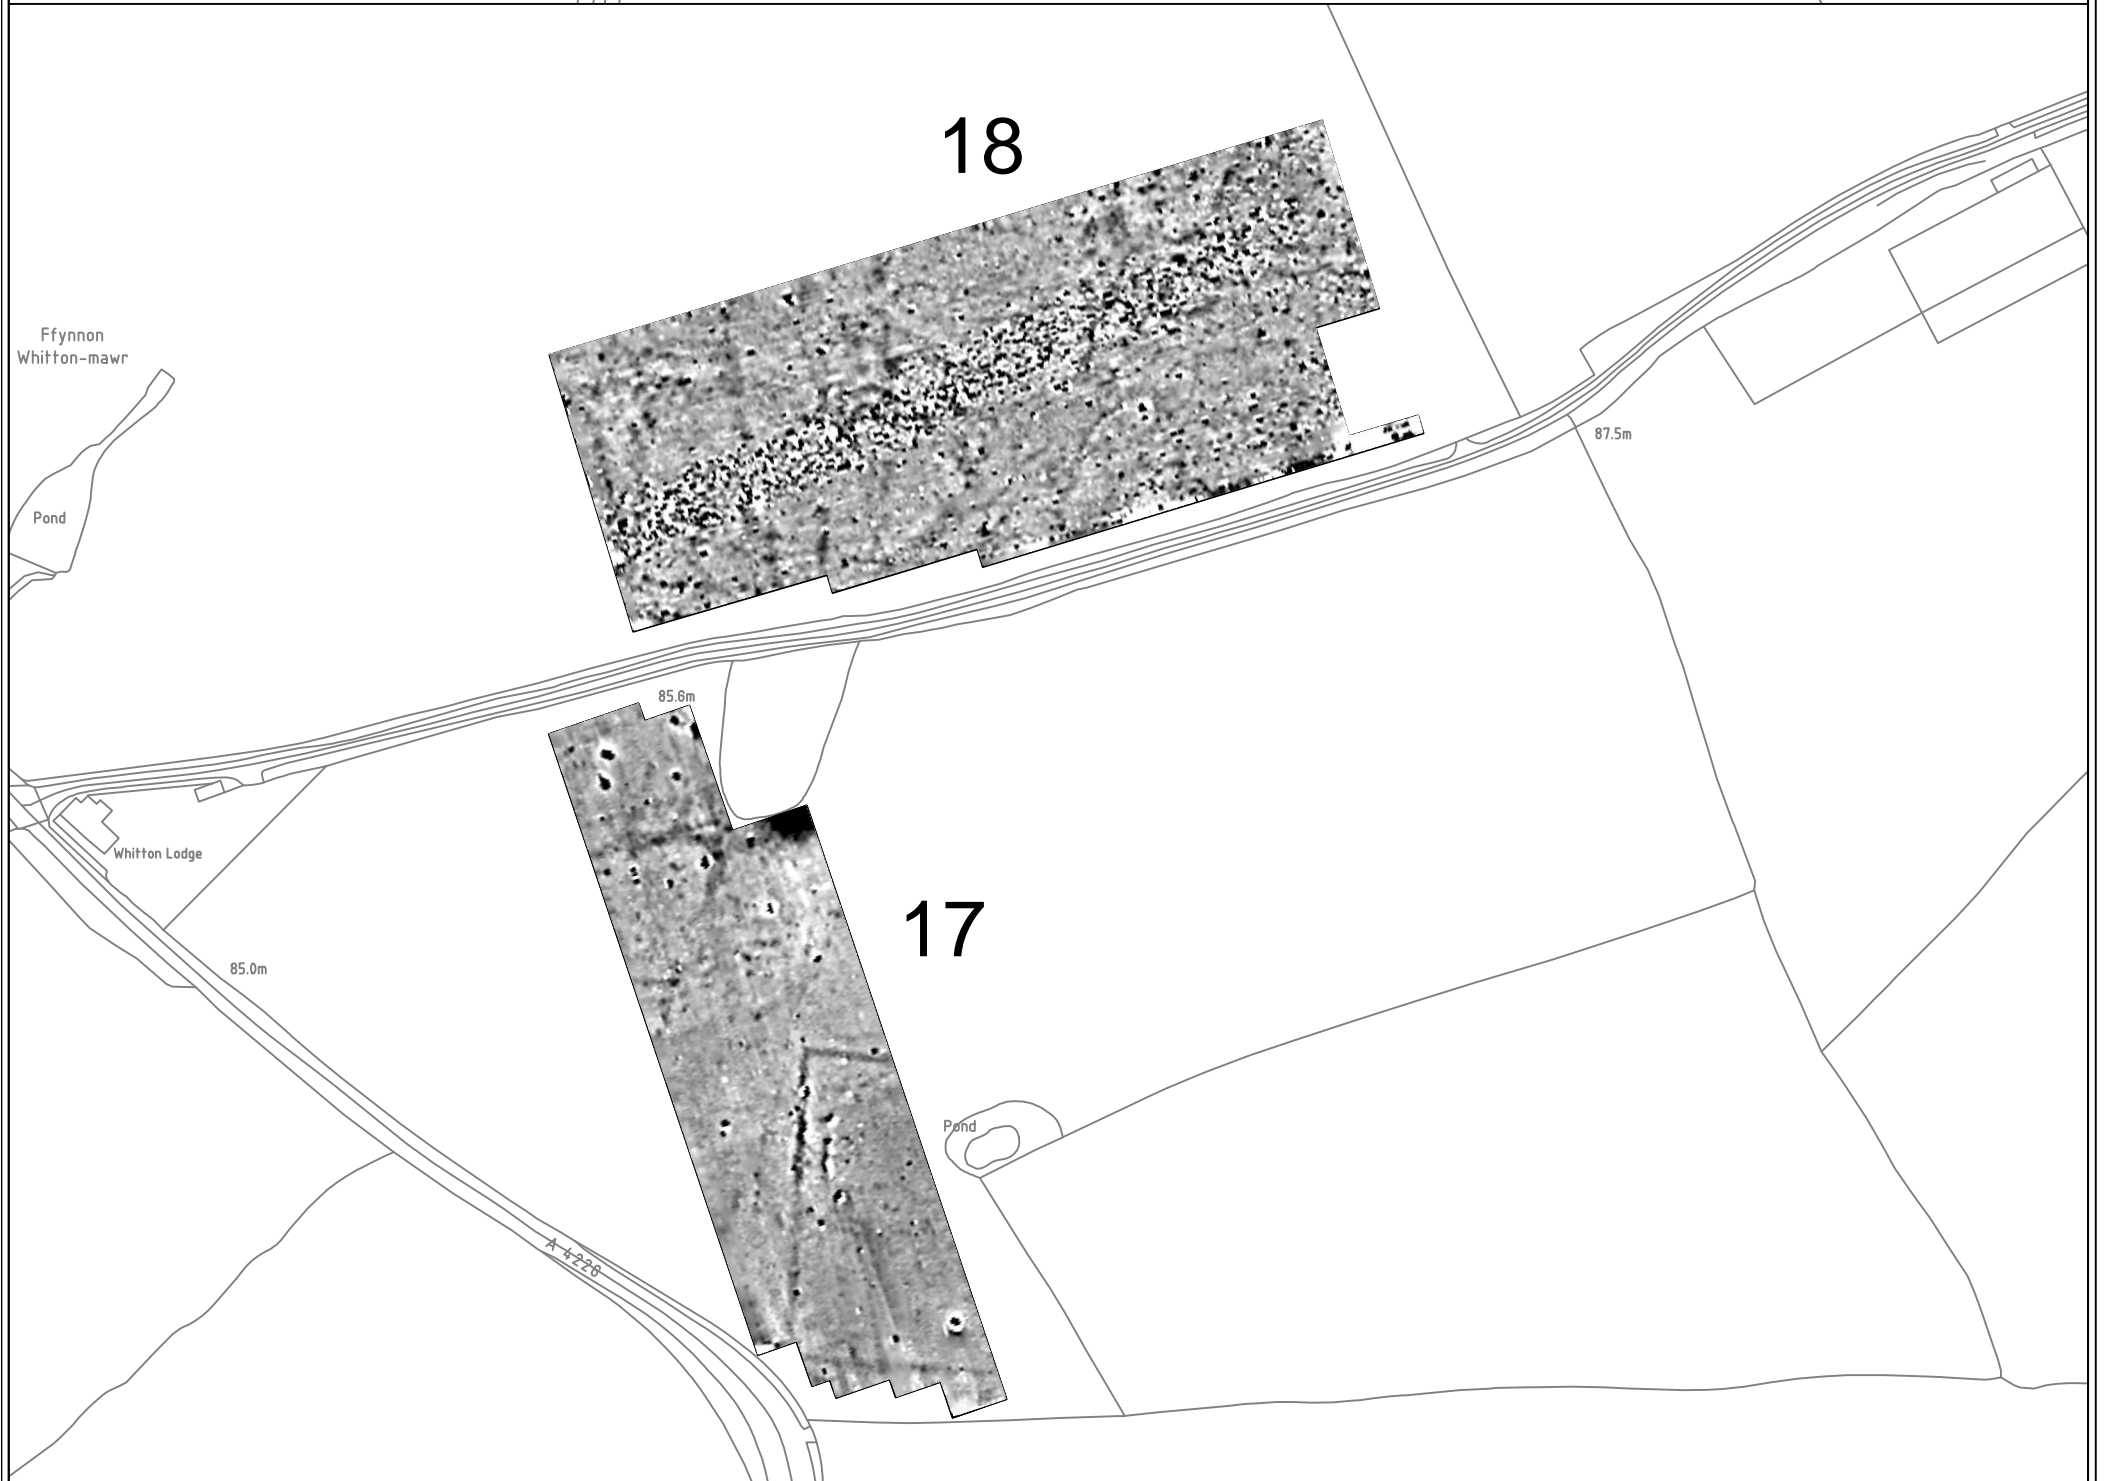
**Figure 9**

- 1.10 There is a clear rectilinear anomaly in Area 17 which presumably relates to the villa in Area 16 to the south. It extends beyond the survey area and apart from a few ferrous type anomalies there do not appear to be any concentrations of features within the western half of the enclosure.

- 1.11 There are several uncertain responses in both survey areas. The anomalies are not as well-defined as the archaeological responses and the limited width of the survey area hinders a wider view. As such it is likely that the data indicate natural variations in the local soils, with the possible exception of the responses closest to the enclosure in Area 17.

- 1.12 A band of magnetic disturbance / enhancement crosses Area 18; it is thought to be recent as it is not visible in data collected in the 2010 survey (GSB).

- 1.13 There is little of interest in the data from Area 19. A large pipe runs along the eastern edge of the survey; there is a small zone of increased magnetic response and a few uncertain trends but neither are thought to be of any archaeological significance.

**Title:** Magnetometer Survey: Greyscale Plot (Areas: 17, 18 and 19)

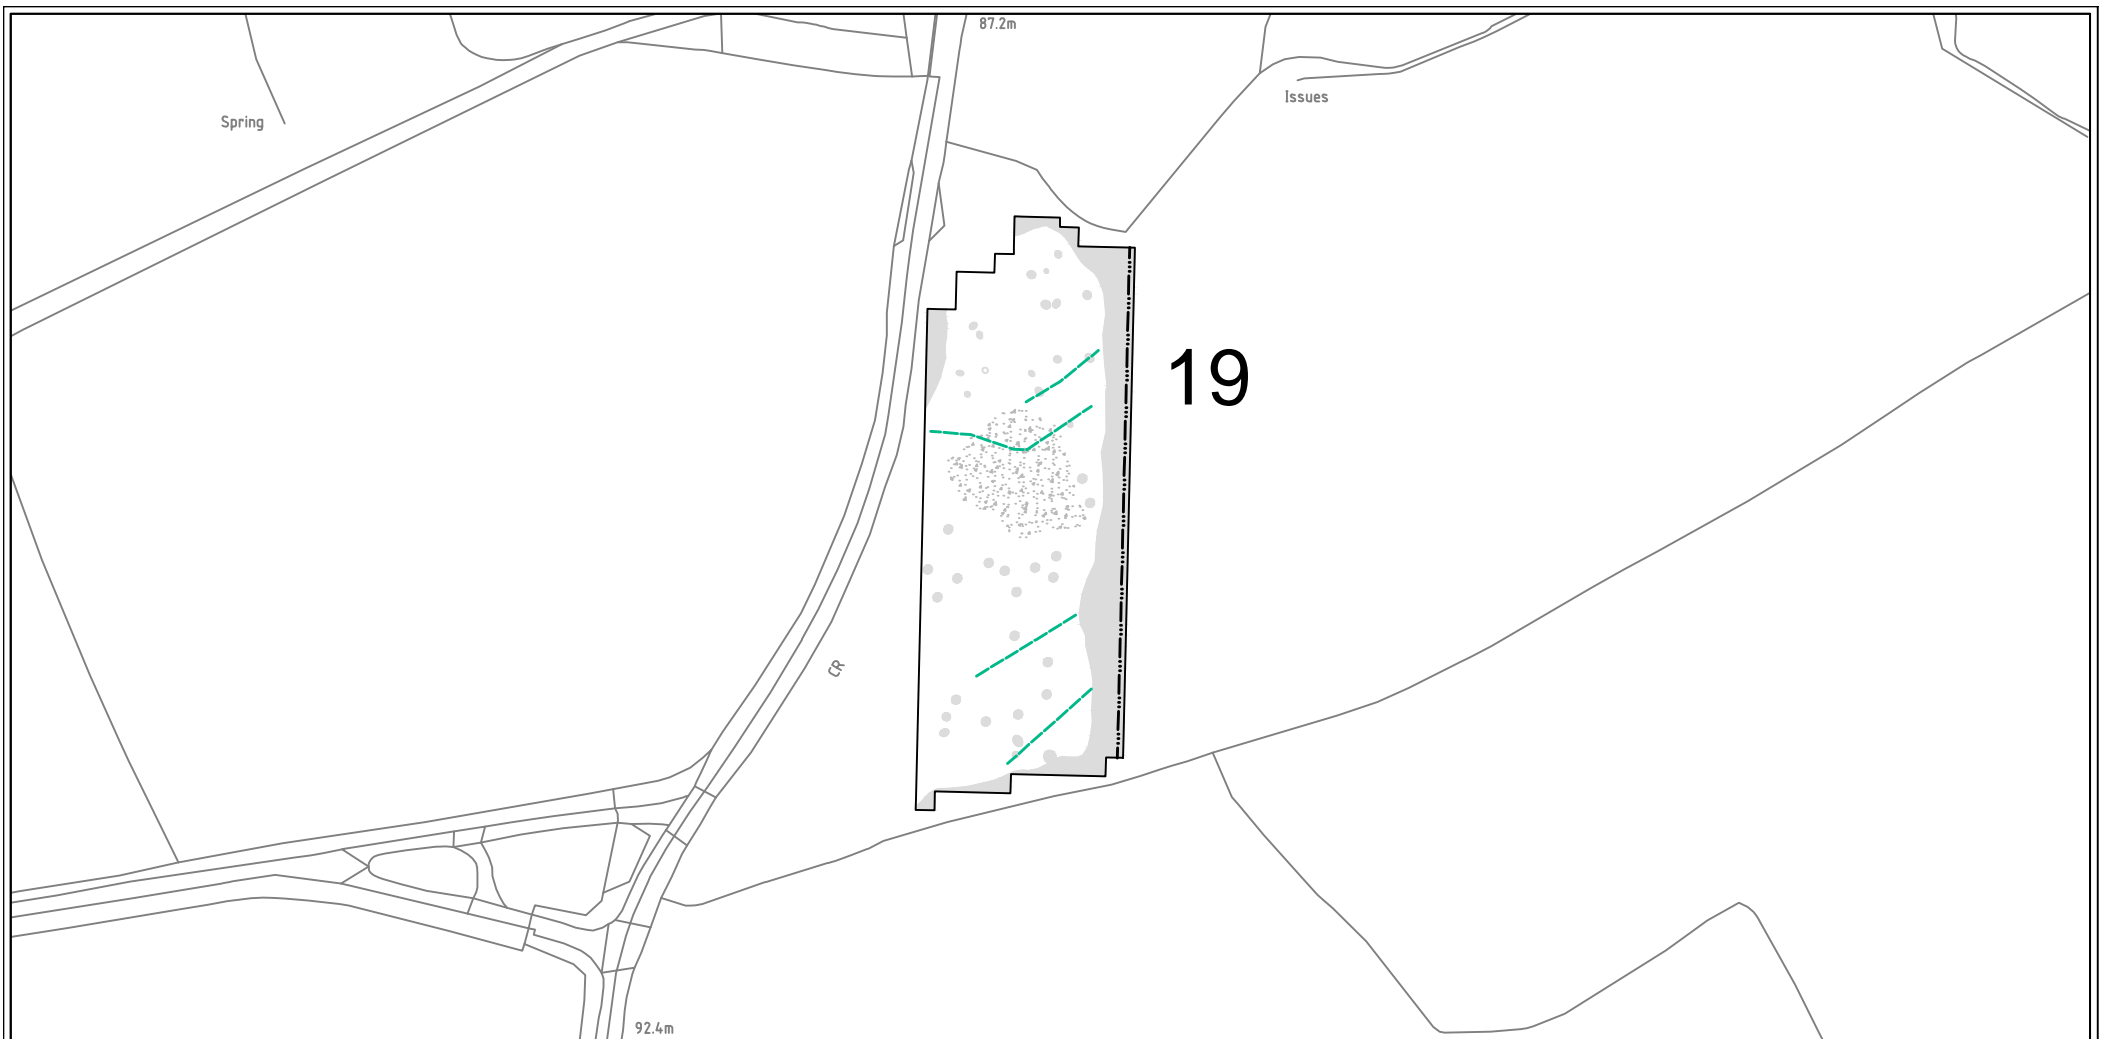
**Figure 10**

**Title:** Magnetometer Survey: Interpretation  
 (Areas: 17, 18 and 19)
