Five Mile Lane Road Improvements, Barry, Vale of Glamorgan

Archaeological Watching Brief

Report No. 1306

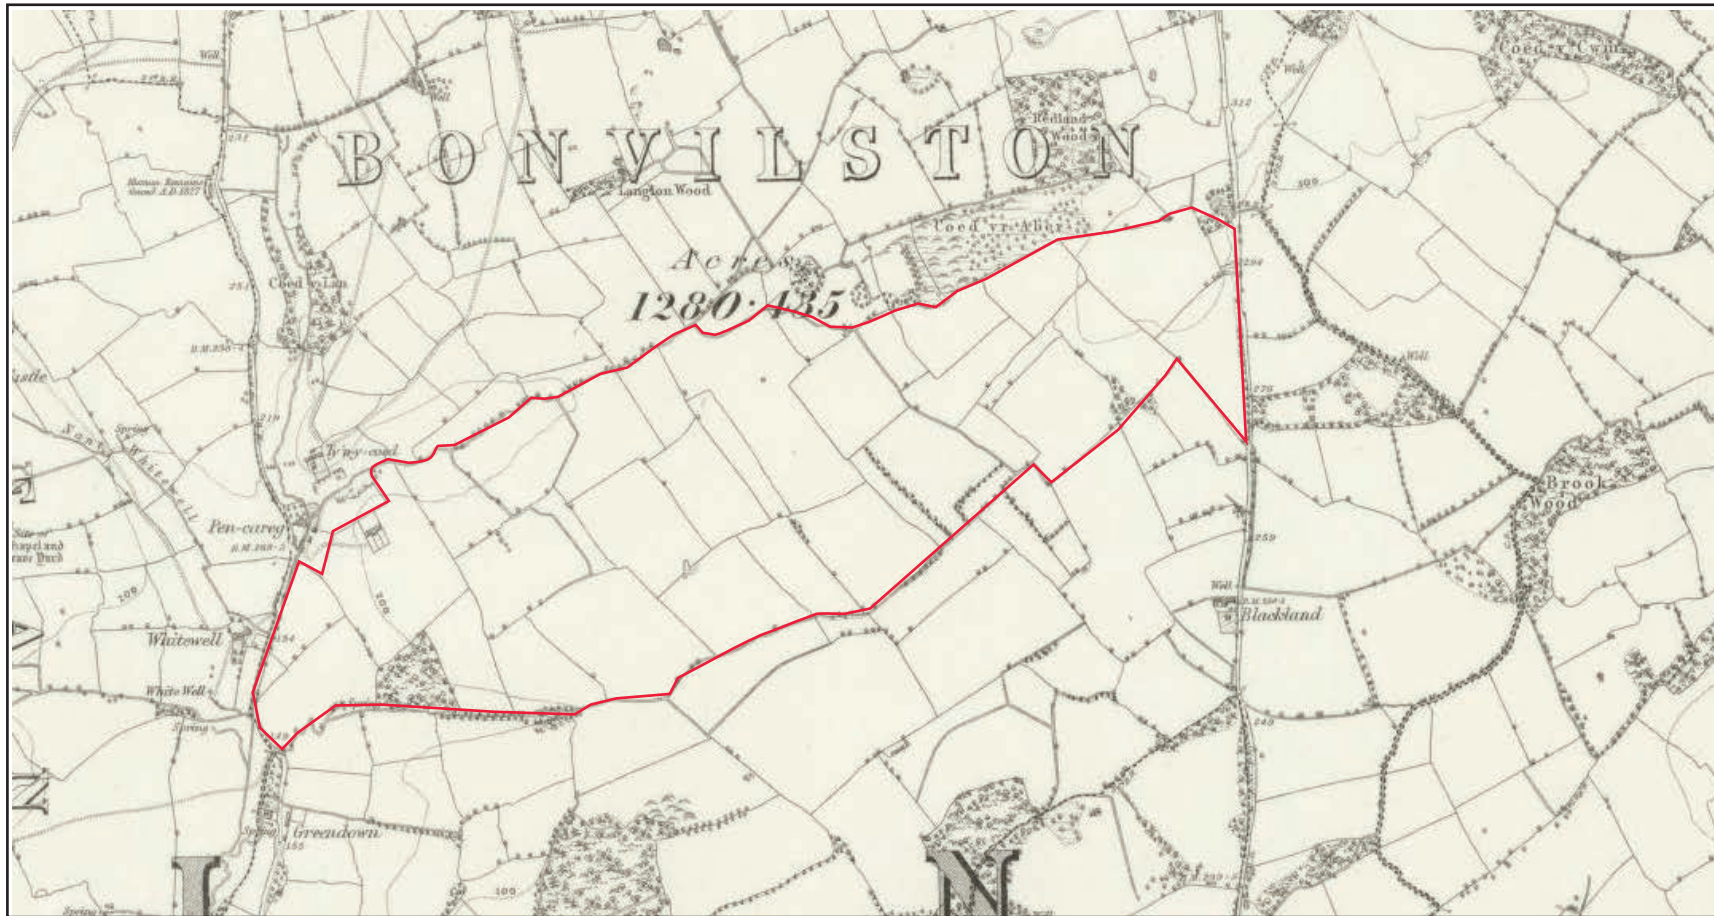
Fig. 4
Bonvilston
Amalgamated
Fieldscape on
1885 OS Map

Bonvilston Fieldscape (HLCA 010), located immediately west of the northern section of the road, displays a good example of the merging of medieval strip fields into a post-medieval field system and possible limestone extraction quarry (GGAT HLCA 010, 2015; figs. 2 and 4).

To the immediate west of the current A4226 and 0.8km south of Bonvilston village Bonvilston Amalgamated Fieldscape (HLCA 010) comprises open fields with preserved earthworks formed by the amalgamation of medieval stripfields (figs. 2, 4). These field boundaries appear to have been opened up post-1945 when they appear intact, as they did in the 1885 OS map (fig. 4).

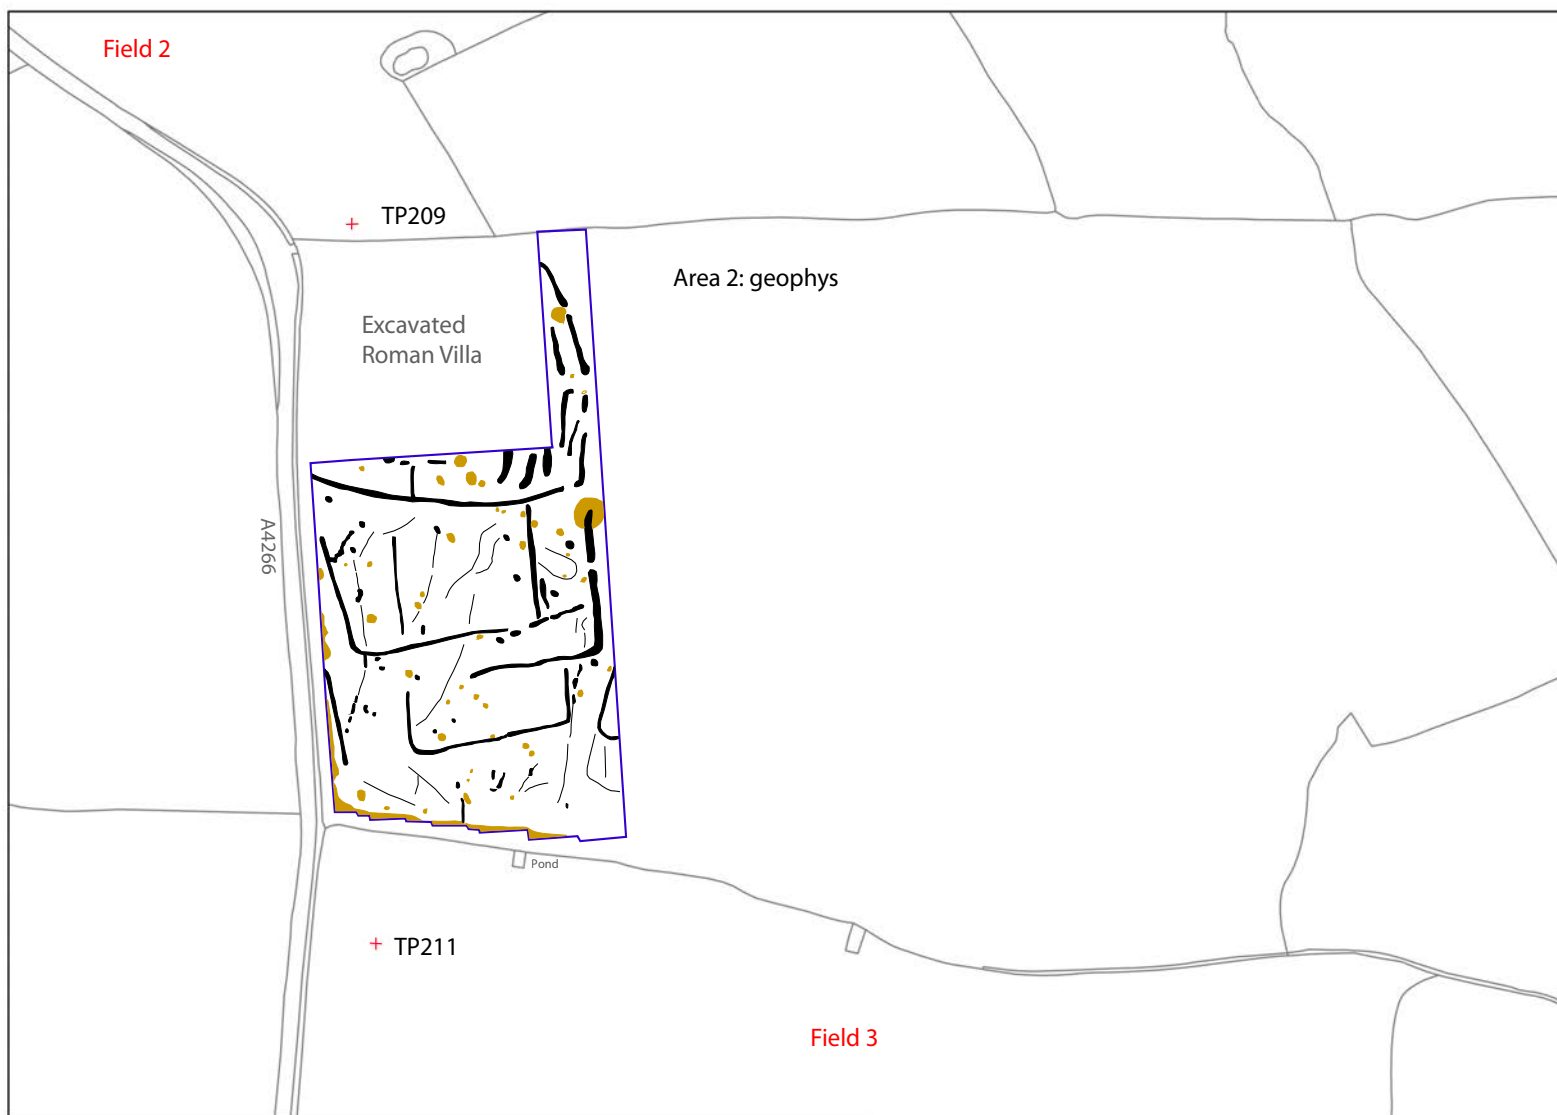
Fig. 7
Area 2 of geophysics
survey
interpretation (after
Tanner 2010, fig.3)

- TP208
+ Test Pit
- Ferrous area
- Anomaly:
probable/possible
archaeology

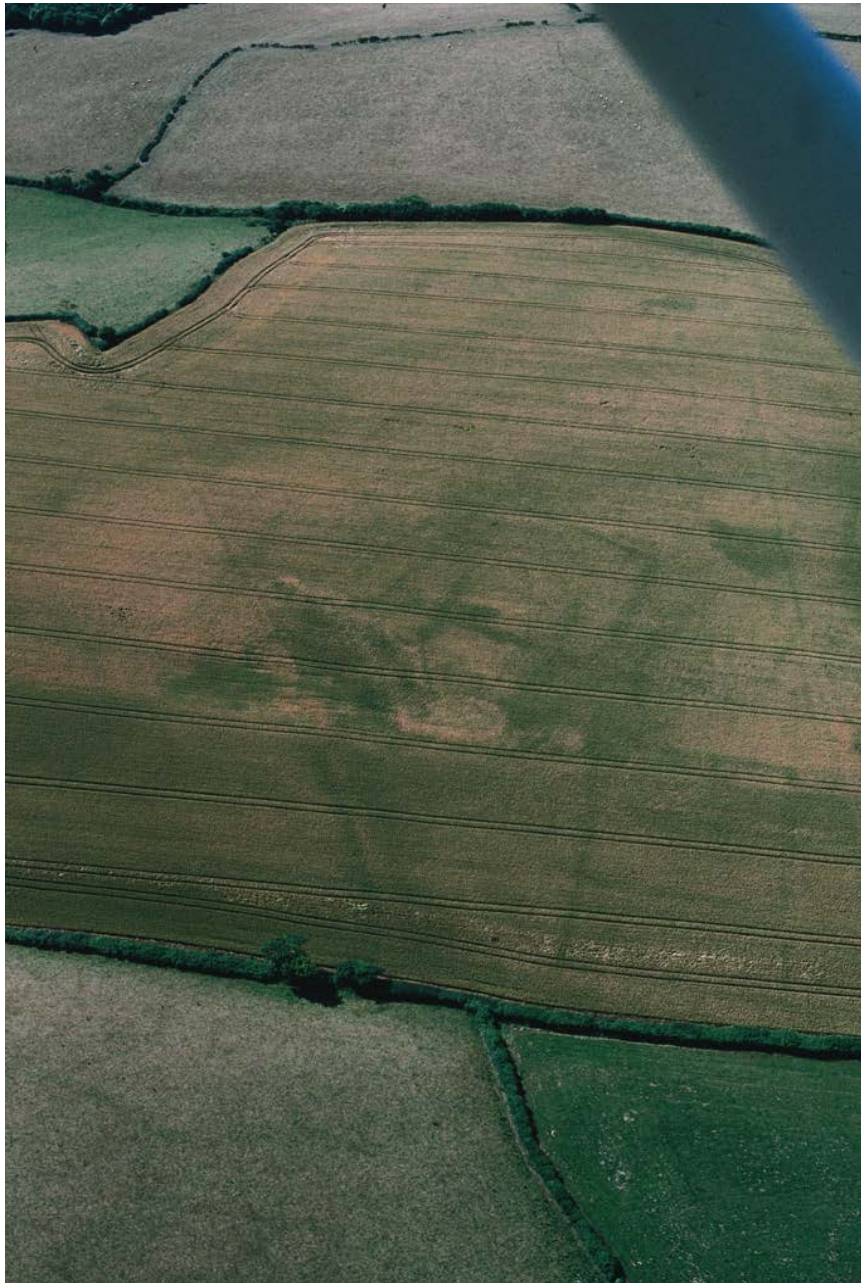
Fig. 8
1996 Aerial Photograph of Whitton Cropmarks

Oblique aerial photograph of Whitton Lodge Roman Villa, (looking south)

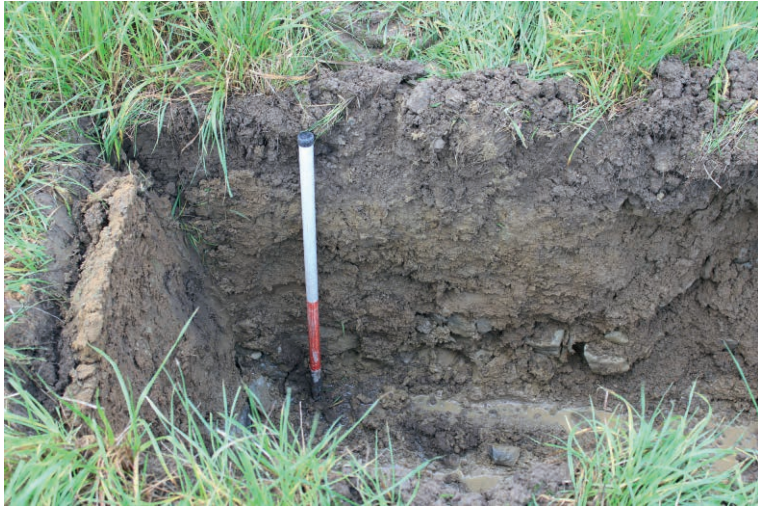
Fig a: Test Pit 206, Scale = 1m

Test pits 201 to 207 were excavated within Field 1, a large sub-rectangular field with an irregular north-eastern corner and curving boundary located adjacent to the A4266, which sloped gently from north to south. The field measures 0.62km north to south and 0.45km east to west and is located to the west of HER site 01434s. Test pits 201 to 205 and 2007 had relatively shallow (0.2m deep) sandy clay topsoil that was found to overlay natural boulder clay. Test Pit 2006, sitting in a hollow towards the southern part of the field, had a colluvial subsoil washed down from the slope on either side resting on top of the natural clay. No archaeological deposits or features were present within these test pits.

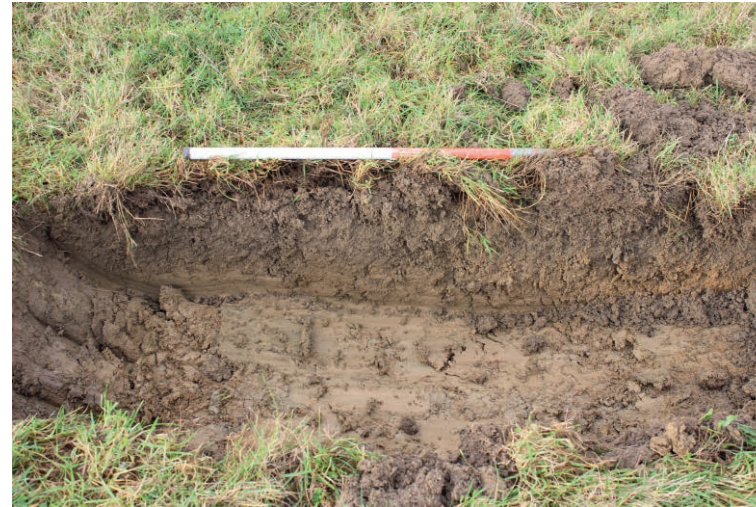
Fig b: Test Pit 208, Scale = 1m

Test pits 208 and 209 were located in the middle and at the southern end of Field 2 to the immediate south of Field 1. This inverted 'L shaped' field is located to the north of 03121s HER site, and measures 0.41km (maximum) east to west by 0.2km (maximum) north to south. Both test pits exposed very similar deposits to those located in the higher areas of Field 1 and no archaeological deposits were observed. Test Pits 211 and 212 were located in Field 3, a sub-rectangular field with an irregular western boundary located to the south of HER site 03121s. The field is aligned east to west and measures 0.45km in this direction and 0.2km north to south. Both test pits were located in the north-eastern and south-eastern areas of the field at similar levels and had characteristic sandy clay top soil of natural boulder clay, which was greyer than those excavated elsewhere. No archaeological deposits or features were observed. Test Pit 213 was excavated in the extreme southern end of Field 4, to the south of Field 3. This 0.9km by 0.6km sub-rectangular field was identical in terms of geology to those excavated in Field 3 and contained no observable archaeological deposits or features.
