CC Ground Investigations Ltd

## FACTUAL REPORT

**SITE:** Five Mile Lane Improvements

**CLIENT:** Vale of Glamorgan Council

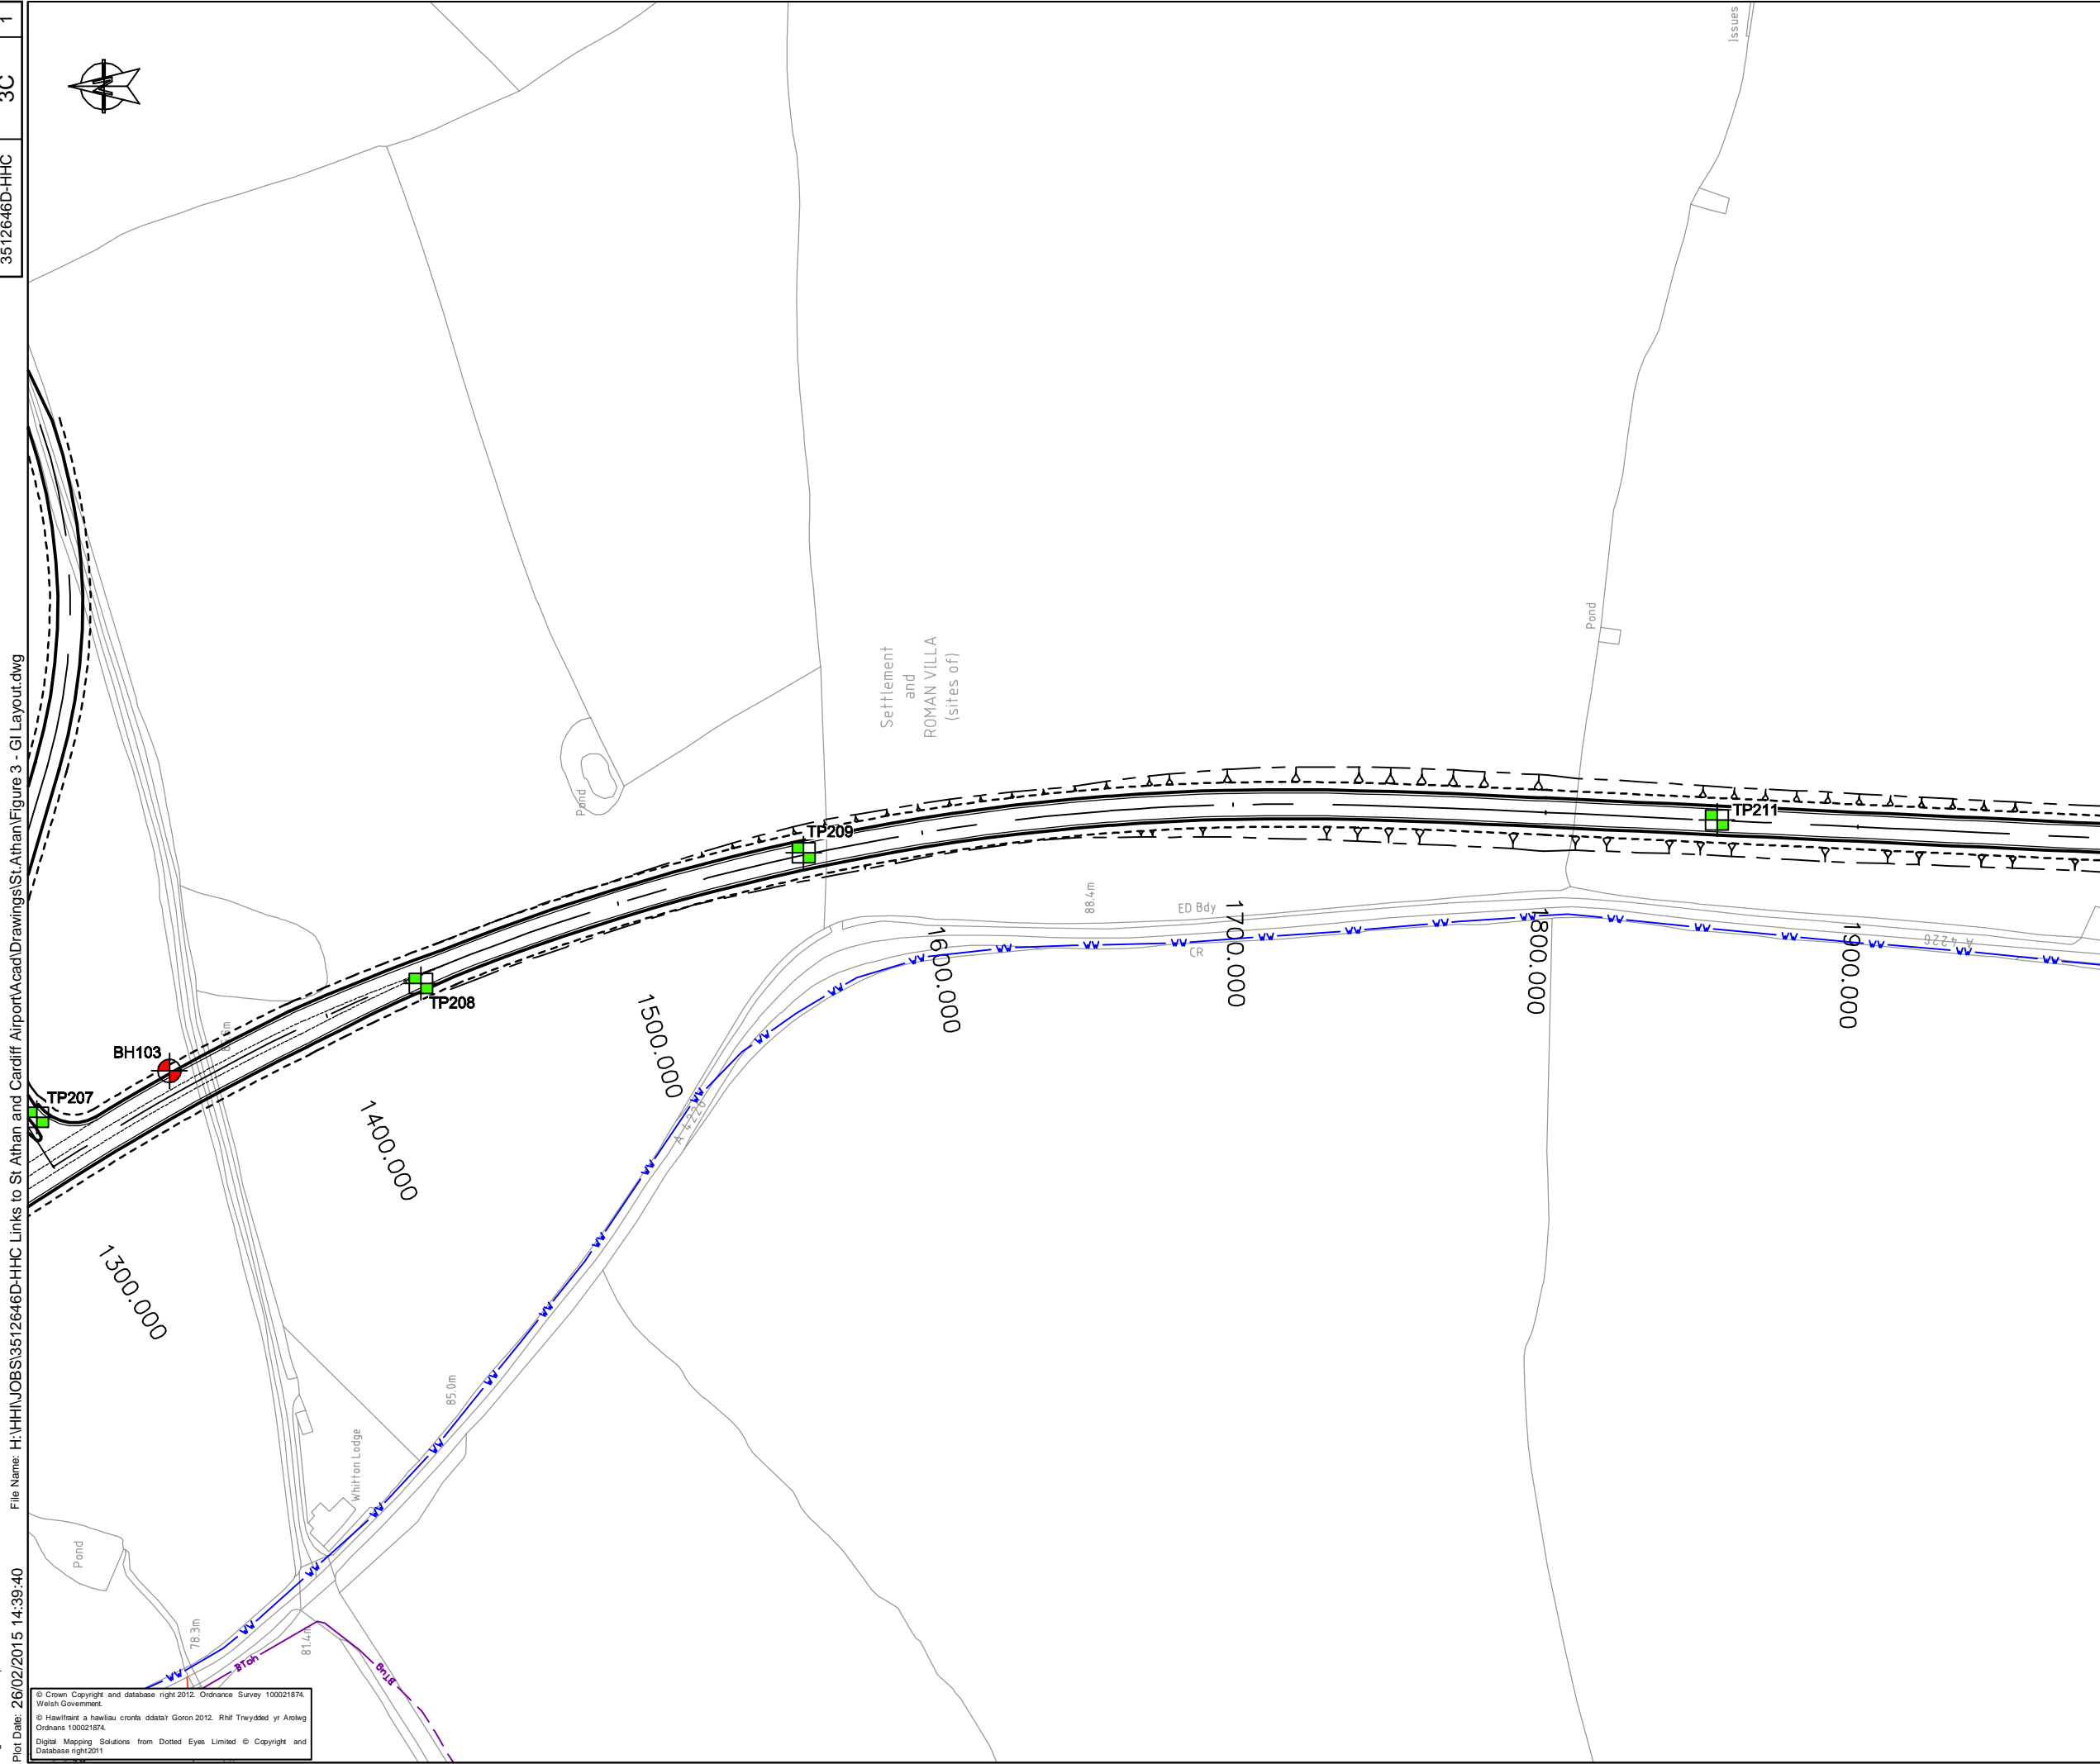
- NOTES**
- THIS IS A C.A.D. DRAWING AND SHOULD NOT BE AMENDED BY HAND.
  - ALL DIMENSIONS IN METRES UNLESS OTHERWISE STATED.
- KEY - INVESTIGATION LOCATIONS**
- TRIAL PIT
  - CBR TEST LOCATION
  - BOREHOLE
- BT UNDERGROUND**
- WATER MAINS**
- NB**
- TP210 OMITTED

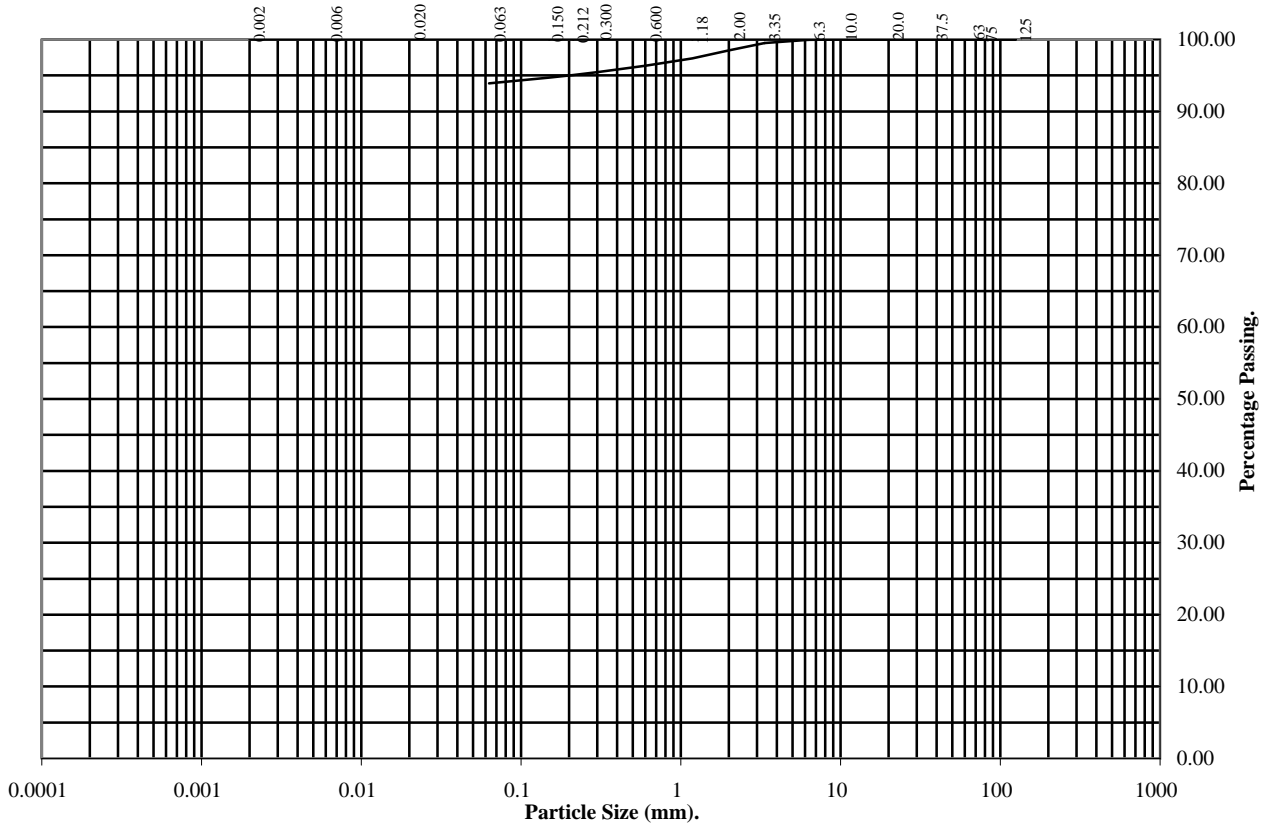
BS Test Sieve	Percentage Passing
125	100
75	100
63	100
37.5	100
20	100
10	100
6.3	100
3.35	100
2	98
1.18	97
0.6	96
0.3	95
0.212	95
0.15	95
0.063	94

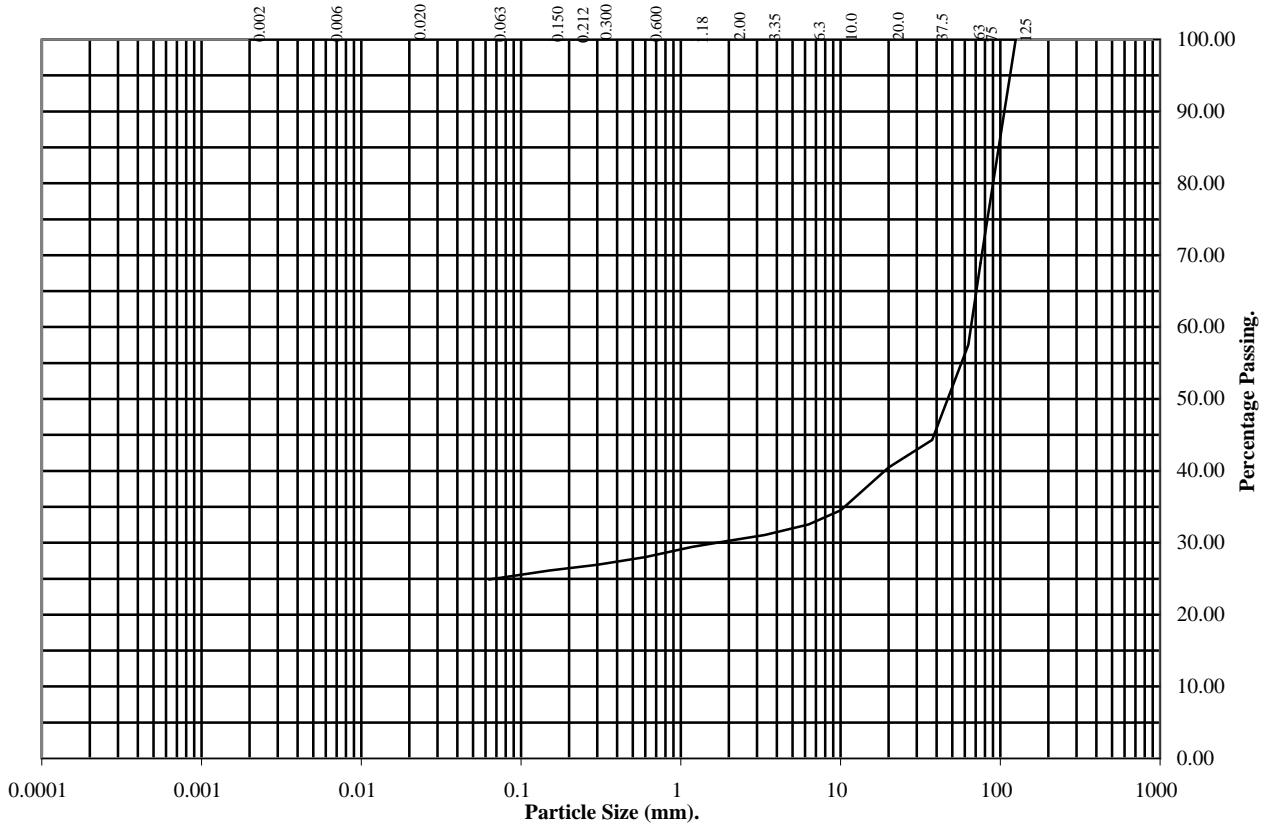
BS Test Sieve	Percentage Passing
125	100
75	69
63	58
37.5	44
20	40
10	34
6.3	33
3.35	31
2	30
1.18	29
0.6	28
0.3	27
0.212	27
0.15	26
0.063	25

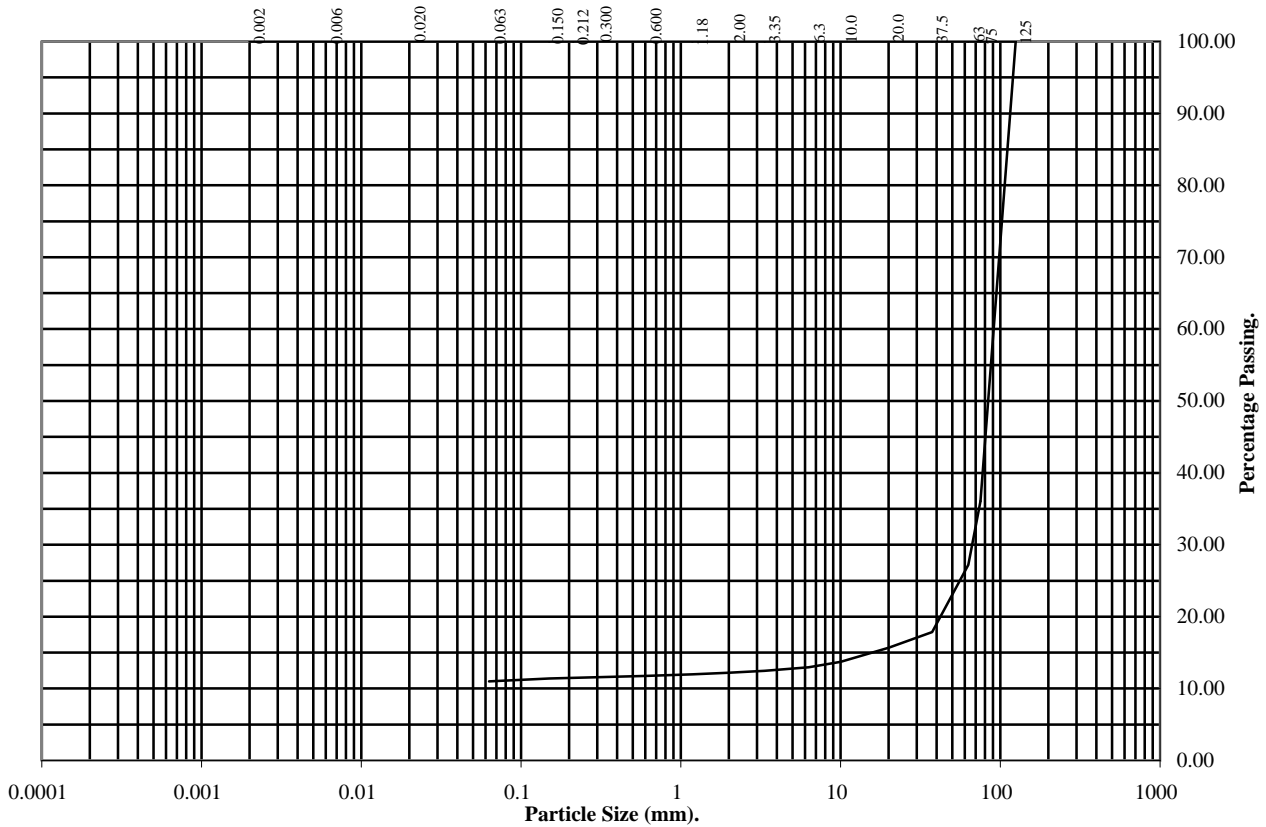
BS Test Sieve	Percentage Passing
125	100
75	36
63	27
37.5	18
20	16
10	14
6.3	13
3.35	12
2	12
1.18	12
0.6	12
0.3	12
0.212	11
0.15	11
0.063	11

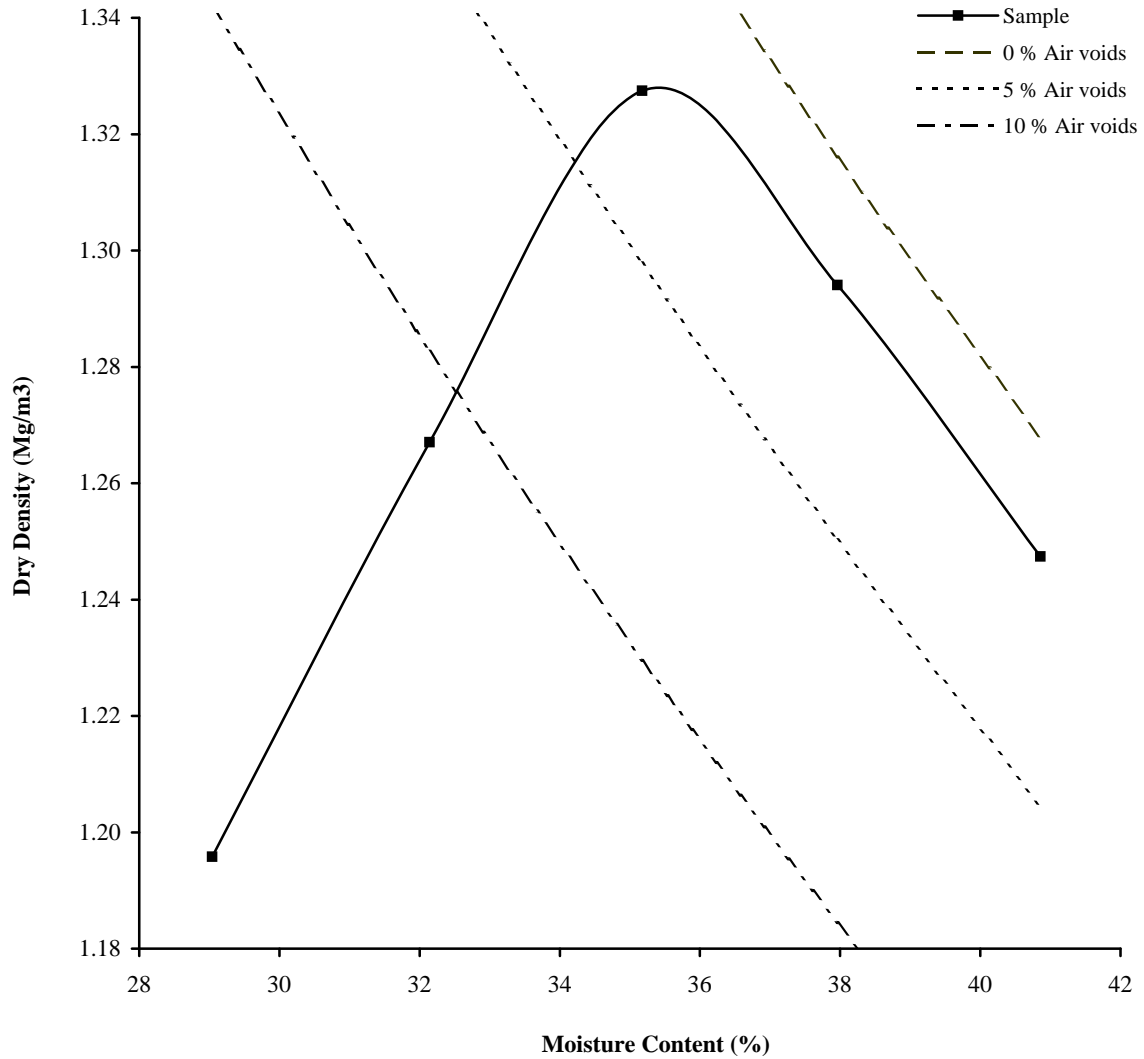
Initial Moisture Content:	38	Method of Compaction	2.5kg / Separate Sample	
Particle Density (Mg/m <sup>3</sup> ):	2.63	Assumed	Material Retained on 37.5 mm Test Sieve (%):	0
Maximum Dry Density (Mg/m <sup>3</sup> ):	1.33		Material Retained on 20.0 mm Test Sieve (%):	0
Optimum Moisture Content (%):	35			
Remarks	See Summary of Soil Descriptions.

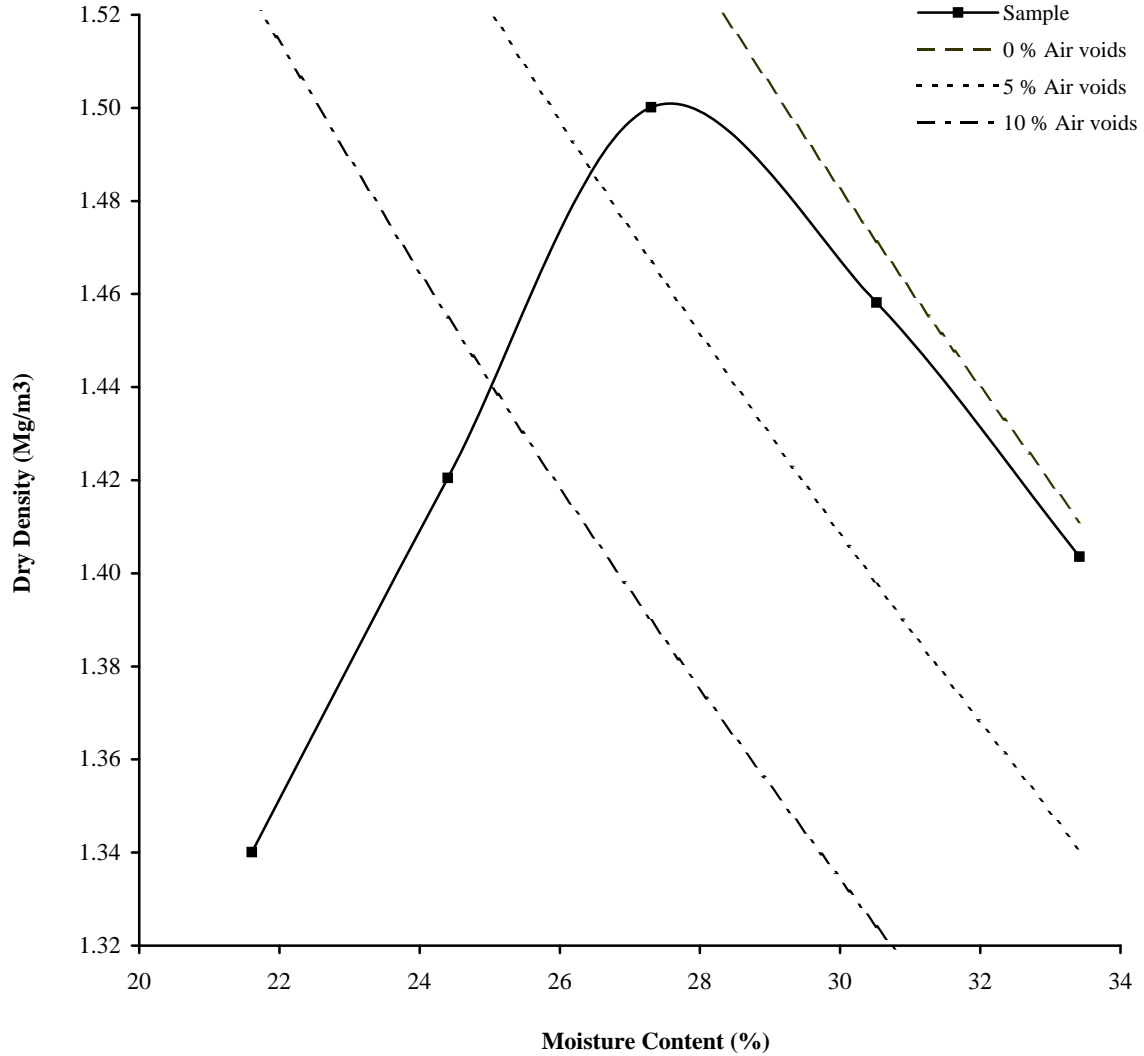
Initial Moisture Content:	31	Method of Compaction	2.5kg / Separate Sample	
Particle Density (Mg/m <sup>3</sup> ):	2.67	Assumed	Material Retained on 37.5 mm Test Sieve (%):	10
Maximum Dry Density (Mg/m <sup>3</sup> ):	1.50		Material Retained on 20.0 mm Test Sieve (%):	5
Optimum Moisture Content (%):	27			
Remarks	See Summary of Soil Descriptions.

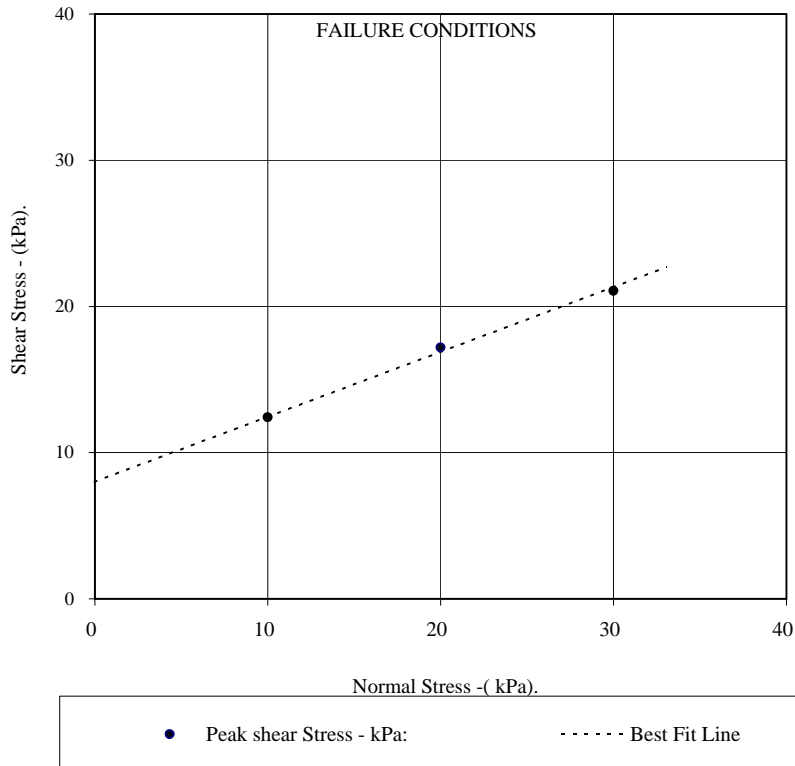
Sample Type:	Recompacted with 2.5kg Effort		
Particle Density - Mg/m <sup>3</sup> :	2.65 (Assumed)		
Specimen Tested:	Submerged Material tested passing 2mm		
Sample Description:	See summary of soil descriptions.		
<b>STAGE</b>	<b>1</b>	<b>2</b>	<b>3</b>
<b>Initial Conditions</b>			
Height - mm:	24.98	24.98	24.98
Length - mm:	60.01	60.01	60.01
Moisture Content - %:	33	33	33
Bulk Density - Mg/m <sup>3</sup> :	1.86	1.86	1.86
Dry Density - Mg/m <sup>3</sup> :	1.40	1.40	1.40
Voids Ratio:	0.893	0.893	0.892
Normal Pressure- kPa	10	20	30
<b>Consolidation</b>			
Consolidated Height - mm:	24.92	24.89	24.74
<b>Shear</b>			
Rate of Strain (mm/min)	0.027	0.027	0.027
Strain at peak shear stress (%)	3.30	2.40	3.20
Peak shear Stress - kPa:	12	17	21
<b>Final Consolidated Conditions</b>			
Moisture Content - %:	36	35	35
Bulk Density - Mg/m <sup>3</sup> :	1.86	1.86	1.88
Dry Density - Mg/m <sup>3</sup> :	1.36	1.38	1.39
<b>PEAK</b>

Angle of Shearing Resistance:( $\theta$ )			<b>24.0</b>
Effective Cohesion - kPa:			<b>8</b>

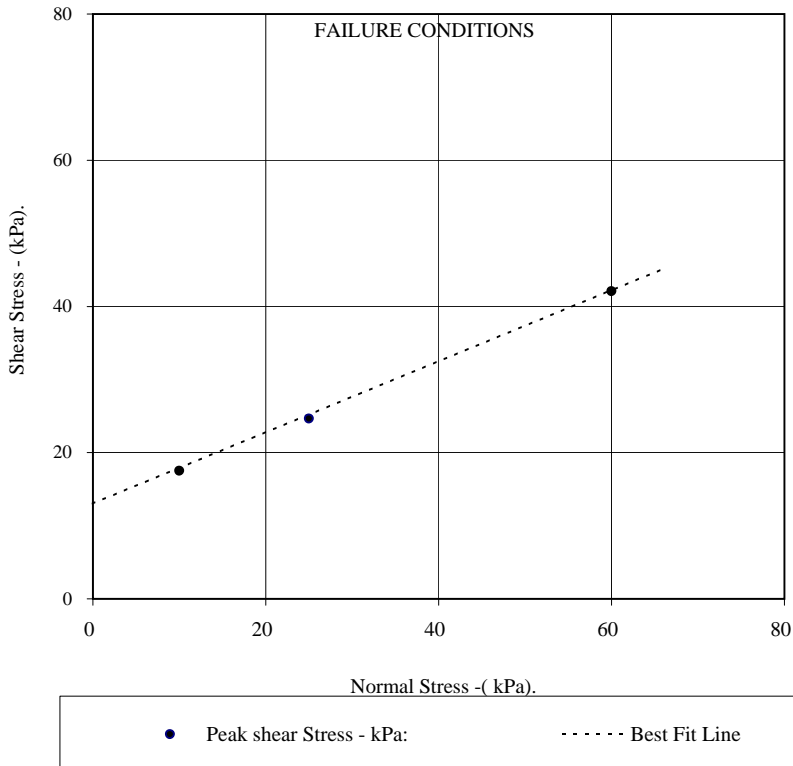
Sample Type:	Recompacted with 2.5kg Effort		
Particle Density - Mg/m <sup>3</sup> :	2.65 (Assumed)		
Specimen Tested:	Submerged Material tested passing 2mm		
Sample Description:	See summary of soil descriptions.		
<b>STAGE</b>	<b>1</b>	<b>2</b>	<b>3</b>
<b>Initial Conditions</b>			
Height - mm:	20.13	20.13	20.13
Length - mm:	59.90	59.90	59.90
Moisture Content - %:	35	35	35
Bulk Density - Mg/m <sup>3</sup> :	1.84	1.84	1.84
Dry Density - Mg/m <sup>3</sup> :	1.36	1.36	1.36
Voids Ratio:	0.954	0.954	0.954
Normal Pressure- kPa	10	25	60
<b>Consolidation</b>			
Consolidated Height - mm:	20.09	19.87	19.63
<b>Shear</b>			
Rate of Strain (mm/min)	0.028	0.028	0.028
Strain at peak shear stress (%)	2.10	2.00	2.80
Peak shear Stress - kPa:	18	25	42
<b>Final Consolidated Conditions</b>			
Moisture Content - %:	36	36	35
Bulk Density - Mg/m <sup>3</sup> :	1.84	1.86	1.88
Dry Density - Mg/m <sup>3</sup> :	1.35	1.37	1.40
<b>PEAK</b>

Angle of Shearing Resistance:(θ)			<b>26.0</b>
Effective Cohesion - kPa:			<b>13</b>

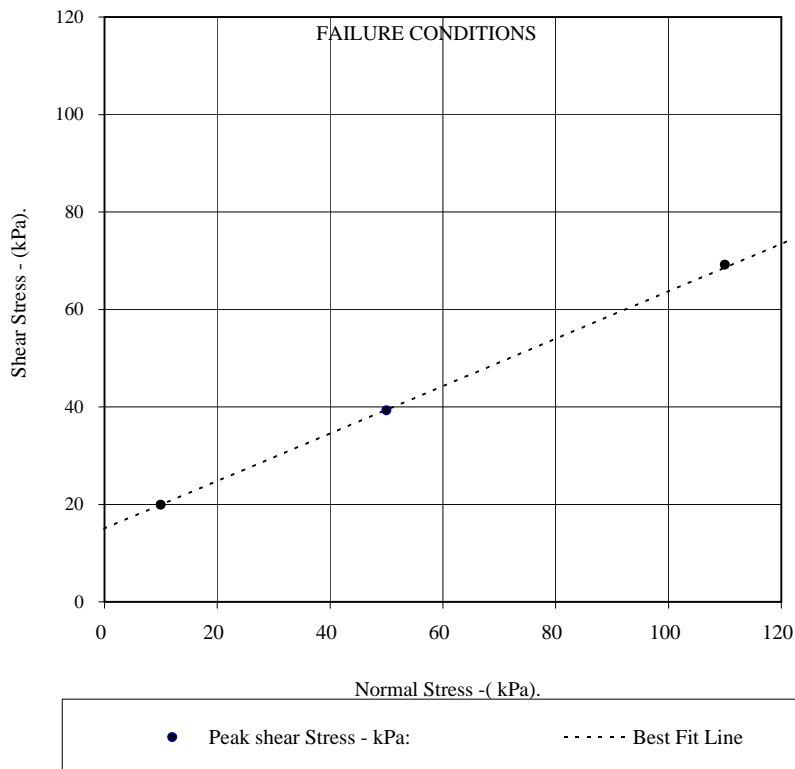
Sample Type:	Recompacted with 2.5kg Effort		
Particle Density - Mg/m <sup>3</sup> :	2.65 (Assumed)		
Specimen Tested:	Submerged Material tested passing 2mm		
Sample Description:	See summary of soil descriptions.		
<b>STAGE</b>	<b>1</b>	<b>2</b>	<b>3</b>
<b>Initial Conditions</b>			
Height - mm:	24.98	24.98	24.98
Length - mm:	60.01	60.01	60.01
Moisture Content - %:	33	33	33
Bulk Density - Mg/m <sup>3</sup> :	1.84	1.84	1.85
Dry Density - Mg/m <sup>3</sup> :	1.39	1.39	1.40
Voids Ratio:	0.909	0.906	0.899
Normal Pressure- kPa	10	50	110
<b>Consolidation</b>			
Consolidated Height - mm:	24.96	24.79	24.54
<b>Shear</b>			
Rate of Strain (mm/min)	0.027	0.027	0.027
Strain at peak shear stress (%)	3.30	4.20	4.40
Peak shear Stress - kPa:	20	39	69
<b>Final Consolidated Conditions</b>			
Moisture Content - %:	37	34	33
Bulk Density - Mg/m <sup>3</sup> :	1.84	1.86	1.88
Dry Density - Mg/m <sup>3</sup> :	1.34	1.39	1.41
<b>PEAK</b>

Angle of Shearing Resistance:( $\theta$ )			<b>26.0</b>
Effective Cohesion - kPa:			<b>15</b>

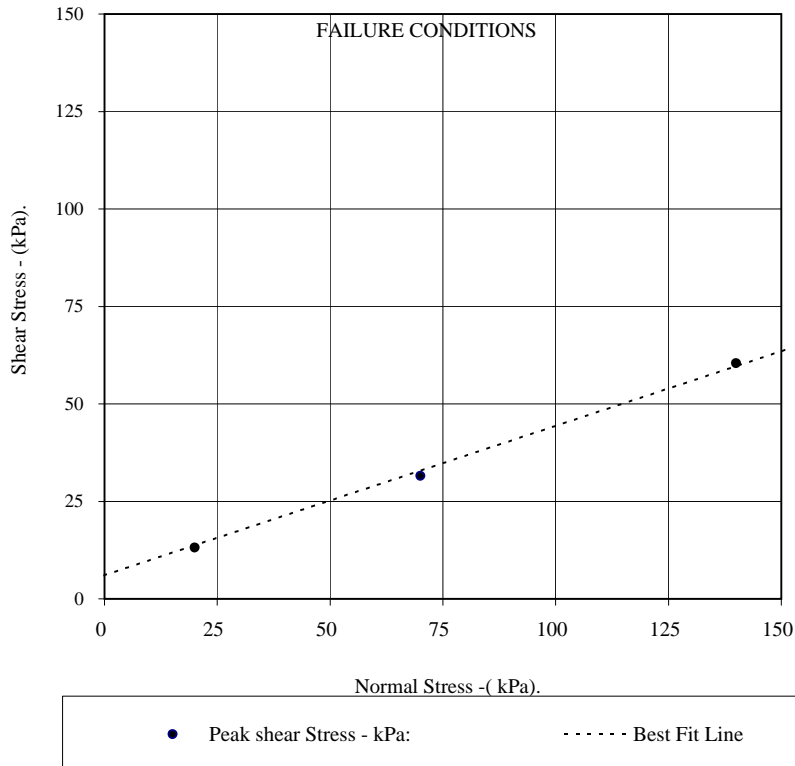
Sample Type:	Recompacted with 2.5kg Effort		
Particle Density - Mg/m <sup>3</sup> :	2.65 (Assumed)		
Specimen Tested:	Submerged Material tested passing 2mm		
Sample Description:	See summary of soil descriptions.		
<b>STAGE</b>	<b>1</b>	<b>2</b>	<b>3</b>
<b>Initial Conditions</b>			
Height - mm:	20.13	20.13	20.13
Length - mm:	59.90	59.90	59.90
Moisture Content - %:	40	40	40
Bulk Density - Mg/m <sup>3</sup> :	1.74	1.74	1.75
Dry Density - Mg/m <sup>3</sup> :	1.25	1.25	1.25
Voids Ratio:	1.125	1.122	1.119
Normal Pressure- kPa	20	70	140
<b>Consolidation</b>			
Consolidated Height - mm:	19.87	19.61	19.19
<b>Shear</b>			
Rate of Strain (mm/min)	0.026	0.026	0.026
Strain at peak shear stress (%)	4.50	7.60	10.00
Peak shear Stress - kPa:	13	32	60
<b>Final Consolidated Conditions</b>			
Moisture Content - %:	40	37	35
Bulk Density - Mg/m <sup>3</sup> :	1.76	1.79	1.83
Dry Density - Mg/m <sup>3</sup> :	1.26	1.30	1.36
<b>PEAK</b>

Angle of Shearing Resistance:( $\theta$ )			<b>21.0</b>
Effective Cohesion - kPa:			<b>6</b>

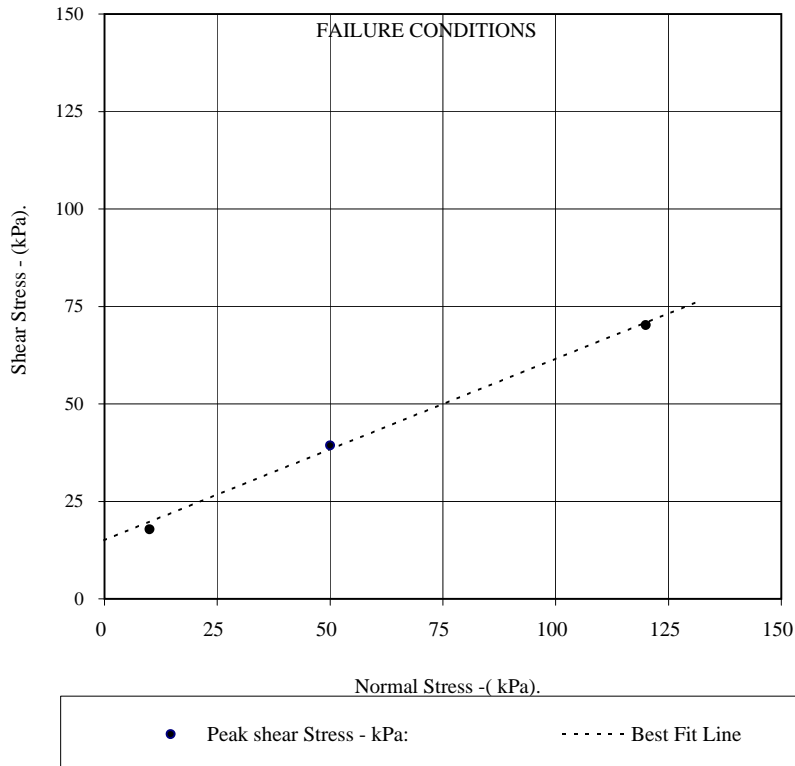
Sample Type:	Recompacted with 2.5kg Effort		
Particle Density - Mg/m <sup>3</sup> :	2.65 (Assumed)		
Specimen Tested:	Submerged Material tested passing 2mm		
Sample Description:	See summary of soil descriptions.		
<b>STAGE</b>	<b>1</b>	<b>2</b>	<b>3</b>
<b>Initial Conditions</b>			
Height - mm:	24.98	24.98	24.98
Length - mm:	60.01	60.01	60.01
Moisture Content - %:	32	32	32
Bulk Density - Mg/m <sup>3</sup> :	1.83	1.84	1.84
Dry Density - Mg/m <sup>3</sup> :	1.39	1.40	1.40
Voids Ratio:	0.904	0.899	0.895
Normal Pressure- kPa	10	50	120
<b>Consolidation</b>			
Consolidated Height - mm:	24.90	24.53	24.11
<b>Shear</b>			
Rate of Strain (mm/min)	0.028	0.028	0.028
Strain at peak shear stress (%)	2.50	2.10	4.20
Peak shear Stress - kPa:	18	39	70
<b>Final Consolidated Conditions</b>			
Moisture Content - %:	37	34	32
Bulk Density - Mg/m <sup>3</sup> :	1.84	1.87	1.91
Dry Density - Mg/m <sup>3</sup> :	1.34	1.39	1.44
<b>PEAK</b>

Angle of Shearing Resistance:( $\theta$ )			<b>25.0</b>
Effective Cohesion - kPa:			<b>15</b>

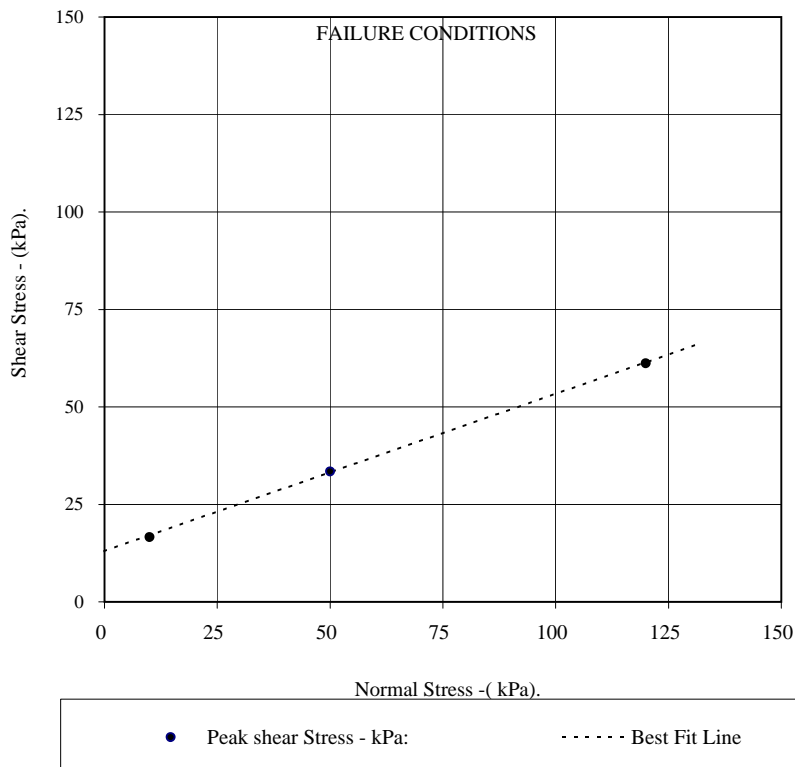
Sample Type:	Recompacted with 2.5kg Effort		
Particle Density - Mg/m <sup>3</sup> :	2.65 (Assumed)		
Specimen Tested:	Submerged Material tested passing 2mm		
Sample Description:	See summary of soil descriptions.		
<b>STAGE</b>	<b>1</b>	<b>2</b>	<b>3</b>
<b>Initial Conditions</b>			
Height - mm:	24.98	24.98	24.98
Length - mm:	60.01	60.01	60.01
Moisture Content - %:	39	39	39
Bulk Density - Mg/m <sup>3</sup> :	1.78	1.78	1.78
Dry Density - Mg/m <sup>3</sup> :	1.28	1.29	1.28
Voids Ratio:	1.066	1.062	1.063
Normal Pressure- kPa	10	50	120
<b>Consolidation</b>			
Consolidated Height - mm:	24.89	24.60	24.08
<b>Shear</b>			
Rate of Strain (mm/min)	0.031	0.031	0.031
Strain at peak shear stress (%)	6.10	7.80	6.90
Peak shear Stress - kPa:	17	33	61
<b>Final Consolidated Conditions</b>			
Moisture Content - %:	43	42	40
Bulk Density - Mg/m <sup>3</sup> :	1.78	1.81	1.85
Dry Density - Mg/m <sup>3</sup> :	1.25	1.27	1.32
<b>PEAK</b>

Angle of Shearing Resistance:( $\theta$ )			<b>22.0</b>
Effective Cohesion - kPa:			<b>13</b>

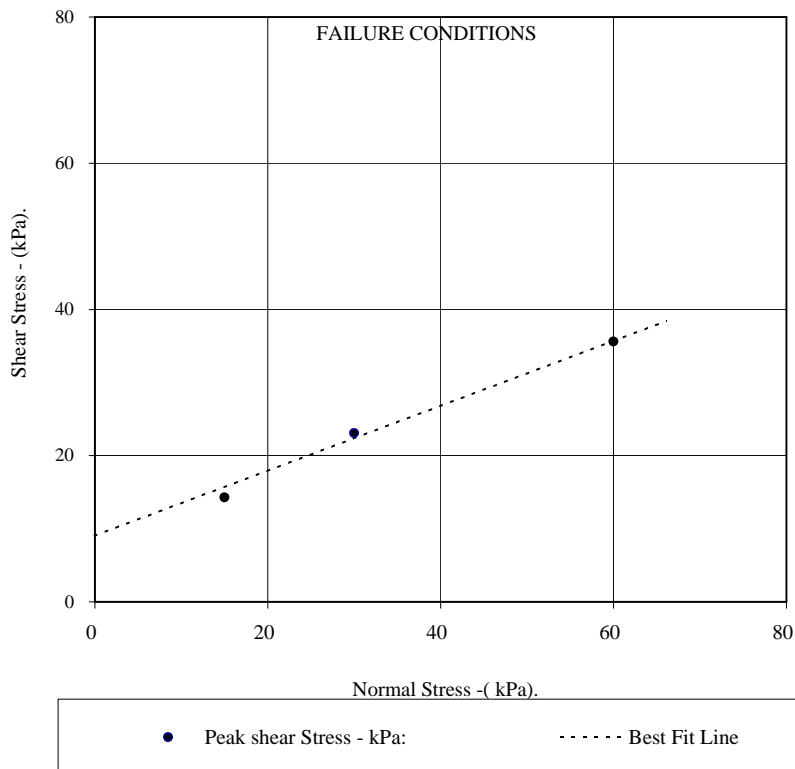
Sample Type:	Recompacted with 2.5kg Effort		
Particle Density - Mg/m <sup>3</sup> :	2.65 (Assumed)		
Specimen Tested:	Submerged Material tested passing 2mm		
Sample Description:	See summary of soil descriptions.		
<b>STAGE</b>	<b>1</b>	<b>2</b>	<b>3</b>
<b>Initial Conditions</b>			
Height - mm:	24.98	24.98	24.98
Length - mm:	60.01	60.01	60.01
Moisture Content - %:	37	37	37
Bulk Density - Mg/m <sup>3</sup> :	1.82	1.82	1.82
Dry Density - Mg/m <sup>3</sup> :	1.33	1.34	1.34
Voids Ratio:	0.989	0.984	0.984
Normal Pressure- kPa	15	30	60
<b>Consolidation</b>			
Consolidated Height - mm:	24.91	24.69	24.37
<b>Shear</b>			
Rate of Strain (mm/min)	0.028	0.028	0.028
Strain at peak shear stress (%)	1.00	2.00	2.00
Peak shear Stress - kPa:	14	23	36
<b>Final Consolidated Conditions</b>			
Moisture Content - %:	39	38	38
Bulk Density - Mg/m <sup>3</sup> :	1.83	1.85	1.87
Dry Density - Mg/m <sup>3</sup> :	1.31	1.34	1.35
<b>PEAK</b>

Angle of Shearing Resistance:(θ)			<b>24.0</b>
Effective Cohesion - kPa:			<b>9</b>

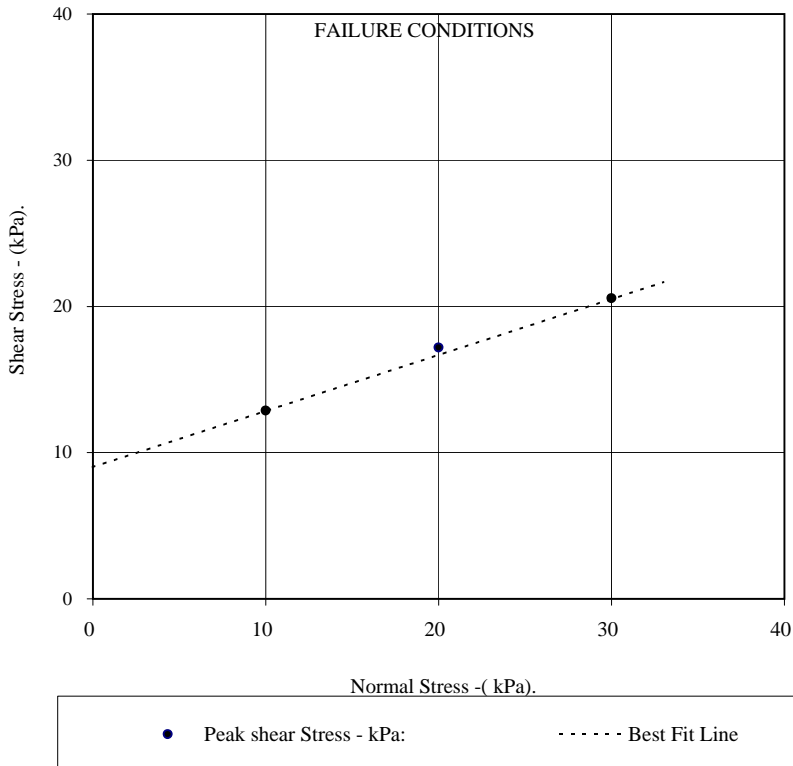
Sample Type:	Recompacted with 2.5kg Effort		
Particle Density - Mg/m <sup>3</sup> :	2.65 (Assumed)		
Specimen Tested:	Submerged Material tested passing 2mm		
Sample Description:	See summary of soil descriptions.		
<b>STAGE</b>	<b>1</b>	<b>2</b>	<b>3</b>
<b>Initial Conditions</b>			
Height - mm:	24.98	24.98	24.98
Length - mm:	60.01	60.01	60.01
Moisture Content - %:	27	27	27
Bulk Density - Mg/m <sup>3</sup> :	1.87	1.87	1.87
Dry Density - Mg/m <sup>3</sup> :	1.47	1.47	1.47
Voids Ratio:	0.800	0.800	0.799
Normal Pressure- kPa	10	20	30
<b>Consolidation</b>			
Consolidated Height - mm:	25.21	25.09	25.05
<b>Shear</b>			
Rate of Strain (mm/min)	0.320	0.320	0.320
Strain at peak shear stress (%)	2.00	2.00	4.00
Peak shear Stress - kPa:	13	17	21
<b>Final Consolidated Conditions</b>			
Moisture Content - %:	33	32	31
Bulk Density - Mg/m <sup>3</sup> :	1.85	1.86	1.87
Dry Density - Mg/m <sup>3</sup> :	1.40	1.41	1.42
<b>PEAK</b>

Angle of Shearing Resistance:( $\theta$ )			<b>21.0</b>
Effective Cohesion - kPa:			<b>9</b>

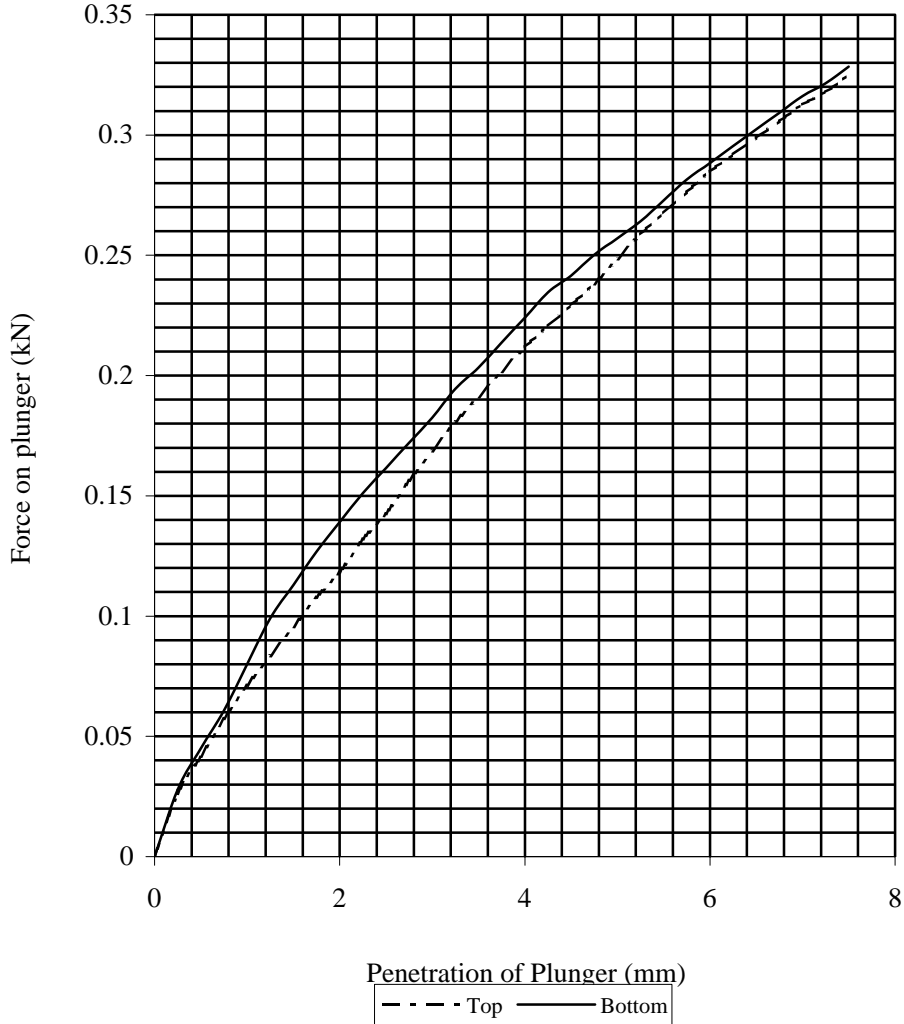
Initial Sample Conditions		Test Conditions		Method of compaction		2.5Kg Rammer	
Moisture Content:	47	Surcharge Kg:	4.00	Final Moisture Content %	C.B.R. Value %		
Bulk Density Mg/m3:	1.65	Soaking Time hrs	0	Sample Top	47	Sample Top	1.2
Dry Density Mg/m3:	1.12	Swelling mm:	0	Sample Bottom	48	Sample Bottom	1.3
Percentage retained on 20mm BS test sieve:	0	Remarks: Brown slightly gravelly slightly sandy CLAY.

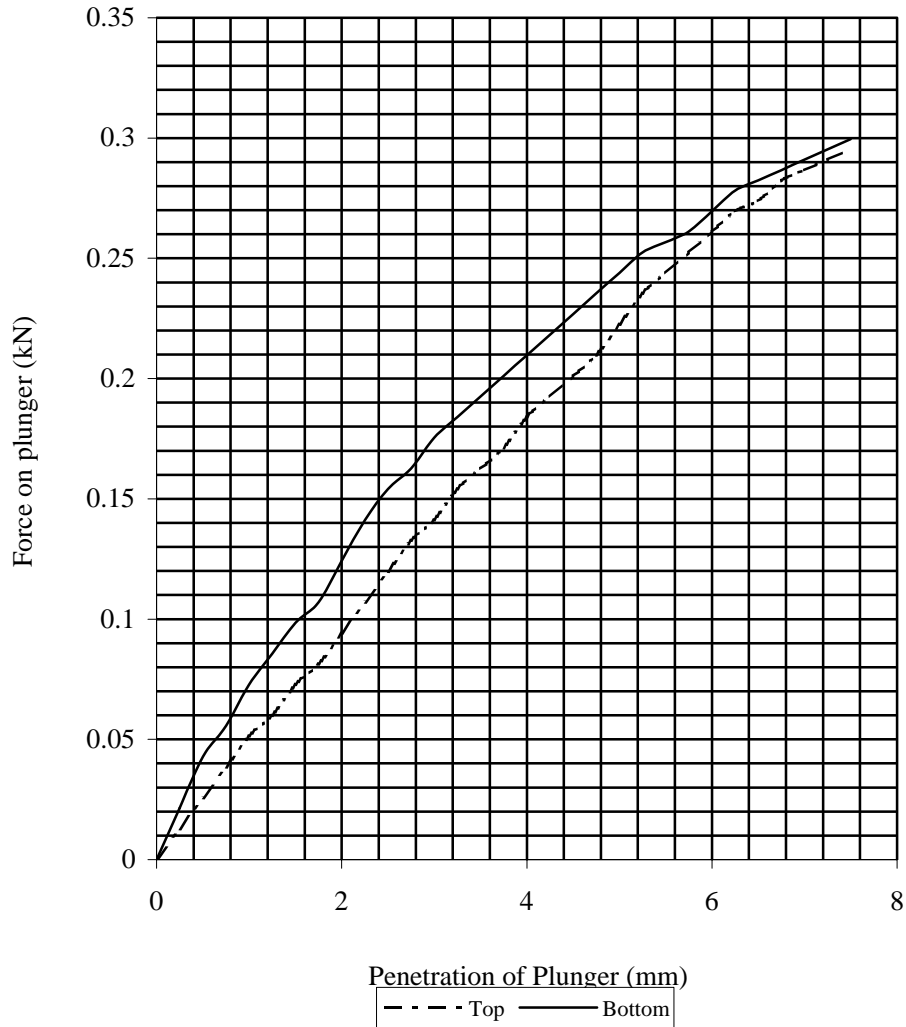
Initial Sample Conditions		Test Conditions		Method of compaction		2.5Kg Rammer	
Moisture Content:	48	Surcharge Kg:	4.00	Final Moisture Content %		C.B.R. Value %	
Bulk Density Mg/m3:	1.65	Soaking Time hrs	0	Sample Top	49	Sample Top	1.1
Dry Density Mg/m3:	1.11	Swelling mm:	0	Sample Bottom	49	Sample Bottom	1.2
Percentage retained on 20mm BS test sieve:	0	Remarks: Brown slightly gravelly slightly sandy CLAY. <b>Soaked for 96 Hours</b>
