FIVE MILE LANE IMPROVEMENTS

DORMOUSE MITIGATION STRATEGY

*FIVE MILE LANE IMPROVEMENTS
DORMOUSE SURVEY REPORT*

Welsh Government
5 Mile Lane
Dormouse Report Figure 1: Habitat Suitability Assessment

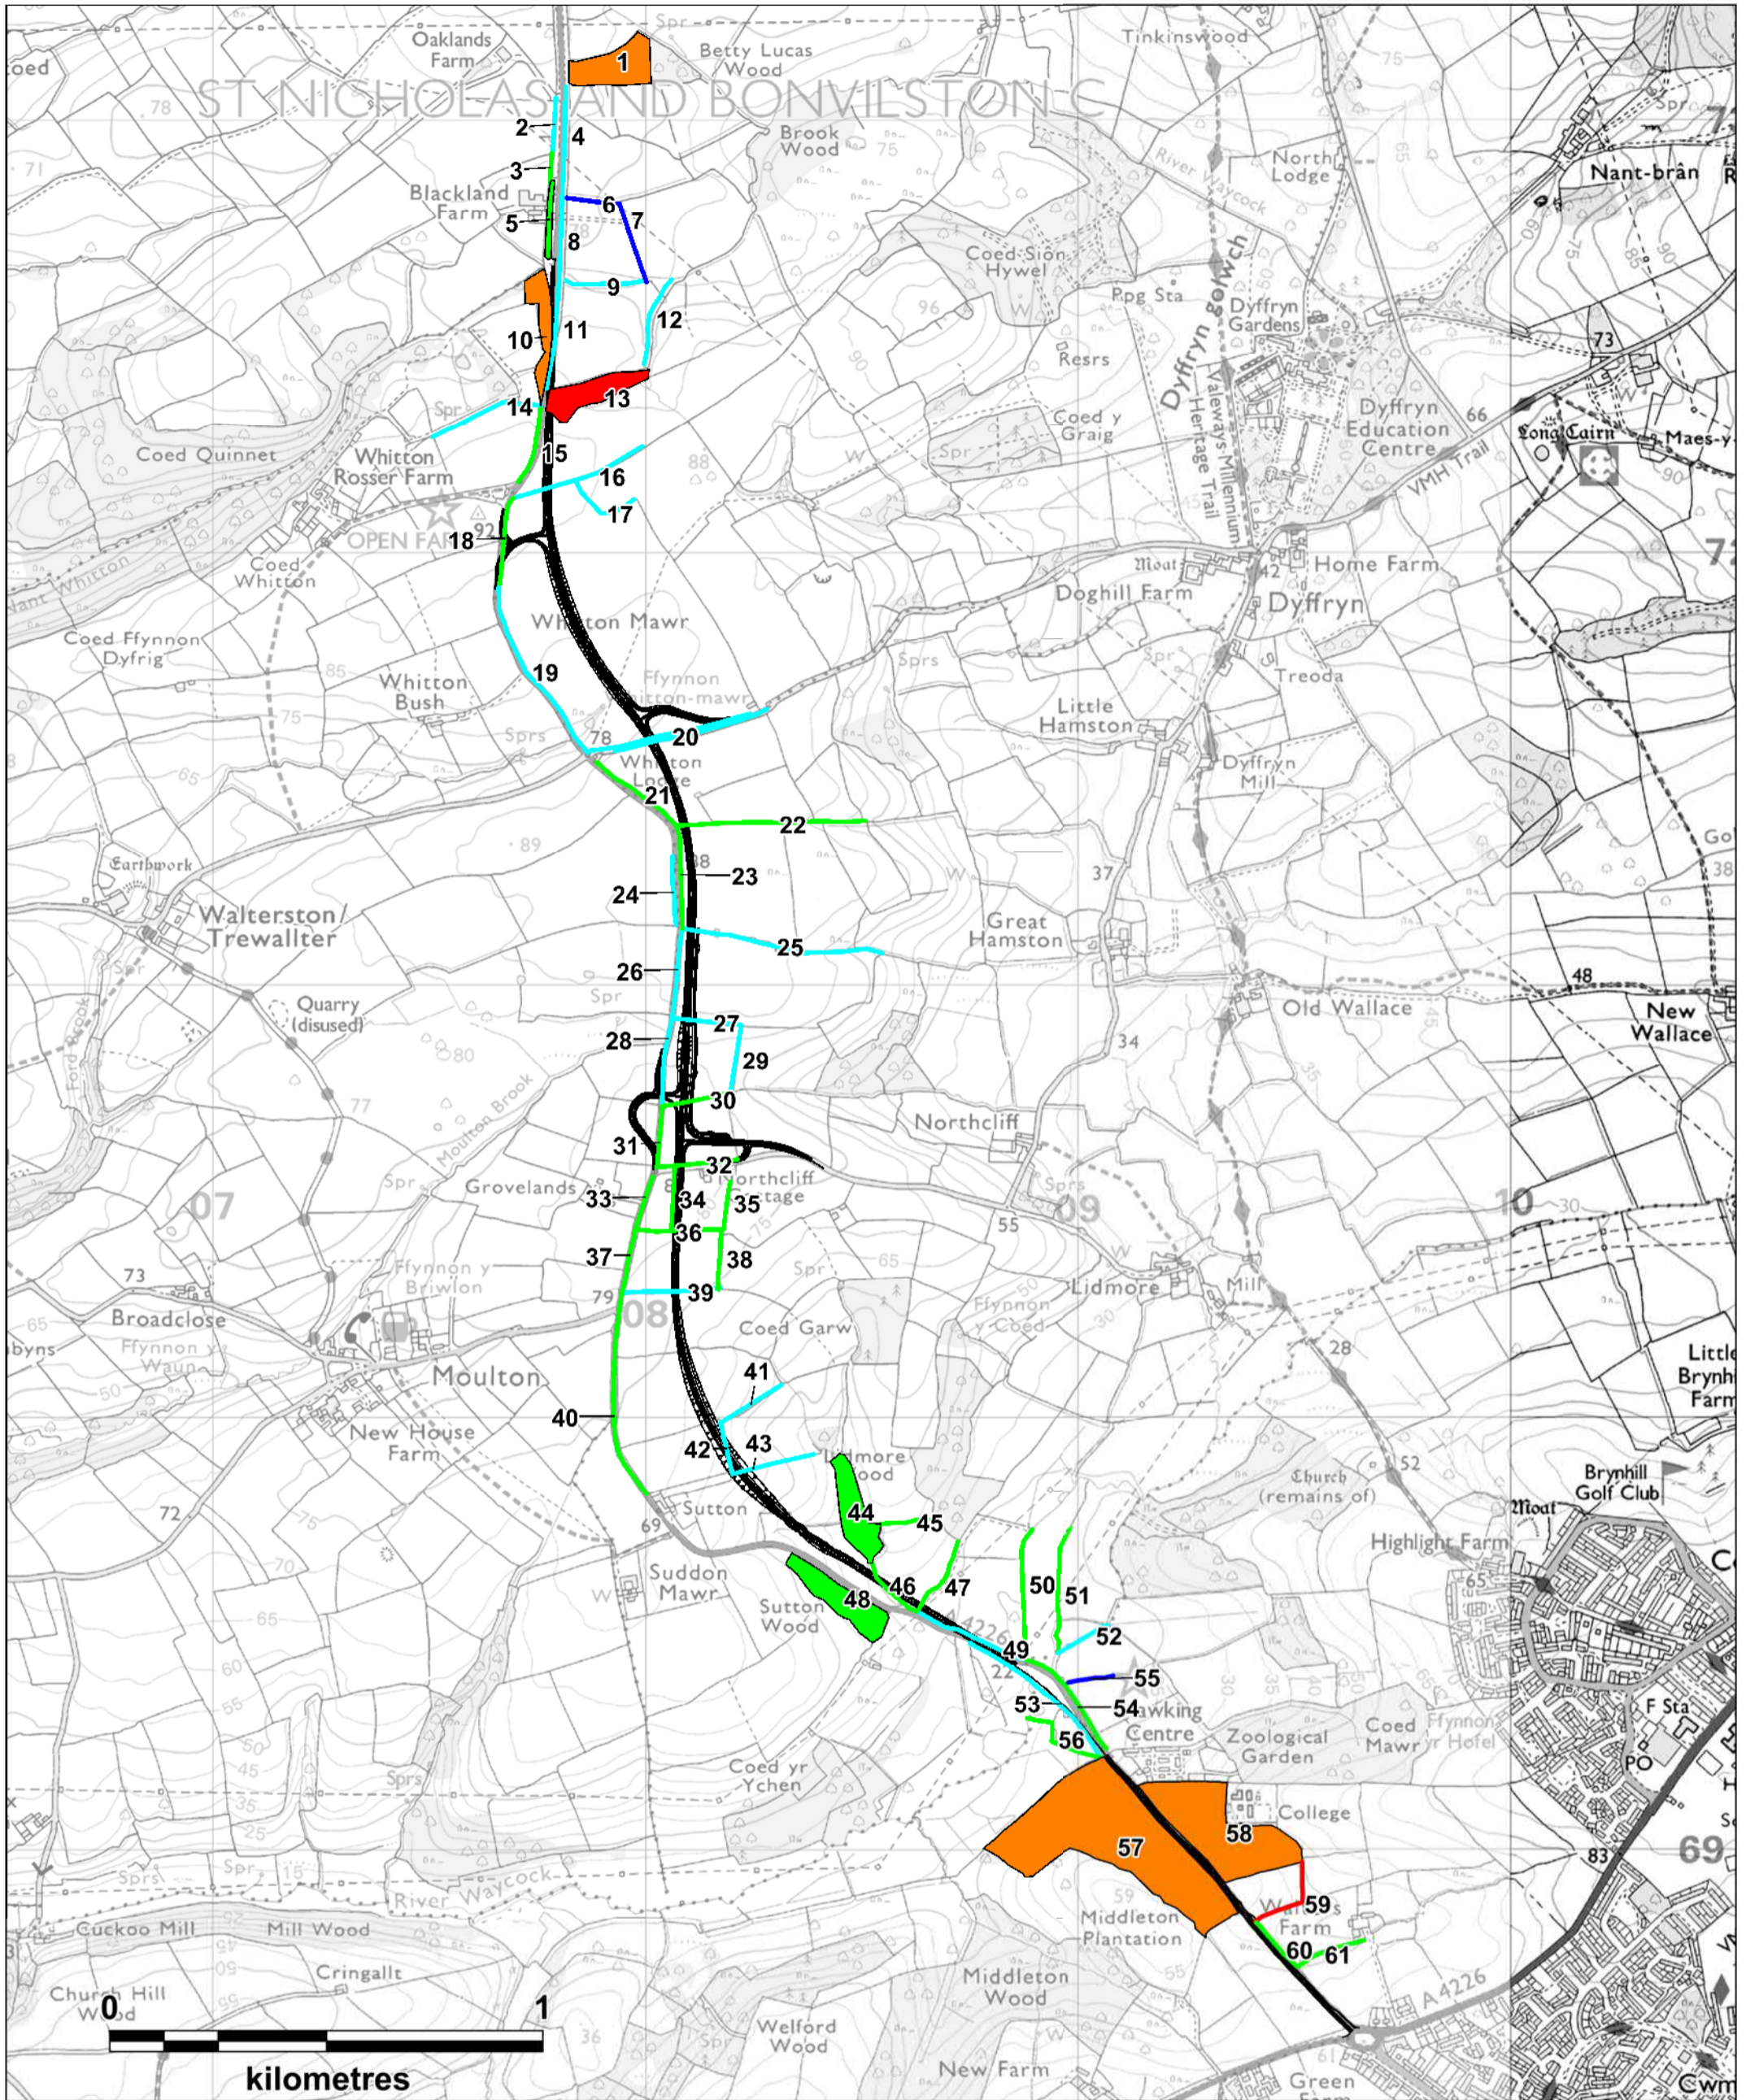
5.3.2 Figure 1 displays the suitability of all woodland/hedgerow/scrub features within the Study Area for dormouse. If dormouse are present within the Scheme boundary, they are most likely to occur in the woodland blocks located at either end of the Scheme, which have been classified as Optimal/Suitable for dormouse. A network of hedgerows and treelines provides linkage between these woodlands, and many of the

hedgerows (28 in total) were considered suitable for dormouse (Category B). Therefore, it may be possible to encounter dormouse throughout the route corridor.

- 3.2.3 The approximate extent of potential dormouse habitat affected by the proposed Scheme was also recorded. A total of 61 features were surveyed for their suitability to support dormouse (see Figure 1).

- 4.2.1 A total of 61 hedgerows and woodlands along the route of the Scheme were assessed for their potential to support dormice (see Figure 1).

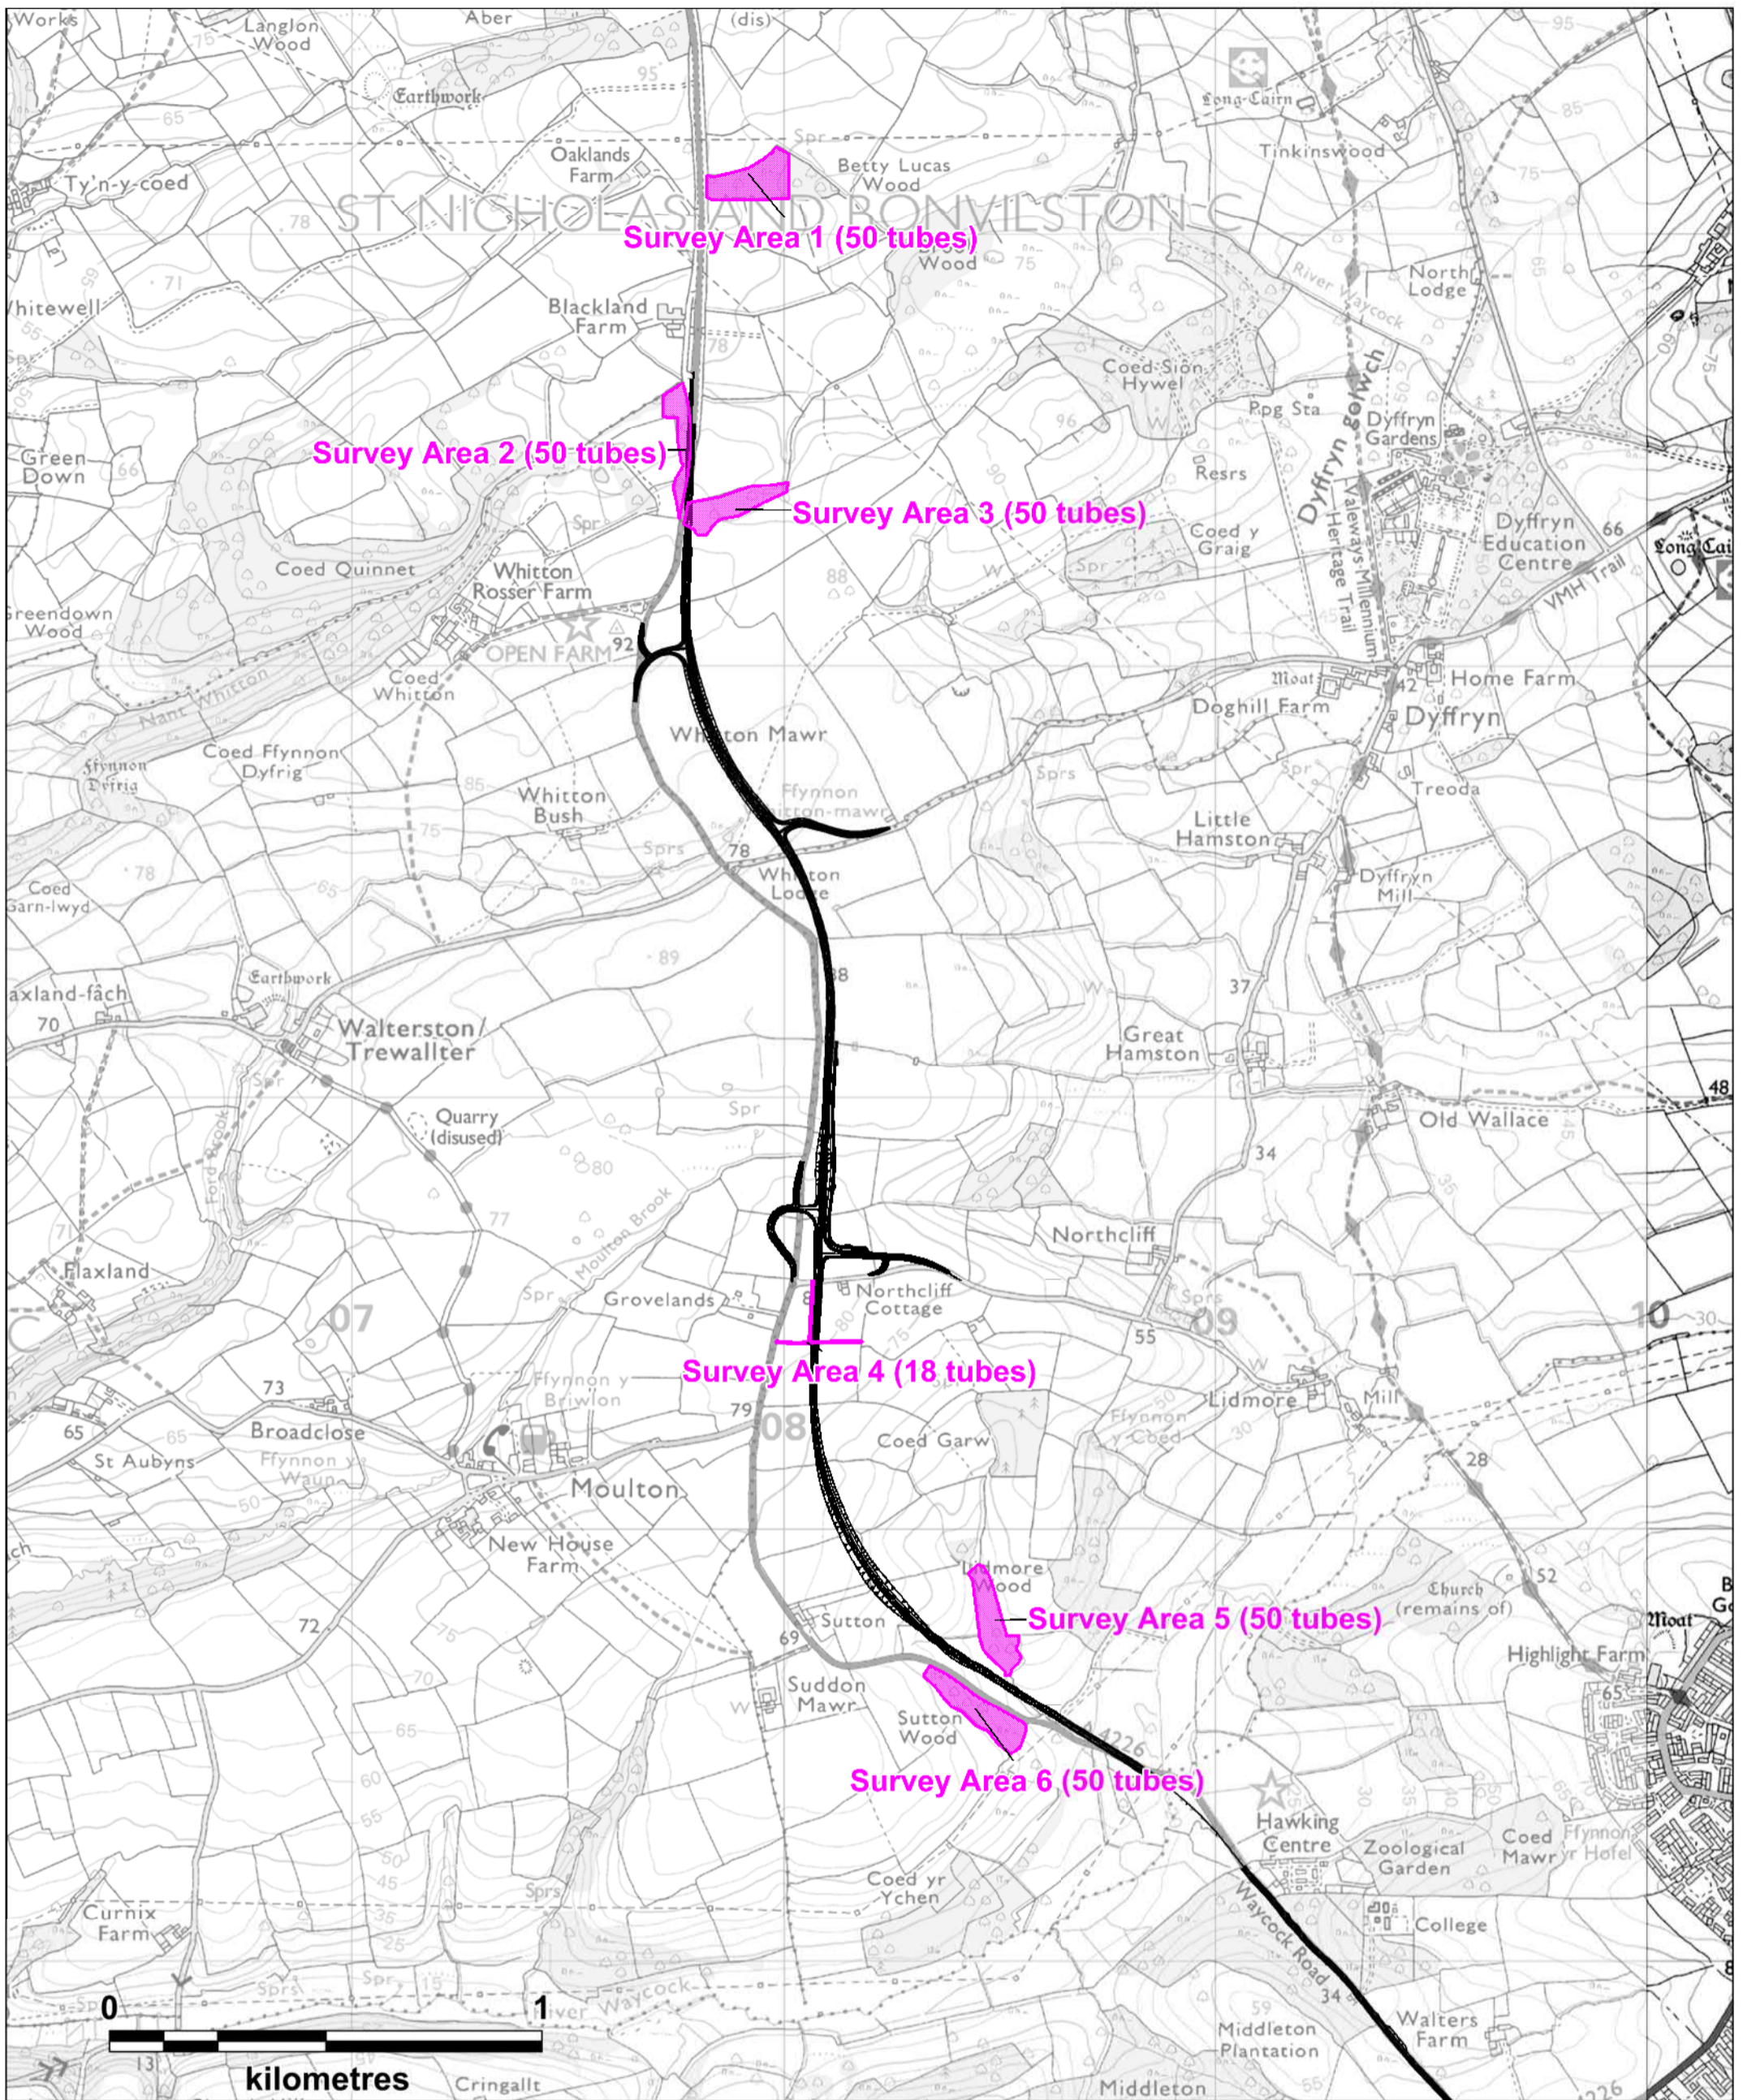
Welsh Government
5 Mile Lane
Dormouse Report Figure 2: Nest Tube Survey Locations

- 3.2.4 As several areas within or near the Scheme footprint were identified as good dormouse habitat, it was considered necessary to carry out targeted dormouse surveys using nest tubes. A total of 268 nest tubes were installed at 6 different locations. Generally, 50 tubes were used at each location, but where there was insufficient space, less were used. Figure 2 shows the nest tube survey locations and indicates how many tubes were used at each location.

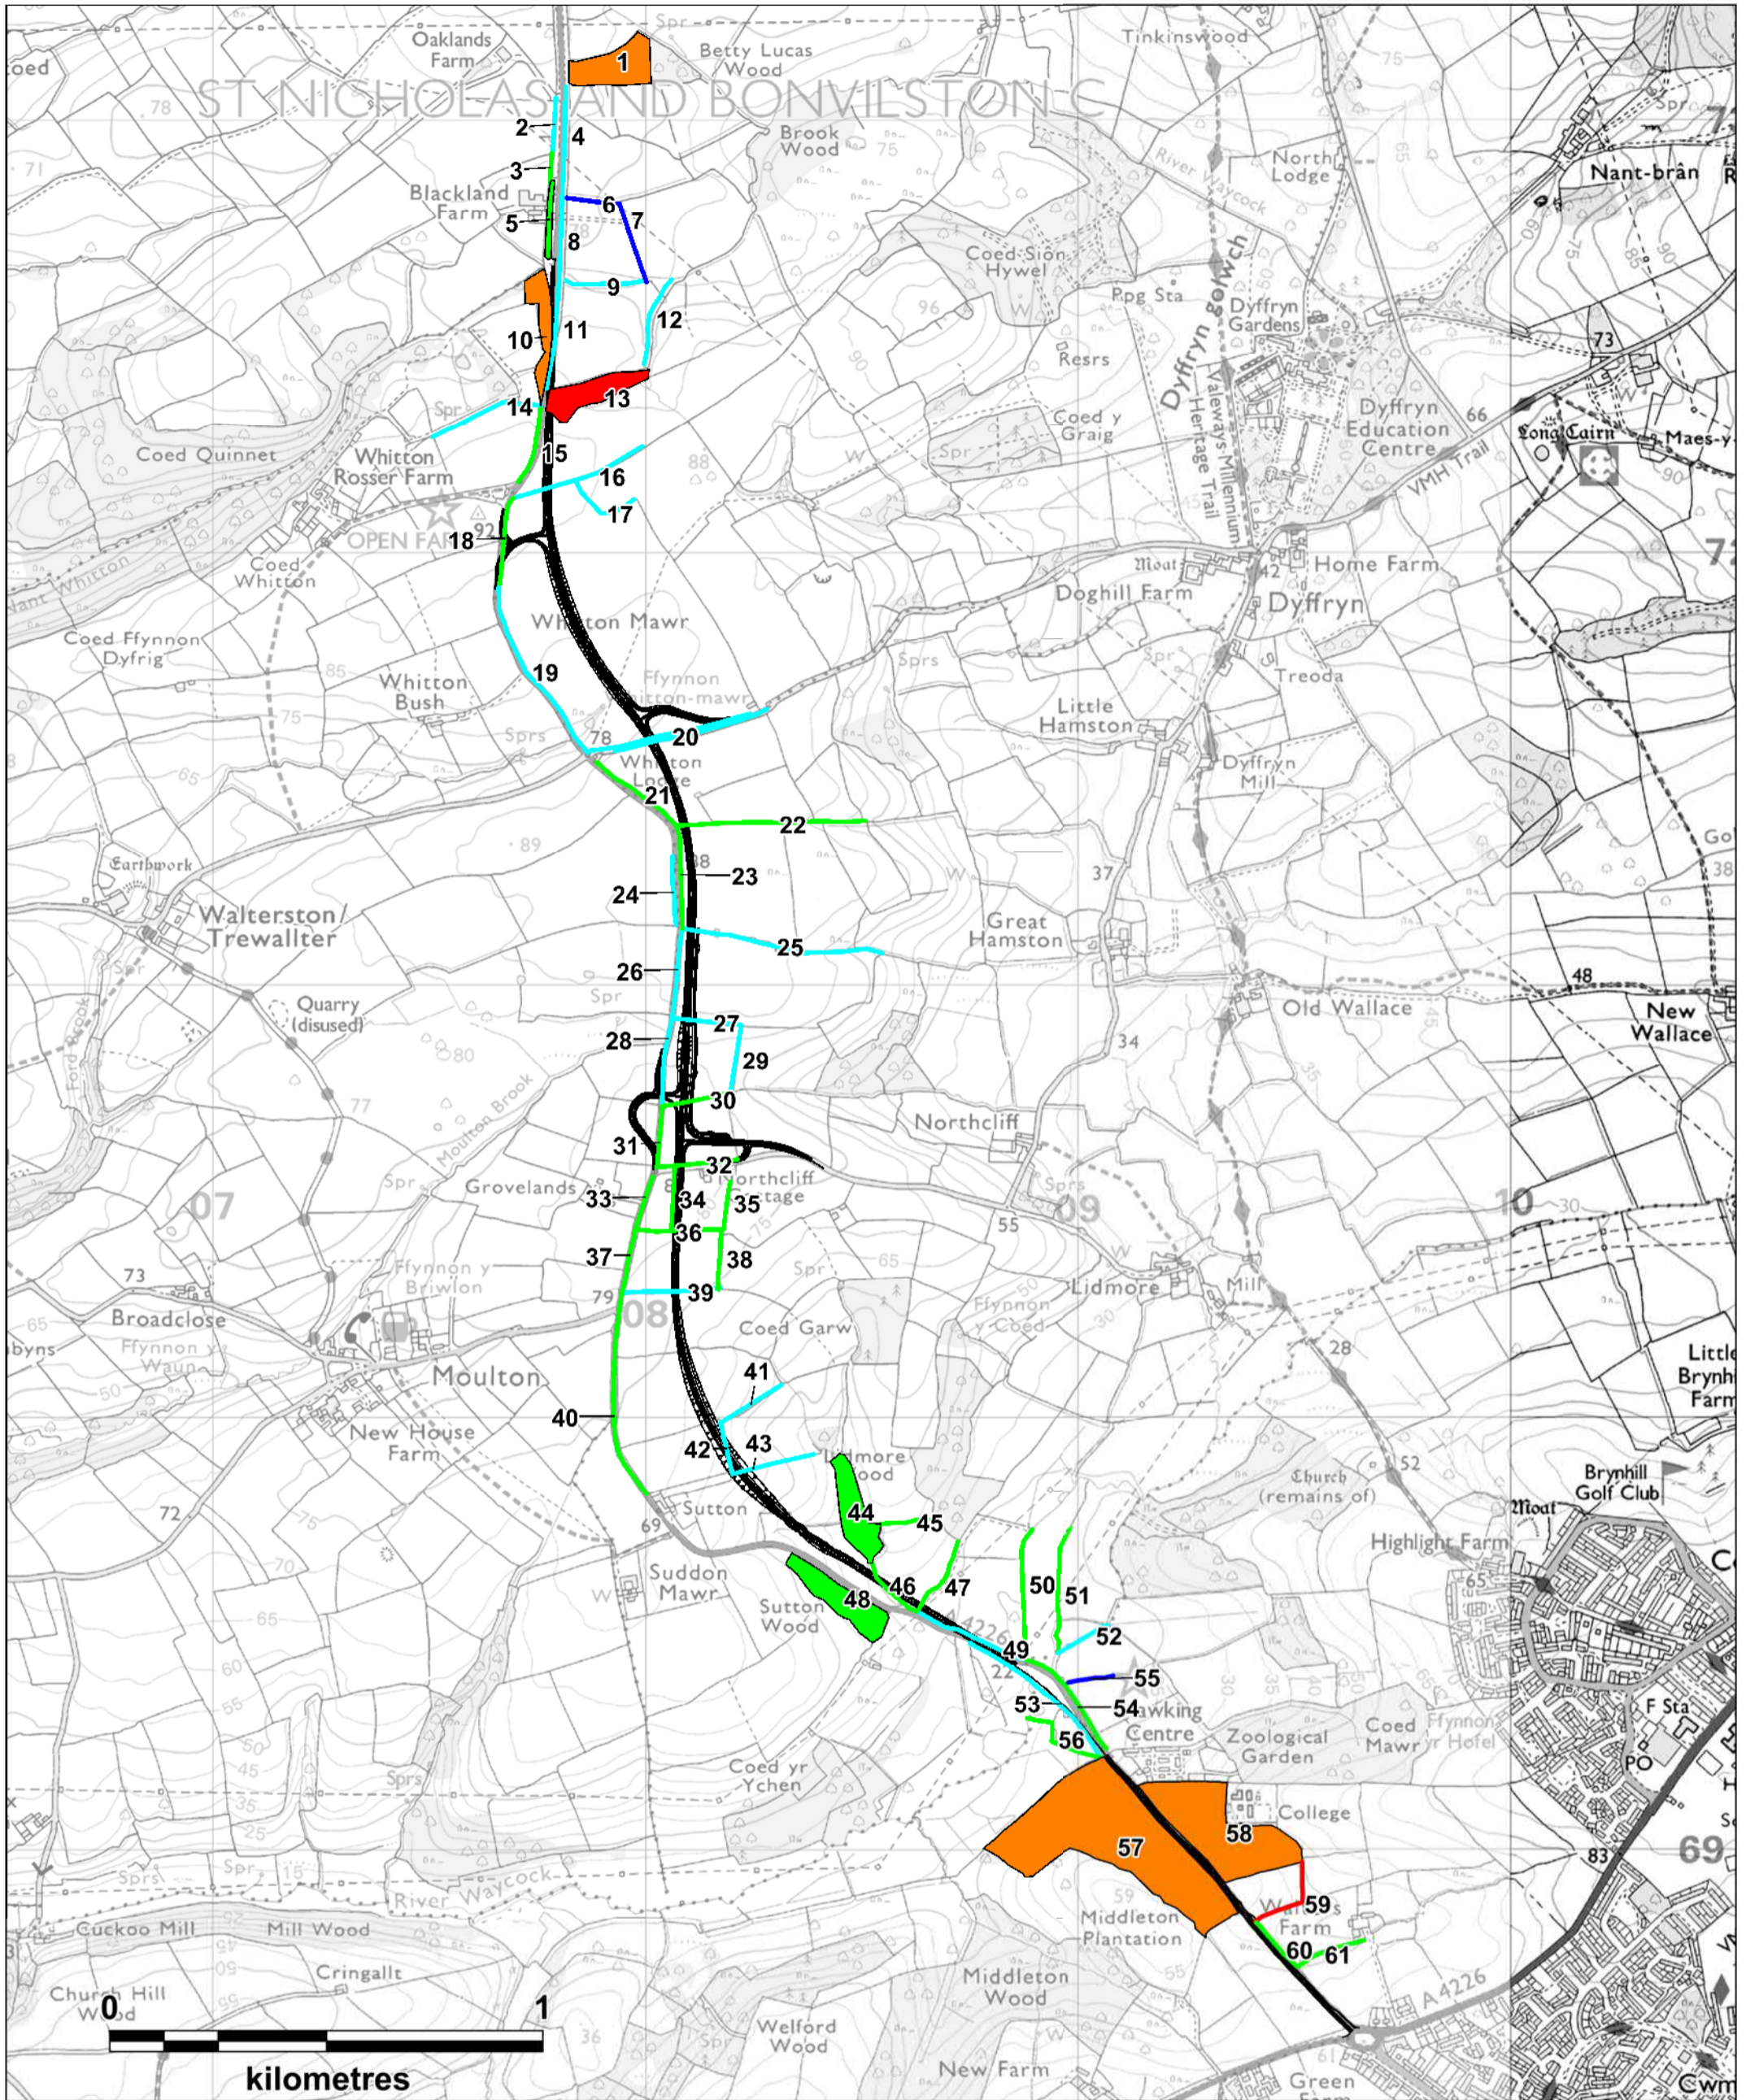
Welsh Government
5 Mile Lane
Dormouse Report Figure 1: Habitat Suitability Assessment

A total of 61 hedgerows and woodlands on the route of the Scheme were assessed for their potential to support dormice (see Figure 1 in Appendix B). Roughly half of these features were considered to be suitable for dormice, and six features were considered optimal:

The clearance methods used will depend on the time of year, the suitability of habitat being cleared (see Figure 1 in Appendix B) and the requirements of the Scheme, for example the need to clear areas for haul routes.

Assessment of habitat suitability of features within the Scheme indicates that if dormice are present, they are most likely to occur in the woodland blocks located at either end of the Scheme. A network of hedgerows and treelines provides linkage between these woodlands, and many of the hedgerows (28 in total) were considered suitable for dormice (Category B). Therefore, dormice may be present throughout the route corridor.
