**Greenyard Farm,  
St. Andrews Major**

**Heritage  
Assessment**

Prepared by:  
**The Environmental  
Dimension Partnership  
Ltd (EDP)**

January 2017  
Report Reference  
**EDP3411\_01a**

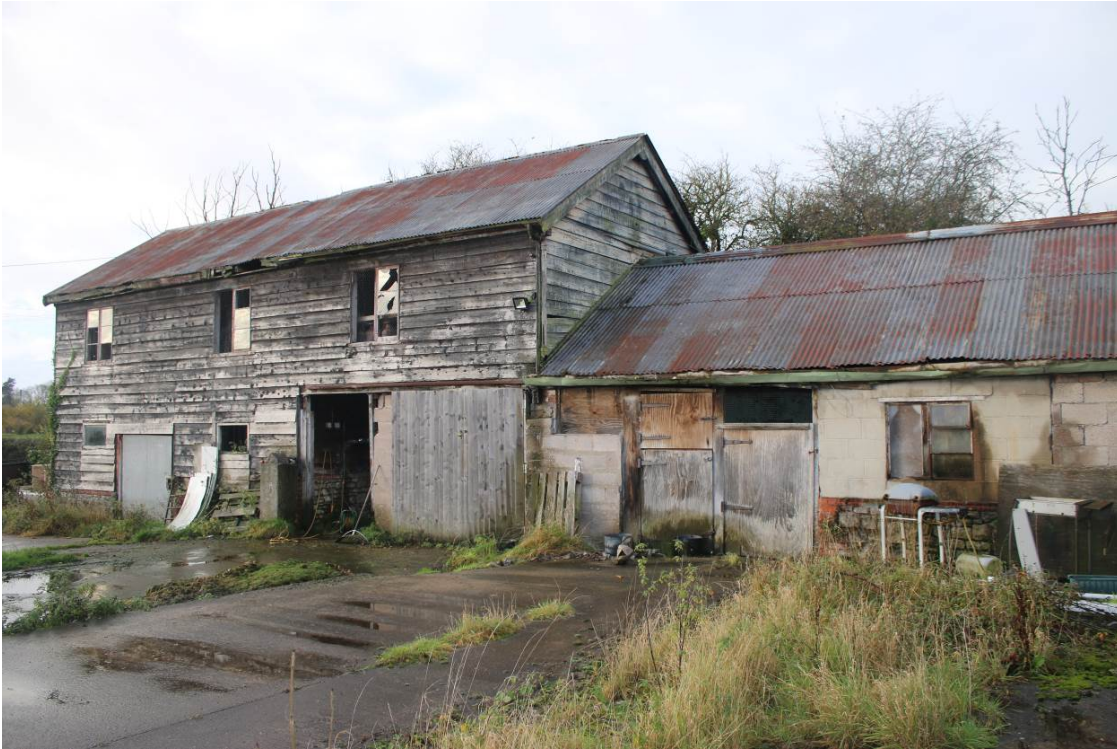
**Image EDP 1:** The barn at Greenyard Farm viewed from the north east

- 2.9 The building is north-south aligned and measures circa 15 metres in length, with the main feature of the structure comprising timber weatherboarding. It is of two storey form, has a gabled roof furnished with corrugated iron sheets and has a blind rear elevation facing the road. It exhibits no less than three first floor window openings overlooking the yard and a number of re-configured ground floor openings too. The outward appearance of the building is shown in **Images EDP 1 and 2**.

- 2.18 The evidence points strongly to the existing weatherboarding representing a secondary treatment to the external faces of the building. Even then, there is copious evidence that the current fabric of the timber framing and the building's external shell have been replaced over time on an ad hoc basis. This is demonstrated by **Images EDP 1** and **14**.

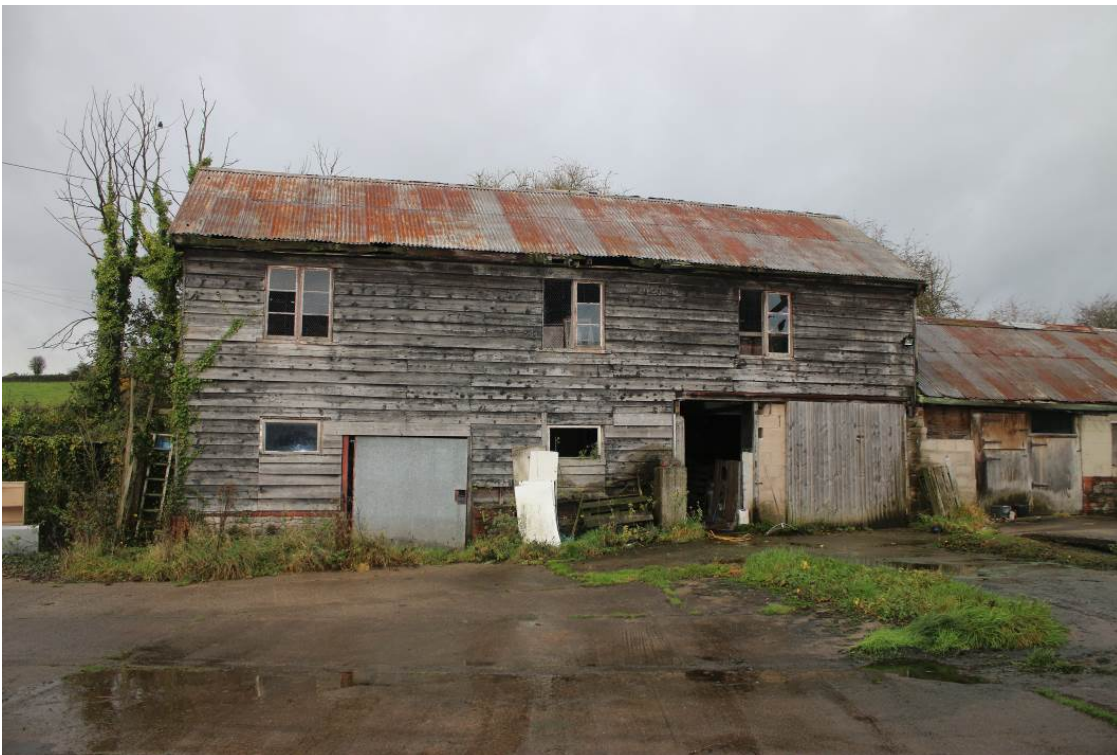
**Image EDP 2:** The barn's principal (east-facing) elevation

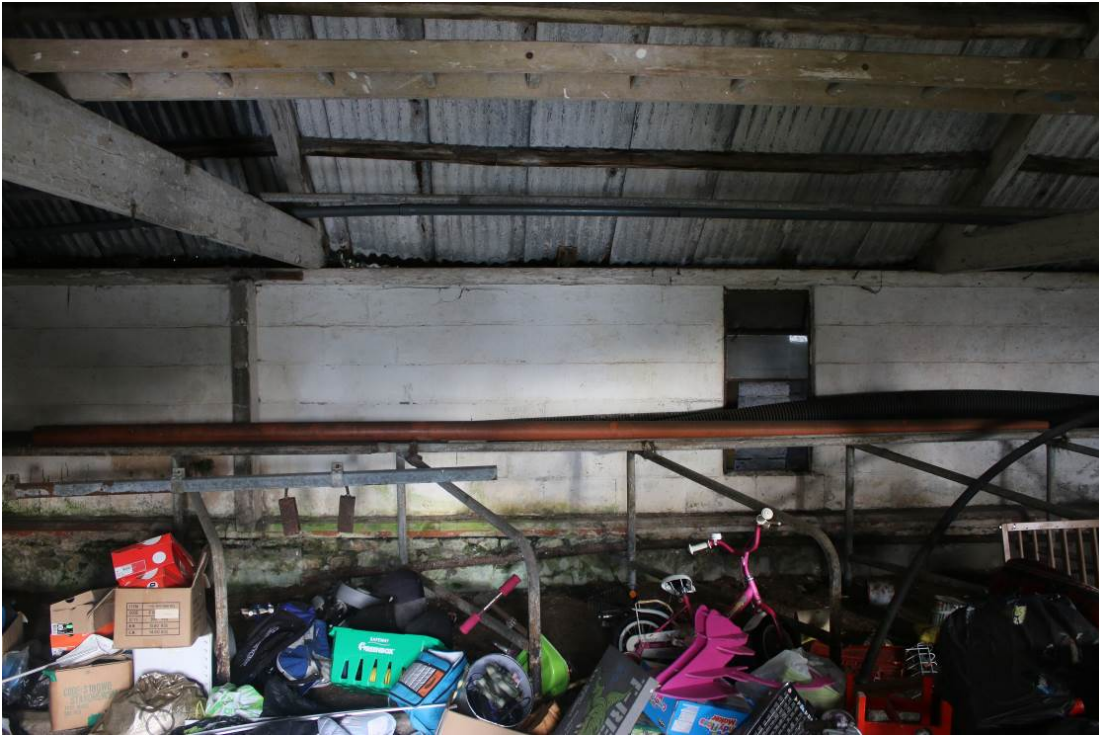
**Image EDP 3:** Photograph showing the continuation of the stone/red brick dwarf wall along the back wall of the northern range

- 2.10 Closer inspection shows that, like the rest of the 1885-1900 period buildings at Greenyard Farm, the building comprises a dwarf wall of shaped lias limestone rubble all the way round and with a coping of red brick on top (see **Images EDP 3 and 4**). This fabric runs all the way up the rear of the building, whereas it is broken on the east side by two openings; one situated at the south end which is now closed by a modern steel door and the other at the northern end which appears to be original (albeit rearranged).

- 2.12 It is noteworthy that the concrete blocks used to support the north end of the cart shed opening continue to be utilised for the external walls around the remainder of the single storey elements defining the north side of the farmyard. It is assumed that this material was utilised as a replacement fabric. The original fabric of the external elevations is likely to have comprised some form of timber-framing, in common with the stable range. This is clearly depicted in **Image EDP 3**.

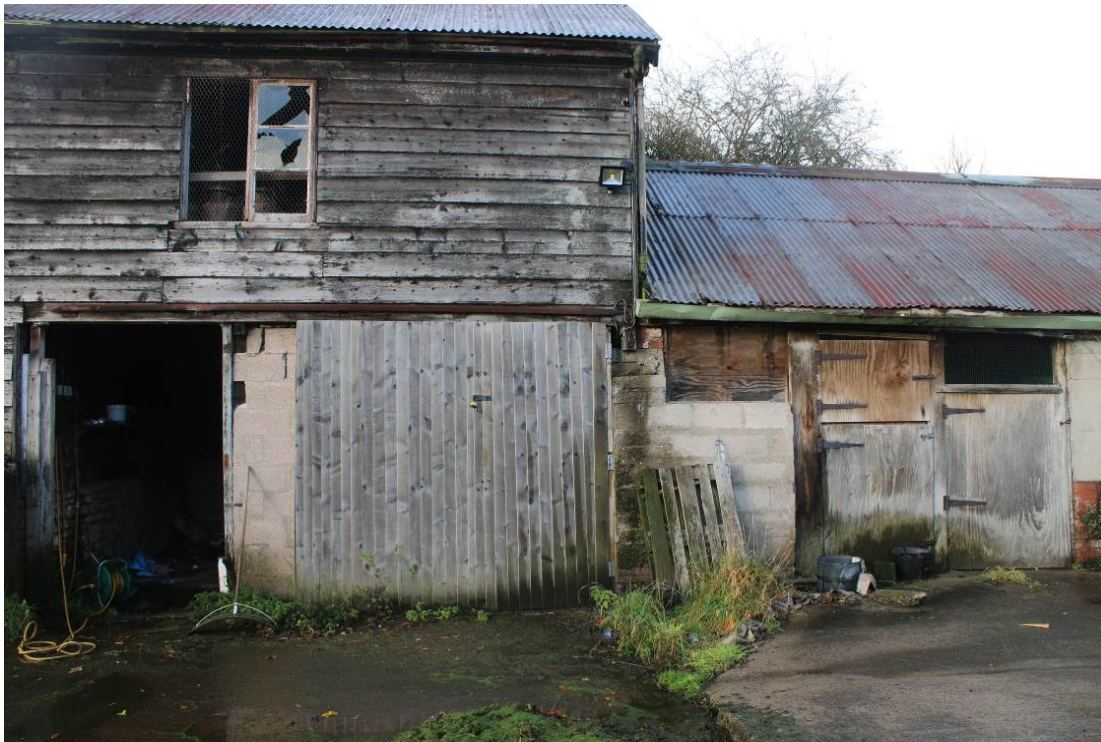
**Image EDP 5:** Close-up of the north end of the barn at Greenyard Farm; here illustrating that the north wall of the late 19<sup>th</sup> century building is supported on concrete blocks

- 2.11 There is clear evidence that the north end of the east-facing elevation has been modified; not least because the north elevation is now supported by a column of breeze blocks and concrete (**Image EDP 5**). Nonetheless, the likelihood is that the opening itself is original; comprising a cart shed at the north end of a combined stable block/cart shed, and with a hay loft on the floor above.

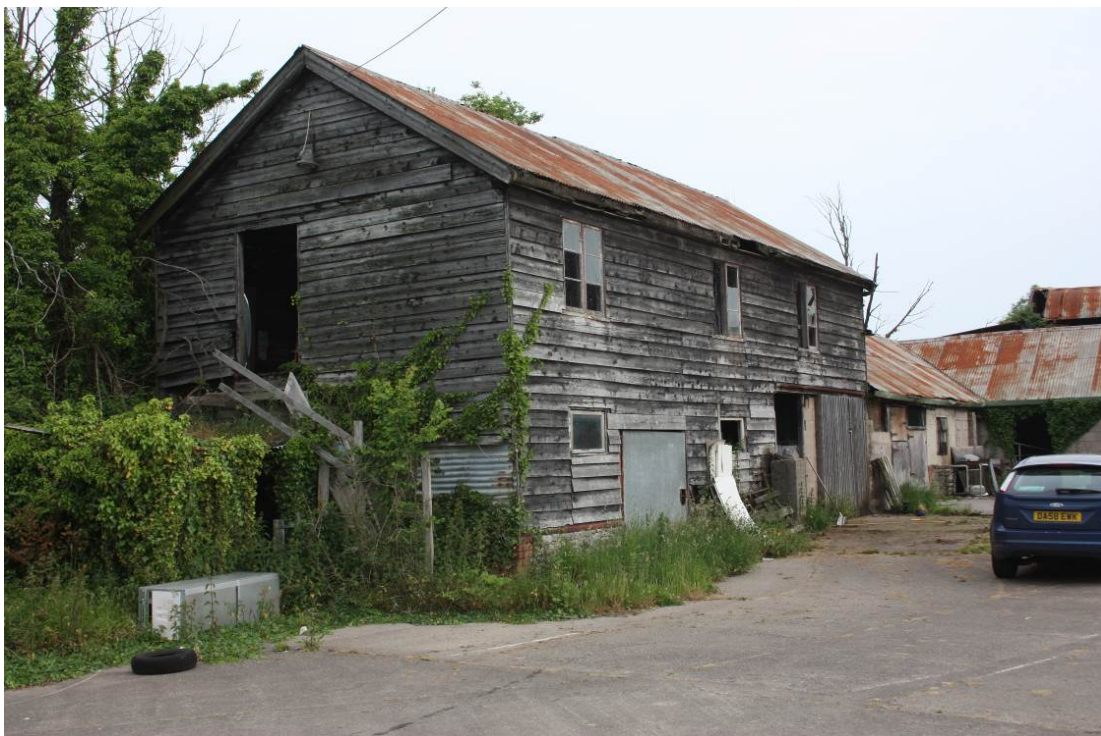
**Image EDP 6:** View of the barn at Greenyard Farm from the south east – here showing the existing (external) means of access to the first floor hay loft

- 2.13 Whilst the first floor hay loft can still be accessed by a stair case and door opening in the south-facing elevation (see **Images EDP 6 and 7**), there is no apparent (original) means of access to the stables' interior. The north side of the steel-doored opening at the south end of the building is neatly defined with red brick and appears to be contiguous with the stone and red brick of the characteristic dwarf wall. In contrast, the south side of the opening is rather more ragged and uses concrete; thus clearly illustrating that this ground floor opening has been partially re-worked and enlarged in recent times. This is illustrated in **Images EDP 8 and 9**.

- The only change to the south-facing elevation will be the removal of the external staircase and the creation of a ‘Juliet balcony’ for the first floor door opening; and

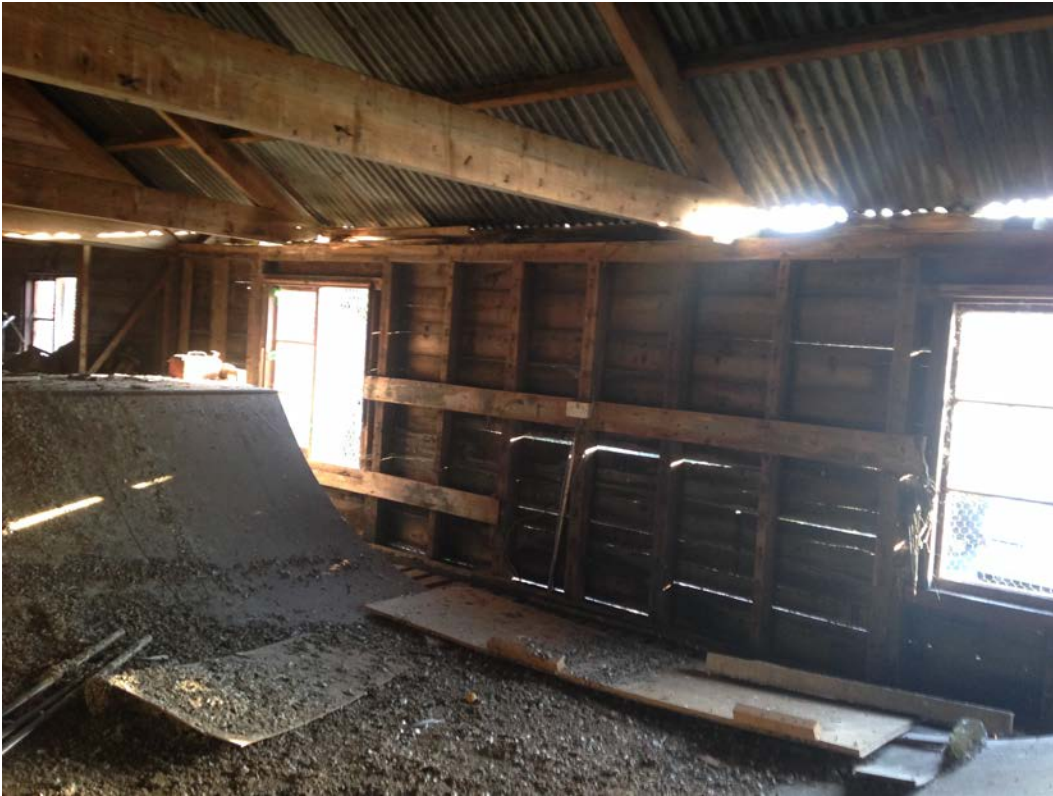
**Image EDP 7:** Representative depiction of the interior of the first floor hay loft

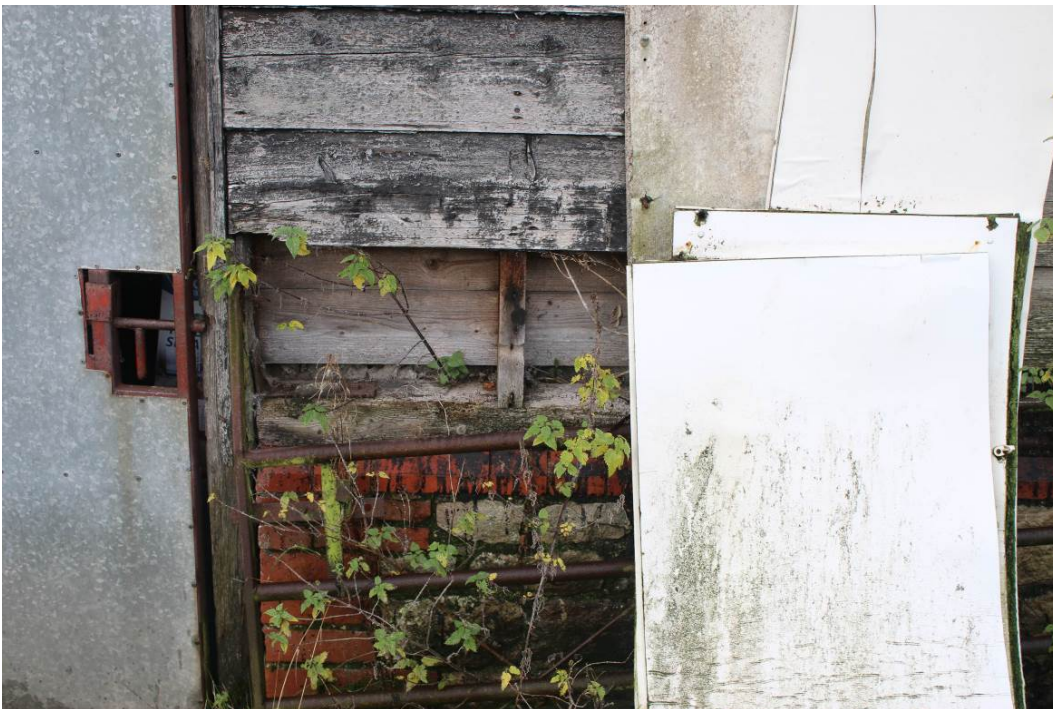
**Image EDP 8:** Close-up of the north side of the main door opening; here illustrating the neat brickwork which strongly suggests originality

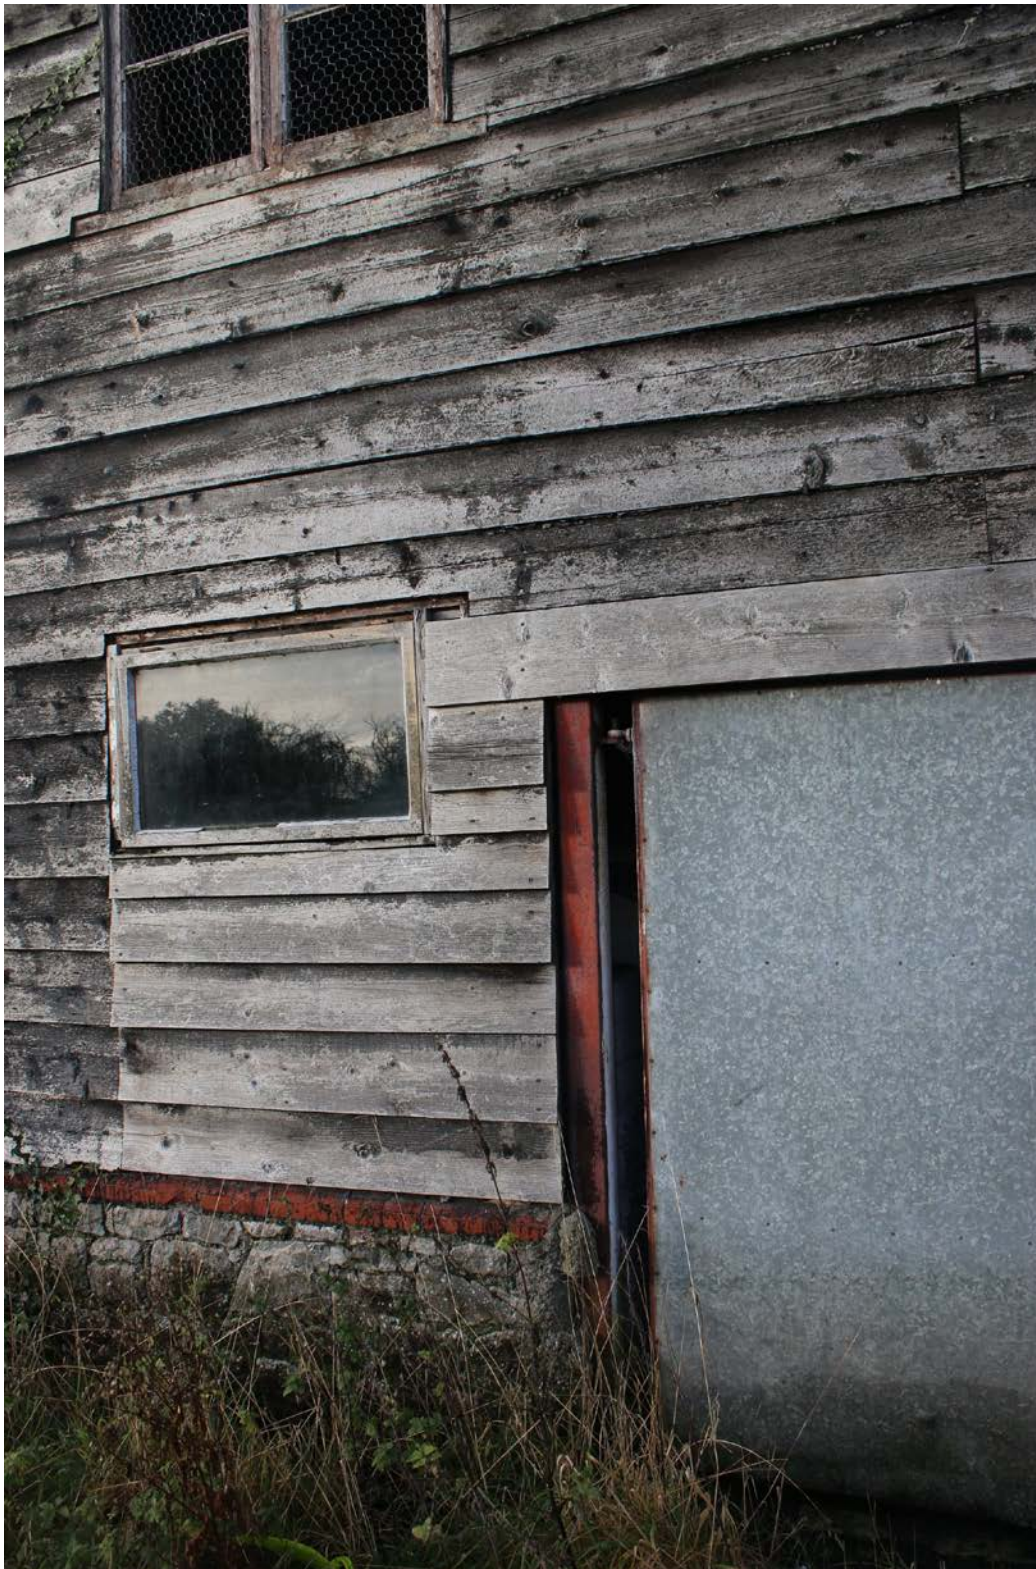
**Image EDP 9:** Close-up of the south side of the main door opening; here illustrating the ragged edge defined with concrete, strongly suggesting that it has been widened in the 20<sup>th</sup> century

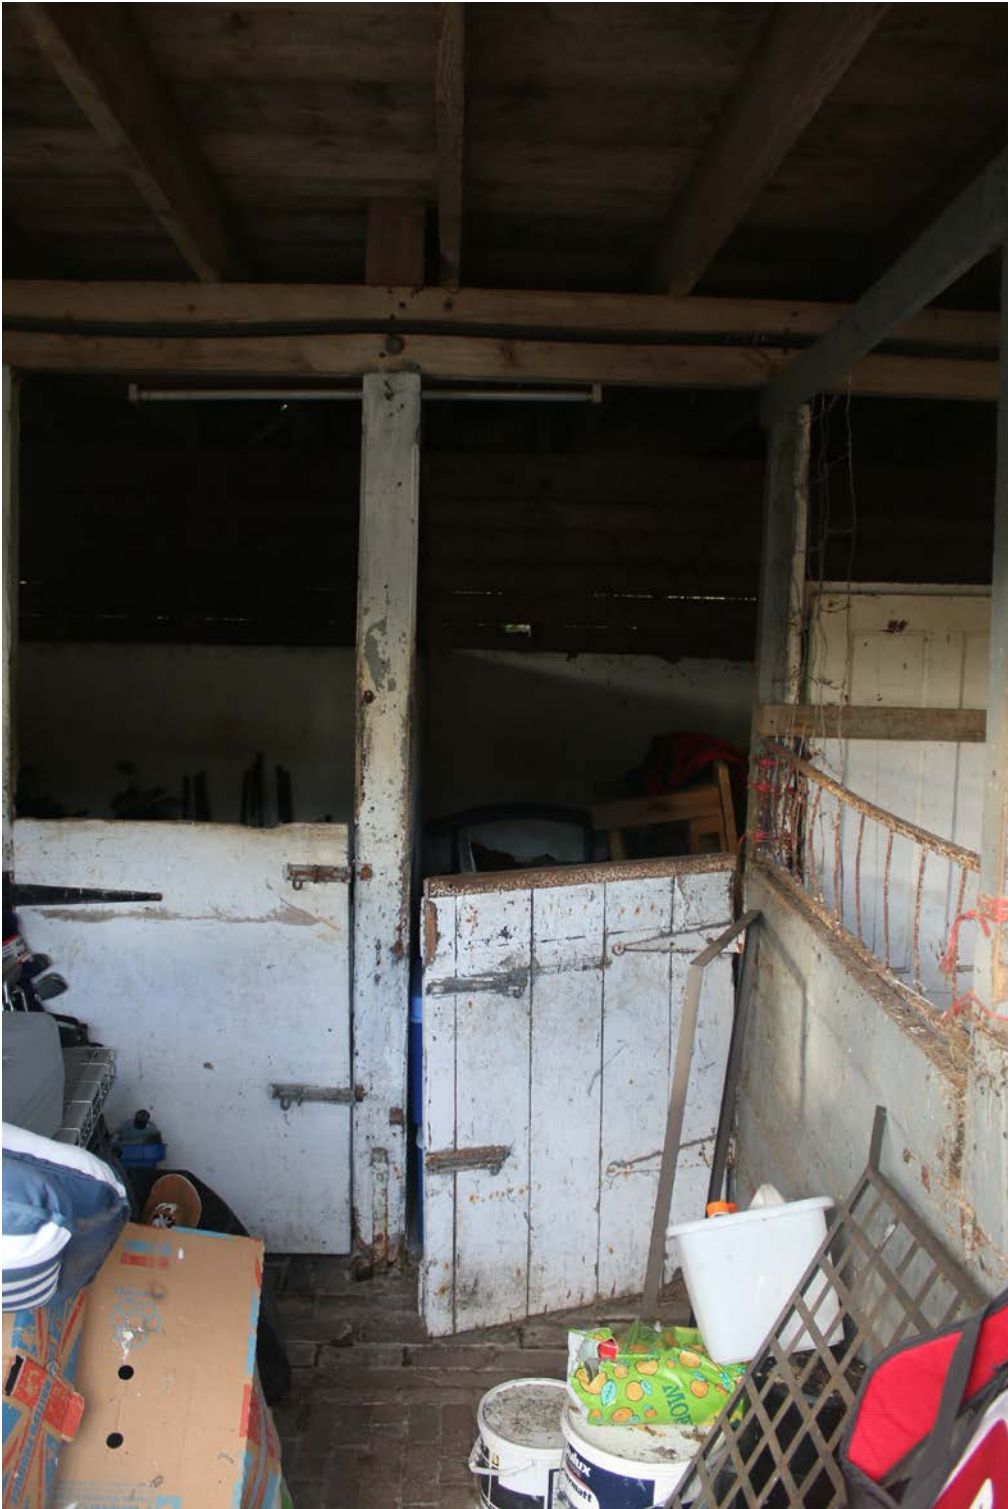
**Image EDP 10:** Representative photograph showing the interior of the stable block

- 2.14 The interesting point (however) is that the internal space still retains original features of the stables; not only does the red brick floor surface retain its inbuilt guttering, but equally the three timber partitions continue to separate the four stalls which are arranged along the west side. However, it is clear that the existing opening would not provide horses with a means of access to the building's interior (**Images EDP 10 & 11**). The opening is too low if the existing weatherboarding is part of the original fabric.

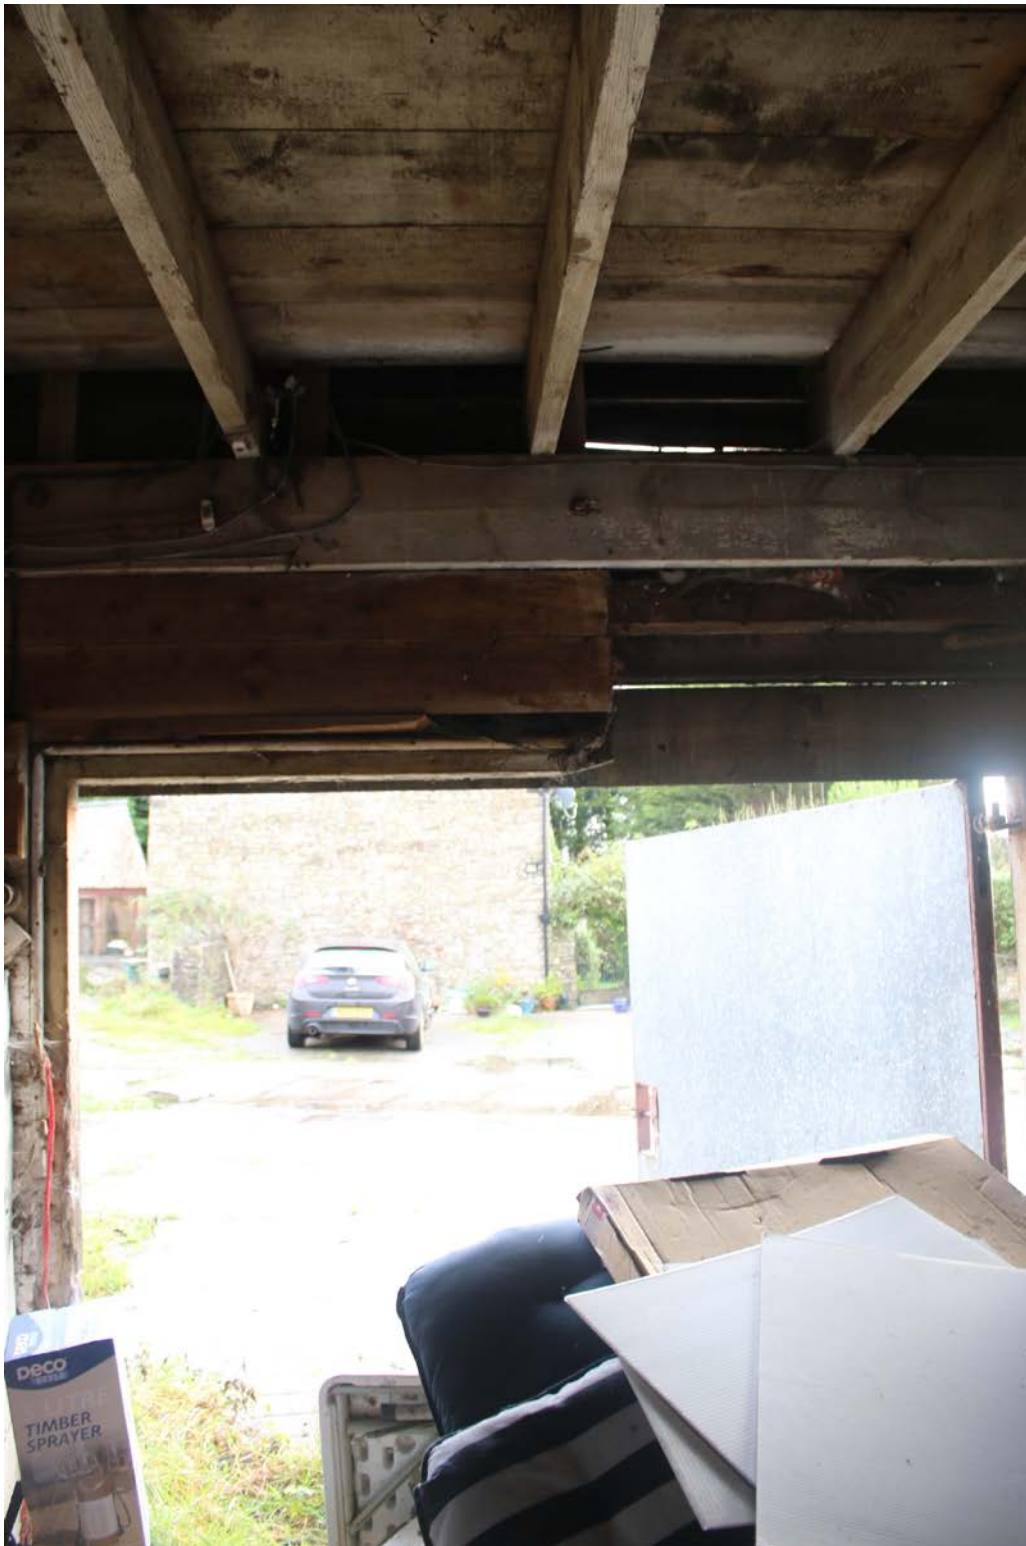
**Image EDP 11:** View out through the main door of the stable block; here illustrating its low height in comparison with the typical horse

- 2.16 It is worth noting that the remainder of the associated outbuilding range to the north exhibits the same underlying stone and brick-built 'dwarf' wall, but the upper elements have been replaced with concrete block fabric. It therefore seems likely that the entirety of the 1885-1900 outbuilding range was originally provided with timber-framed upper walls on top of the stone/brick. Nonetheless, the evidence supports the view that the existing external treatment of the barn at Greenyard Farm is not the original covering, as it appears to prevent the access of horses to the interior of the stable range.

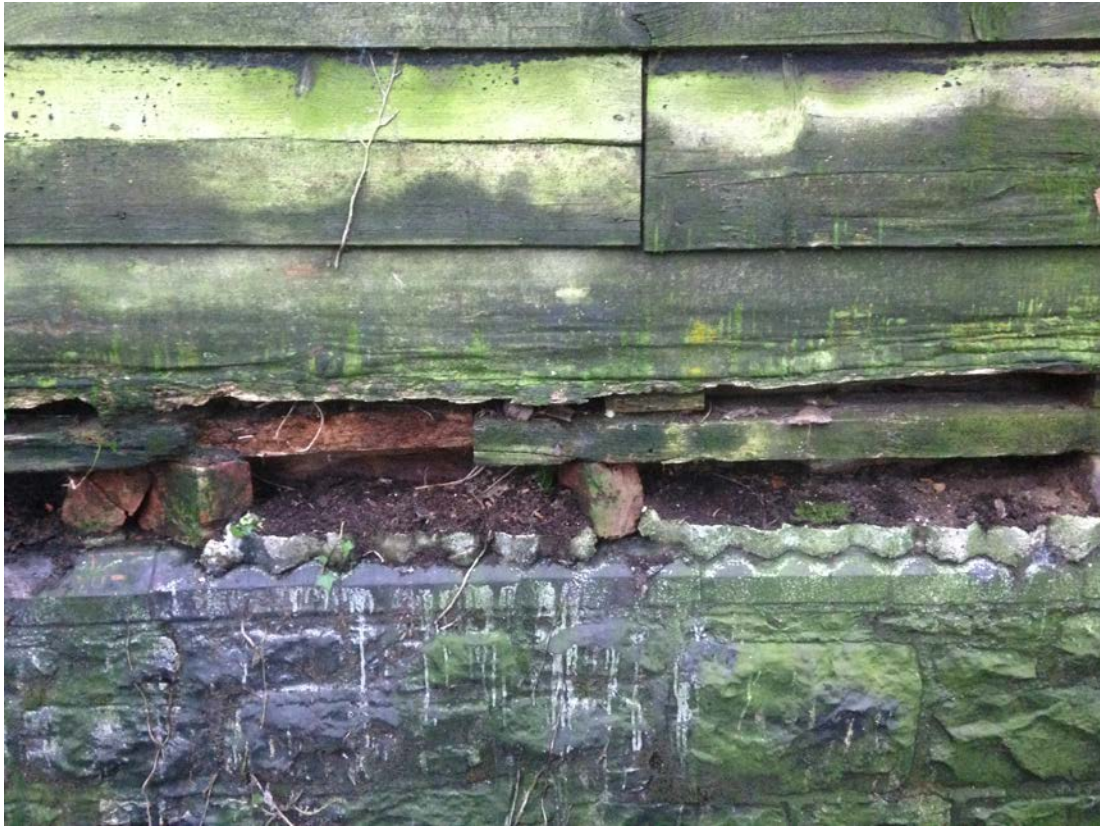
**Image EDP 12:** Close-up showing the relationship between the timber sill beam and the stone and red brick dwarf wall at the rear of the barn; clearly highlighting the use of basic materials

- 2.17 This proposition is given added weight by the fact that the timber framed structure and weatherboarding on the rear elevation is no longer supported by a sill beam, and instead it is supported by a mish-mash of red brick and pieces of concrete. This is illustrated by **Images EDP 12** and **13**.

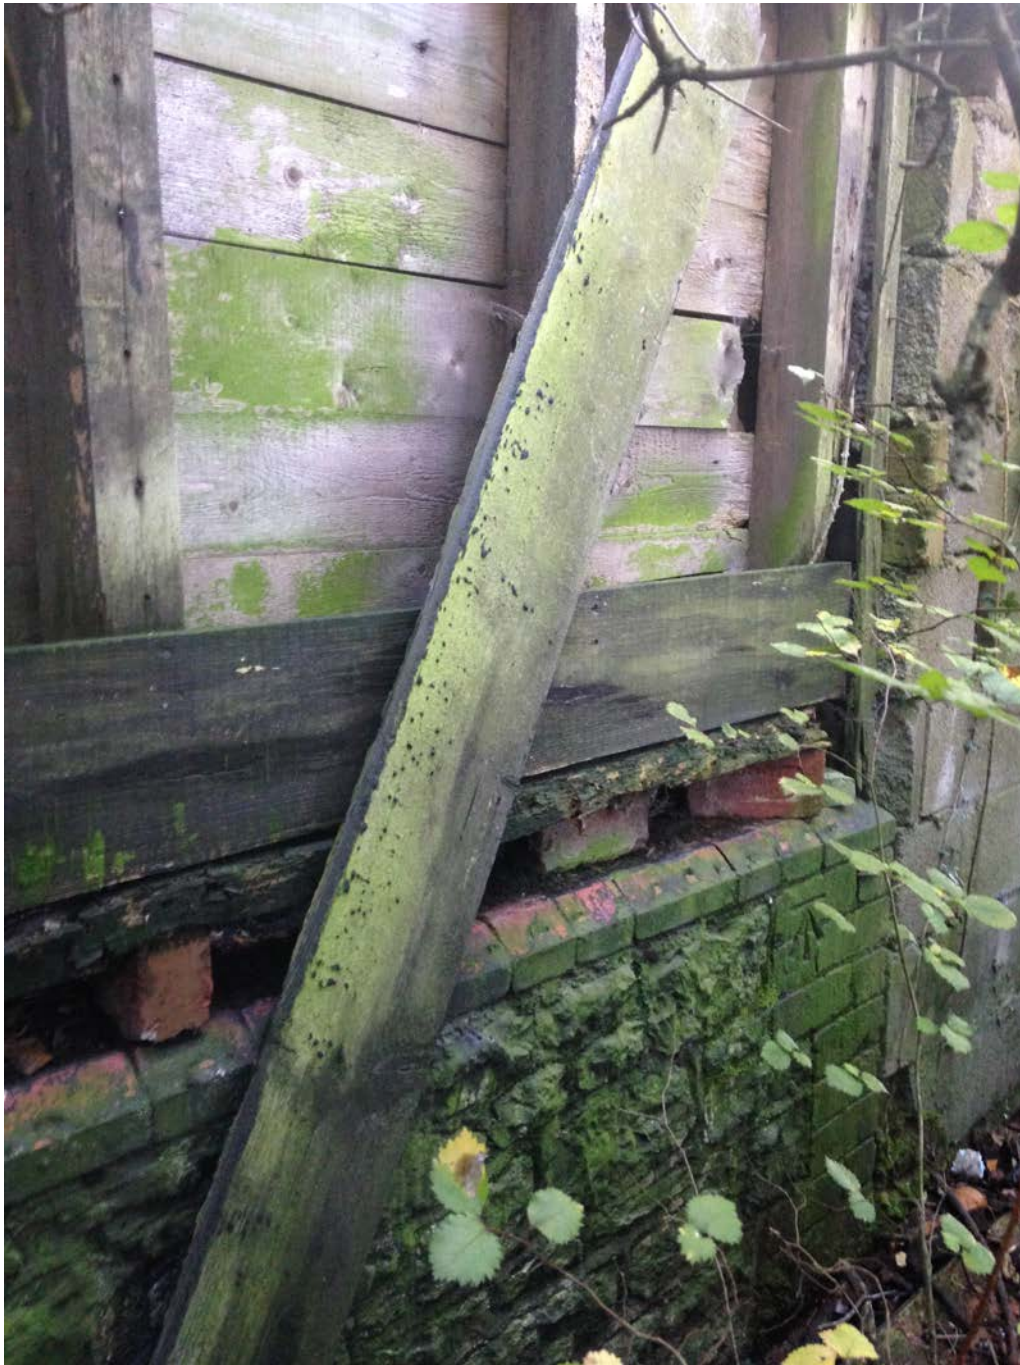
**Image EDP 13:** Depiction of the south west corner of the barn, here highlighting the use of basic modern materials to fill the gap between the timber sill beam and the stone and red brick dwarf wall characterising the outbuilding range
