Bat Survey  
Greenyard Farm  
Argae Lane  
St Andrews Major  
Vale Of Glamorgan  
CF63 1BL  
February 2016  
ON THE INSTRUCTION  
OF  
Andrew Edmunds

Reported by Mr. Richard Watkins  
10 Mount Pleasant, Llanelly Hill, Abergavenny,  
Monmouthshire. NP7 0NT  
Tel: 07866461726  
Email: [richard.bats@gmail.com](mailto:richard.bats@gmail.com)

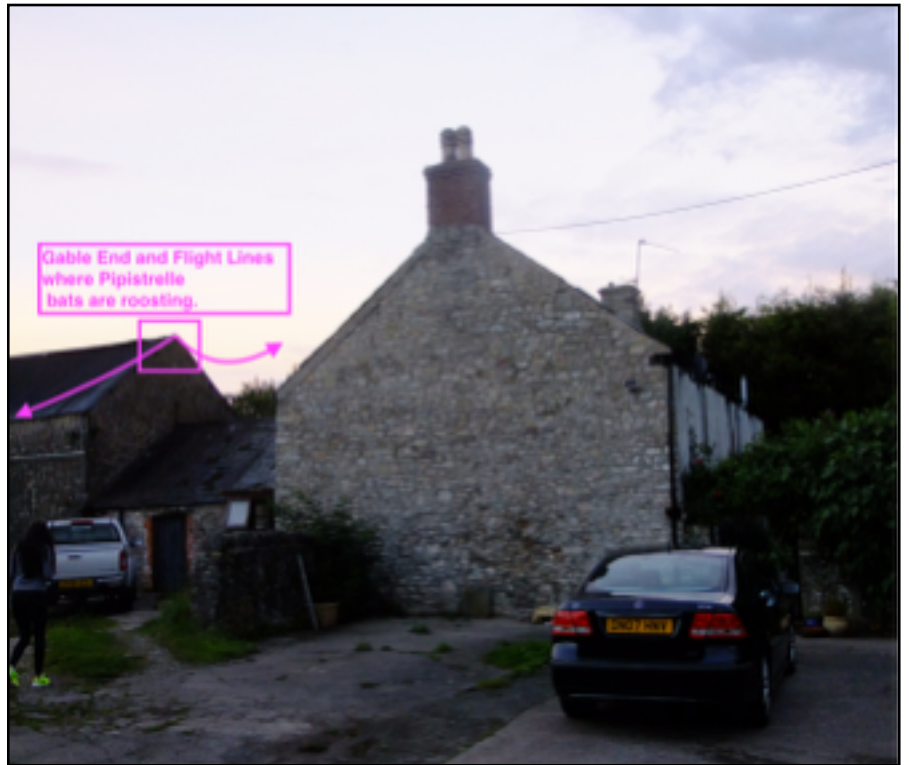
**Common Pipistrelle exit point out of stone barn**

**Stone Barn with Pipistrelle roost at the apex of the gable end.**

**4 Common Pipistrelles was observed leaving from the south apex of the stone barn .**

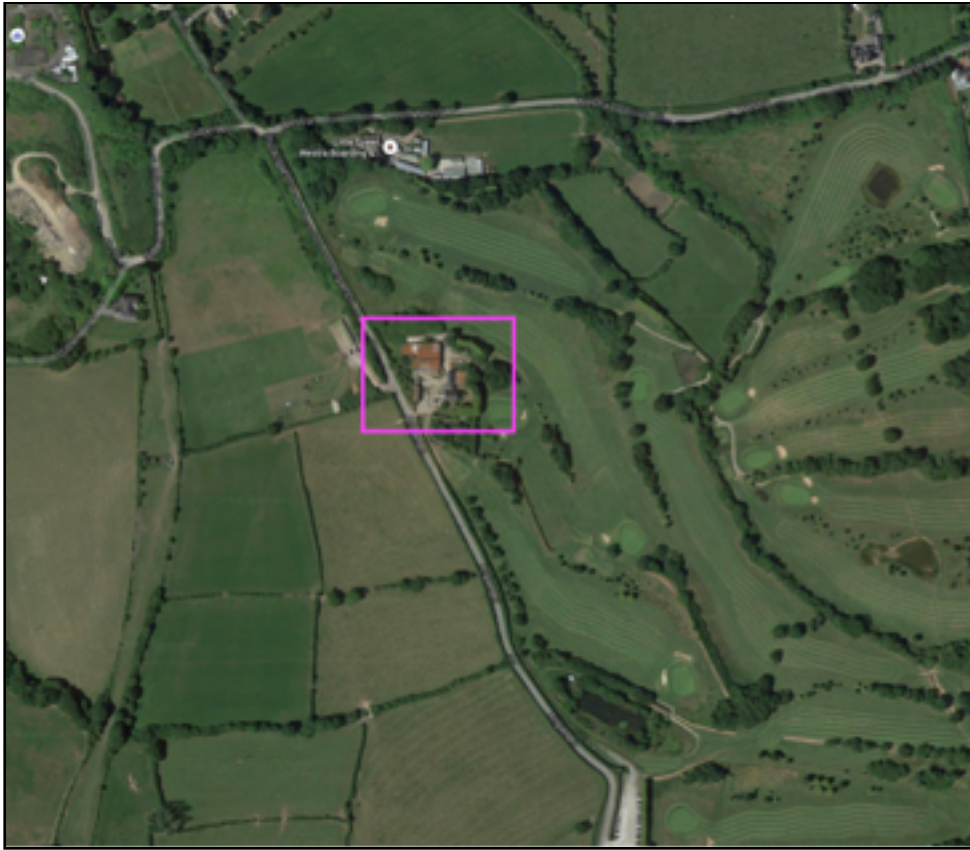
**The Building in its larger environment offering excellent conditions for bats.**
