Slope Stability Desk Study Report Proposed Residential Development North Cliff Lodge, Penarth

Job No: 13124

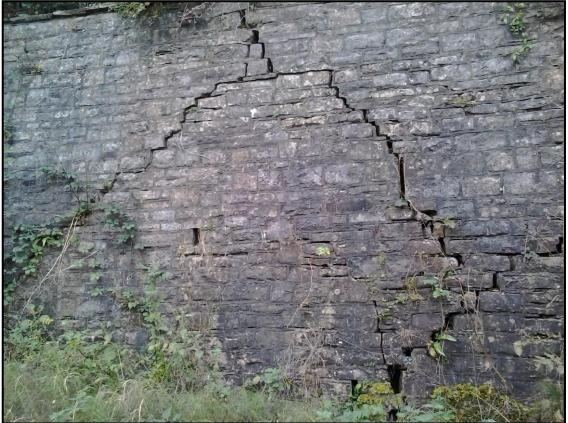
Plate 2.1. Cracking in retaining wall.

The site was visited on 23rd October 2015. The site currently comprises a domestic property with a large garden. The garden in divided into terraces with the lower terrace accessed via steps from the mid-terrace. A stone retaining wall separates the lower and mid terrace. Significant cracking is apparent in the retaining wall.

Cracking was also noted in the ground above the retaining wall and evidence of ground movement was also apparent in the garden steps.

We would recommend that an intrusive investigation be performed to determine the ground conditions beneath the site and also to install monitoring instrumentation to assess seasonal groundwater variation beneath the site and to assess whether any deep seated movement is underway.

Retaining structures on site may also be required to be founded on piles. The final foundation solution will be verified by the investigation works.

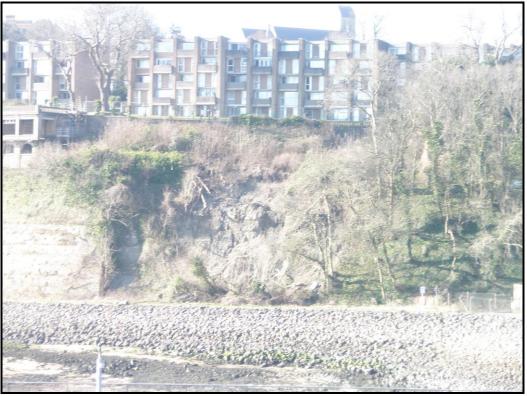
Plate 2.2. 2013 Landslide adjacent to study site.

In 2013 Terra Firma Wales Ltd were engaged to assess a landslide at Penarth Marina, located immediately east of the current study site. A failure had occurred on the slope and Terra Firma Wales Ltd performed an inspection of the slope and the surrounding area. Landslide morphology was apparent and features including tree 'piston gripping' (i.e., curvature in the base of trees as they correct themselves to vertical following historical ground movement events) was noted adjacent to the slide, indicating further historical land movement to the northwest of the 2013 landslide.

The groundwater elevation beneath the site is currently unknown to Terra Firma Wales Ltd. During the 2013 landslide areas of seepage were noted in the face following the failure. An inspection chamber and damaged pipe work were noted in the slope and it is conceivable that these may have directed water in to the landslide.

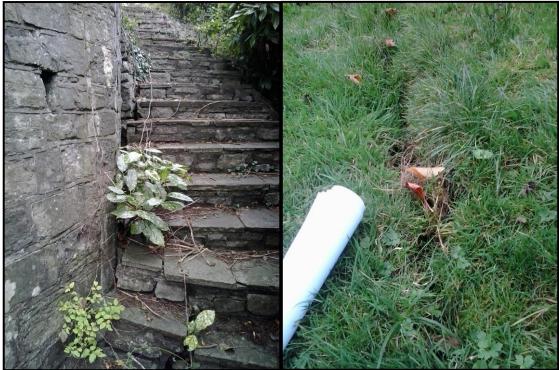
Plate 2.3. Evidence of Ground Movement during October 2015 visit.

During the walkover of the current study site significant damage to a retaining wall, gaps between the retaining wall and the stairs and cracking in the ground of the mid level terrace were noted.

We anticipate that given the evidence detailed above it will be necessary to employ a foundation solution that will transfer the foundation load to depth, below any potential slip surface.

We therefore anticipate that any new development will require pre-bored steel cased piled foundations. Such a foundation would not further load any landslip and also provide a degree of lateral support. Such a foundation solution together with a sympathetic development ethos should reduce the risk of ground movement to an acceptable level.
