Appendix A Trial Pit Logs

Equipment & Methods: JCB 3CX	Project Name: St. Athan Northern Access Road		Job No: 60509148
	Project Location: St. Athan		
	Client: Welsh Government		
	Co-ordinates: E: 298335.157 N: 168941.925	Ground Level (m): 44.96 AOD	Date Started: 23/11/2016 Date Completed: 23/11/2016

Appendix C Soakaway Test Results

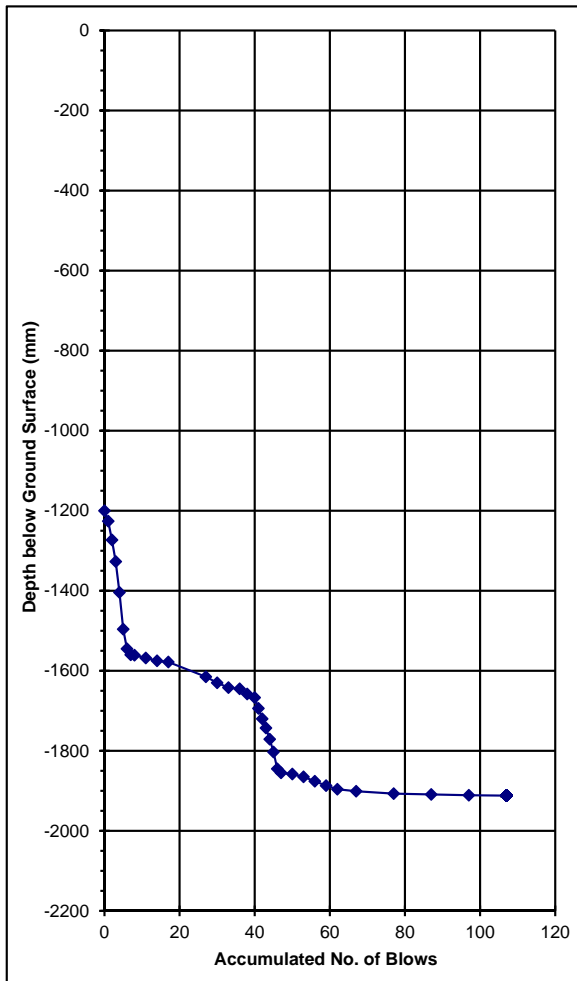
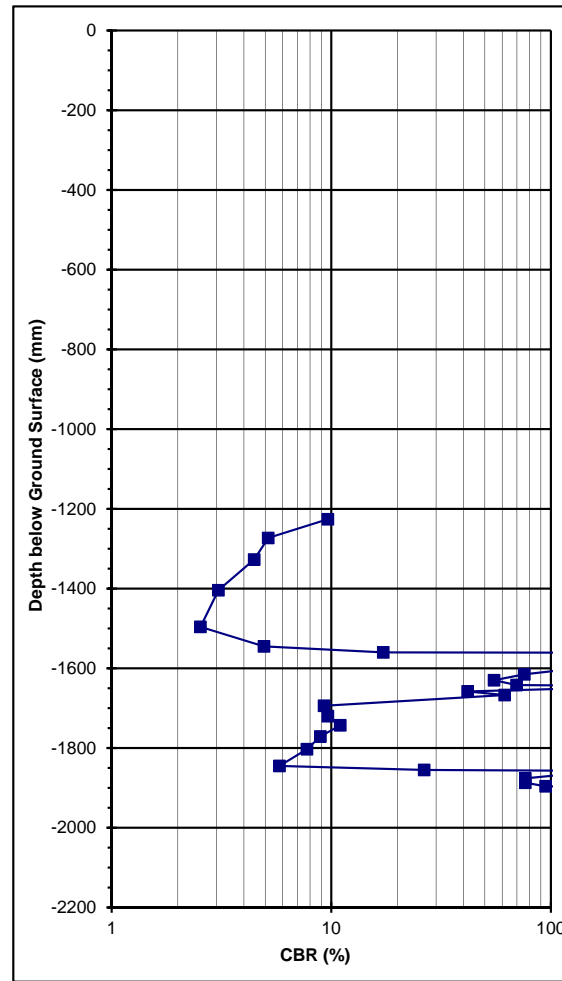
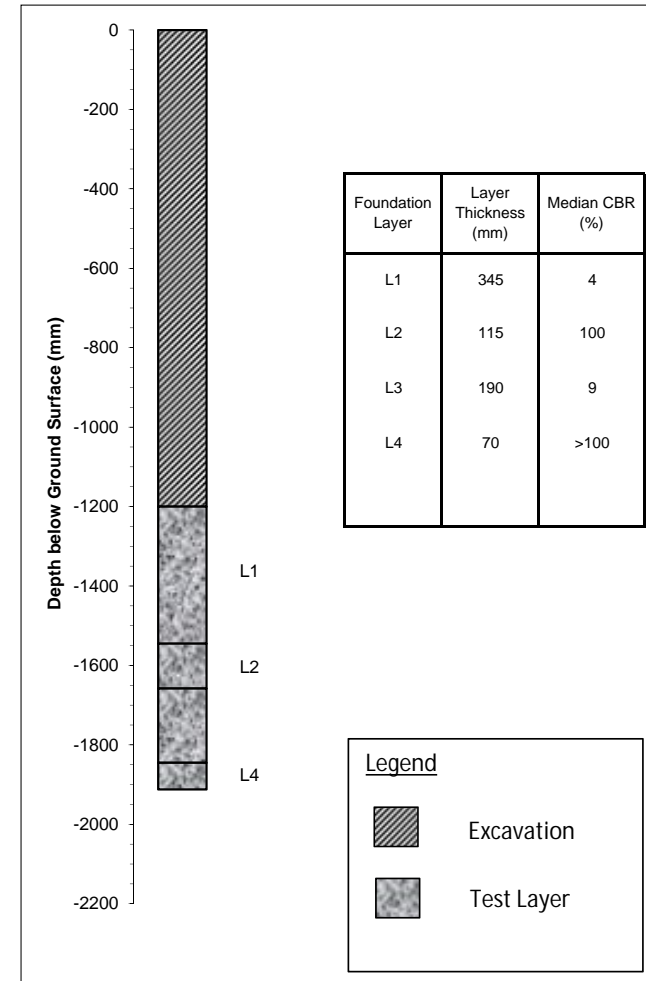
OSGR: 298335.157, 168941.925

Notes: Test commenced from the base of top soil in SK501 machine-excavated trial pit

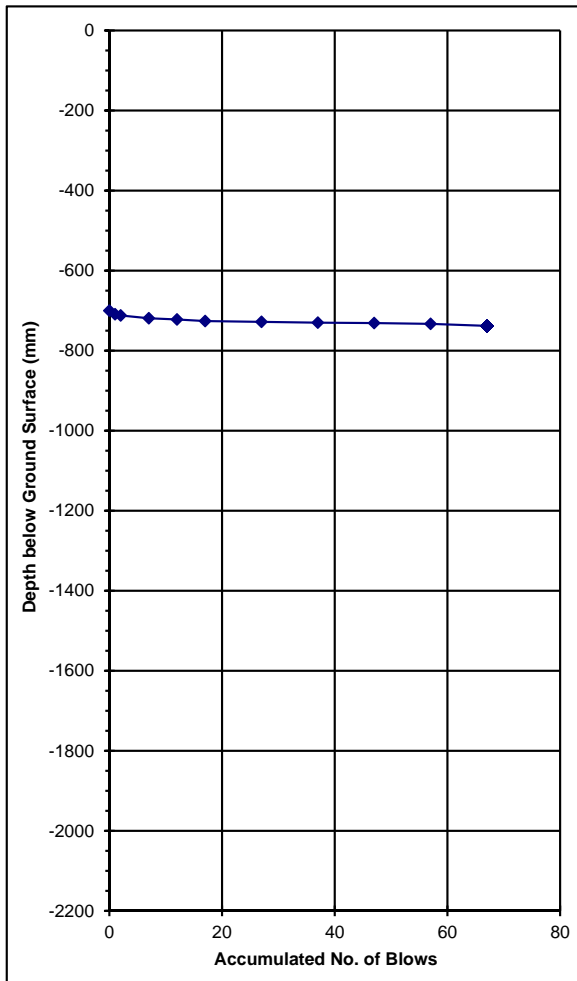
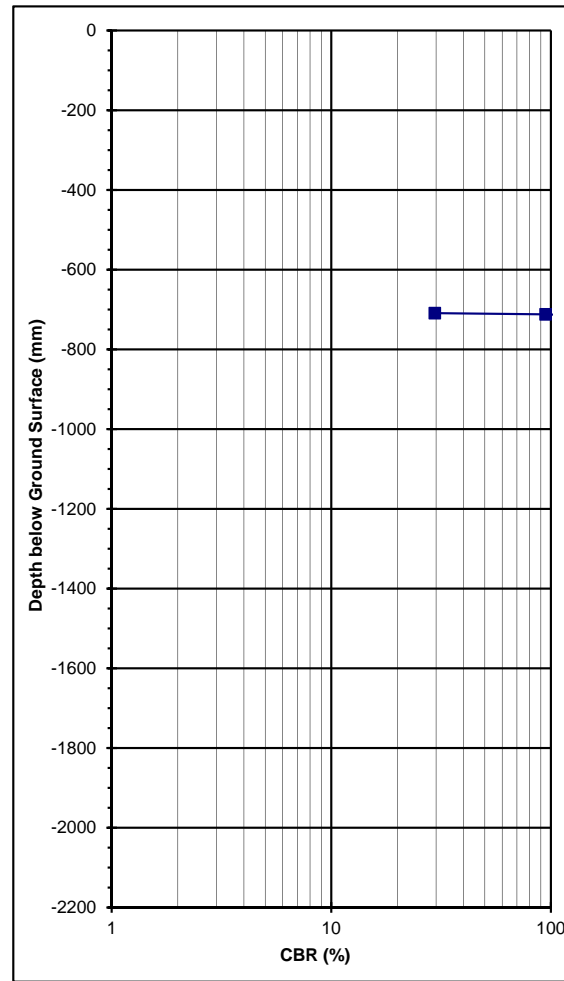
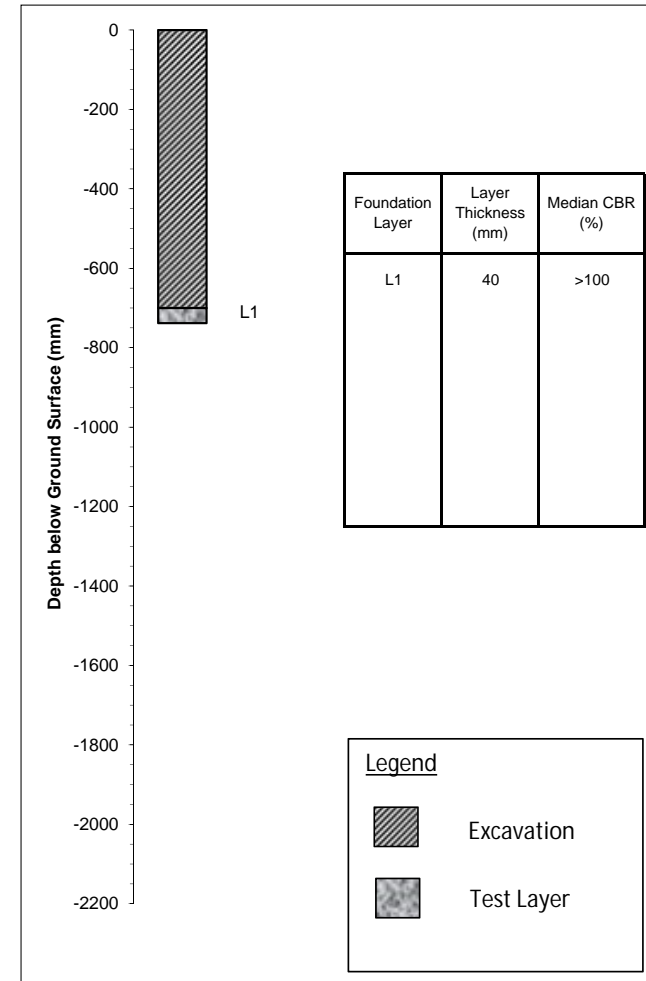
Job Number : 60509148
 DCP/Core Number : SK502
 DCP Operator : CC/WH
 Date Tested : 23/11/16
 Plot Prepared By : LT
 Plot Checked By : MB
 Date Prepared : 05/12/16

OSGR: 298511.703, 169002.432

Notes: Test commenced from the base of top soil in SK502 machine-excavated trial pit

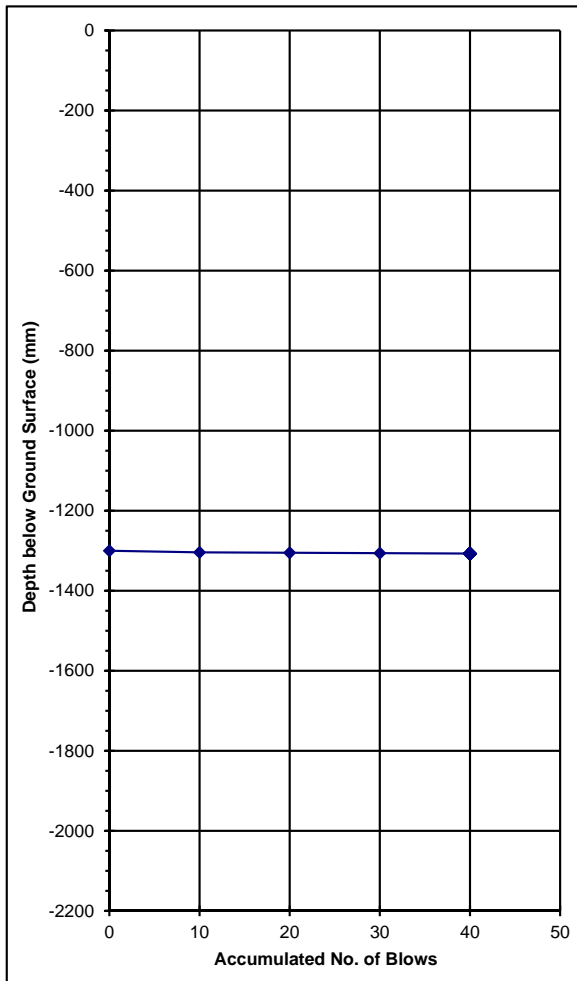
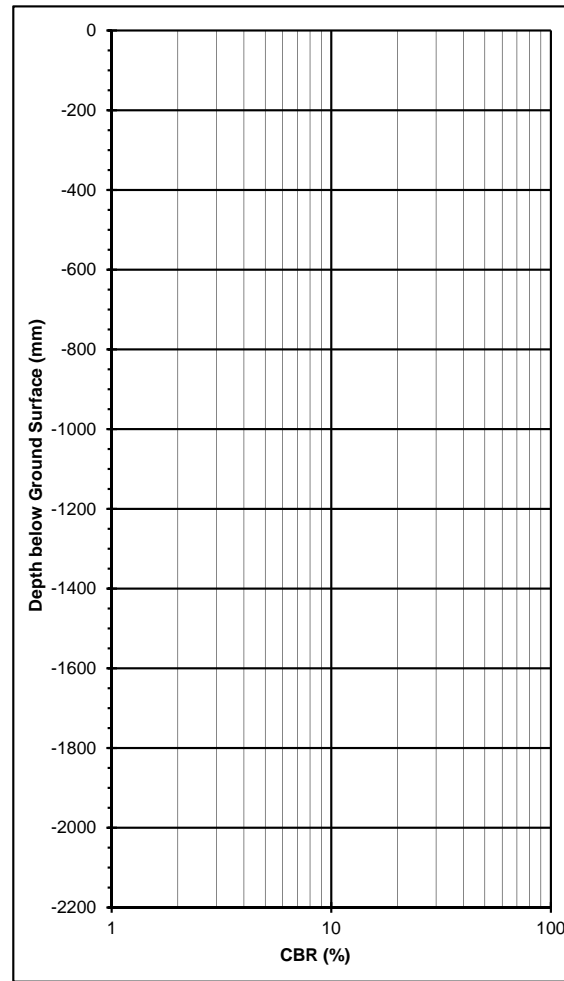
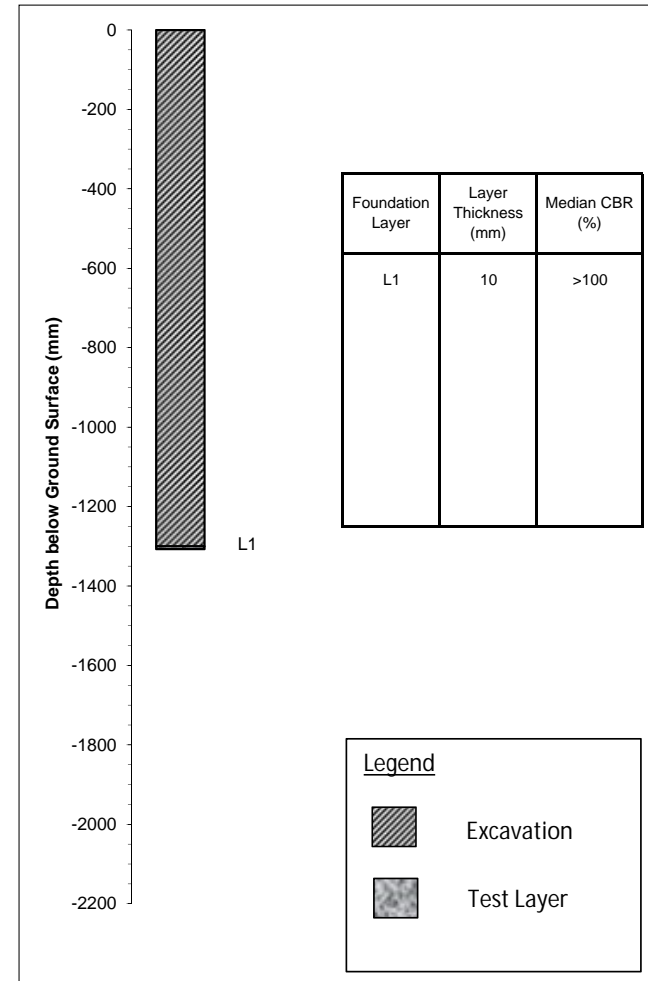
Job Number : 60509148
 DCP/Core Number : SK503
 DCP Operator : CC/WH
 Date Tested : 25/11/16
 Plot Prepared By : LT
 Plot Checked By : MB
 Date Prepared : 05/12/16

OSGR: 298759.892, 169081.211

Notes: Test commenced from the base of top soil in SK503 machine-excavated trial pit

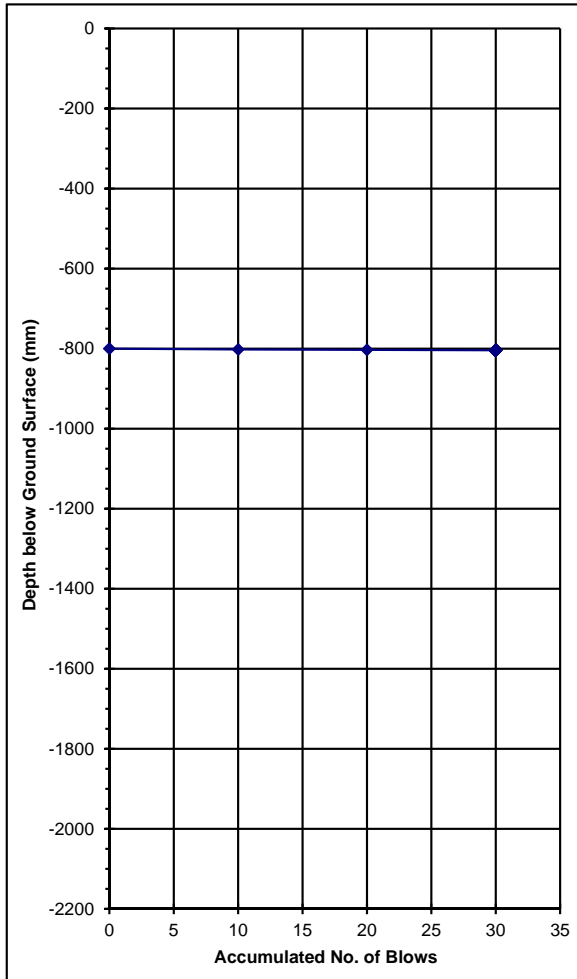
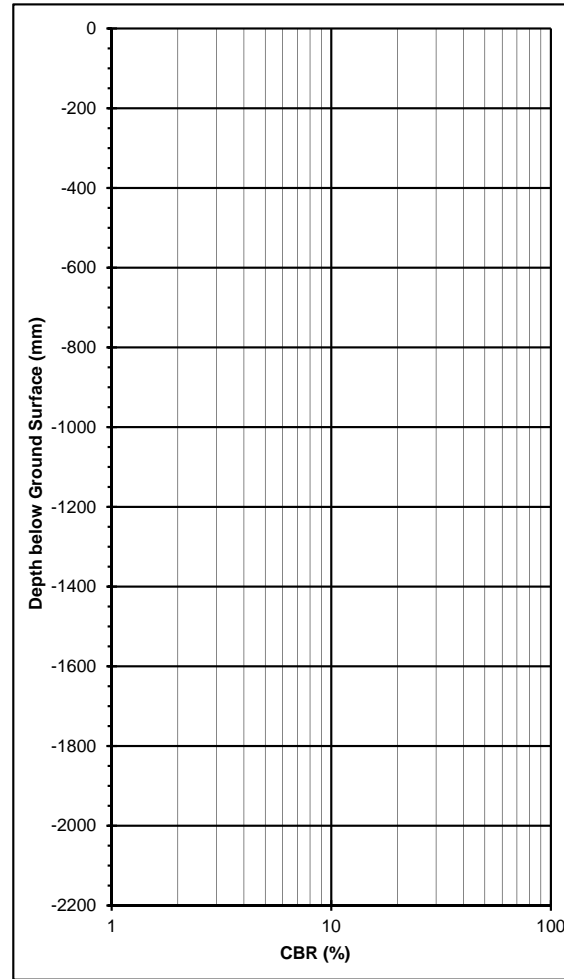
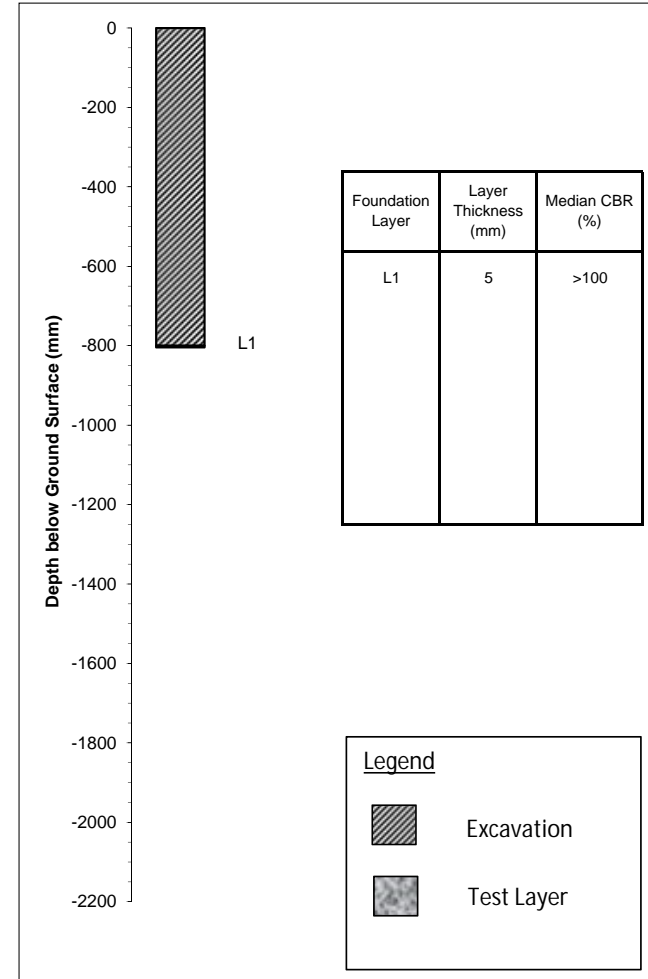
Job Number : 60509148
 DCP/Core Number : SK504
 DCP Operator : CC/WH
 Date Tested : 25/11/16
 Plot Prepared By : LT
 Plot Checked By : MB
 Date Prepared : 05/12/16

OSGR: 298881.314, 169149.165

Notes: Test commenced from the base of top soil in SK504 machine-excavated trial pit

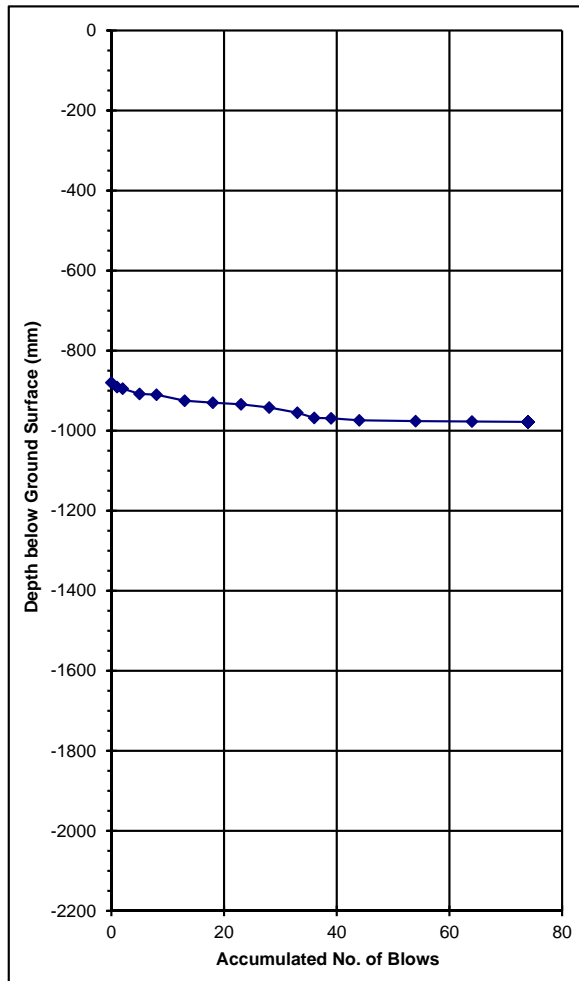
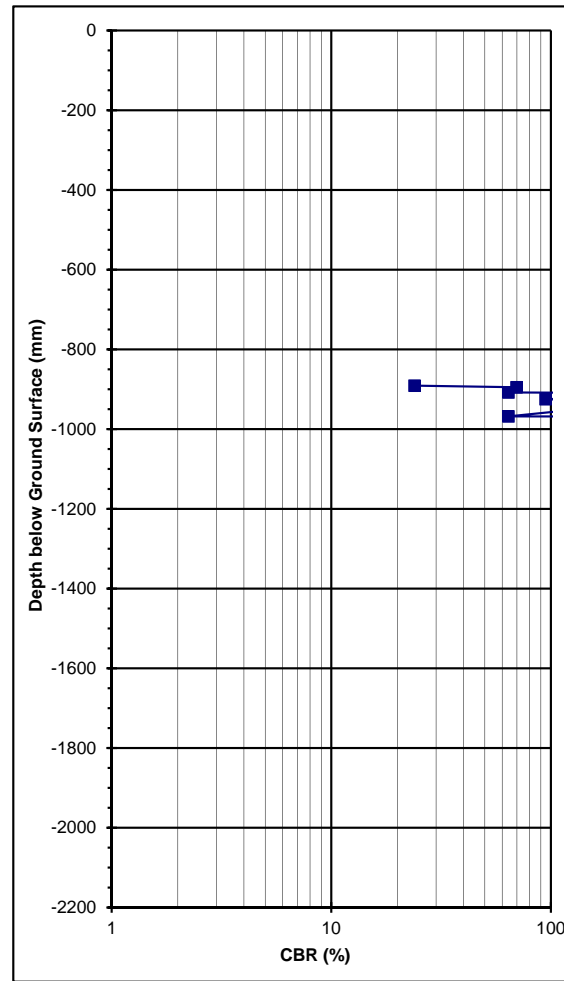
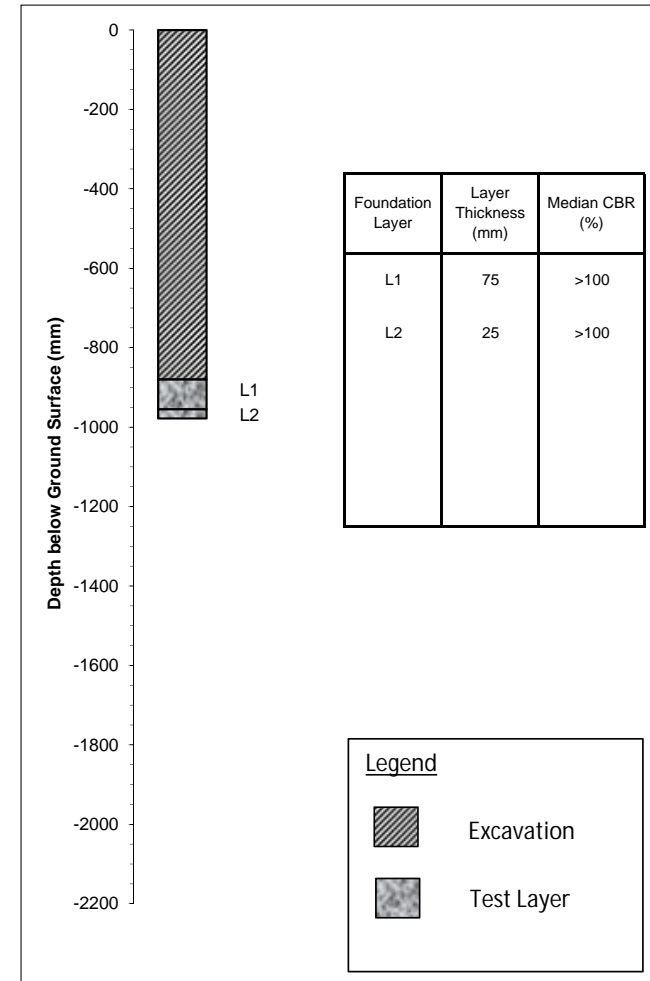
Job Number : 60509148
 DCP/Core Number : SK505
 DCP Operator : CC/WH
 Date Tested : 24/11/16
 Plot Prepared By : LT
 Plot Checked By : MB
 Date Prepared : 05/12/16

OSGR: 299067.672, 169210.291

Notes: Test commenced from the base of top soil in SK505 machine-excavated trial pit

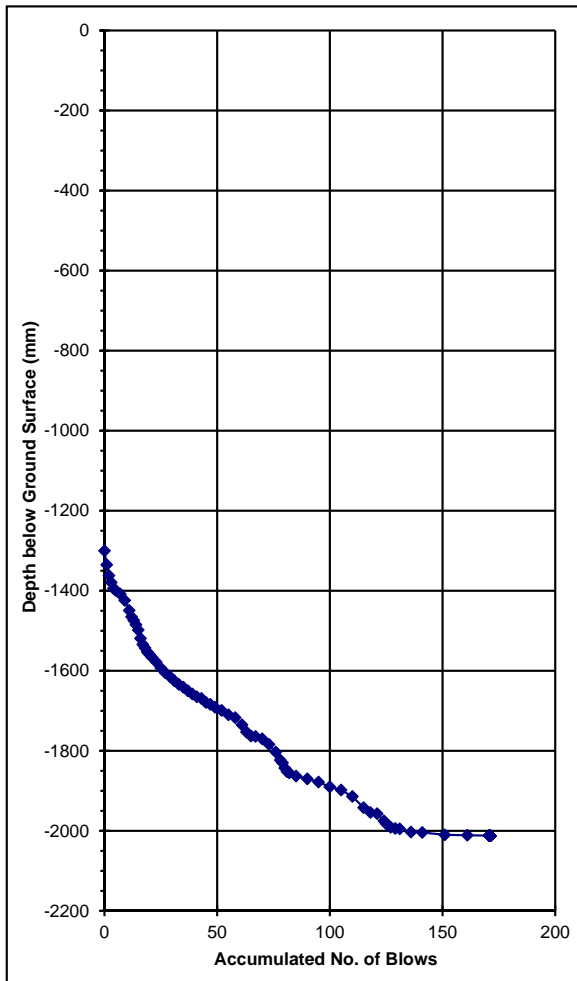
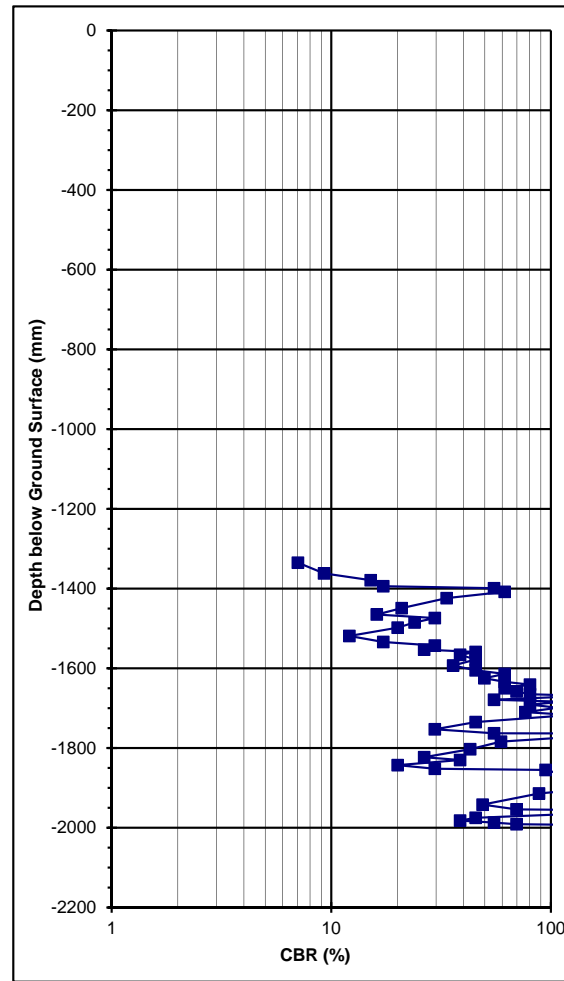
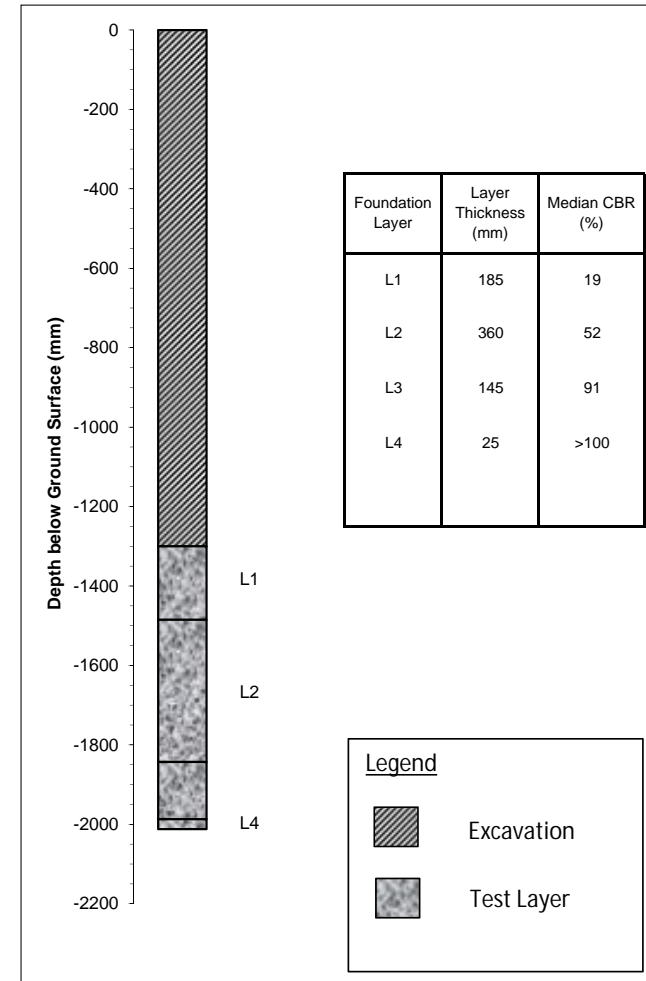
Job Number : 60509148
 DCP/Core Number : SK506
 DCP Operator : CC/WH
 Date Tested : 24/11/16
 Plot Prepared By : LT
 Plot Checked By : MB
 Date Prepared : 05/12/16

OSGR: 299152.675, 169307.883

Notes: Test commenced from the base of top soil in SK506 machine-excavated trial pit

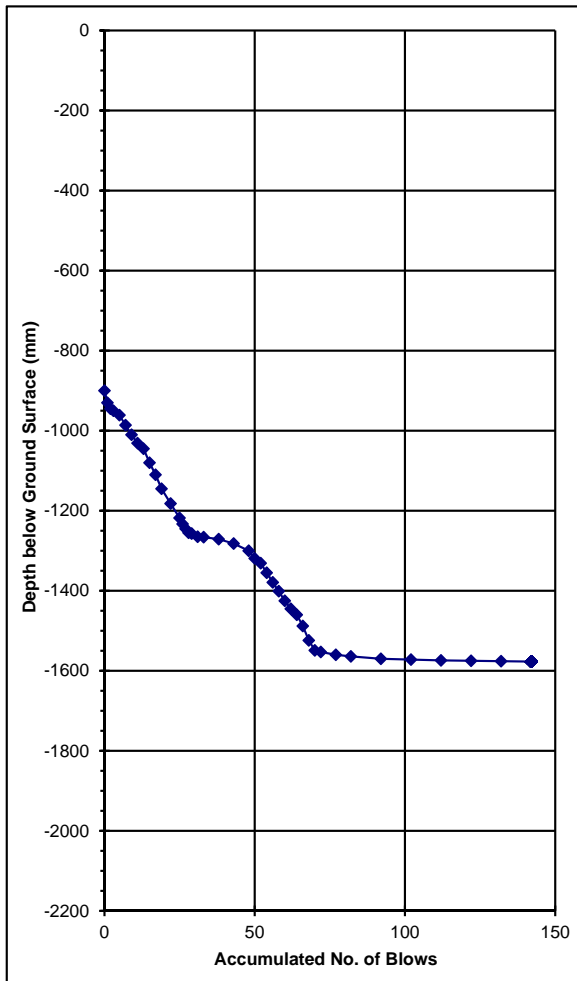
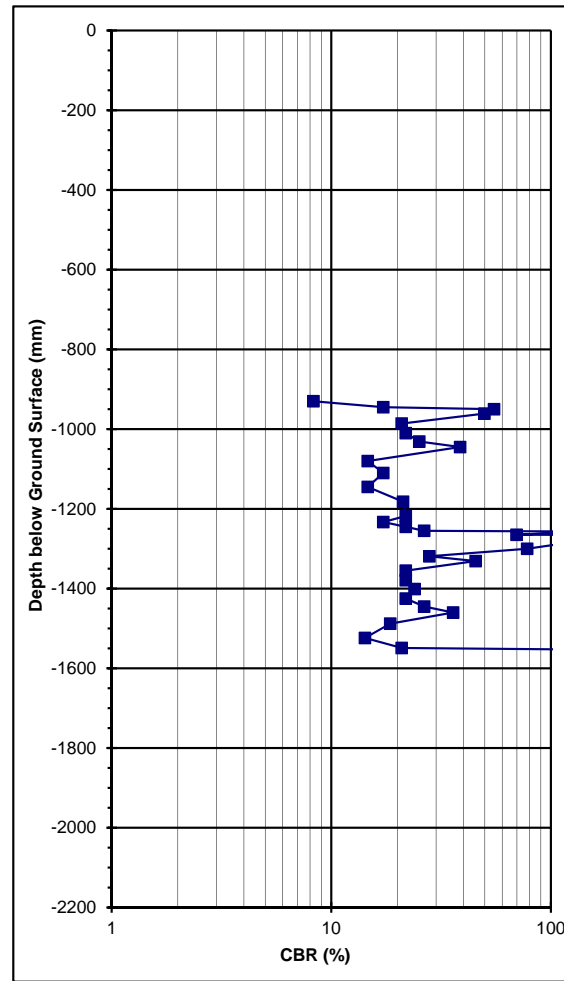
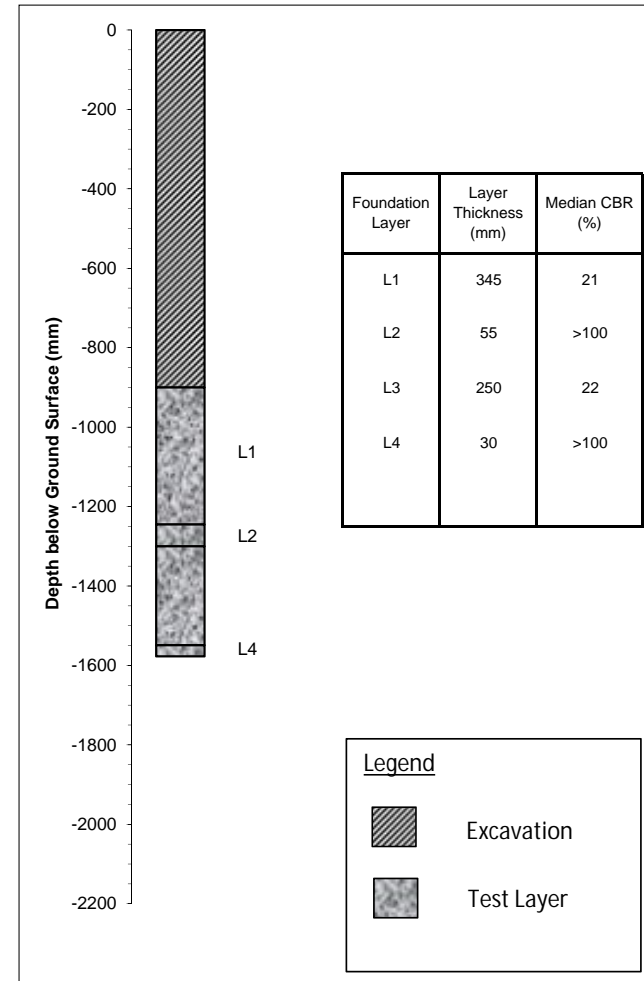
Job Number : 60509148
 DCP/Core Number : SK507
 DCP Operator : CC/WH
 Date Tested : 23/11/16
 Plot Prepared By : LT
 Plot Checked By : MB
 Date Prepared : 05/12/16

OSGR: 299452.038, 169293.941

Notes: Test commenced from the base of top soil in SK507 machine-excavated trial pit

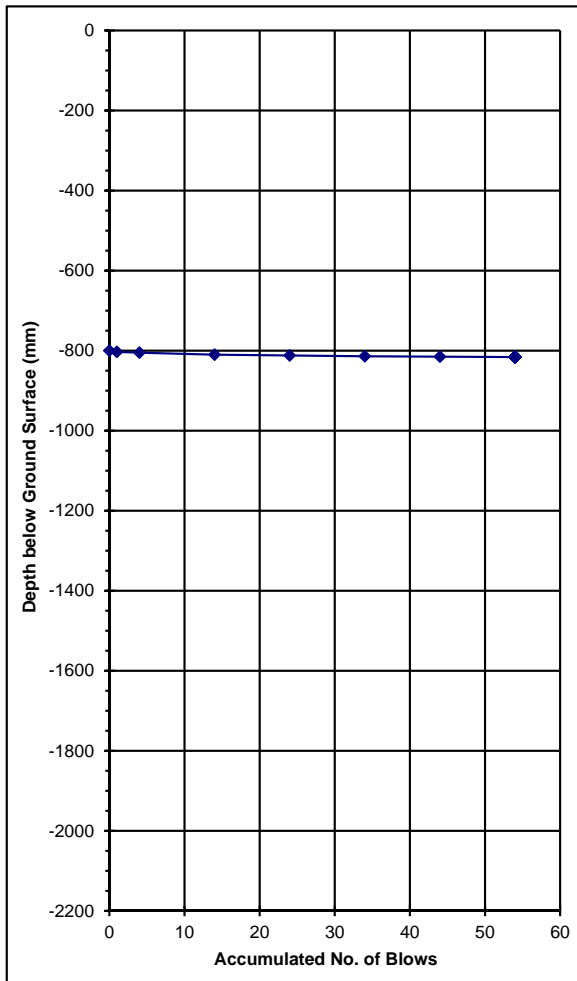
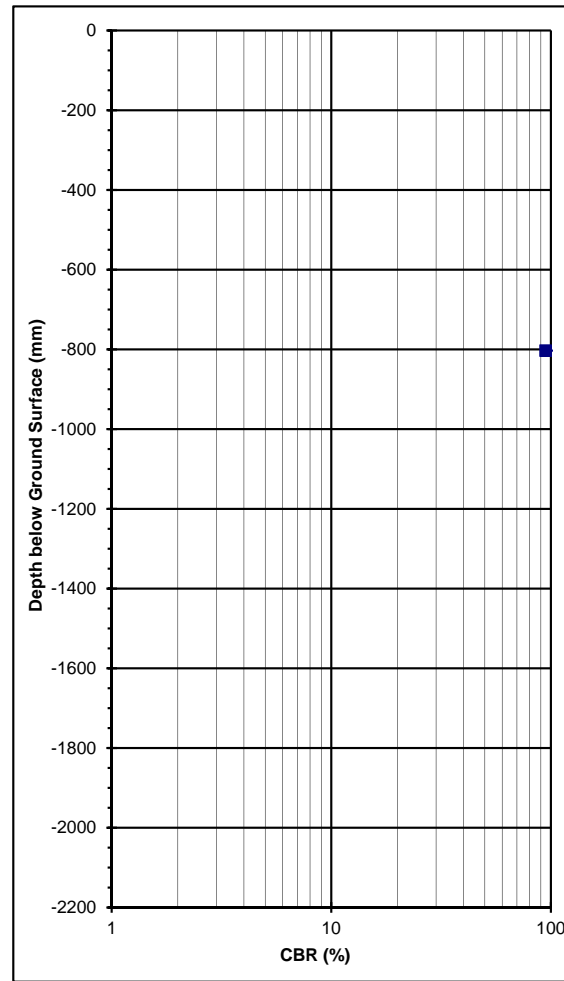
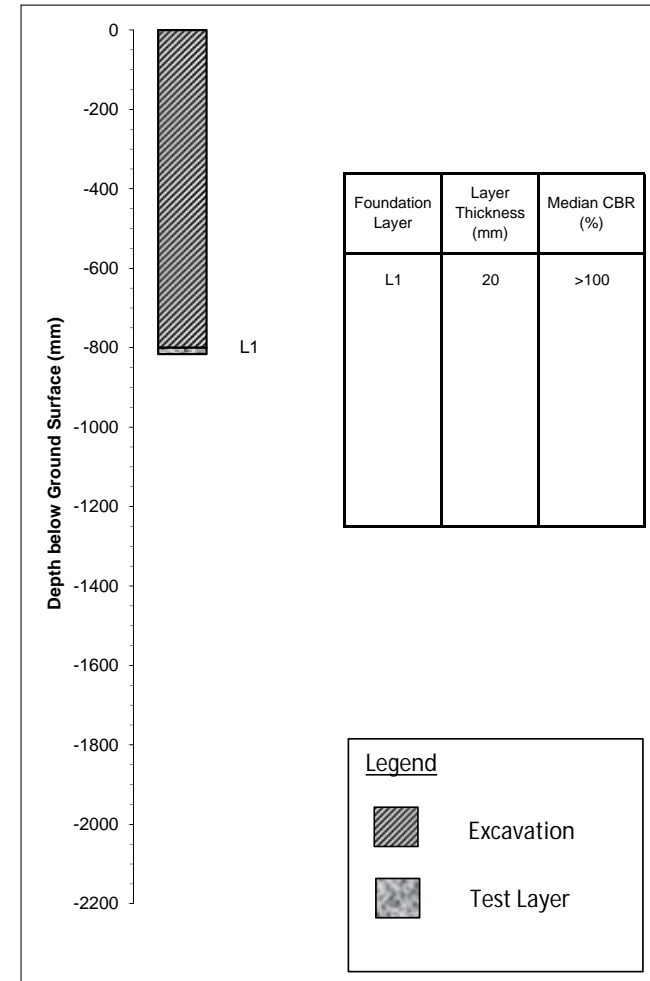
Job Number : 60509148
 DCP/Core Number : SK508
 DCP Operator : CC/WH
 Date Tested : 22/11/16
 Plot Prepared By : LT
 Plot Checked By : MB
 Date Prepared : 05/12/16

OSGR: 299678.218, 169171.911

Notes: Test commenced from the base of top soil in SK508 machine-excavated trial pit

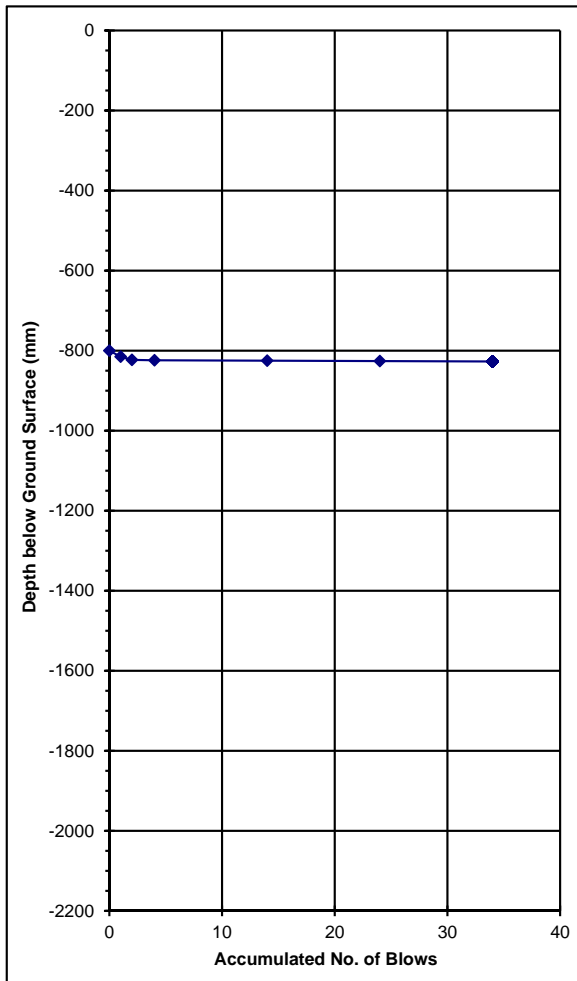
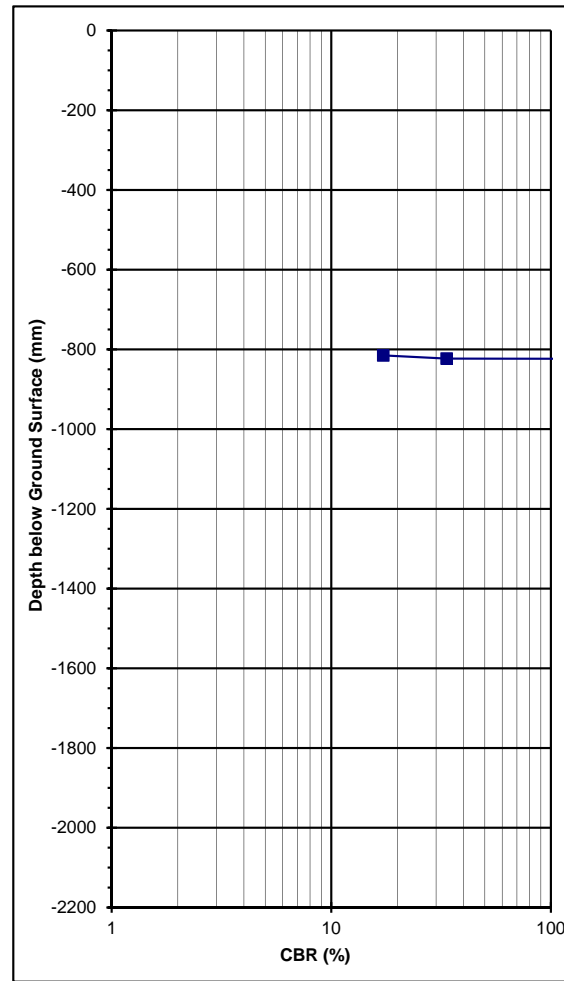
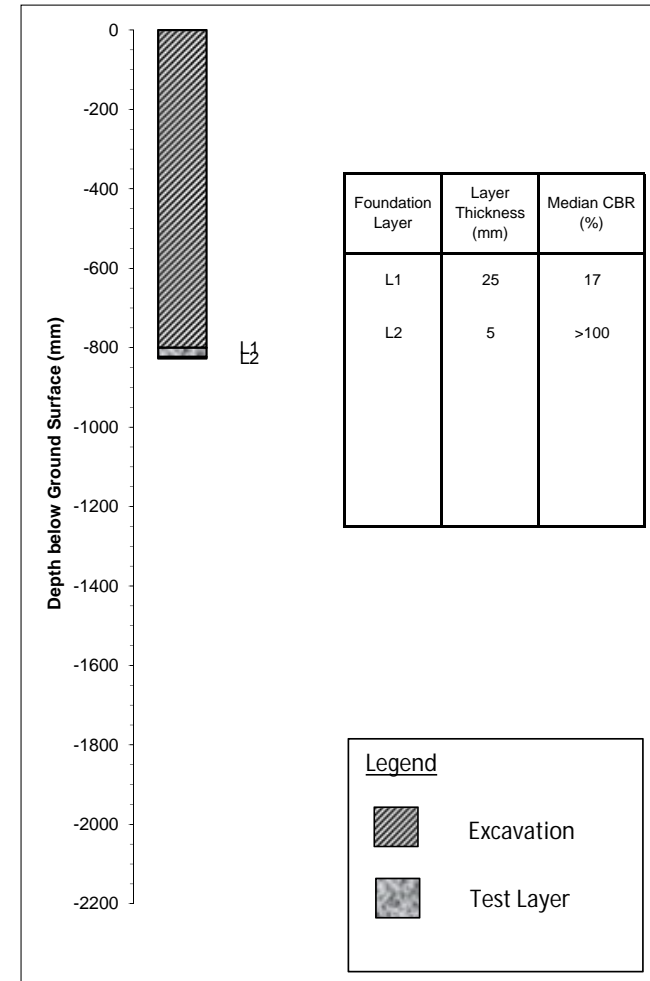
Job Number : 60509148
 DCP/Core Number : SK509
 DCP Operator : CC/WH
 Date Tested : 22/11/16
 Plot Prepared By : LT
 Plot Checked By : MB
 Date Prepared : 05/12/16

OSGR: 299981.456, 169255.033

Notes: Test commenced from the base of top soil in SK509 machine-excavated trial pit

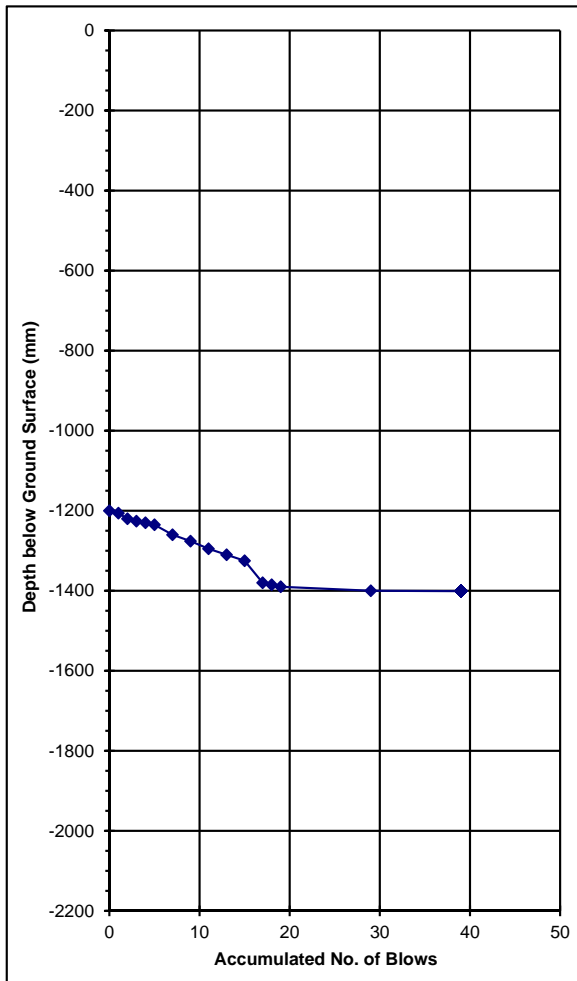
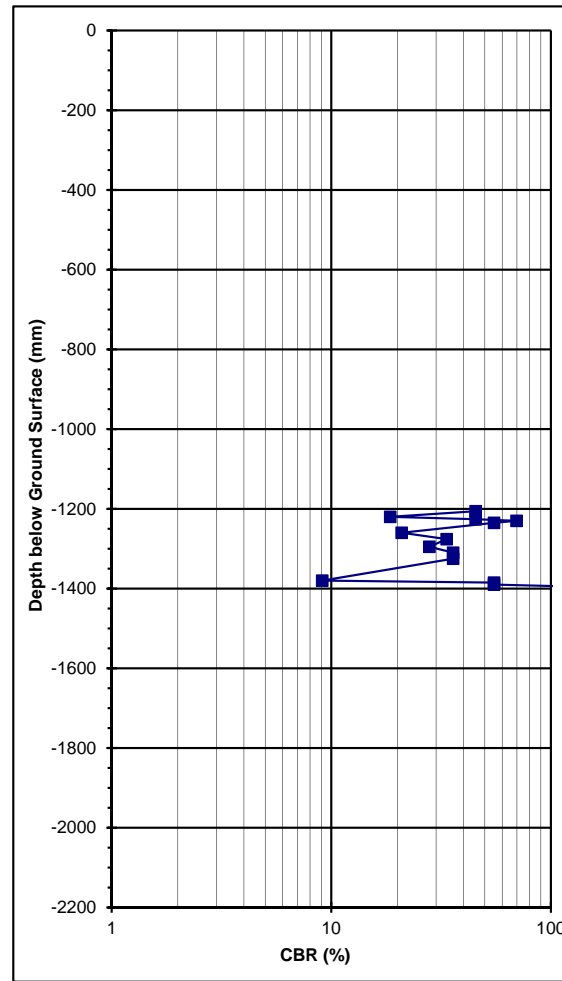
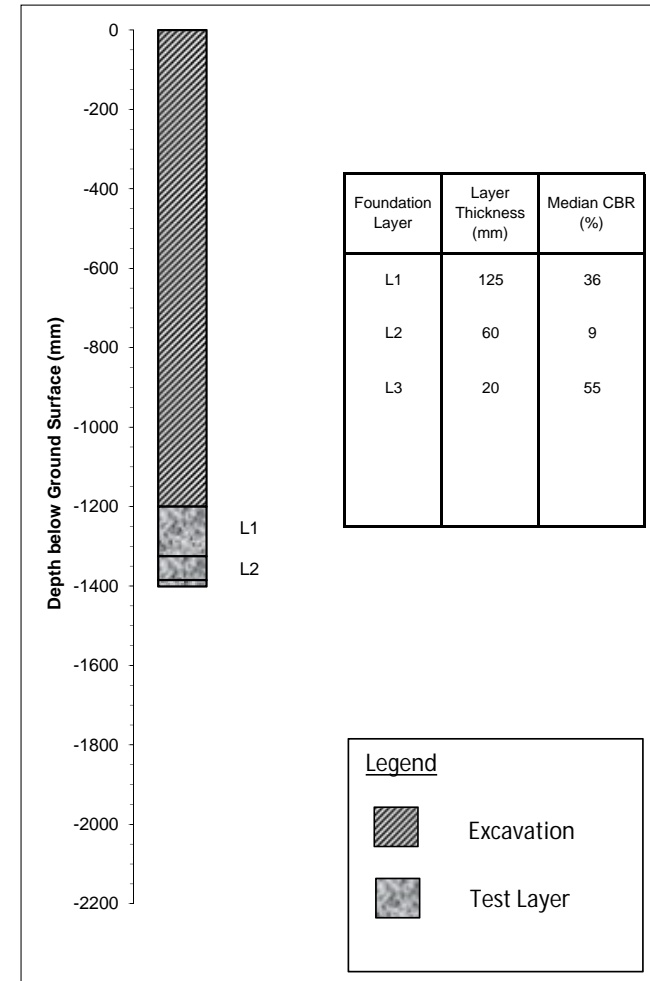
Job Number : 60509148
 DCP/Core Number : SK510
 DCP Operator : CC/WH
 Date Tested : 22/11/16
 Plot Prepared By : LT
 Plot Checked By : MB
 Date Prepared : 05/12/16

OSGR: 300129.129, 169202.376

Notes: Test commenced from the base of top soil in SK510 machine-excavated trial pit

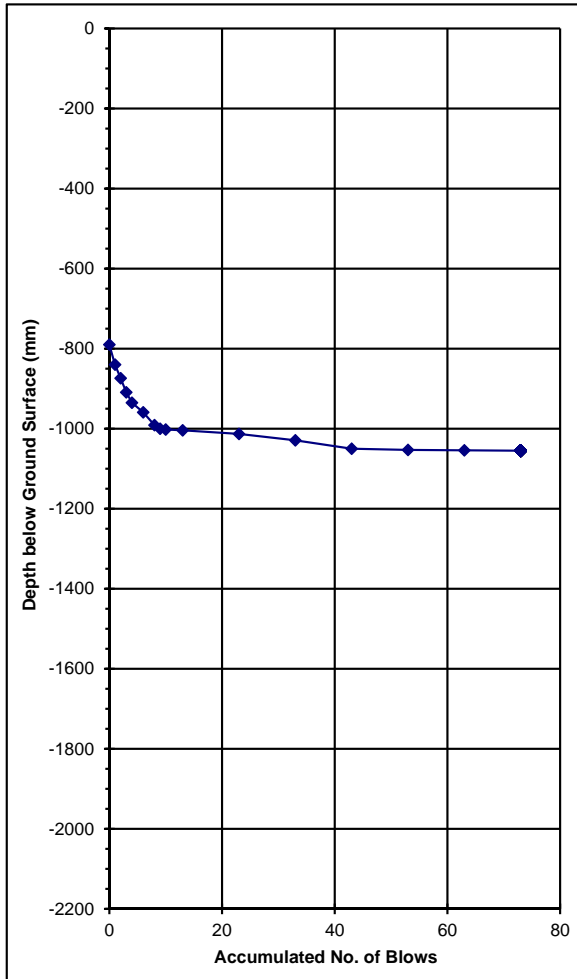
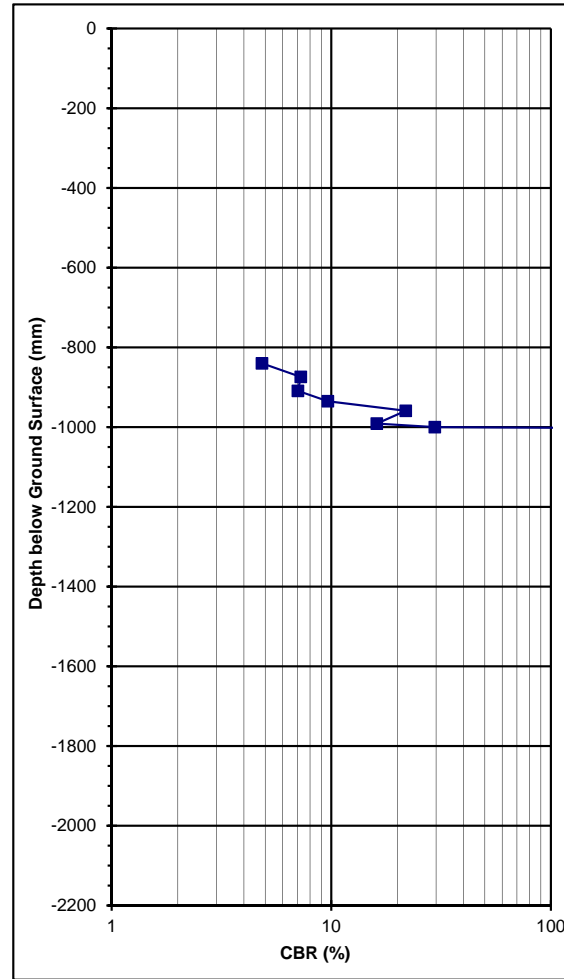
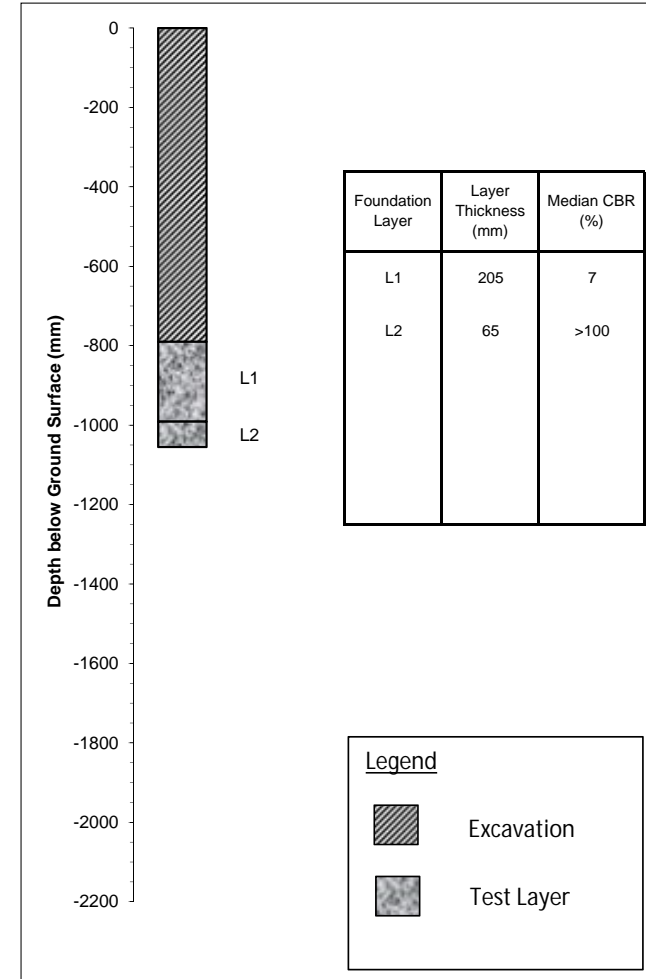
Job Number : 60509148
 DCP/Core Number : TP501
 DCP Operator : CC/WH
 Date Tested : 22/11/16
 Plot Prepared By : LT
 Plot Checked By : MB
 Date Prepared : 05/12/16

OSGR: 300313.446, 169301.712

Notes: Test commenced from the base of top soil in TP501

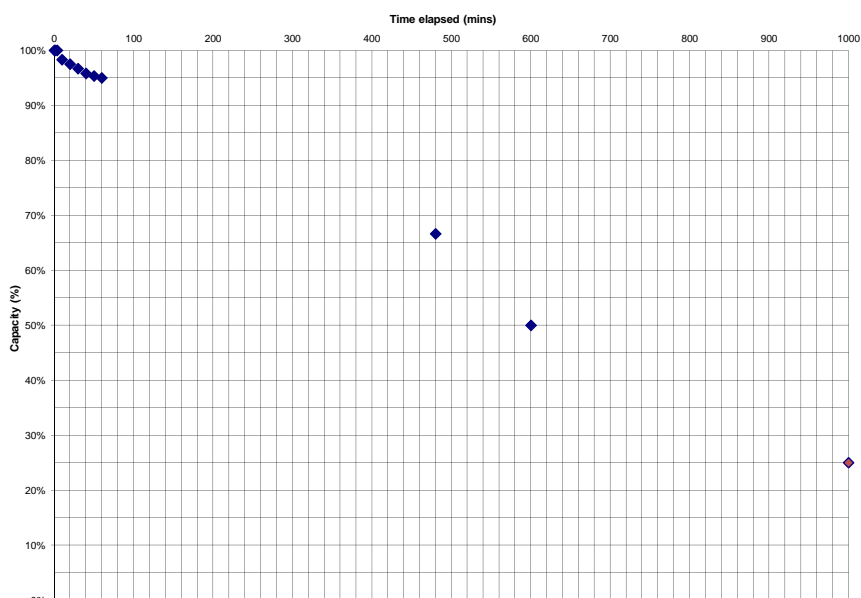
Test Location ID:	SK501	Test No:	1 of 1
Weather Conditions:	Dry	Test Date:	23-Nov-16

Depth to Water (m bgl)	Capacity (%)	Time elapsed (min)
0.800	100.00%	0
0.800	100.00%	2
0.800	100.00%	4
0.810	98.33%	10
0.815	97.50%	20
0.820	96.67%	30
0.825	95.83%	40
0.828	95.33%	50
0.830	95.00%	60
1.000	66.67%	480
1.100	50.00%	600
1.250	25.00%	1000*

Vp75-25	=	0.378000	m ³ **	Soil Infiltration Rate, <i>f</i> =	$\frac{Vp75-25}{aP50 \times Tp75-25}$
aP50	=	2.7600	m ²		
Tp75-25	=	680.00	mins

Test depth range (m bgl)	Soil Infiltration Rate, <i>f</i> (m/s) ***
0.800 to 1.100	3.36E-06

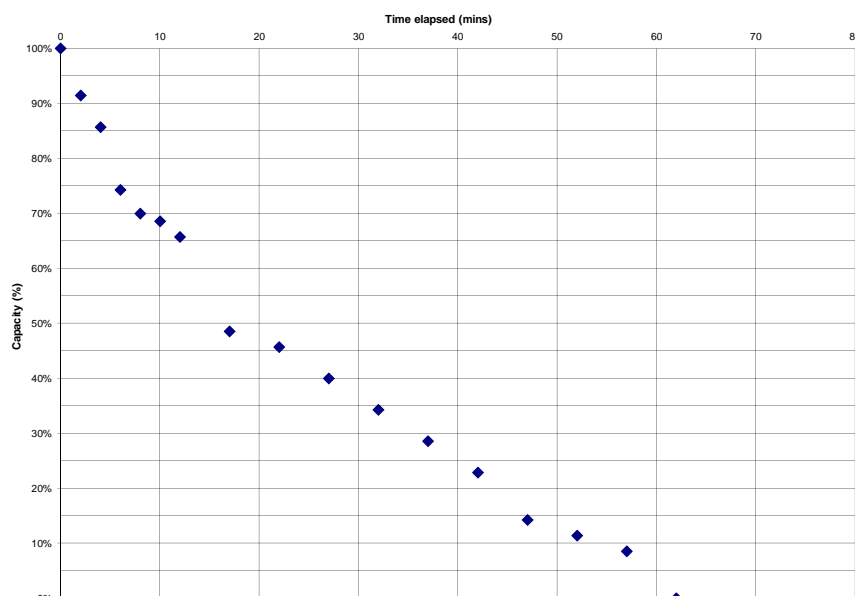
Test Location ID:	SK502	Test No:	2 of 2
Weather Conditions:	Dry	Test Date:	24-Nov-16

Depth to Water (m bgl)	Capacity (%)	Time elapsed (min)
0.350	100.00%	0
0.380	91.43%	2
0.400	85.71%	4
0.440	74.29%	6
0.455	70.00%	8
0.460	68.57%	10
0.470	65.71%	12
0.530	48.57%	17
0.540	45.71%	22
0.560	40.00%	27
0.580	34.29%	32
0.600	28.57%	37
0.620	22.86%	42
0.650	14.29%	47
0.660	11.43%	52
0.670	8.57%	57
0.700	0.00%	62

Vp75-25	=	0.171500	m ³ *	Soil Infiltration Rate, <i>f</i> =	$\frac{Vp75-25}{aP50 \times Tp75-25}$
aP50	=	1.7150	m ²		
Tp75-25	=	34.25	mins

Test depth range (m bgl)	Soil Infiltration Rate, <i>f</i> (m/s)
0.350 to 0.700	4.87E-05

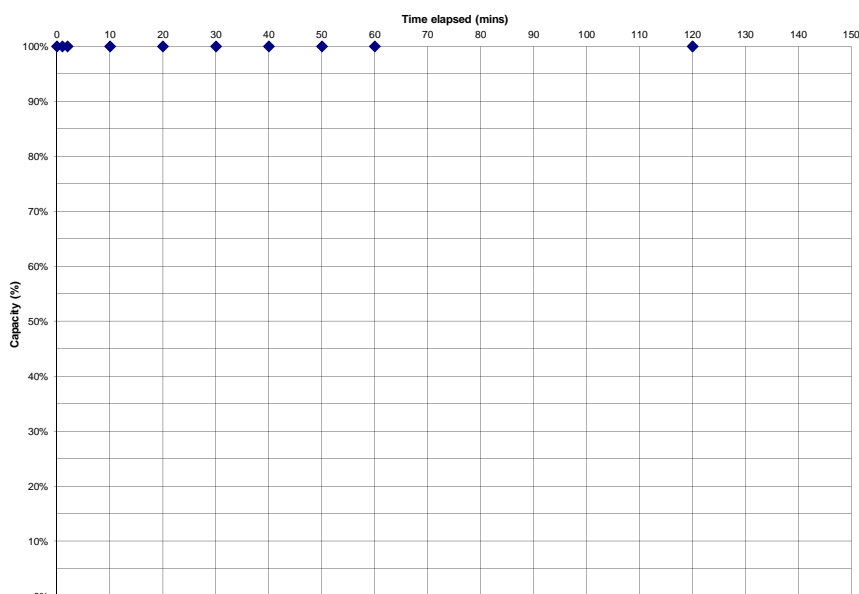
Test Location ID:	SK503	Test No:	1 of 1
Weather Conditions:	Dry	Test Date:	25-Nov-16

Depth to Water (m bgl)	Capacity (%)	Time elapsed (min)
0.500	100.00%	0
0.500	100.00%	1
0.500	100.00%	2
0.500	100.00%	10
0.500	100.00%	20
0.500	100.00%	30
0.500	100.00%	40
0.500	100.00%	50
0.500	100.00%	60
0.500	100.00%	120

** No infiltration recorded during test - possibly rising groundwater level

Departures from BRE365 test method:	Only 1no. Test was undertaken due to negligible infiltration rate.
-------------------------------------	--

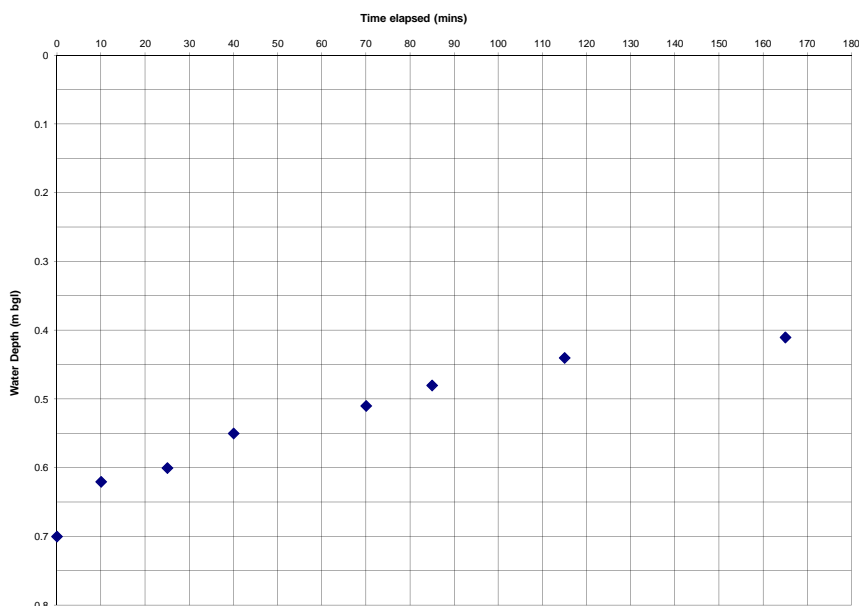
Test Location ID:	SK504	Test No:	1 of 1
Weather Conditions:	Dry	Test Date:	25-Nov-16

Depth to Water (m bgl)	Capacity (%)	Time elapsed (min)
0.700	100.00%	0
0.620	180.00%	10
0.600	200.00%	25
0.550	250.00%	40
0.510	290.00%	70
0.480	320.00%	85
0.440	360.00%	115
0.410	390.00%	165

* Trial Pit stable - granular fill not required
 ** Ground water level rising - no infiltration

Departures from BRE365 test method:	No infiltration test undertaken due to rising ground water level.
--	---
