Appendix A Trial Pit Logs

Equipment & Methods: JCB 3CX	Project Name: St. Athan Northern Access Road		Job No: 60509148
	Project Location: St. Athan		
	Client: Welsh Government		
	Co-ordinates: E: 298335.157 N: 168941.925	Ground Level (m): 44.96 AOD	Date Started: 23/11/2016 Date Completed: 23/11/2016

Appendix C Soakaway Test Results

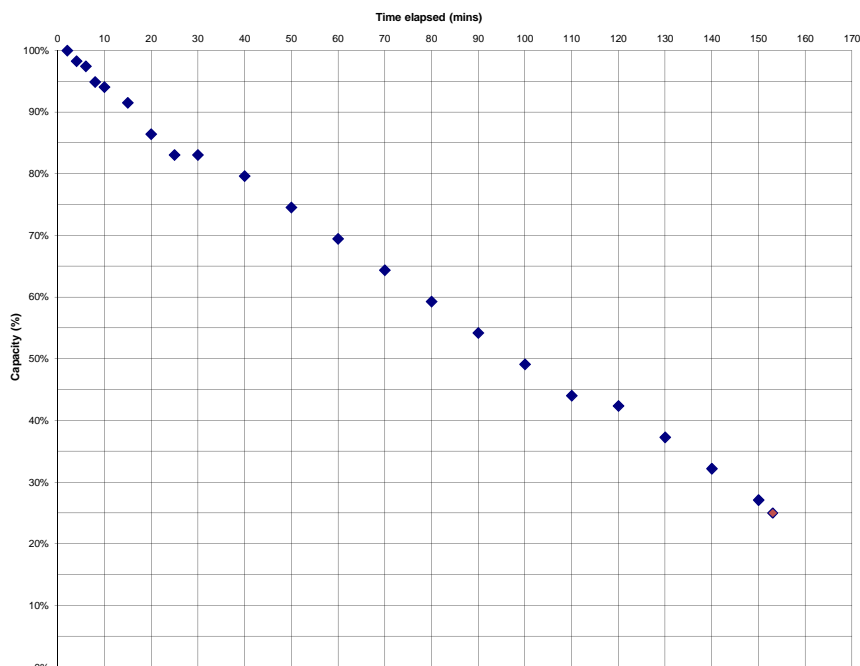
Test Location ID:	SK505	Test No:	1 of 1
Weather Conditions:	Dry	Test Date:	25-Nov-16

Depth to Water (m bgl)	Capacity (%)	Time elapsed (min)
0.310	100.00%	2
0.320	98.31%	4
0.325	97.46%	6
0.340	94.92%	8
0.345	94.07%	10
0.360	91.53%	15
0.390	86.44%	20
0.410	83.05%	25
0.410	83.05%	30
0.430	79.66%	40
0.460	74.58%	50
0.490	69.49%	60
0.520	64.41%	70
0.550	59.32%	80
0.580	54.24%	90
0.610	49.15%	100
0.640	44.07%	110
0.650	42.37%	120
0.680	37.29%	130
0.710	32.20%	140
0.740	27.12%	150
0.753	25.00%	153*

Vp75-25	=	0.287625	m ³ **	Soil Infiltration Rate, f =	$\frac{Vp75-25}{aP50 \times Tp75-25}$
aP50	=	2.2435	m ²		
Tp75-25	=	102.82	mins

Test depth range (m bgl)	Soil Infiltration Rate, f (m/s) ***
0.310 to 0.740	2.08E-05

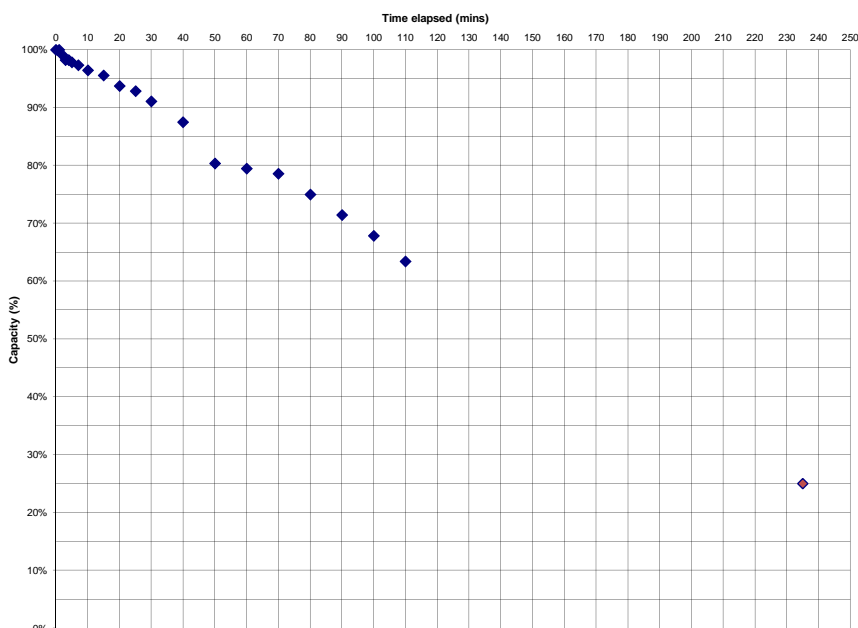
Test Location ID:	SK506	Test No:	1 of 1
Weather Conditions:	Dry	Test Date:	24-Nov-16

Depth to Water (m bgl)	Capacity (%)	Time elapsed (min)
0.640	100.00%	0
0.640	100.00%	1
0.645	99.11%	2
0.650	98.21%	3
0.650	98.21%	4
0.652	97.86%	5
0.655	97.32%	7
0.660	96.43%	10
0.665	95.54%	15
0.675	93.75%	20
0.680	92.86%	25
0.690	91.07%	30
0.710	87.50%	40
0.750	80.36%	50
0.755	79.46%	60
0.760	78.57%	70
0.780	75.00%	80
0.800	71.43%	90
0.820	67.86%	100
0.845	63.39%	110
1.060	25.00%	235*

Vp75-25	=	0.340480	m ³ **	Soil Infiltration Rate, f =	
aP50	=	2.5376	m ²	$\frac{Vp75-25}{aP50 \times Tp75-25}$	
Tp75-25	=	155.00	mins

Test depth range (m bgl)	Soil Infiltration Rate, f (m/s) ***
0.640 to 0.845	1.44E-05

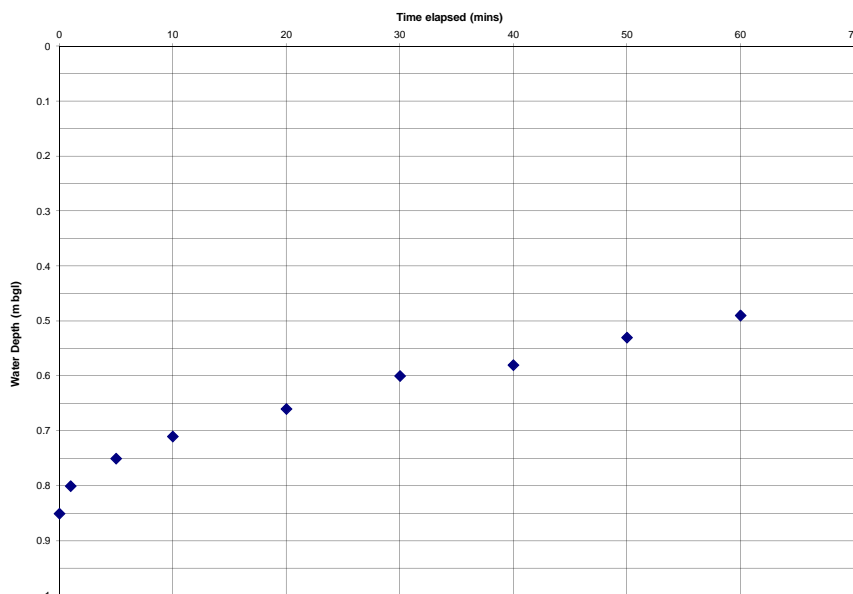
Test Location ID:	SK507	Test No:	1 of 1
Weather Conditions:	Dry	Test Date:	23-Nov-16

Depth to Water (m bgl)	Capacity (%)	Time elapsed (min)
0.850	100.00%	0
0.800	200.00%	1
0.750	300.00%	5
0.710	380.00%	10
0.660	480.00%	20
0.600	600.00%	30
0.580	640.00%	40
0.530	740.00%	50
0.490	820.00%	60

** Ground water level rising - no infiltration

Departures from BRE365 test method:	No infiltration test undertaken due to ground water level rising.
--	---

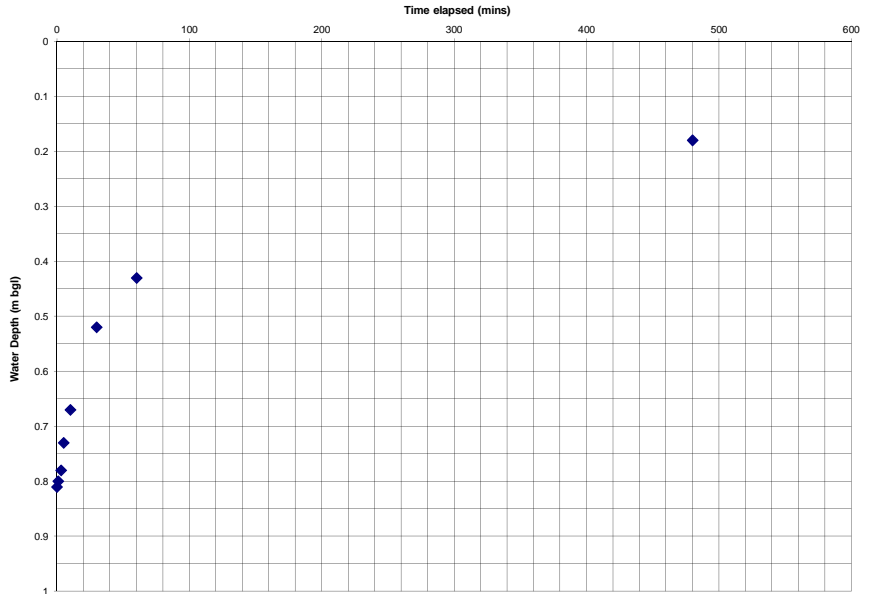
Test Location ID:	SK508	Test No:	1 of 1
Weather Conditions:	Dry	Test Date:	23-Nov-16

Depth to Water (m bgl)	Capacity (%)	Time elapsed (min)
0.810	100.00%	0
0.800	107.14%	1
0.780	121.43%	3
0.730	157.14%	5
0.670	200.00%	10
0.520	307.14%	30
0.430	371.43%	60
0.180	550.00%	480

* Trial Pit stable - granular fill not required
 ** Water level rising - no infiltration

Departures from BRE365 test method:	No infiltration test undertaken due to ground water level rising.
--	---

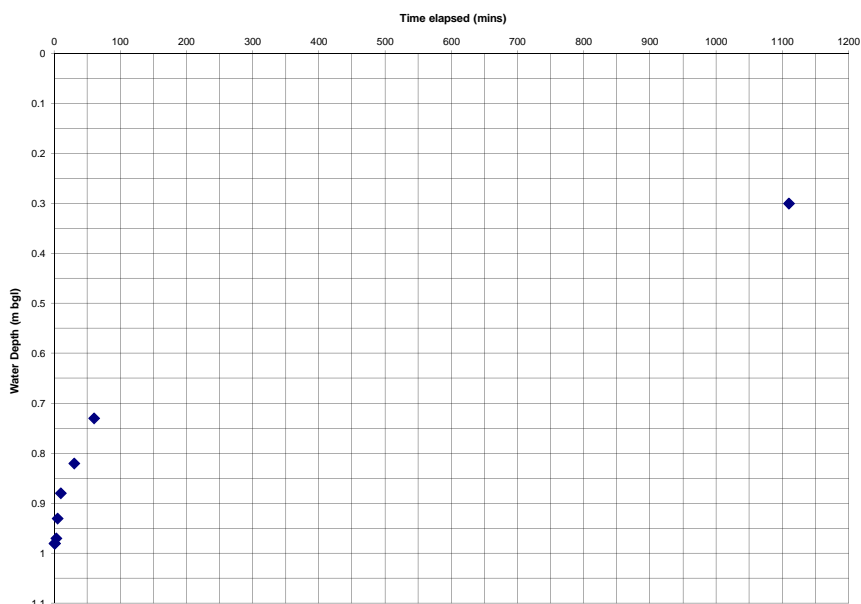
Test Location ID:	SK509	Test No:	1 of 1
Weather Conditions:	Dry	Test Date:	23-Nov-16

Depth to Water (m bgl)	Capacity (%)	Time elapsed (min)
0.980	100.00%	0
0.980	100.00%	1
0.970	102.94%	3
0.930	114.71%	5
0.880	129.41%	10
0.820	147.06%	30
0.730	173.53%	60
0.300	300.00%	1110

* Trial Pit stable - granular fill not required
 ** Ground water level rising - no infiltration

Departures from BRE365 test method:	No infiltration test undertaken due to ground water level rising.
--	---

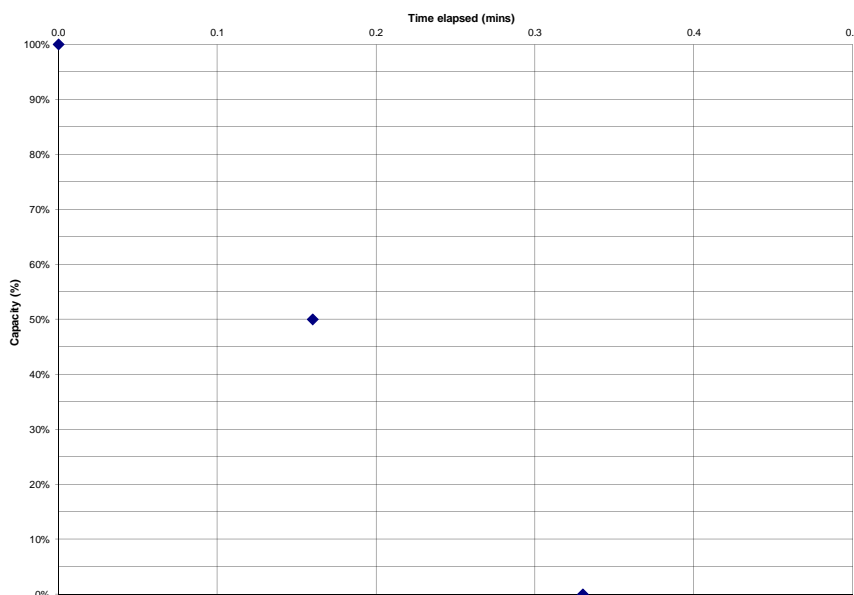
Test Location ID:	SK510	Test No:	1 of 3
Weather Conditions:	Dry	Test Date:	22-Nov-16

Depth to Water (m bgl)	Capacity (%)	Time elapsed (min)
1.300	100.00%	0
1.350	50.00%	0.16
1.400	0.00%	0.33

Vp75-25	=	0.064000	m ³ *	Soil Infiltration Rate, <i>f</i> =	$\frac{Vp75-25}{aP50 \times Tp75-25}$
aP50	=	1.5200	m ²		
Tp75-25	=	0.10	mins

Test depth range (m bgl)	Soil Infiltration Rate, <i>f</i> (m/s) **
1.300 to 1.400	7.02E-03

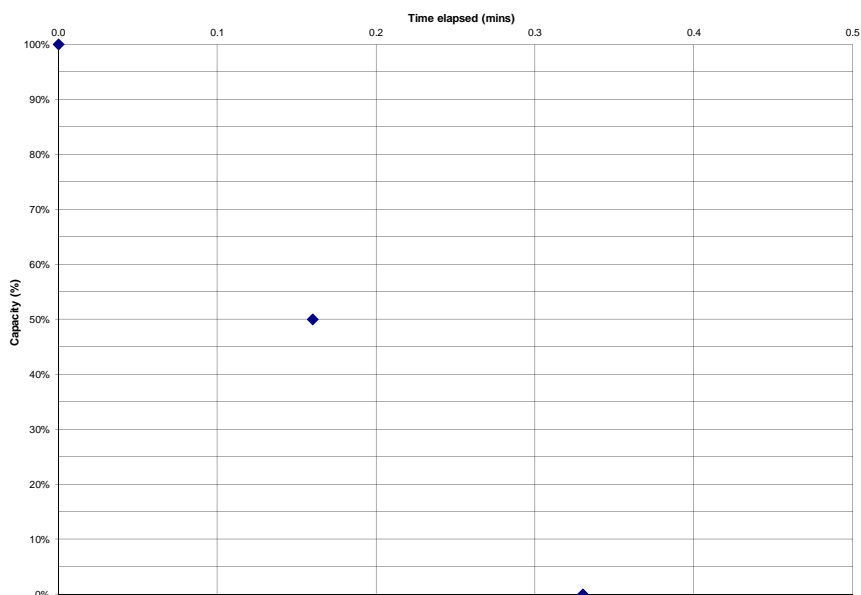
Test Location ID:	SK510	Test No:	2 of 3
Weather Conditions:	Dry	Test Date:	22-Nov-16

Depth to Water (m bgl)	Capacity (%)	Time elapsed (min)
1.300	100.00%	0
1.350	50.00%	0.16
1.400	0.00%	0.33

Vp75-25	=	0.064000	m ³ *	Soil Infiltration Rate, <i>f</i> =	$\frac{Vp75-25}{aP50 \times Tp75-25}$
aP50	=	1.5200	m ²		
Tp75-25	=	0.10	mins

Test depth range (m bgl)	Soil Infiltration Rate, <i>f</i> (m/s) **
1.300 to 1.400	7.02E-03

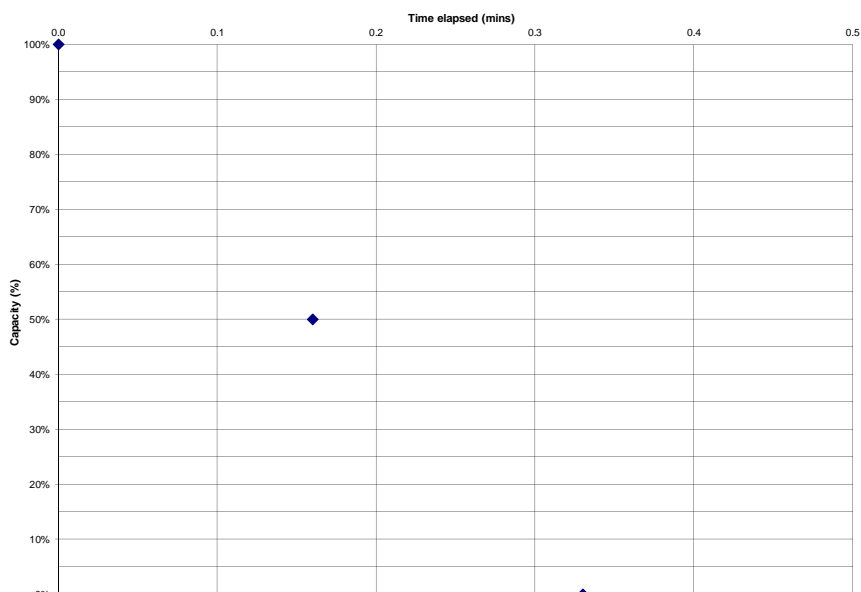
Depth to Water (m bgl)	Capacity (%)	Time elapsed (min)
1.300	100.00%	0
1.350	50.00%	0.16
1.400	0.00%	0.33

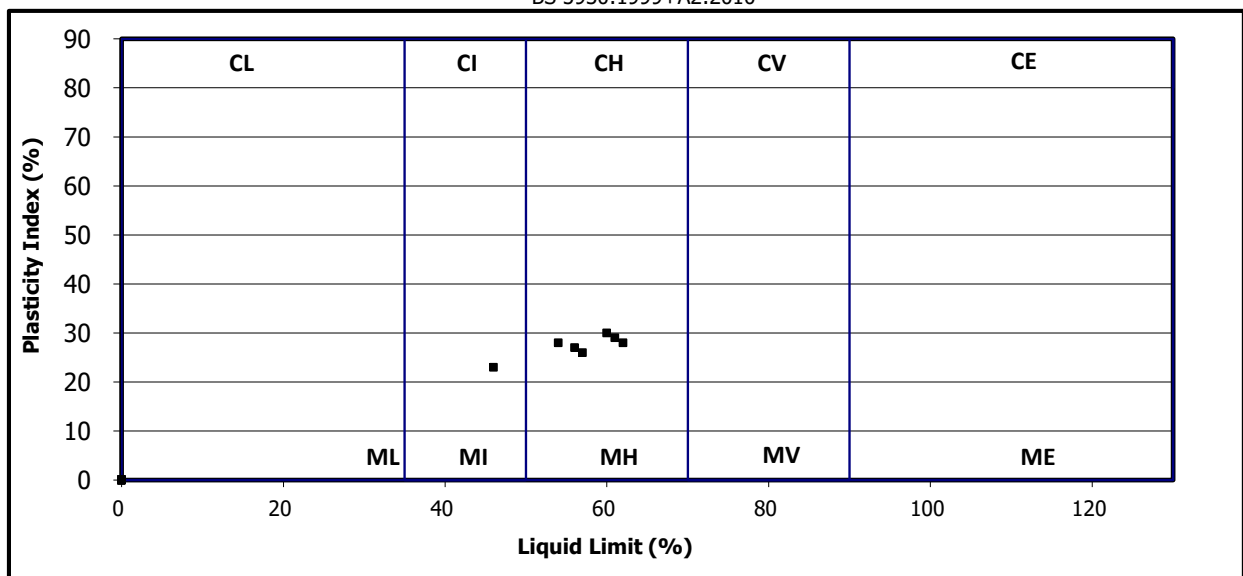
Symbols: NP : Non Plastic # : Liquid Limit and Plastic Limit Wet Sieved
PLASTICITY CHART FOR CASAGRANDE CLASSIFICATION.

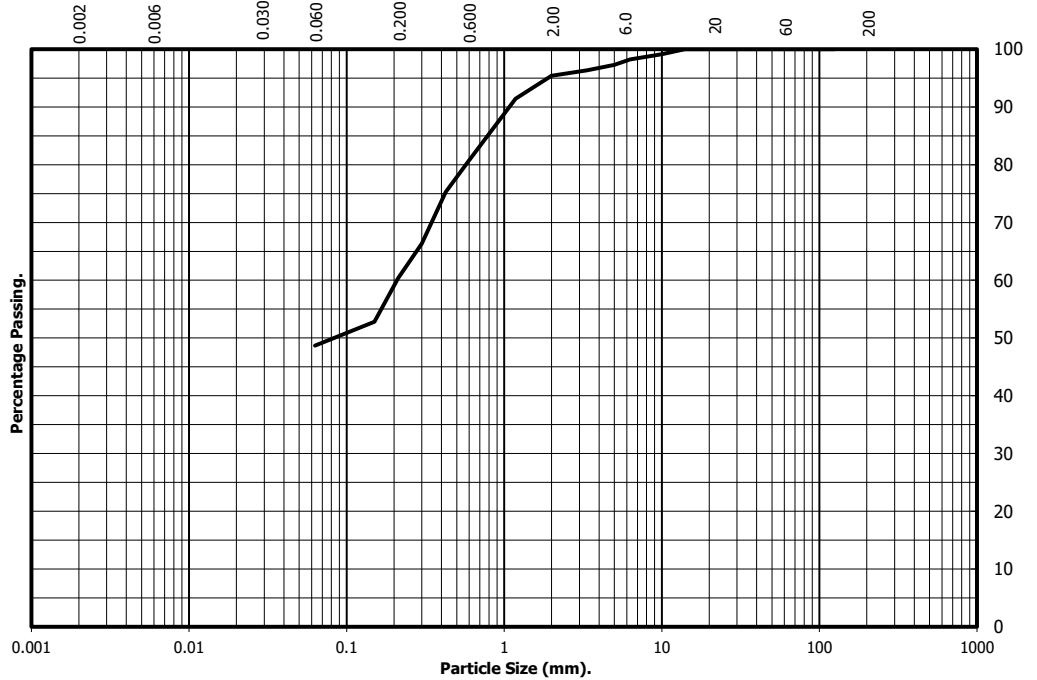
BS Test Sieve	% Passing
125	100
90	100
75	100
63	100
50	100
37.5	100
28	100
20	100
14	100
10	99
6.3	98
5.0	97
3.35	96
2.00	95
1.18	91
0.60	81
0.425	75
0.300	66
0.212	60
0.150	53
0.063	49

Silt and Clay	Sand	Gravel	Cobbles	Soil Fraction
	49	46	5	0	Total Percentage

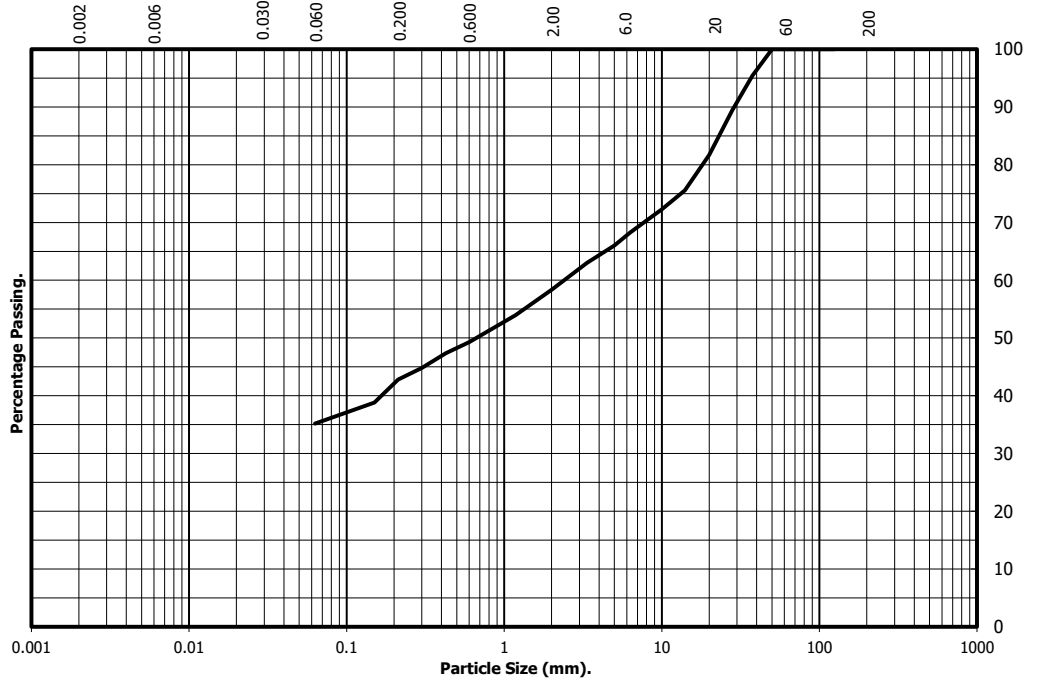
BS Test Sieve	% Passing
125	100
90	100
75	100
63	100
50	100
37.5	95
28	89
20	82
14	76
10	72
6.3	68
5.0	66
3.35	63
2.00	58
1.18	54
0.60	49
0.425	47
0.300	45
0.212	43
0.150	39
0.063	35

Silt and Clay	Sand	Gravel	Cobbles	Soil Fraction
	35	23	42	0	Total Percentage

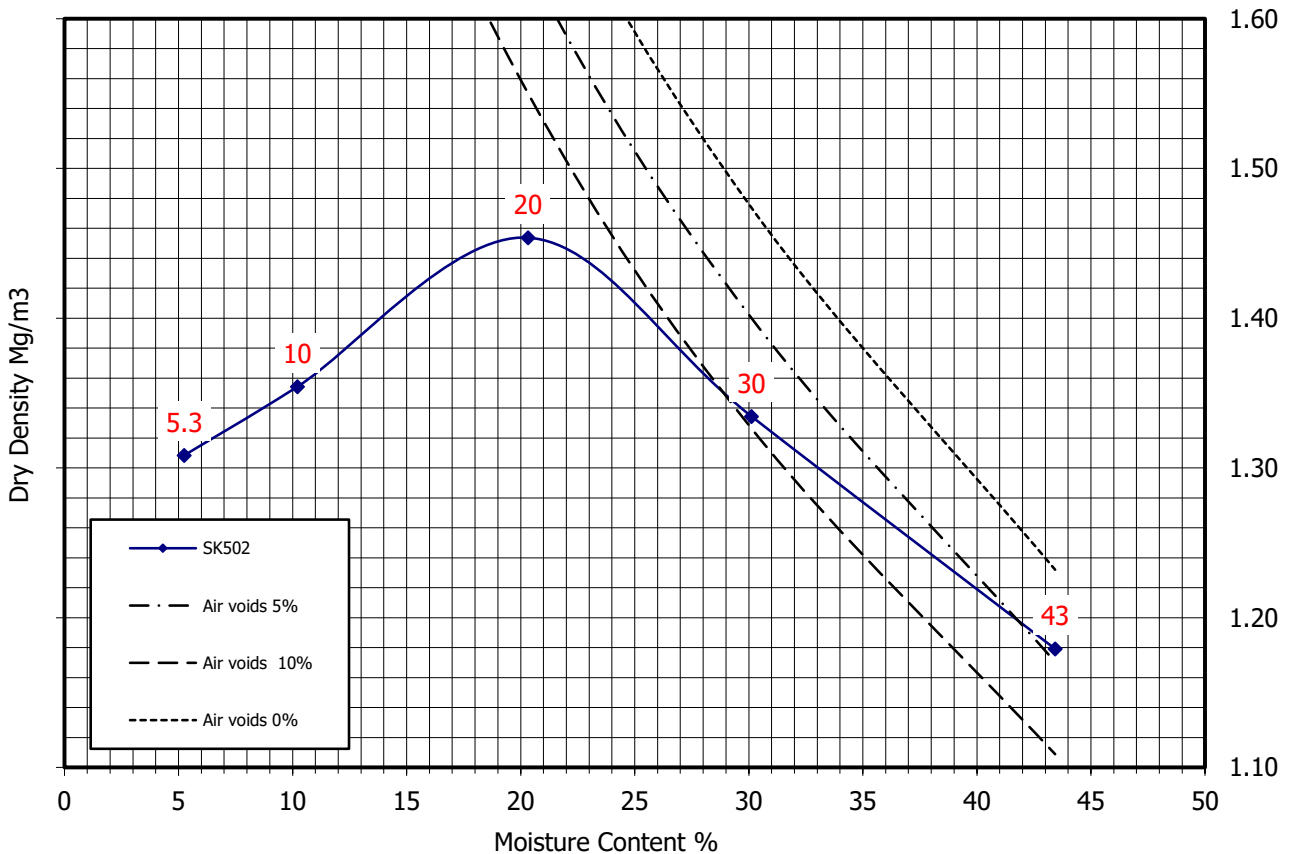
Client ref: **60509148**
 Location: **St Athan Northern Access Road GI**
 Contract Number: **33562-**
 Hole Number: **SK502**
 Sample Number: **N/A**
 Depth (m): **0.35 - 0.70**
 Sample Type: **B**
 Description: **Brown silty organic CLAY.**

Compaction Point:	1	2	3	4	5
Moisture Content:	5.3	10	20	30.1	43.4
Bulk Density (Mg/m ³):	1.38	1.49	1.75	1.74	1.69
Dry Density (Mg/m ³):	1.31	1.35	1.45	1.33	1.18

Initial Moisture Content: **43** Method of Compaction: **2.5kg Rammer**
 Particle Density (Mg/m³): **2.65 Assumed** Material Retained on 37.5 mm Test Sieve (%): **0**
 Maximum Dry Density (mg/m³): **1.45** Material Retained on 20.0 mm Test Sieve (%): **0**
 Optimum Moisture Content (%): **20** Sample Preparation Clause: **3.2.4.1**

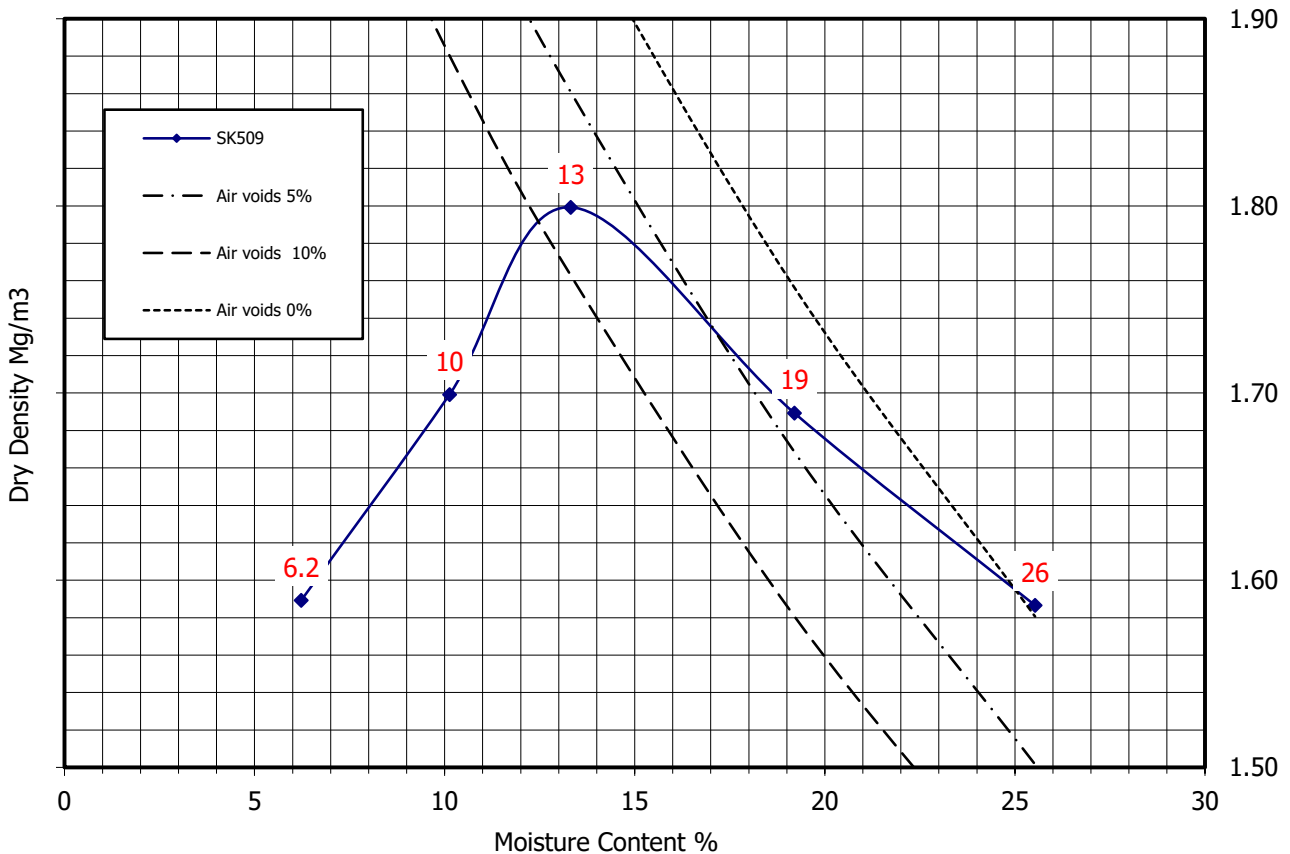
Client ref: **60509148**
 Location: **St Athan Northern Access Road GI**
 Contract Number: **33562-**
 Hole Number: **SK509**
 Sample Number: **N/A**
 Depth (m): **0.35 - 0.80**
 Sample Type: **B**
 Description: **Brown gravelly silty CLAY.**

Compaction Point:	1	2	3	4	5
Moisture Content:	6.2	10	13	19.2	25.5
Bulk Density (Mg/m ³):	1.69	1.87	2.04	2.01	1.99
Dry Density (Mg/m ³):	1.59	1.70	1.80	1.69	1.59

Initial Moisture Content: **25** Method of Compaction: **2.5kg Rammer**
 Particle Density (Mg/m³): **2.65 Assumed** Material Retained on 37.5 mm Test Sieve (%): **8.2**
 Maximum Dry Density (mg/m³): **1.80** Material Retained on 20.0 mm Test Sieve (%): **4.6**
 Optimum Moisture Content (%): **13** Sample Preparation Clause: **3.2.4.2**
