ST ATHAN

March 2010

GEO-ENVIRONMENTAL
VALIDATION REPORT

SA-C100E-RP-XXX-PC-X-3129

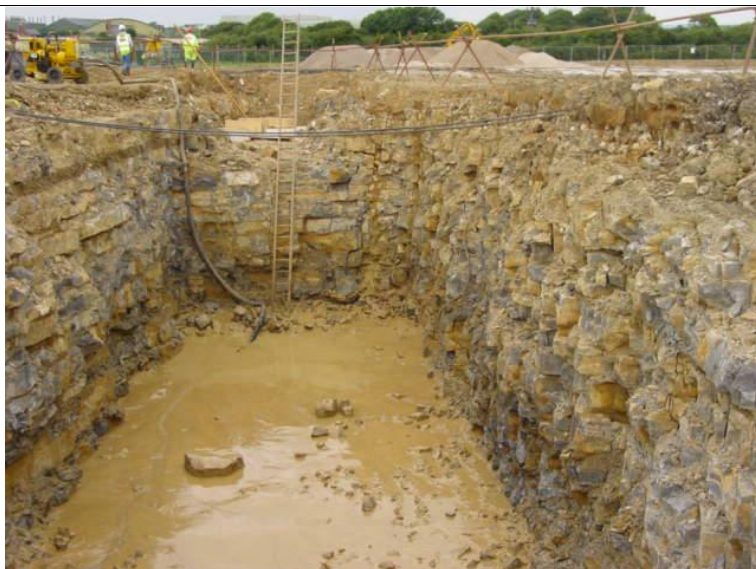
Plate 1: Photograph showing fractured and interbedded fine-grained limestones.

The Lower Lias Porthkerry Formation is described in the BGS memoir as comprising up to 120m of fractured, interbedded fine-grained limestones (See Plate 1 below) and calcareous shaley mudstones, which are subdivided into four units (D to A) as detailed below:

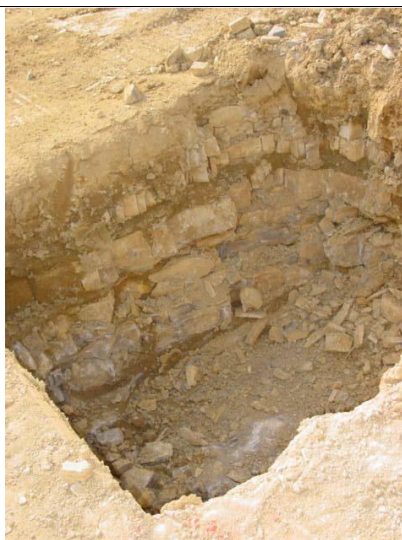
Plate 2: Photograph showing thin mudstone partings.
