St Athan Northern Access Road

Factual Ground Investigation Report

Project Number: 60509148

February 2017

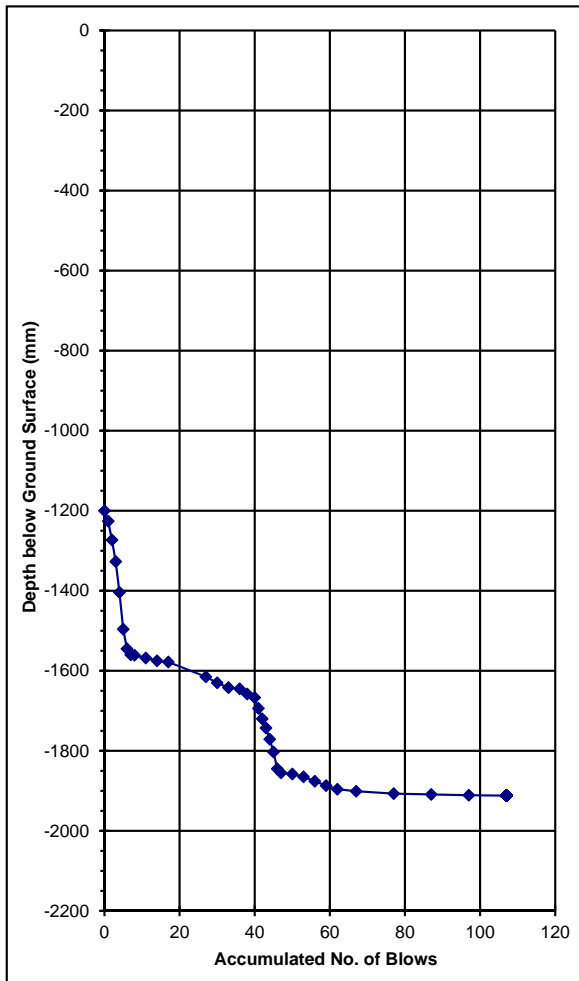
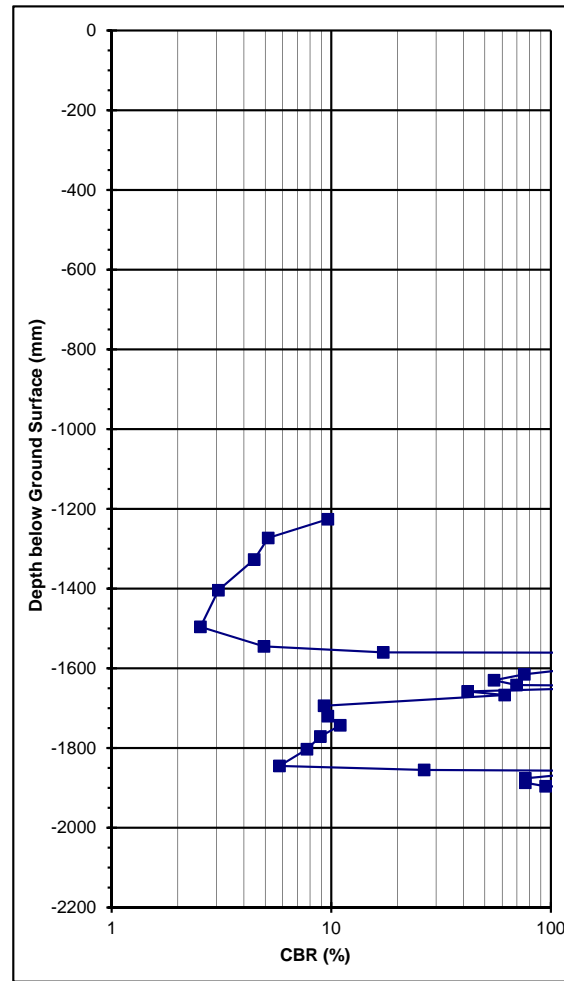
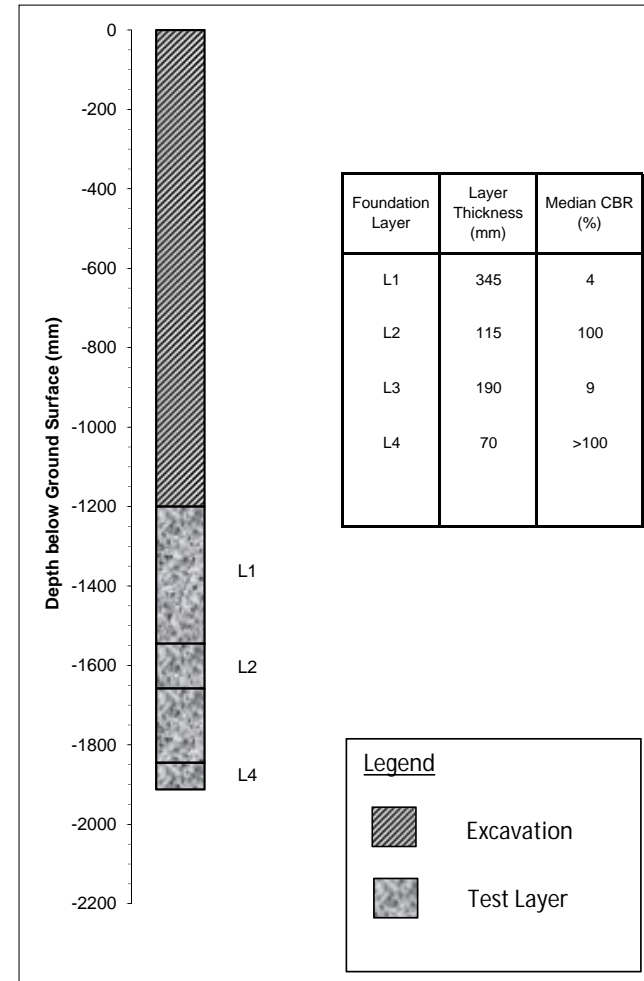
Notes: Test commenced from the base of top soil in SK501 machine-excavated trial pit

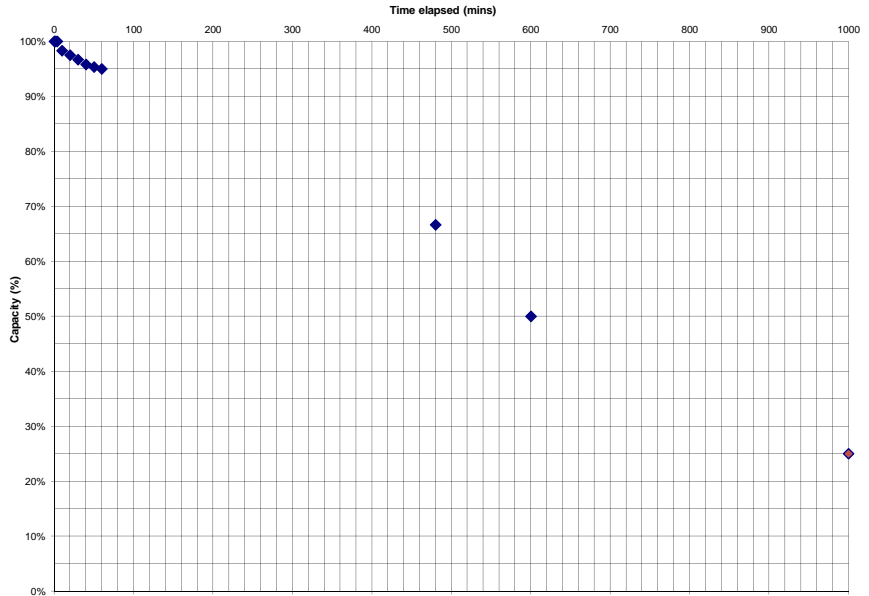
Test Location ID:	SK501	Test No:	1 of 1
Weather Conditions:	Dry	Test Date:	23-Nov-16

Depth to Water (m bgl)	Capacity (%)	Time elapsed (min)
0.800	100.00%	0
0.800	100.00%	2
0.800	100.00%	4
0.810	98.33%	10
0.815	97.50%	20
0.820	96.67%	30
0.825	95.83%	40
0.828	95.33%	50
0.830	95.00%	60
1.000	66.67%	480
1.100	50.00%	600
1.250	25.00%	1000*

Vp75-25	=	0.378000	m ³ **	Soil Infiltration Rate, <i>f</i> =	$\frac{Vp75-25}{aP50 \times Tp75-25}$
aP50	=	2.7600	m ²		
Tp75-25	=	680.00	mins

Test depth range (m bgl)	Soil Infiltration Rate, <i>f</i> (m/s) ***
0.800 to 1.100	3.36E-06

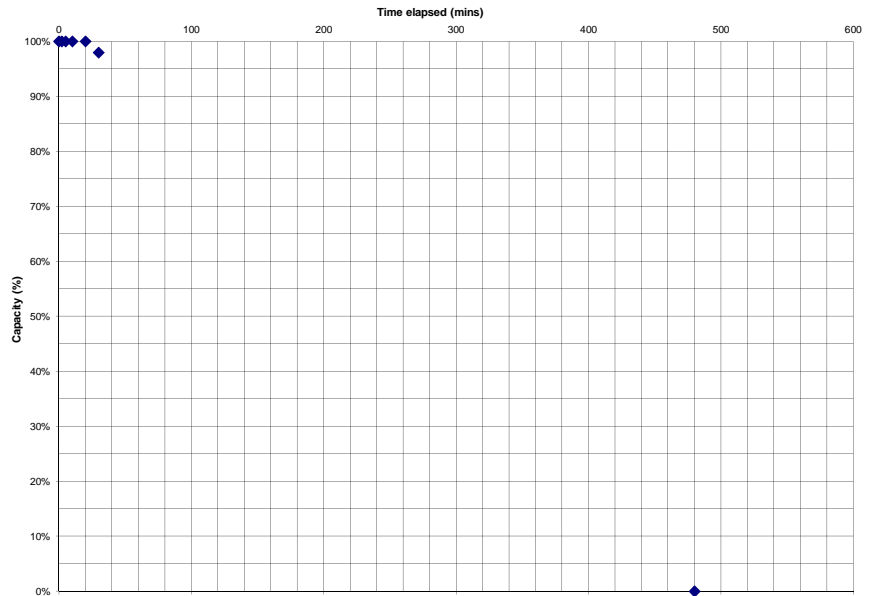
Test Location ID:	SK502	Test No:	1 of 2
Weather Conditions:	Dry	Test Date:	23-Nov-16

Depth to Water (m bgl)	Capacity (%)	Time elapsed (min)
0.200	100.00%	0
0.200	100.00%	2
0.200	100.00%	5
0.200	100.00%	10
0.200	100.00%	20
0.210	98.00%	30
0.700	0.00%	480

Vp75-25	=	0.245000	m ³ *	Soil Infiltration Rate, <i>f</i> =	$\frac{Vp75-25}{aP50 \times Tp75-25}$
aP50	=	2.0300	m ²		
Tp75-25	=	230.00	mins

Test depth range (m bgl)	Soil Infiltration Rate, <i>f</i> (m/s) **
0.200 to 0.700	8.75E-06

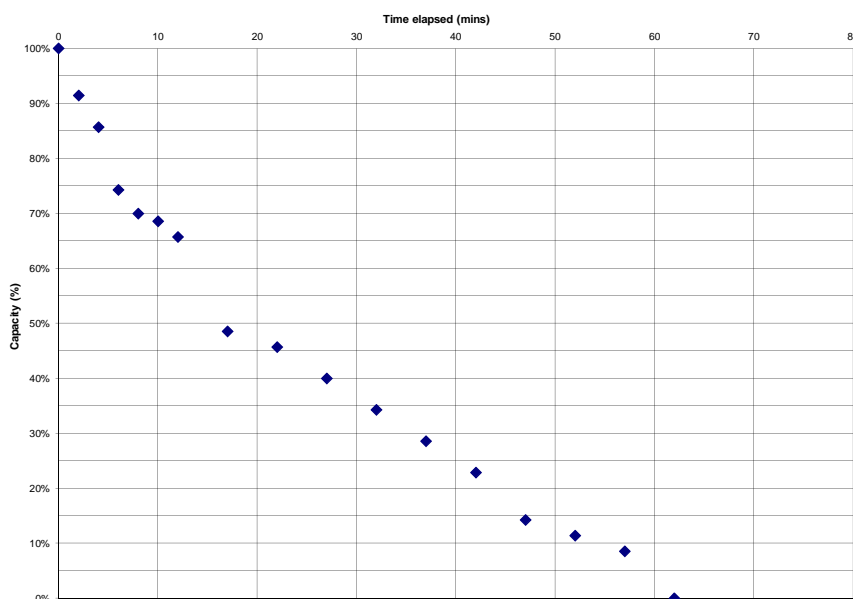
Test Location ID:	SK502	Test No:	2 of 2
Weather Conditions:	Dry	Test Date:	24-Nov-16

Depth to Water (m bgl)	Capacity (%)	Time elapsed (min)
0.350	100.00%	0
0.380	91.43%	2
0.400	85.71%	4
0.440	74.29%	6
0.455	70.00%	8
0.460	68.57%	10
0.470	65.71%	12
0.530	48.57%	17
0.540	45.71%	22
0.560	40.00%	27
0.580	34.29%	32
0.600	28.57%	37
0.620	22.86%	42
0.650	14.29%	47
0.660	11.43%	52
0.670	8.57%	57
0.700	0.00%	62

Vp75-25	=	0.171500	m ³ *	Soil Infiltration Rate, <i>f</i> =	$\frac{Vp75-25}{aP50 \times Tp75-25}$
aP50	=	1.7150	m ²		
Tp75-25	=	34.25	mins

Test depth range (m bgl)	Soil Infiltration Rate, <i>f</i> (m/s)
0.350 to 0.700	4.87E-05

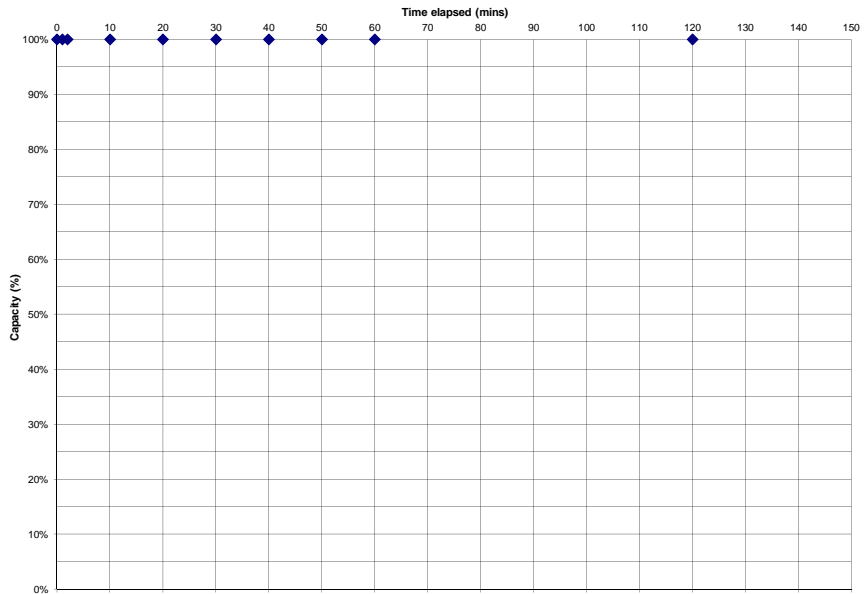
Test Location ID:	SK503	Test No:	1 of 1
Weather Conditions:	Dry	Test Date:	25-Nov-16

Depth to Water (m bgl)	Capacity (%)	Time elapsed (min)
0.500	100.00%	0
0.500	100.00%	1
0.500	100.00%	2
0.500	100.00%	10
0.500	100.00%	20
0.500	100.00%	30
0.500	100.00%	40
0.500	100.00%	50
0.500	100.00%	60
0.500	100.00%	120

* Trial Pit stable - granular fill not required
 ** No infiltration recorded during test - possibly rising groundwater level

Departures from BRE365 test method: Only 1no. Test was undertaken due to negligible infiltration rate.

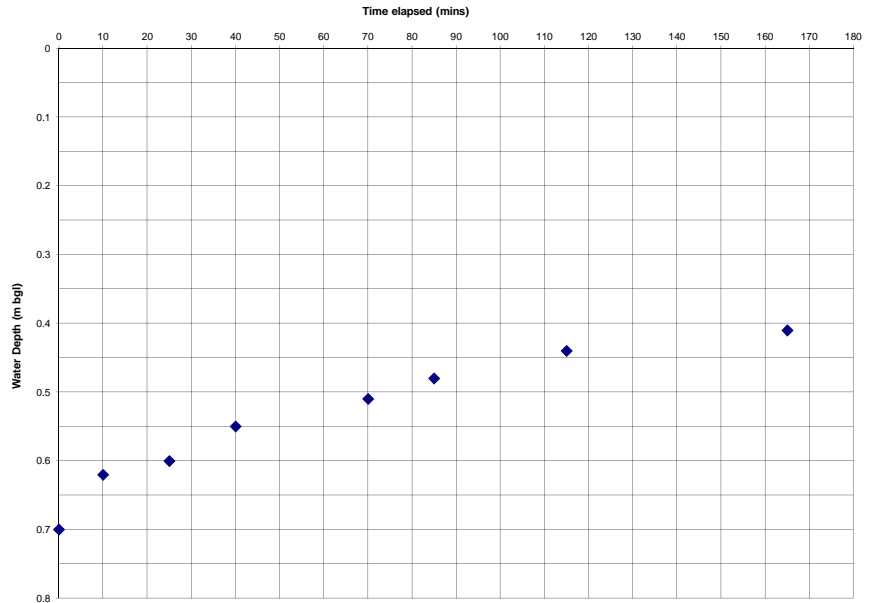
Test Location ID:	SK504	Test No:	1 of 1
Weather Conditions:	Dry	Test Date:	25-Nov-16

Depth to Water (m bgl)	Capacity (%)	Time elapsed (min)
0.700	100.00%	0
0.620	180.00%	10
0.600	200.00%	25
0.550	250.00%	40
0.510	290.00%	70
0.480	320.00%	85
0.440	360.00%	115
0.410	390.00%	165

* Trial Pit stable - granular fill not required
 ** Ground water level rising - no infiltration

Departures from BRE365 test method: No infiltration test undertaken due to rising ground water level.

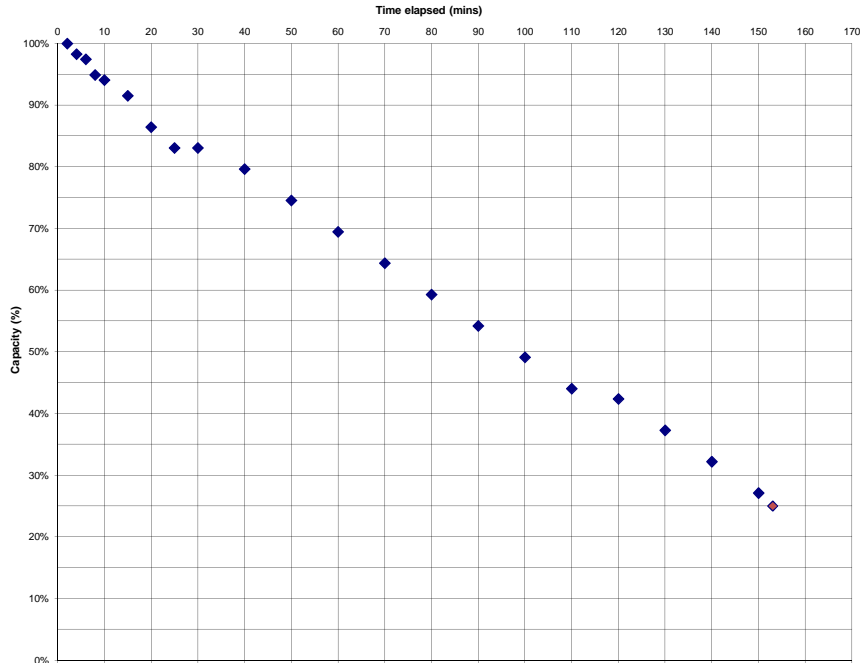
Test Location ID:	SK505	Test No:	1 of 1
Weather Conditions:	Dry	Test Date:	25-Nov-16

Depth to Water (m bgl)	Capacity (%)	Time elapsed (min)
0.310	100.00%	2
0.320	98.31%	4
0.325	97.46%	6
0.340	94.92%	8
0.345	94.07%	10
0.360	91.53%	15
0.390	86.44%	20
0.410	83.05%	25
0.410	83.05%	30
0.430	79.66%	40
0.460	74.58%	50
0.490	69.49%	60
0.520	64.41%	70
0.550	59.32%	80
0.580	54.24%	90
0.610	49.15%	100
0.640	44.07%	110
0.650	42.37%	120
0.680	37.29%	130
0.710	32.20%	140
0.740	27.12%	150
0.753	25.00%	153*

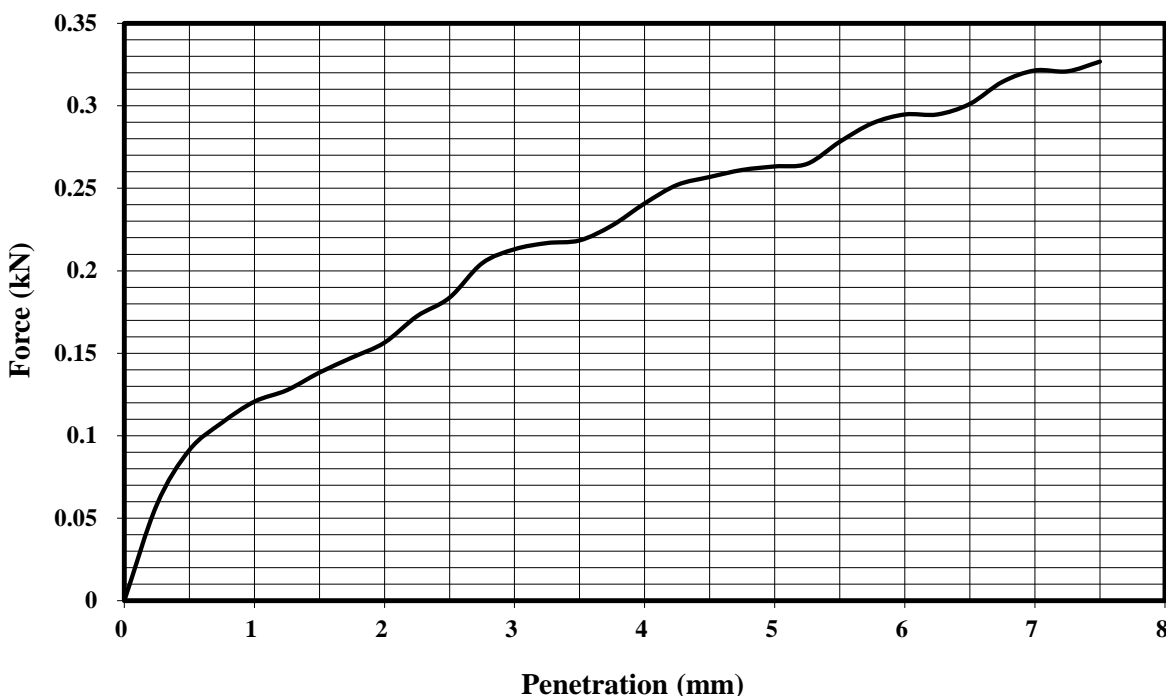
Client ref: 60509148
 Location: St Athan Northern Access Road GI
 Contract Number: 33562-
 Sample Type: B
 Hole Number: SK502
 Sample Number: N/A
 Depth (m): 0.35 - 0.70
 Description: Brown silty CLAY containing organic material.

Initial Sample Conditions		Test Conditions		Method of Compaction:	
Moisture Content:	43	Surcharge Kg:	2.0	2.5kg Rammer	
Bulk Density Mg/m3:	1.69	Soaking Time (hrs):		Final Moisture Content %	
Dry Density Mg/m3:	1.18	Swelling mm:		Sample Top	43
C.B.R. Value %	Sample Top		1.39	Sample Bottom	43
Percentage retained on 20mm BS test sieve:	0	Remarks:

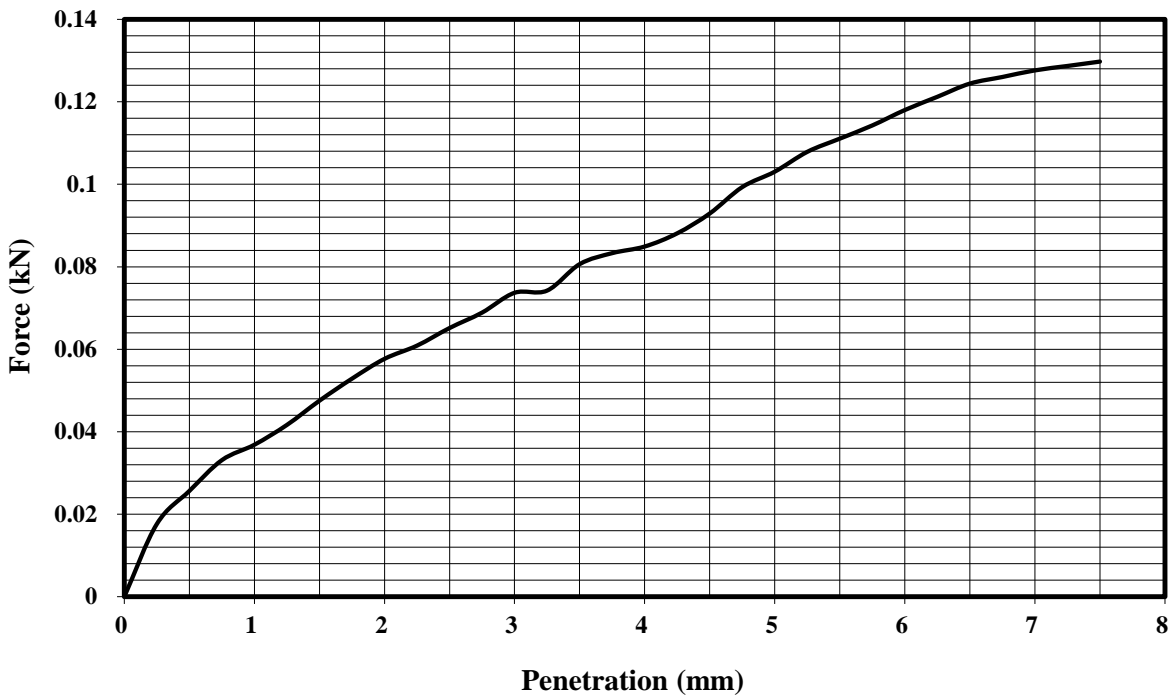
Client ref: 60509148
 Location: St Athan Northern Access Road GI
 Contract Number: 33562-
 Sample Type: B
 Hole Number: SK508
 Sample Number: N/A
 Depth (m): 0.50 - 0.95
 Description: Brown silty CLAY.

Initial Sample Conditions		Test Conditions		Method of Compaction:	
Moisture Content:	38	Surcharge Kg:	2.0	2.5kg Rammer	
Bulk Density Mg/m3:	1.79	Soaking Time (hrs):		Final Moisture Content %	
Dry Density Mg/m3:	1.30	Swelling mm:		Sample Top	38
C.B.R. Value %	Sample Top		0.52	Sample Bottom	38
Percentage retained on 20mm BS test sieve:	0	Remarks:

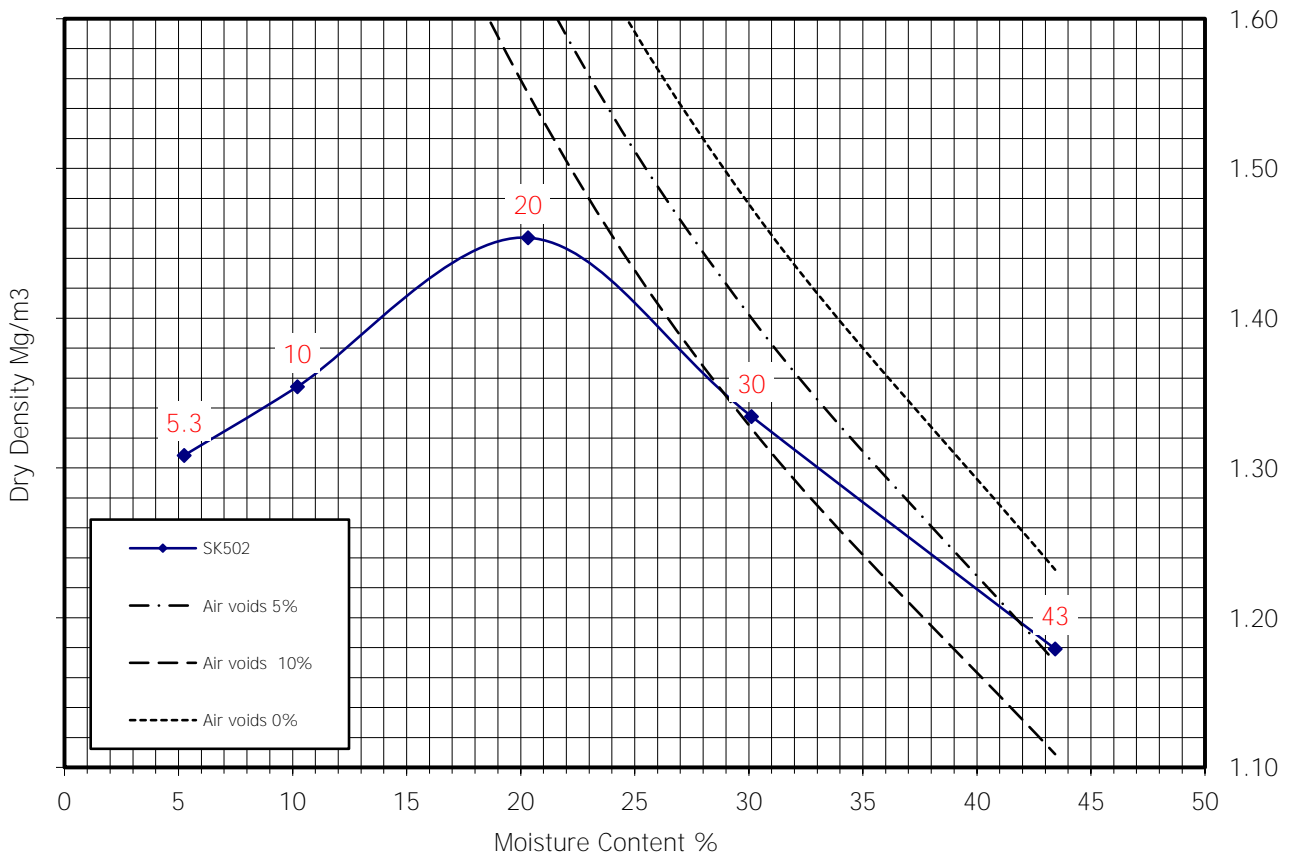
Client ref: 60509148
 Location: St Athan Northern Access Road GI
 Contract Number: 33562-
 Hole Number: SK502
 Sample Number: N/A
 Depth (m): 0.35 - 0.70
 Sample Type: B
 Description: Brown silty organic CLAY.

Compaction Point:	1	2	3	4	5
Moisture Content:	5.3	10	20	30.1	43.4
Bulk Density (Mg/m ³):	1.38	1.49	1.75	1.74	1.69
Dry Density (Mg/m ³):	1.31	1.35	1.45	1.33	1.18

Initial Moisture Content:	43	Method of Compaction:	2.5kg Rammer
Particle Density (Mg/m ³):	2.65 Assumed	Material Retained on 37.5 mm Test Sieve (%):	0
Maximum Dry Density (mg/m ³):	1.45	Material Retained on 20.0 mm Test Sieve (%):	0
Optimum Moisture Content (%):	20	Sample Preparation Clause:	3.2.4.1

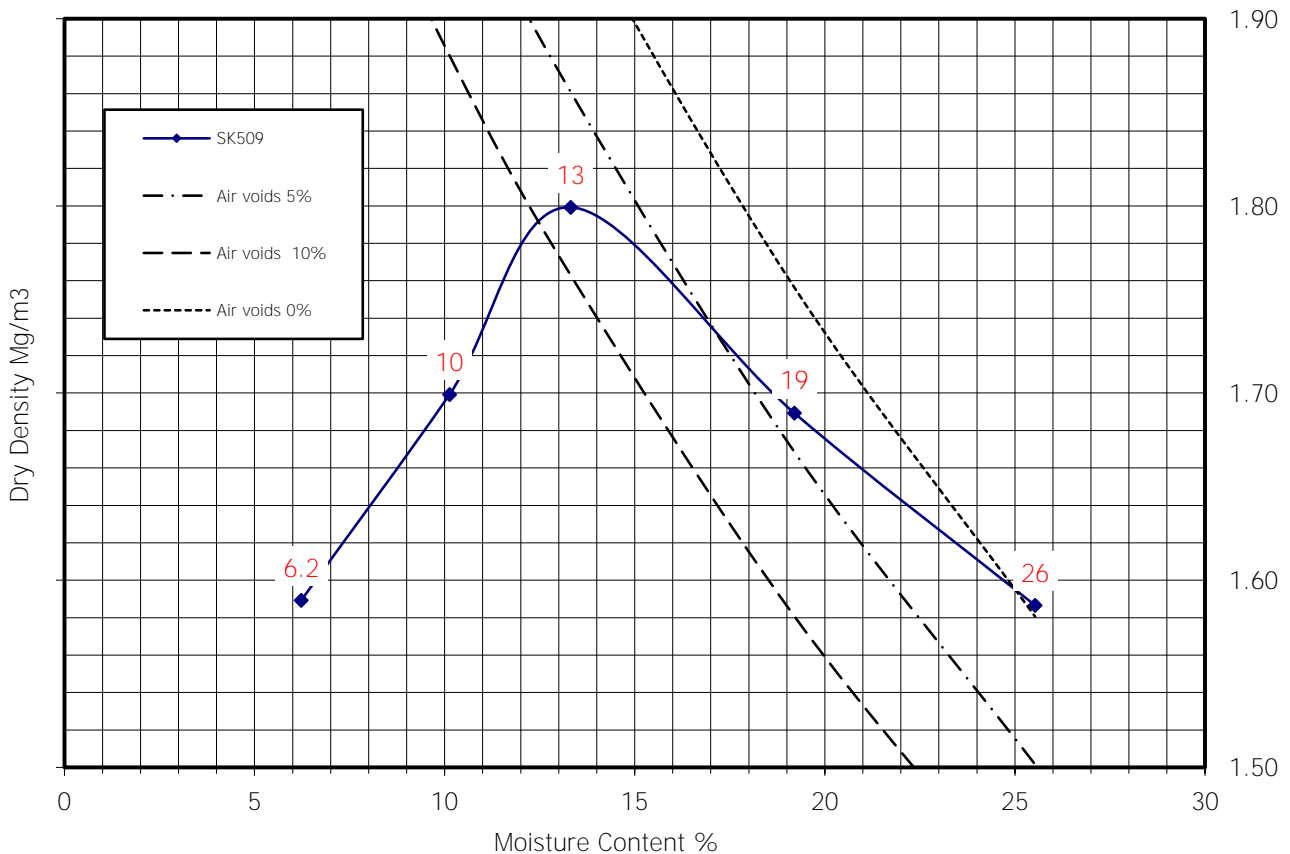
Client ref: 60509148
 Location: St Athan Northern Access Road GI
 Contract Number: 33562-
 Hole Number: SK509
 Sample Number: N/A
 Depth (m): 0.35 - 0.80
 Sample Type: B
 Description: Brown gravelly silty CLAY.

Compaction Point:	1	2	3	4	5
Moisture Content:	6.2	10	13	19.2	25.5
Bulk Density (Mg/m ³):	1.69	1.87	2.04	2.01	1.99
Dry Density (Mg/m ³):	1.59	1.70	1.80	1.69	1.59

Initial Moisture Content:	25	Method of Compaction:	2.5kg Rammer
Particle Density (Mg/m ³):	2.65 Assumed	Material Retained on 37.5 mm Test Sieve (%):	8.2
Maximum Dry Density (mg/m ³):	1.80	Material Retained on 20.0 mm Test Sieve (%):	4.6
Optimum Moisture Content (%):	13	Sample Preparation Clause:	3.2.4.2
