St. Athan Northern Access Road Preliminary Sources Study Report

Prepared for: Welsh Government

Prepared by: AECOM Limited

Project Number: 60509148
Document ref.: 60509148/PSSR

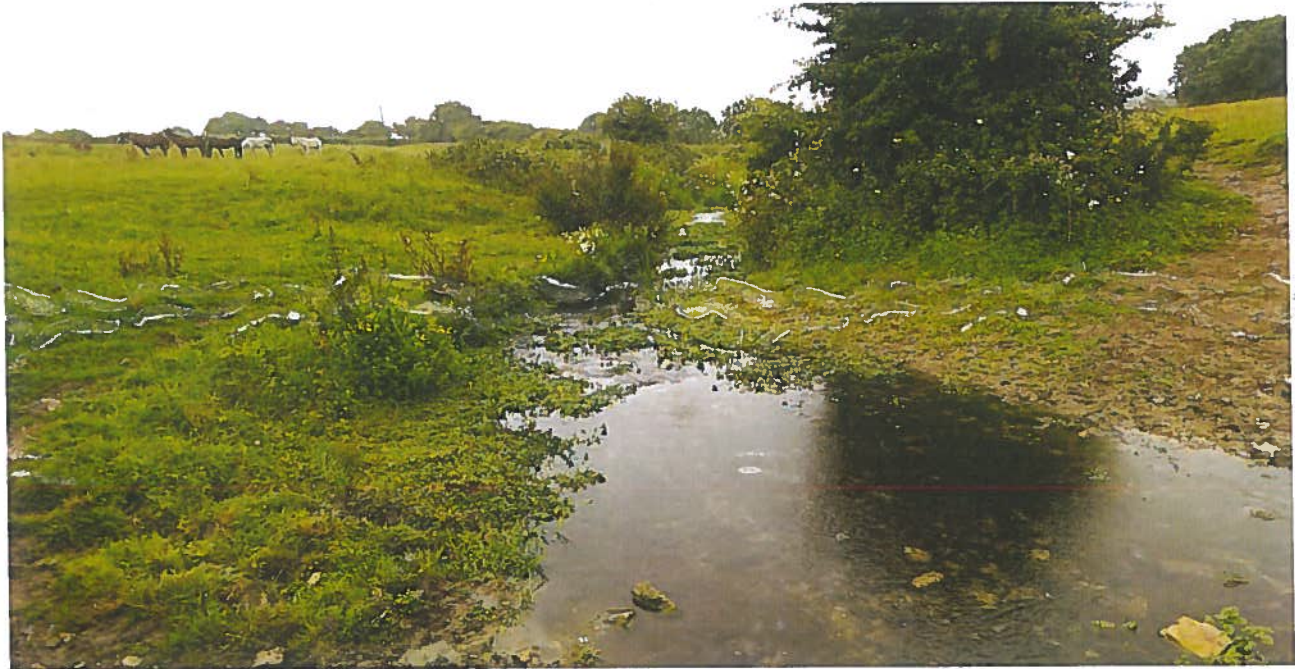
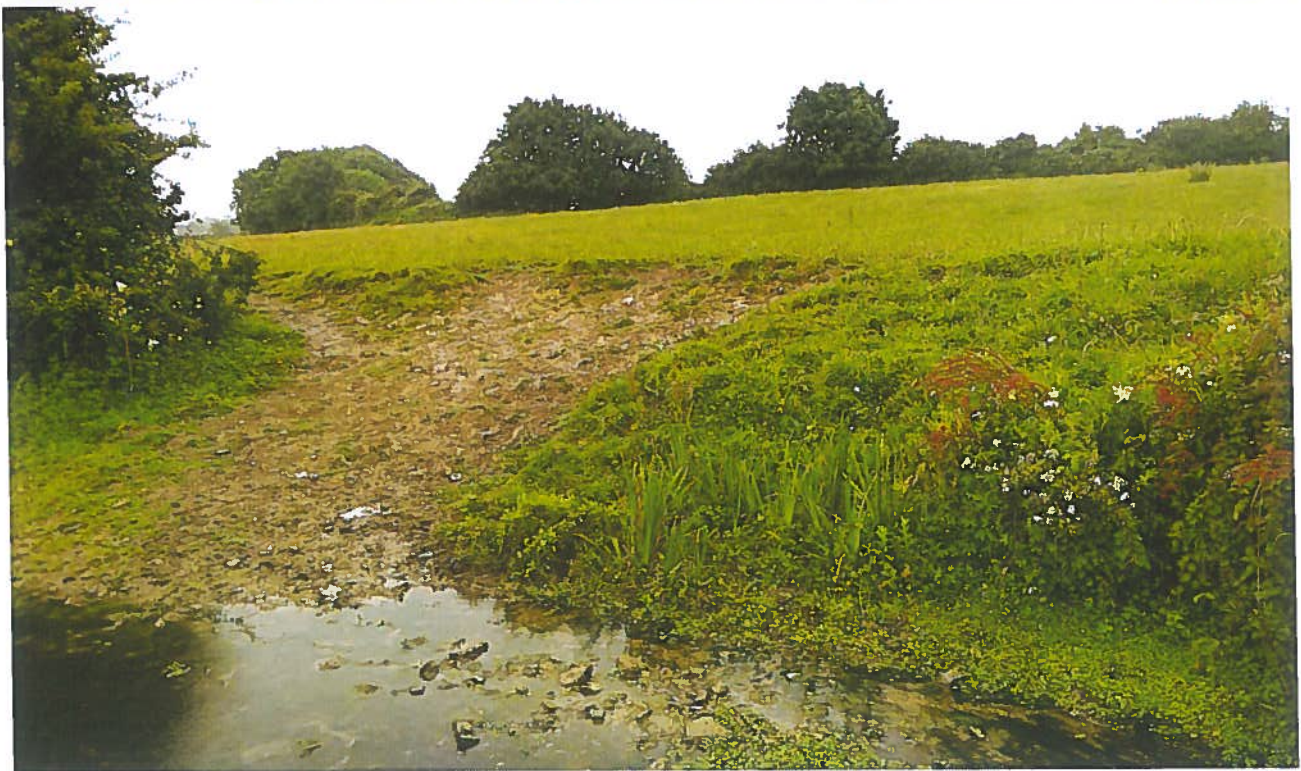
Photos 1 and 2 Llanmaes Brook looking South (photo 1) and west showing embankment along the brook (photo 2)

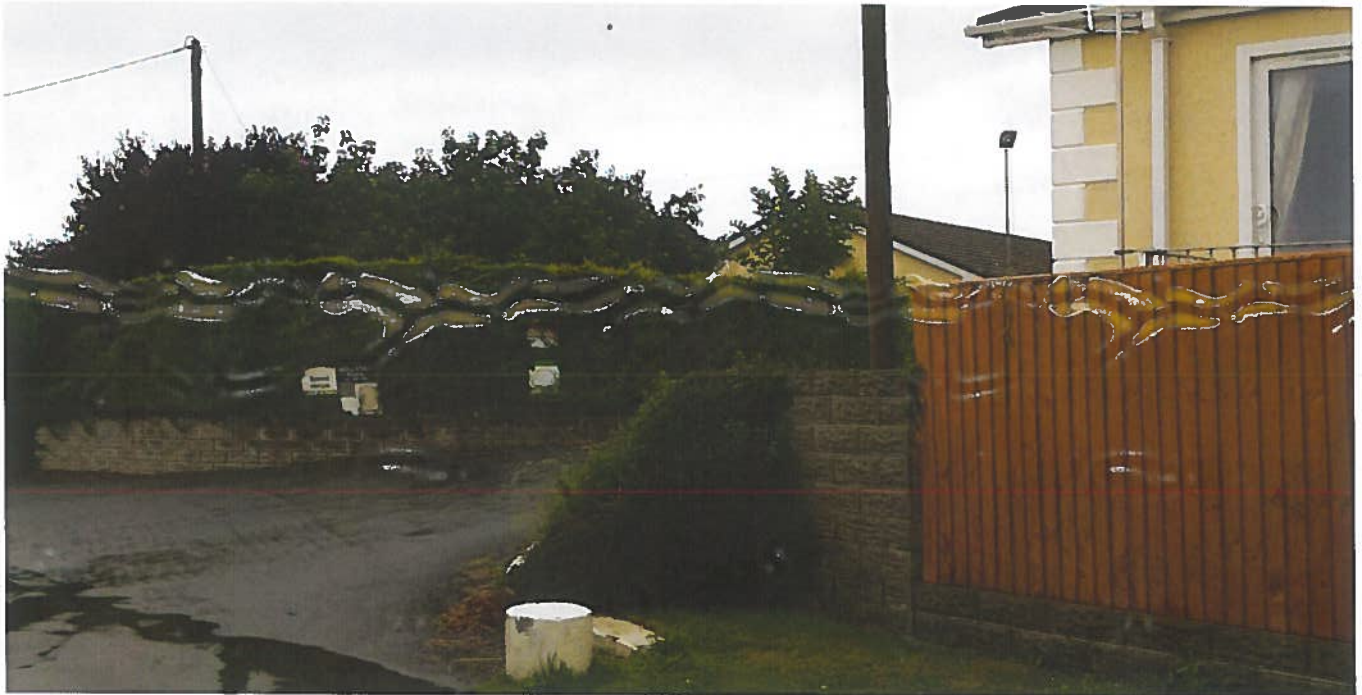
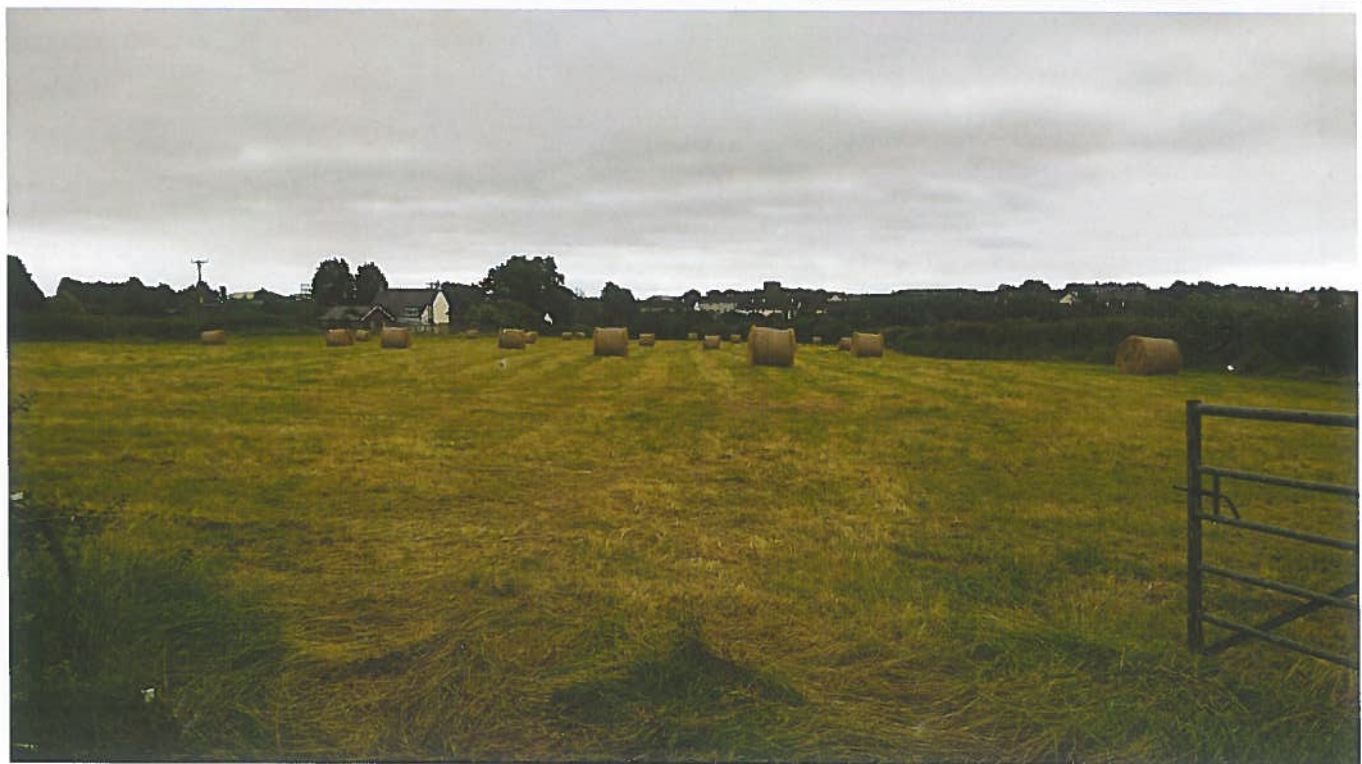
Photos 3 and 4 Millands Caravan Park approx. 30m south of and field in the vicinity of Ch. 900m

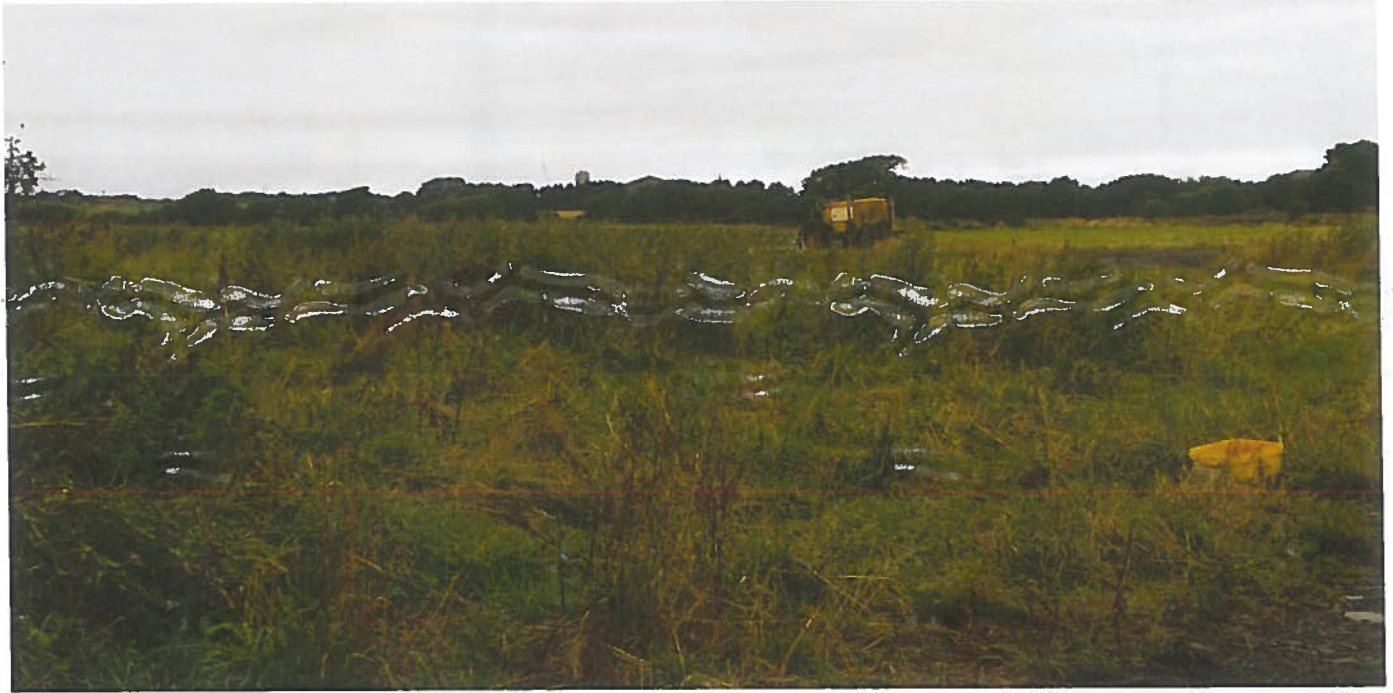
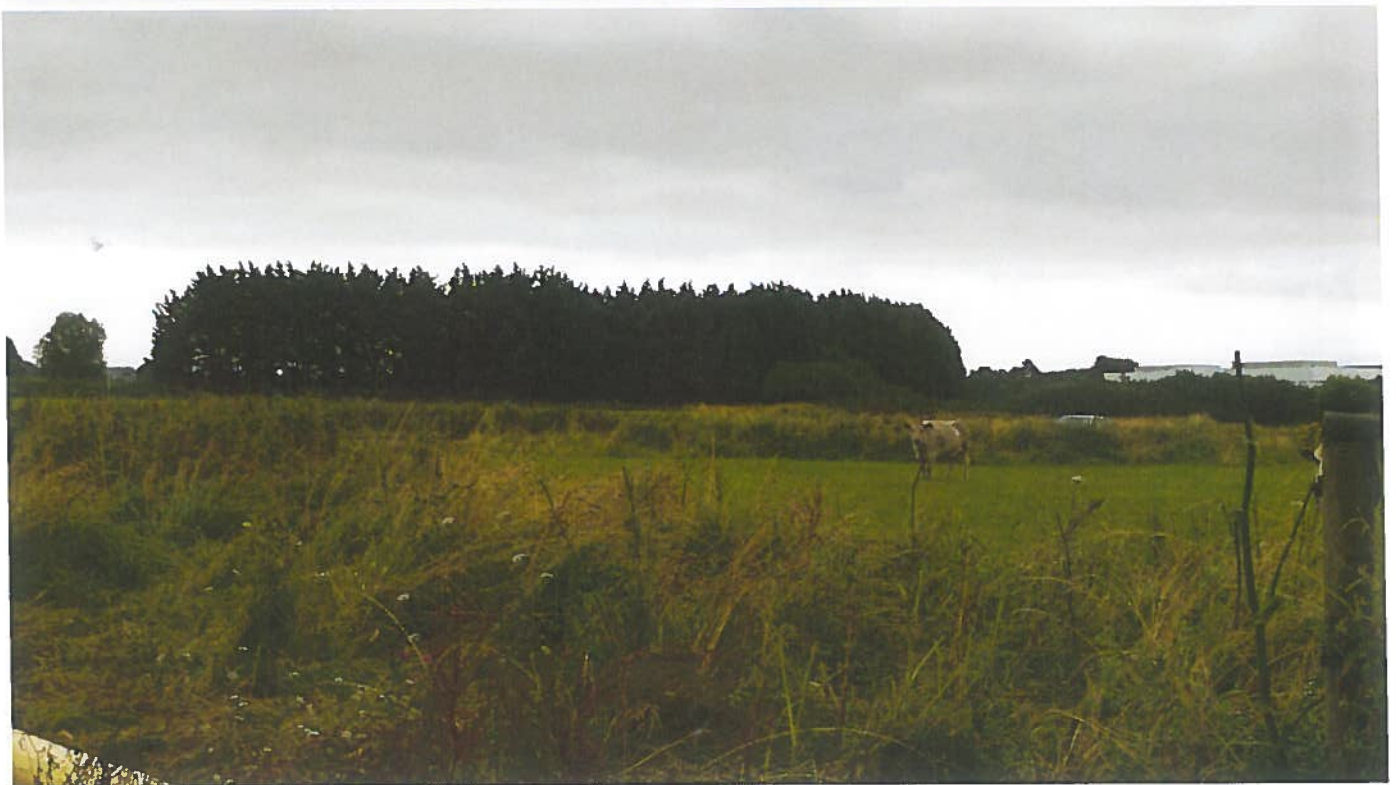
Photos 5 and 6 Proposed location of road alignment (Ch.1550m)

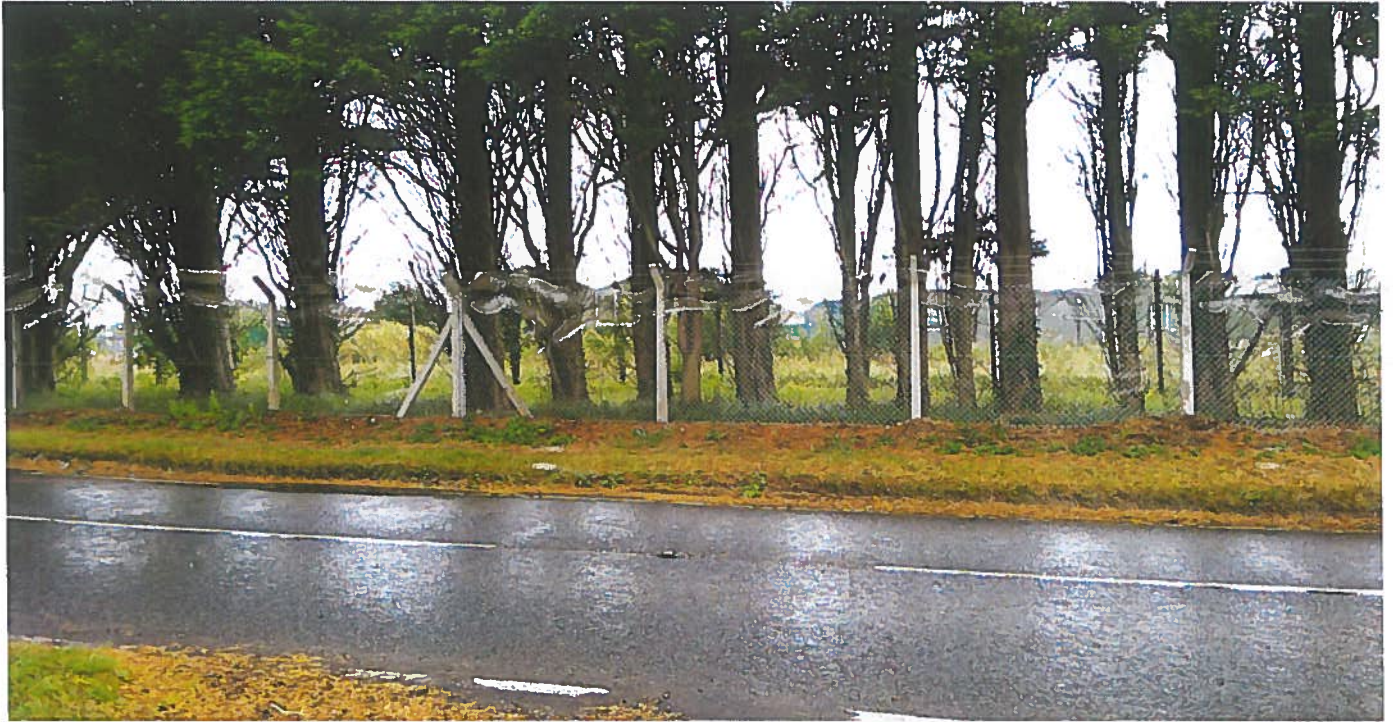
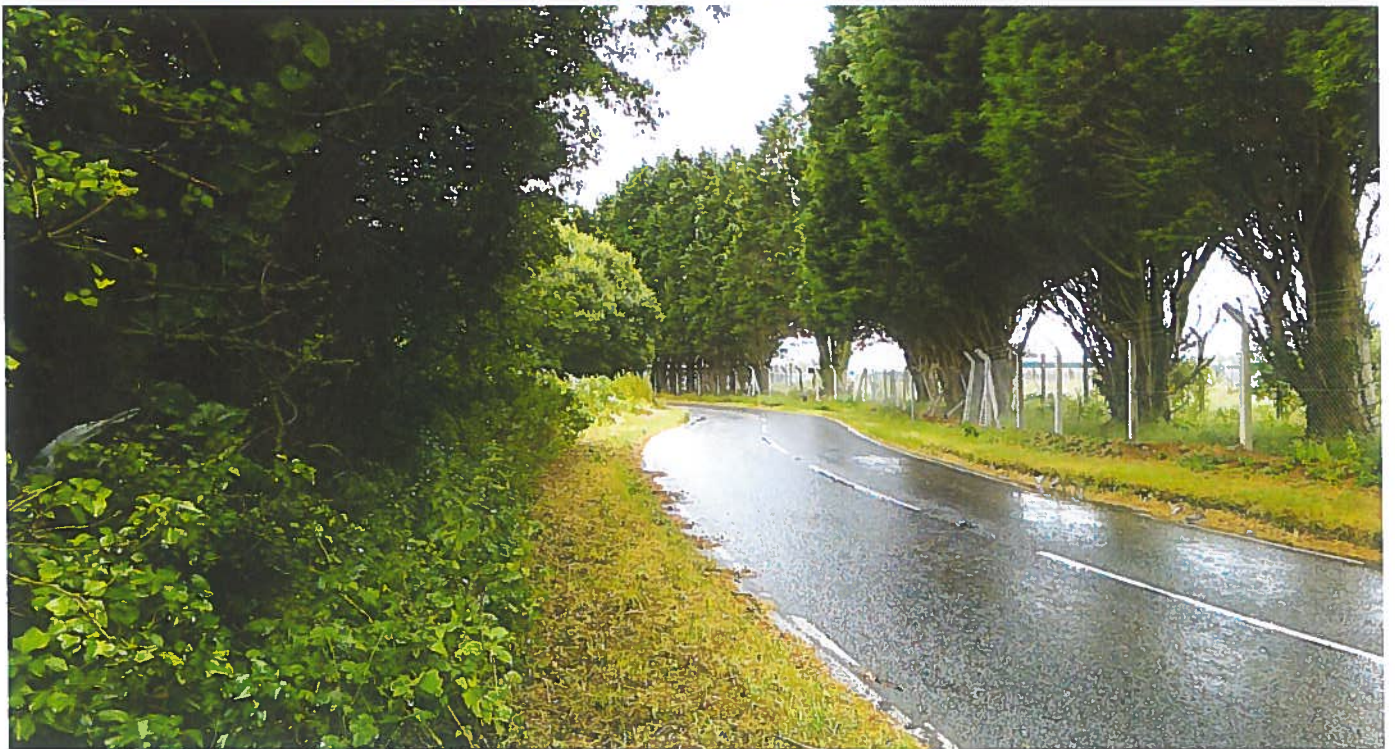
Photos 7 and 8 Eglwys Brewis Road in vicinity of proposed tie-in. St. Athan MOD base is located south of fence.
