**GEOTECHNICAL &
GEO- ENVIRONMENTAL REPORT**
PROPOSED RESIDENTIAL DEVELOPMENT ON
LAND OFF CAERLEON ROAD,
DINAS POWYS

**Prepared for:
Kier Living Ltd**

April 2017

Job No: 12224

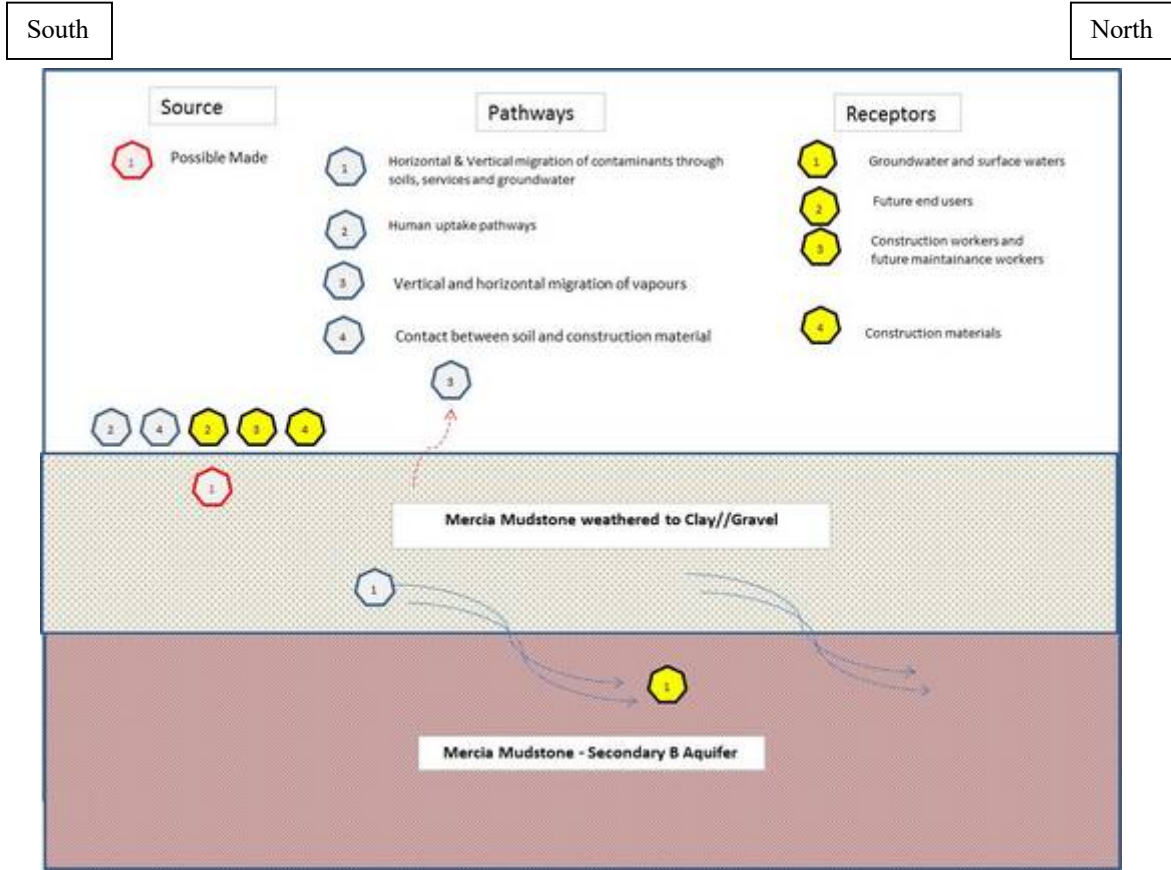
The preceding sections enable a preliminary conceptual model of the site to be drawn up.

Below is a theorised conceptual model of the site. The drawing is generalised and not to scale.

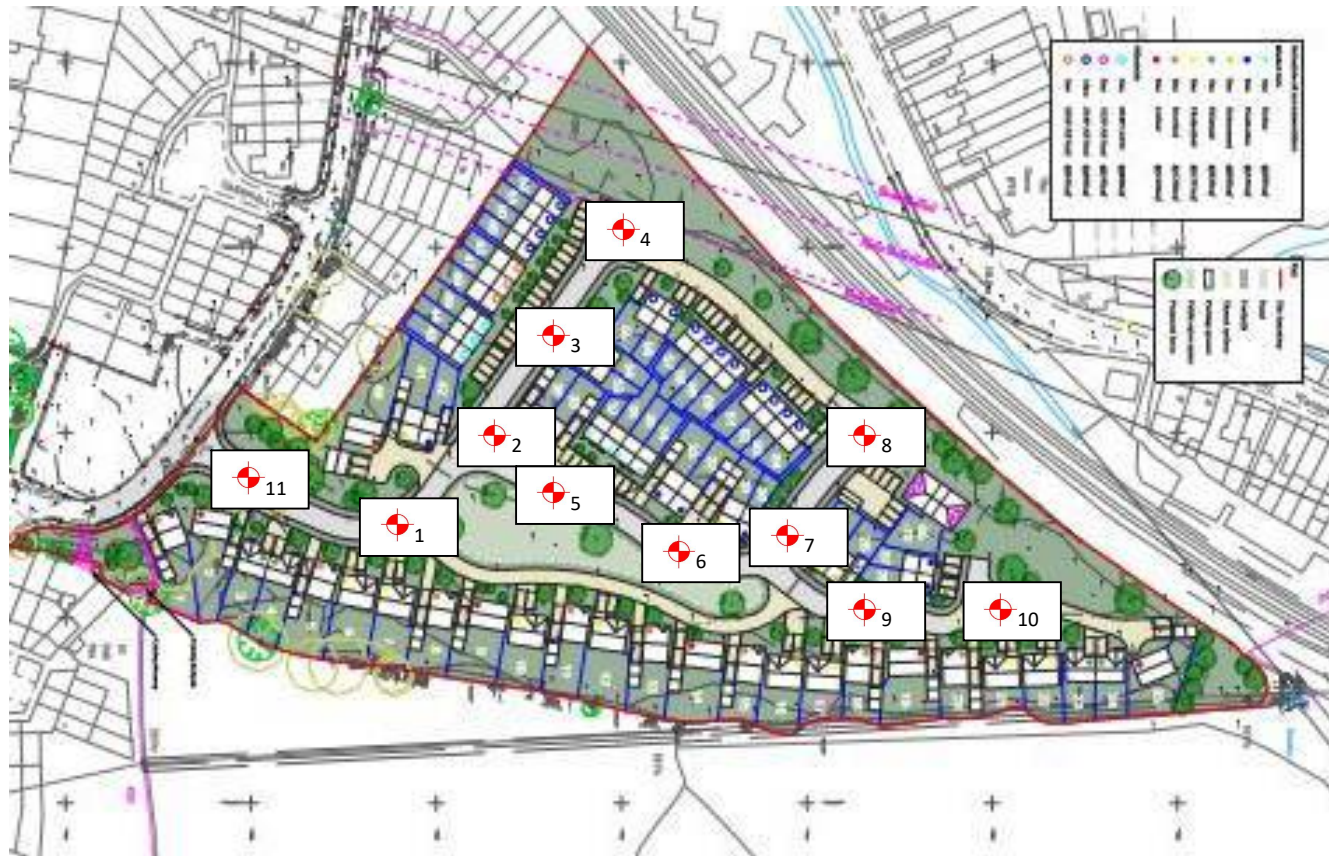
TP/SA = Combined trial pit and soakaway
