Vale of Glamorgan Schools - Pencoedtre High School

Bat Roost Survey Report

Project number: 6057132

November 2018

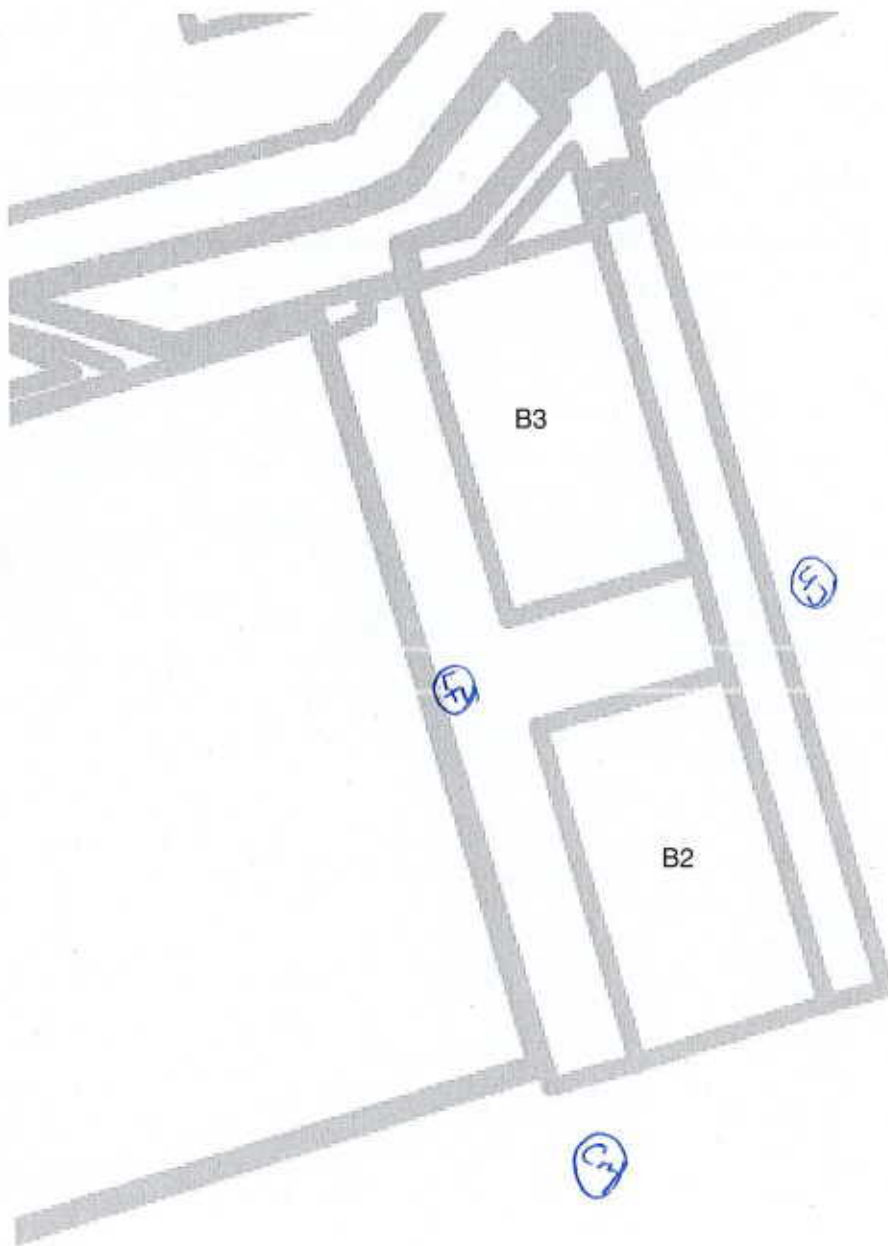
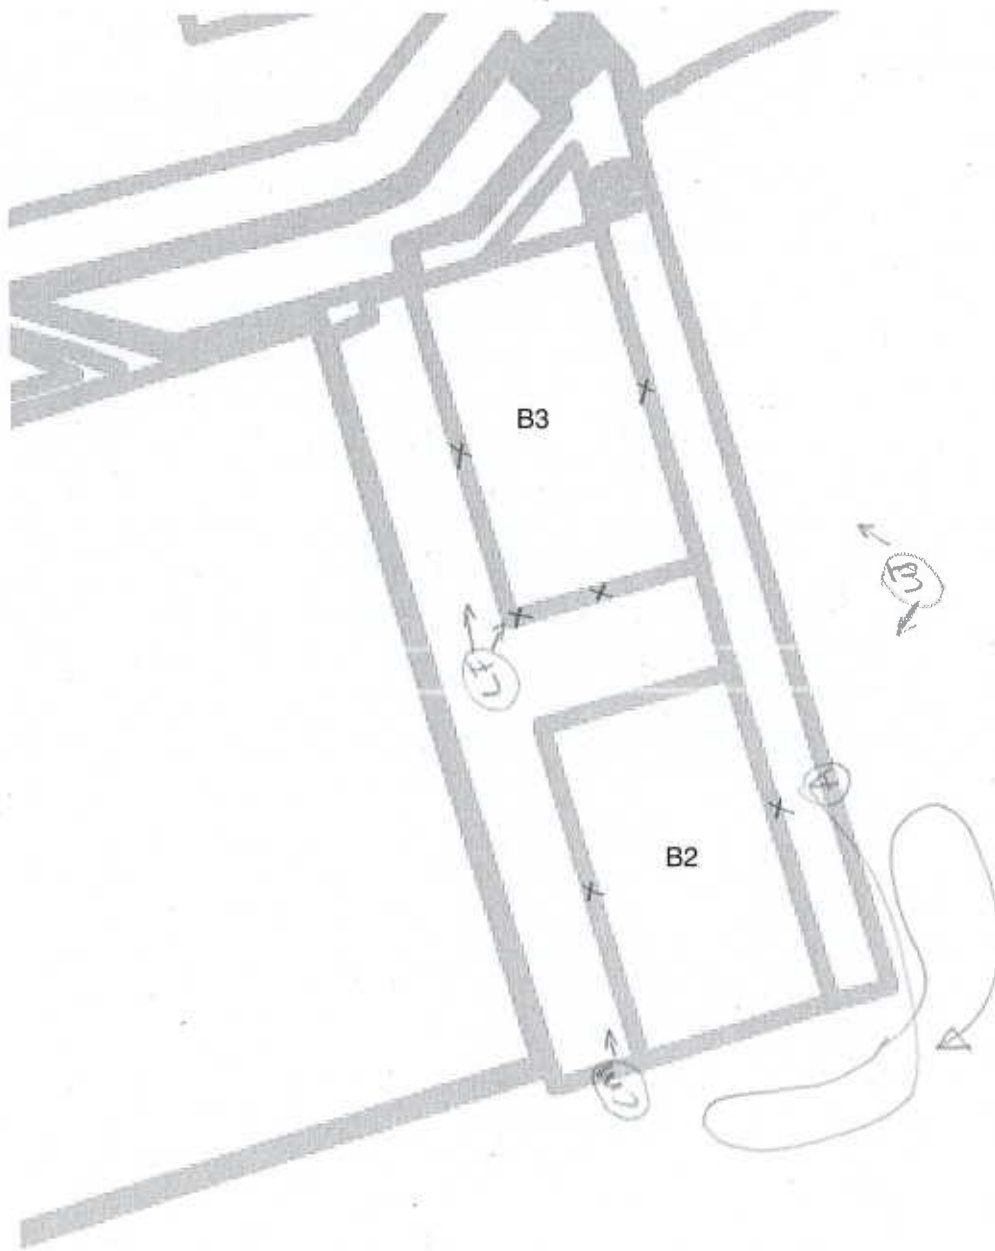
Pencoedtre B2 & B3

NO ROOST

X - FACES OR CORNERS
W/ BRP FEATURES

FLOODLIGHT ON BUILDING
BEHIND SPILLING ON TO
EAST FACE OF B2 + B3.
Photos:

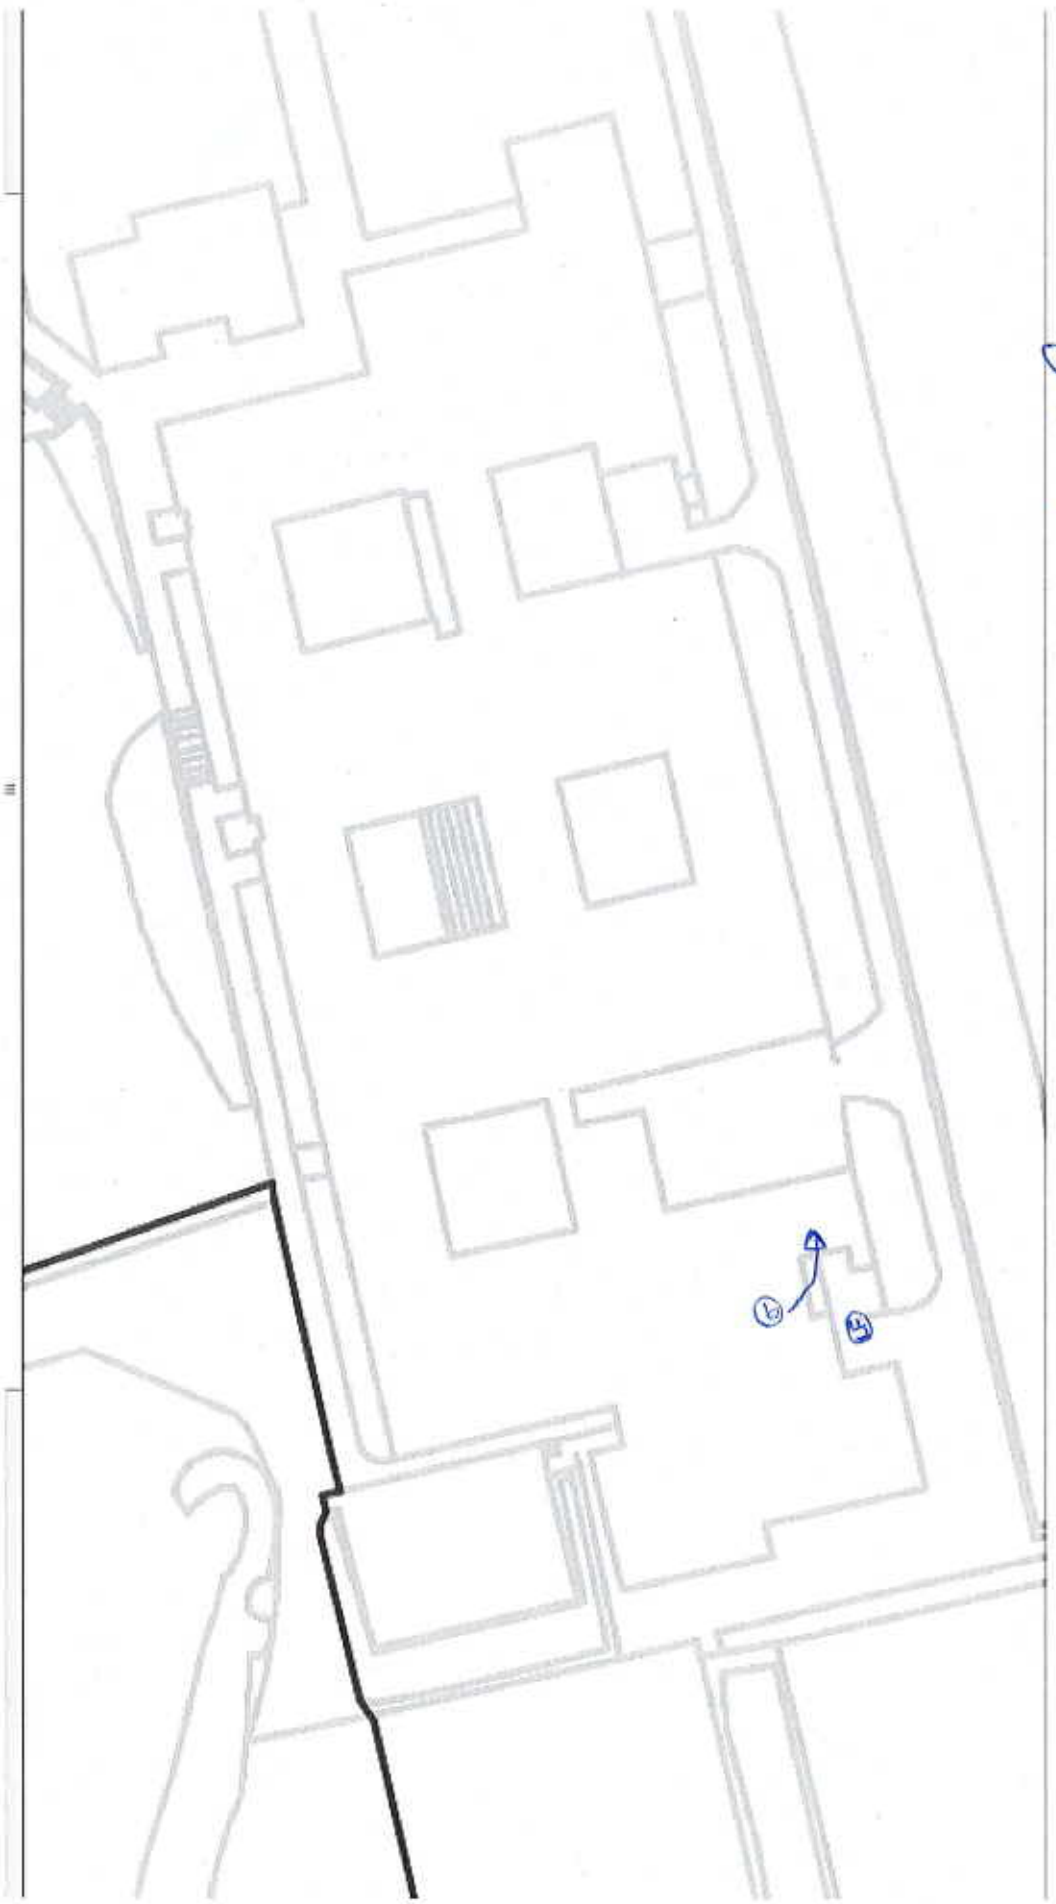
Pen B1 - dusk Mon.
30/07/18. Lucy Foster.

Lighting inside building + security light outside.

No boost.

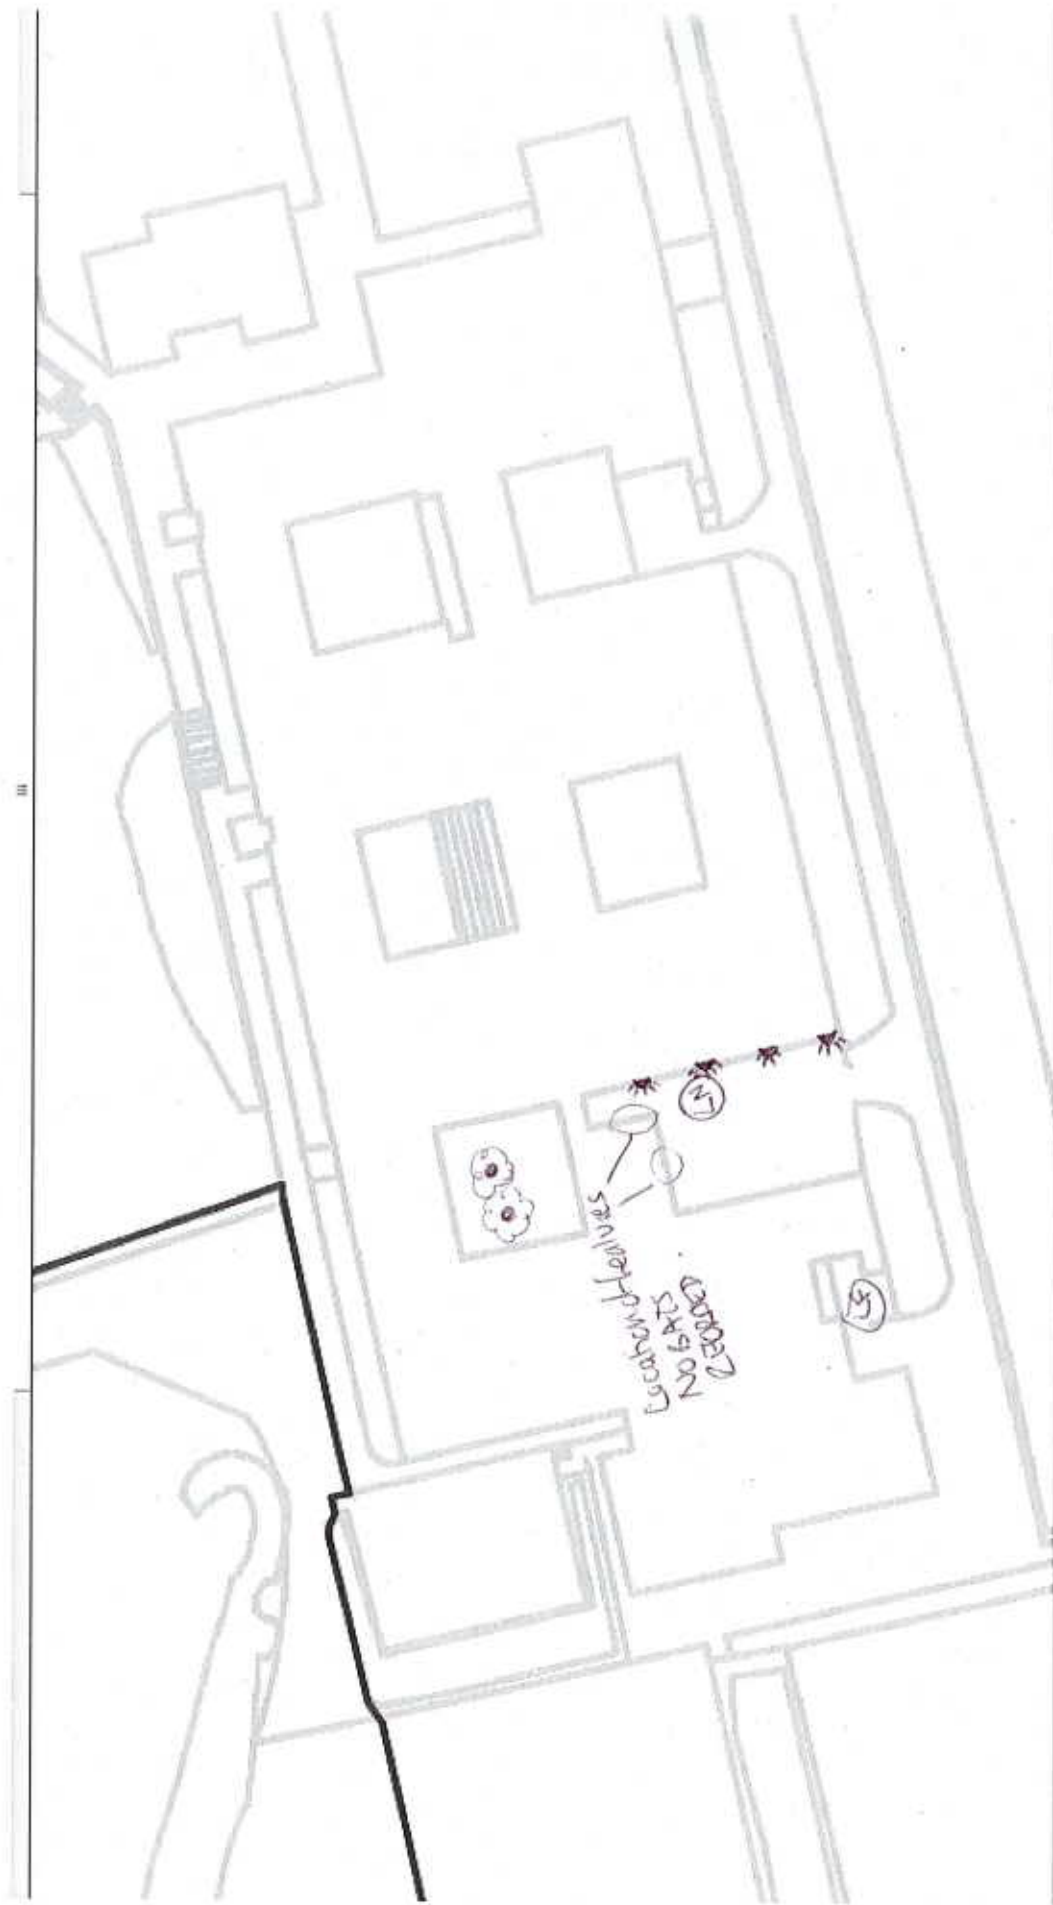
PENCOETTERIE BAT SURVEY BUILDING 1

- NO BAT ACTIVITY
- NO BAT ROOSTS.

30-07-18
Dusk. LNASH.
Covering future
about window +
facia board
