St David's Church In Wales Primary School

Bat Roost Survey Report

Vale of Glamorgan Council

Project number: 60607805

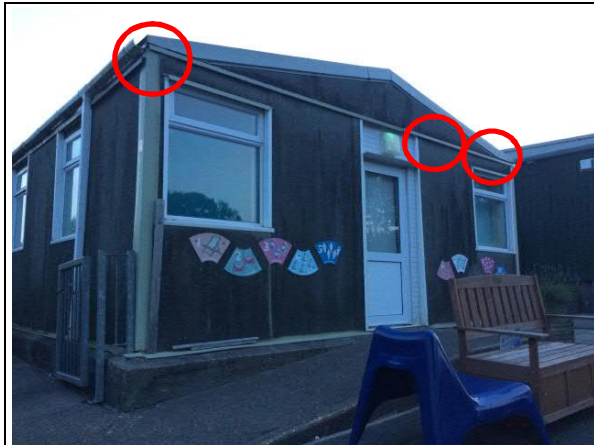
The existing St David's Primary School supports a non-maternity roost of two common pipistrelle bats located in Building 2 (Figure 2). Common pipistrelle bats are a common and widespread species. The building does not support a roost of rare bats or a roost of high conservation value. The roost entrance is located on the south face of the building (Appendix A, Photographs 1 and 2).

Photograph 1: Building 2 – south face. Roost entry / emergence location circled, beneath gable end fascia board.

Demolition of Building 2 will require a European Protected Species Licence (EPSL).

To mitigate for this loss, two (loss + one) compensatory roost crevices/ bat boxes will be installed in the new school building.

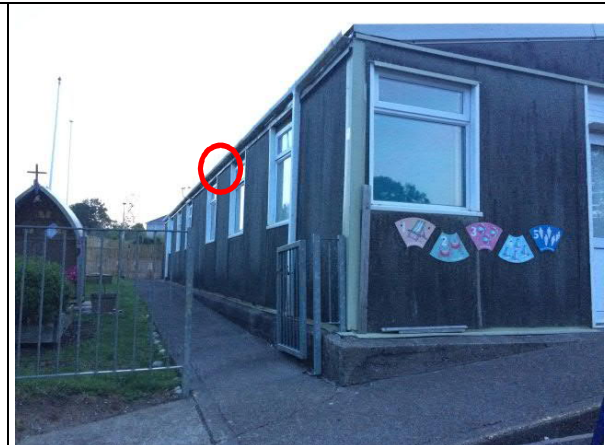
Photograph 2: Building 2 - west face. Roost re-entry on 02/08/2019 location circled.

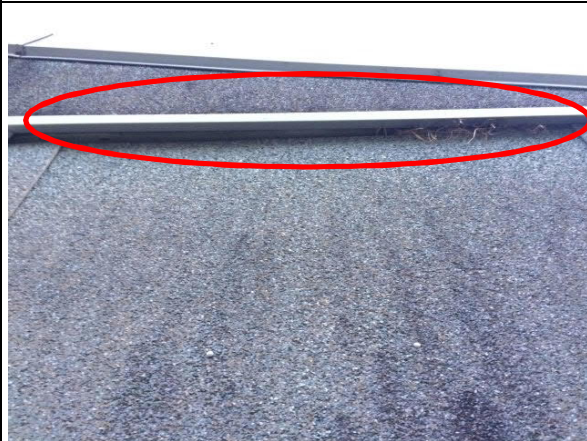
Photograph 3: Building 2 – South face. Roost entry / emergence location, beneath gable end fascia board. This feature is also used by nesting house sparrow (nest material can be seen).

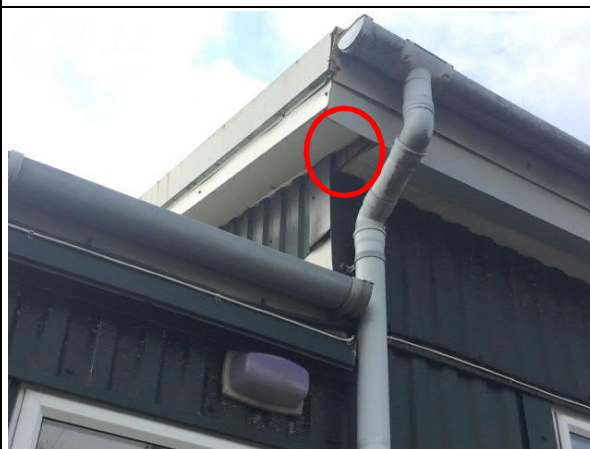
Photograph 5: Building 1. Potential roost features - Gap between soffit. Not roosting activity recorded.

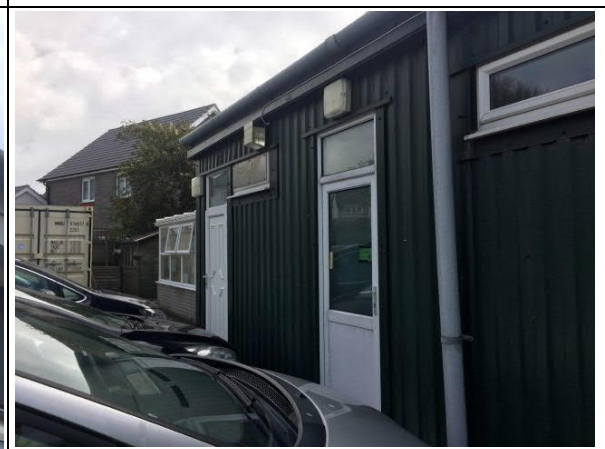
Photograph 6: Building 1 .

Building No.	Survey Date	Roost Results	Ad-Hoc Bat Activity Results
B1	18/06/2019	No roost - No bats were recorded emerging. Appendix A – Photographs 5 and 6	Common pipistrelles frequent, occasional soprano pipistrelles, seen foraging and commuting around site boundaries and along hedgerow on western site boundary and along the lane/hedgerows outside the site. Occasional noctules and serotine foraging and commuting over the Site. One call with characteristics of Leisler's was identified.
B2	18/06/2019	Confirmed Roost. (21:57) At least one common pipistrelle emerged from corner of the fascia on south side of building and flew along the hedgerow, 25 minutes after sunset. Appendix A – Photographs 1, 2 and 3.	Common pipistrelles frequent, occasional soprano pipistrelles, seen foraging and commuting around site boundaries and along hedgerow on western site boundary and along the lane/hedgerows outside the site. Occasional noctules and serotine foraging and commuting over the Site.
